Basslink Condition Assessment

PAU0359-REPT-001

06 September 2023

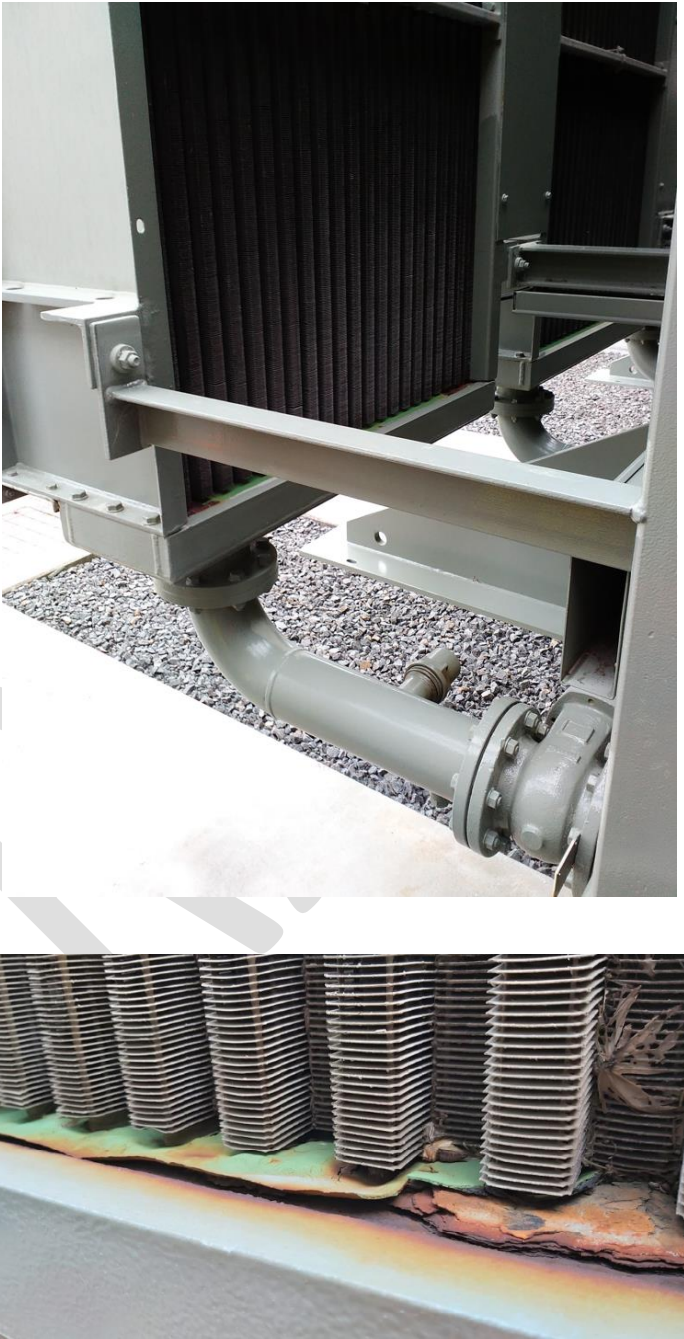
- **Converter Station Equipment:** The in-service and spare converter transformers at both George Town and Loy Yang display corrosion on the inside bottom of the cooling fins steel header attached oil/air coolers.

Asset Area	Image 1
Converter Station Equipment	<p data-bbox="635 367 1155 398">Converter transformers attached oil/air coolers</p>

3. **Converter Transformer:** The in-service and spare converter transformers at both George Town and Loy Yang display corrosion on attached oil/air coolers. Localised repair options are currently being investigated with indicative costs, as we understand based on site discussions, for full replacement radiators being in order of AUD \$2.0 million. If a radiator were to develop an oil leak, it can be individually isolated for repair, while allowing the other three coolers to continue operating. Subject to confirmation, our understanding is that only three of the four cooling circuits are required for rated operation i.e., one is redundant.

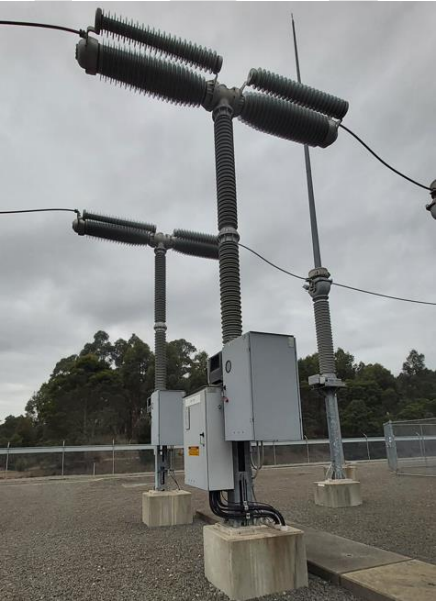
Asset Area	Image 3
Converter Station Equipment	<p data-bbox="695 1041 1091 1070">220 kV AC Circuit Breaker in AC Yard</p>

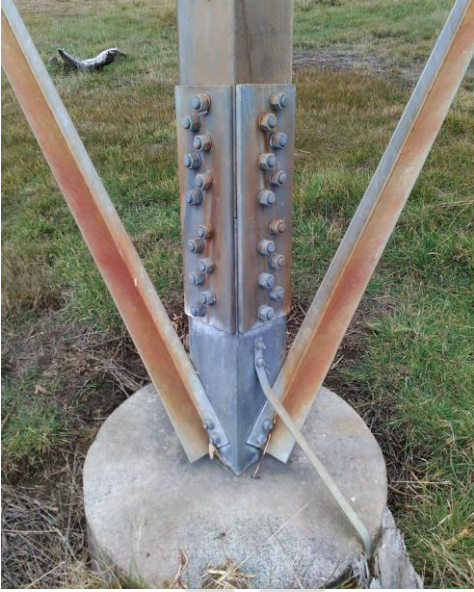
- **AC and HVDC overhead transmission lines:** Some of the galvanised steel transmission line towers and hardware, especially those close to the sea, are showing signs of deterioration of the galvanising and minor onset of rust break through. Only some structures are impacted, and the mitigation applied would be specific to each affected tower.

Asset Area	Image 4
AC and HVDC Overhead Transmission Lines	<p data-bbox="699 297 1098 324">Transmission Tower -Light corrosion</p>

1. **Overhead lines:** Some of the coastal towers and line hardware are displaying signs of corrosion, with this being identified in the 2021 [2] and 2023 [3] line inspection reports. This will require regular inspection and remediation. If not already actioned, it is recommended that a corrosion mitigation/hardware replacement program be initiated. The mitigation would be specific to each affected tower and could include replacement of individual steel members, replacement of bolts and hardware, paint system or application of cathodic protection. In general, it is stated in the 2023 inspection [3] report that the *“Overall condition of structures, insulators and hardware was good, with a few towers where works are recommended”* pp 11.
