AER Information Request

2025-30

Reference	Root Cause Analysis	Date	September 2024
Attachments to response	N/A

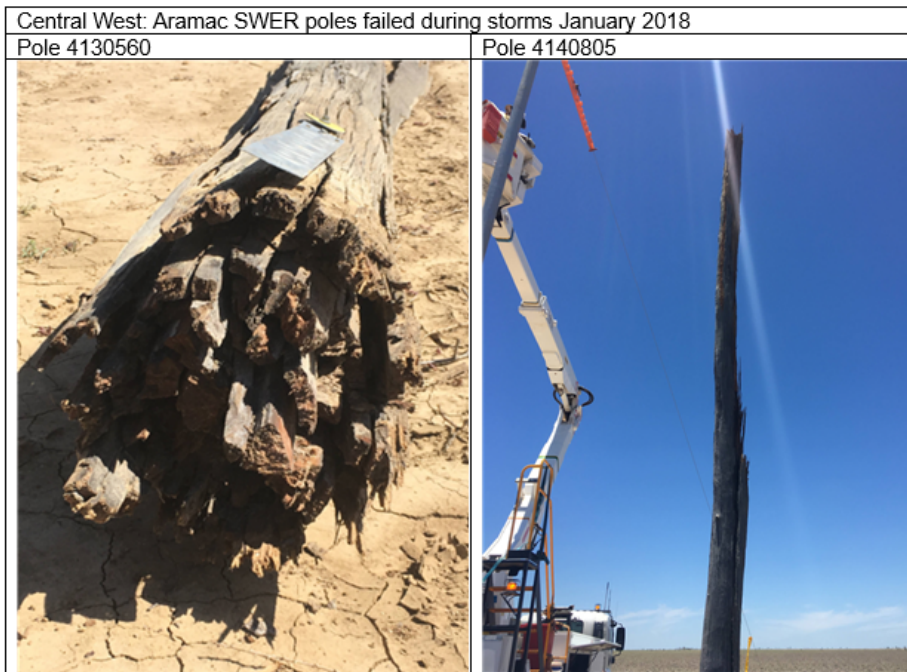
Figure 5 – Examples of unassisted 3kN pole failures

Figure 5 shows 2 of the 3kN unassisted pole failures that contributed to the review.

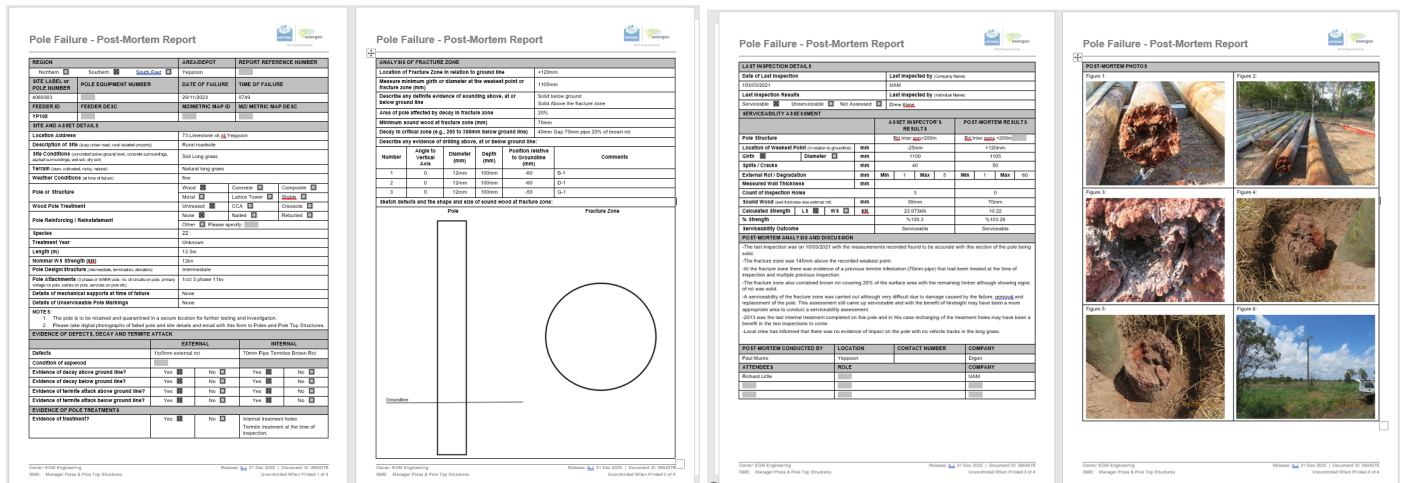
Figure 10 – Example of a pole failure post mortem.

In cases where the pole has been inspected within the 12 months prior to the failure, a formal post mortem is completed, generally by a pole inspection auditor, to compare results from the recent inspection in order to identify any issues with the quality of the inspection, specific inspector training requirements, process or system problems or reporting issues and recommend improvements. An example is shown in Figure 10.

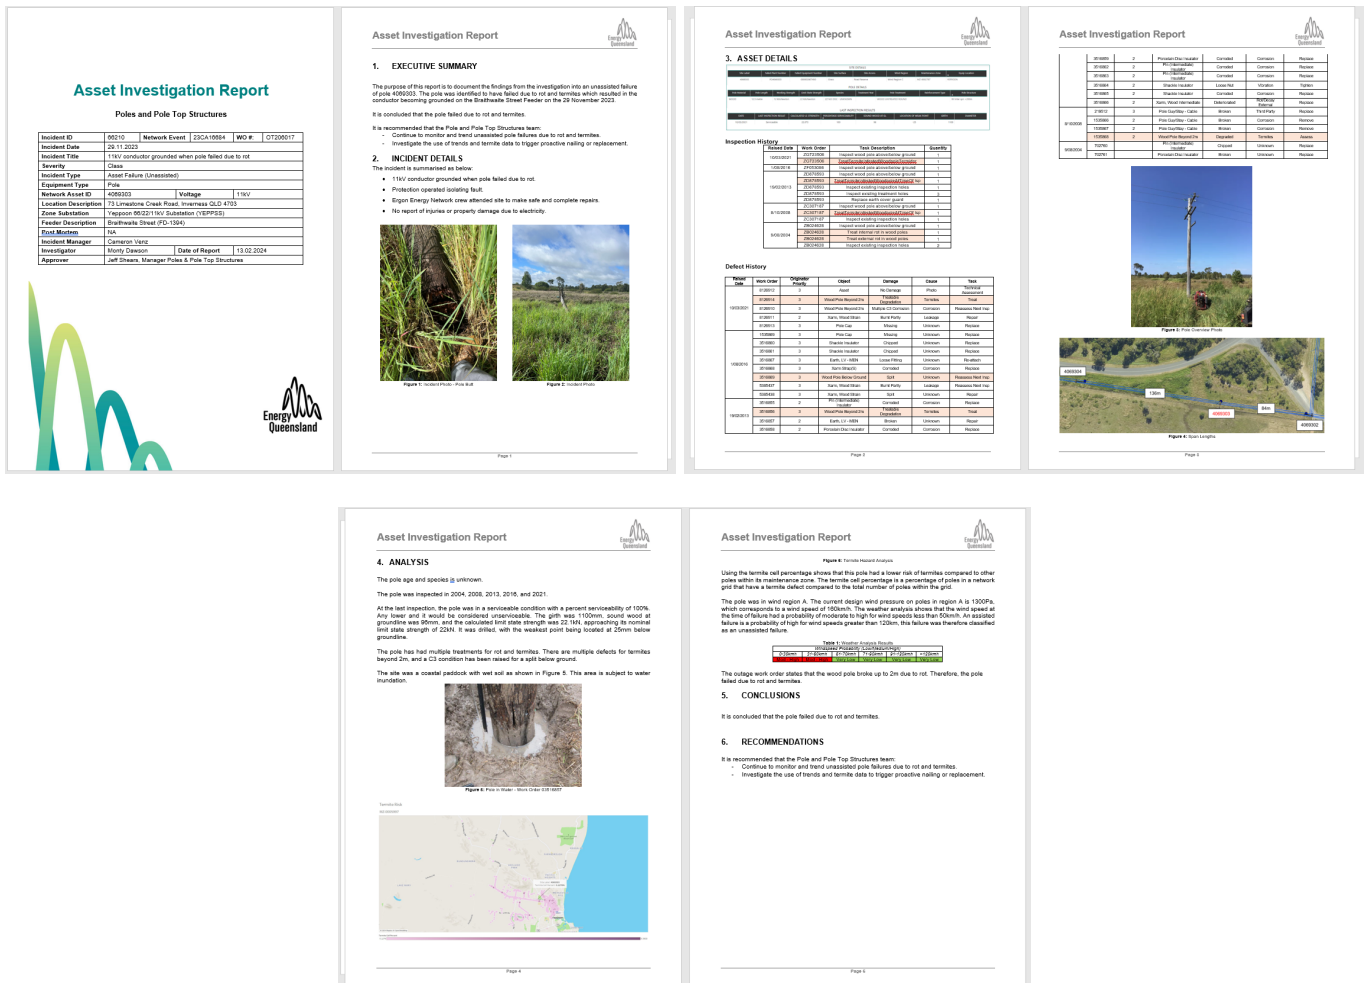
Figure 11 – Example of an unassisted pole failure investigation report

This post mortem information is combined with the other investigation information to determine clear conclusions around how and why the unassisted pole failure occurs and any recommendations for improvement actions. An example of an investigation report is shown in Figure 11.

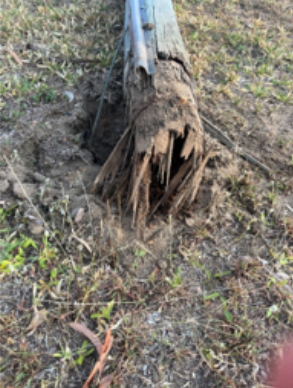
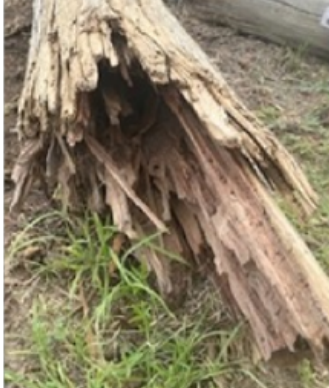
Site Label: 5071274 Inspection Date: 25 th November 2022 Failure Date: 30 th September 2024	Site Label: 5022043 Inspection Date: 21 st October 2019 Failure Date: 26 th October 2023

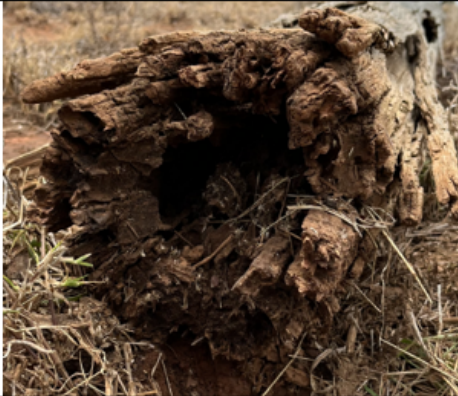
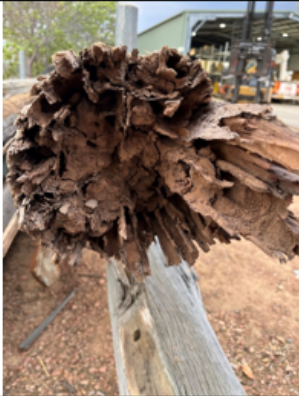
Site Label: 3103388 Inspection Date: 23 rd January 2020 Failure Date: 5 th November 2023	Site Label: 5234433 Inspection Date: 6 th September 2023 Failure Date: 17 th November 2023

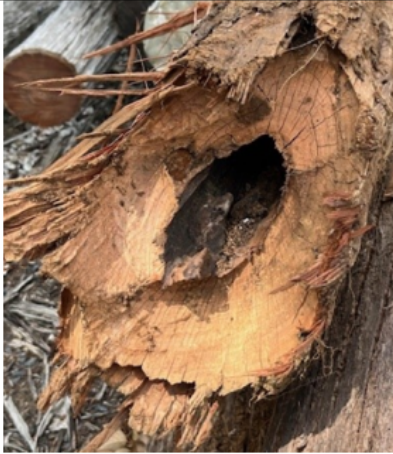
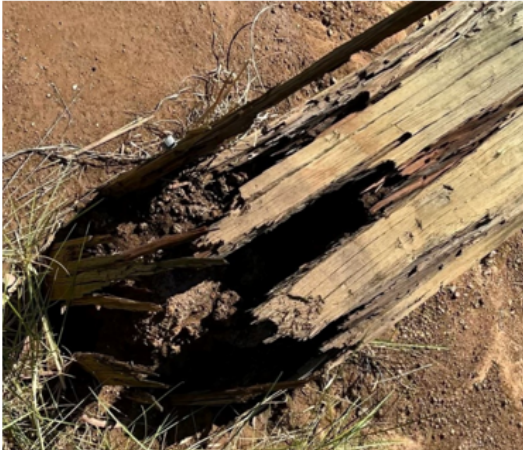
Site Label: 4226153 Inspection Date: 13 th April 2021 Failure Date: 7 th December 2023	Site Label: 5209341 Inspection Date: 17 th August 2018 Failure Date: 20 th October 2022

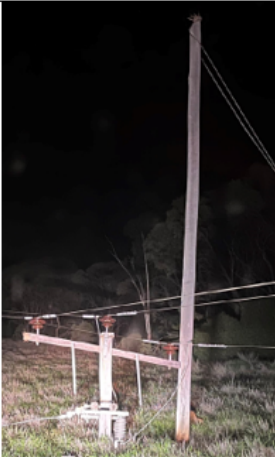
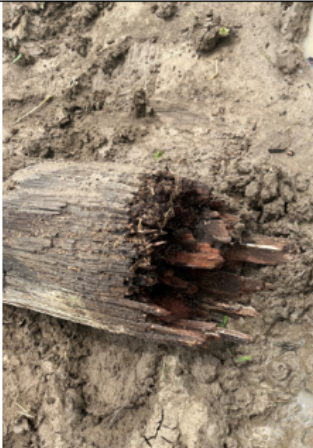
Site Label: 3193847 Inspection Date: 22 nd April 2020 Failure Date: 9 th December 2023	Site Label: 2074150 Inspection Date: 15 th September 2023 Failure Date: 1 st January 2024

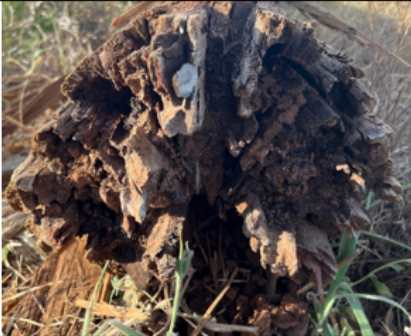
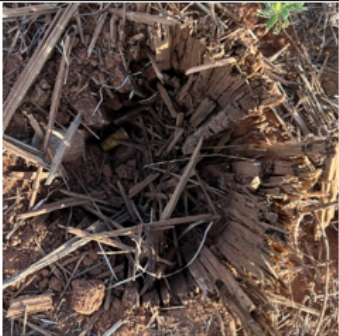
Site Label: 4225495 Inspection Date: 27 April 2018 Failure Date: 27 th January 2023

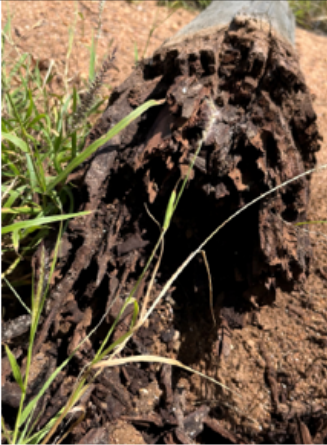
Site Label: 2118219 Inspection Date: 20 th September 2022 Failure Date: 8 th March 2023	Site Label: 3201281 Inspection Date: 9 th March 2021 Failure Date: 6 th January 2024

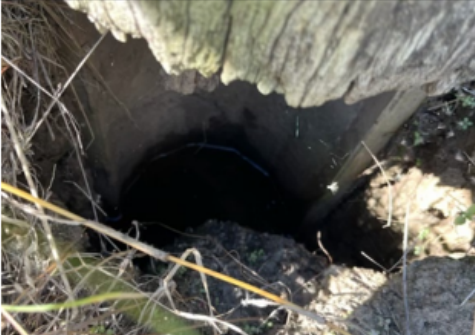
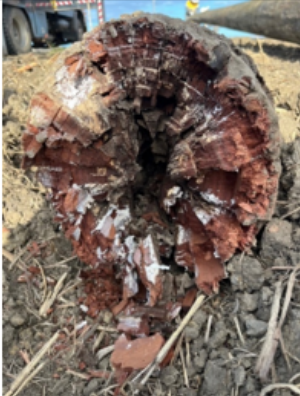
Site Label: 2091529 Inspection Date: 13 th May 2019 Failure Date: 14 th May 2024	Site Label: 3009730 Inspection Date: 8 th August 2023 Failure Date: 29 th September

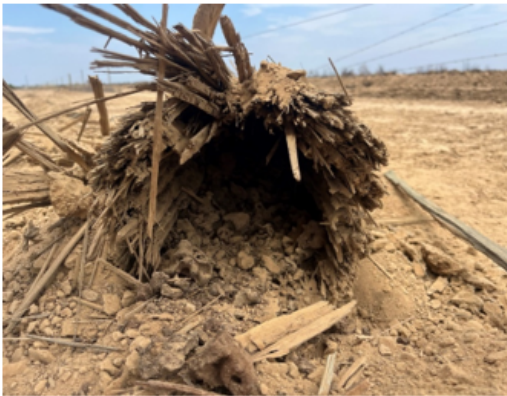
Site Label: 5022088 Inspection Date: 8 th October 2019 Failure Date: 11 th January 2024	Site Label: 2074519 Inspection Date: 12 th April 2024 Failure Date: 27 th September 2024

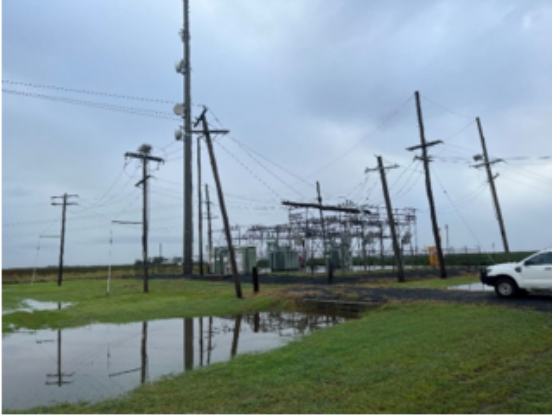
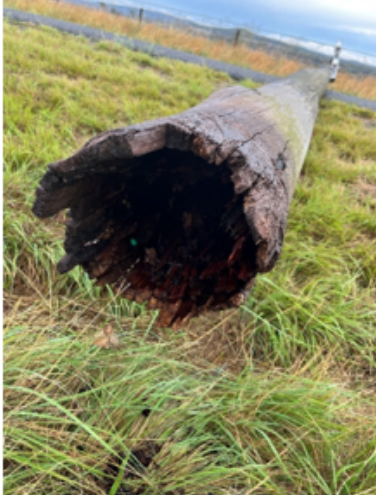
Site Label: 3145248 Inspection Date: 19 th January 2024 Failure Date: 7 th April 2024	Site Label: 3054189 Inspection Date: 27 th September 2022 Failure Date: 2 nd February 2023

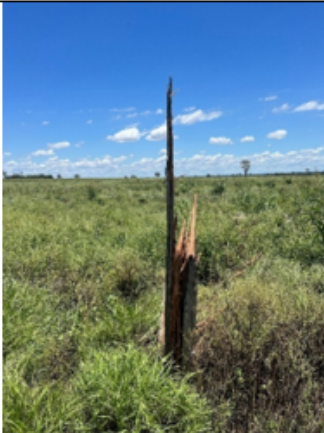
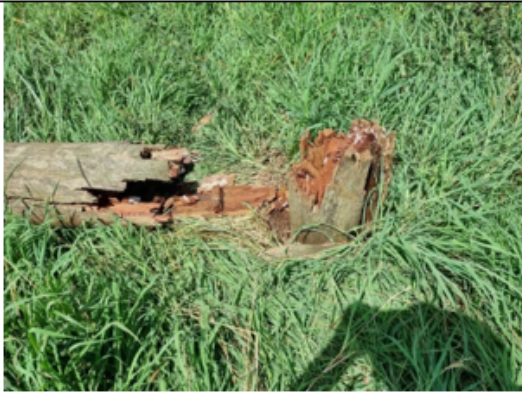
Site Label: 4125050 Inspection Date: 7 th September 2021 Failure Date: 13 th March 2023	Site Label: 5002190 Inspection Date: 11 th December 2020 Failure Date: 9 th April 2023

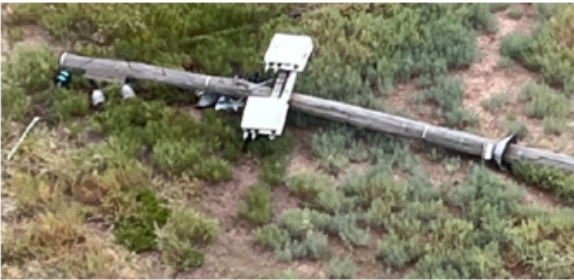
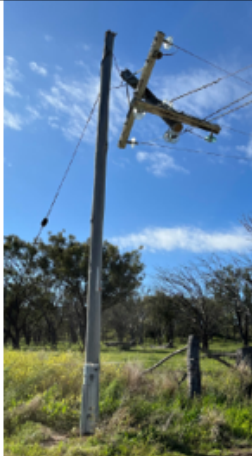
Site Label: 5090143 Inspection Date: 8 th October 2020 Failure Date: 8 th March 2023	Site Label: 3054101 Inspection Date: 4 th October 2022 Failure Date: 8 th October 2022

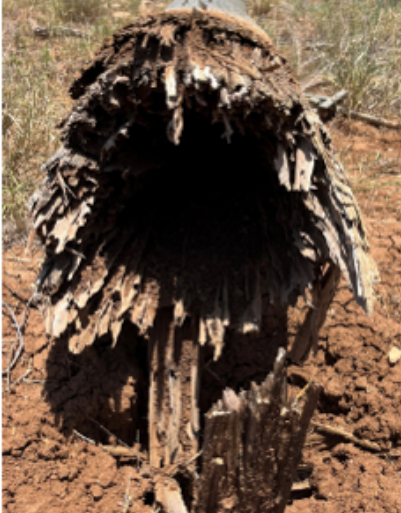
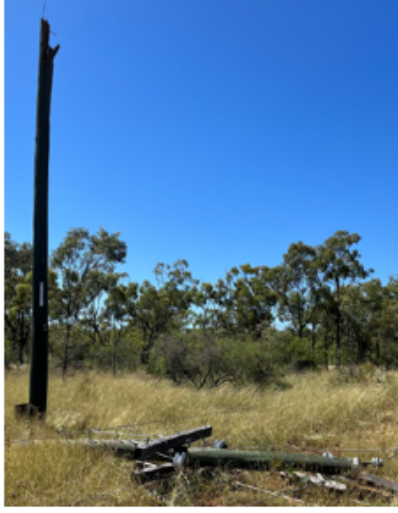
<p>Site Label: 4147043 Inspection Date: 15th July 2020 Failure Date: 23rd January 2024</p>	<p>Site Label: 5149534 Inspection Date: 13th November 2018 Failure Date: 29th March 2023</p>

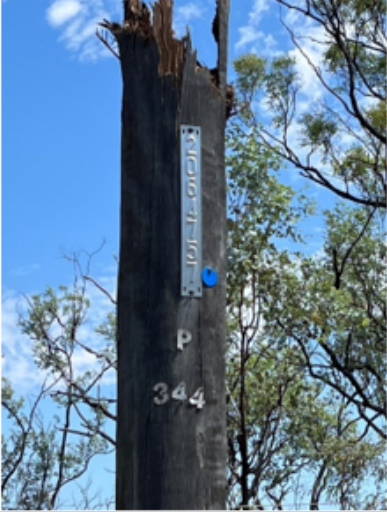
<p>Site Label: 2064757 Inspection Date: 29th April 2019 Failure Date: 29th October 2022</p>

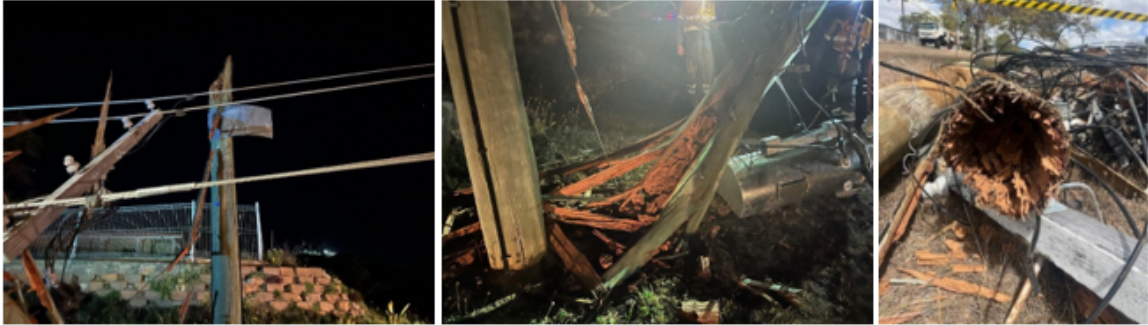
<p>Site Label: 5241595 Inspection Date: 19th May 2022 Failure Date: 10th September 2024</p>
