MARAYONG ZONE SUBSTATION RENEWAL

TS146 - Network Investment Options

Prepared by Asset Strategy and Planning

August 2017

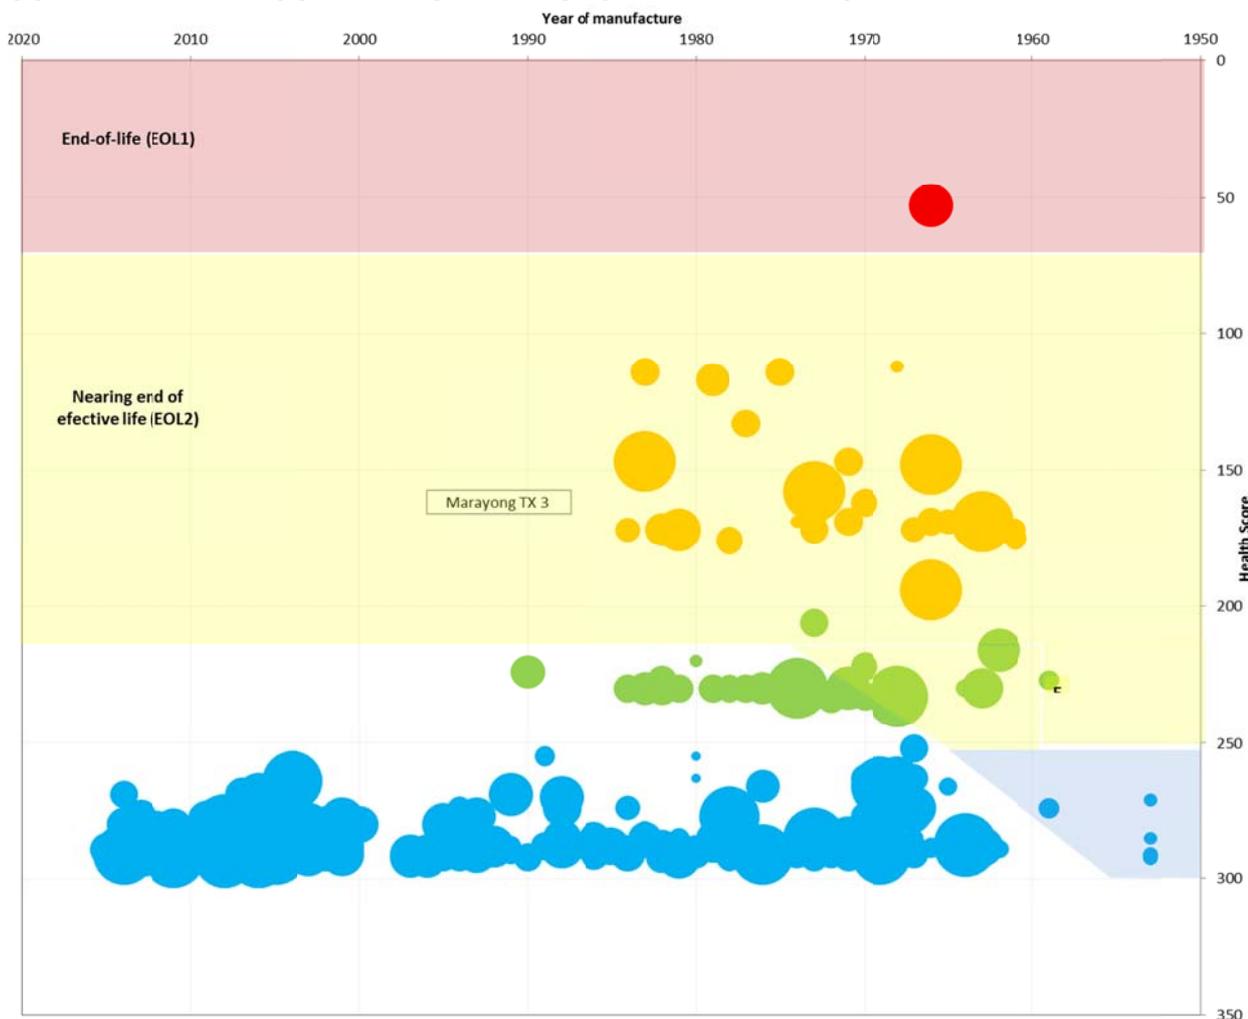
FIGURE 2 – ENDEAVOUR ENERGY TRANSFORMER HEALTH CHART

Figure 2 shows a plot off all power transformer by comparing their age and health index as detailed in the Asset Class Condition – Power Transformers report [2]. All Marayong transformers lie in the “Nearing end of life” category. Transformer Nos 1 to 3 rank 28th, 24th and 11th respectively in priority for replacement due to condition out of a total of 454 units in service in the network.

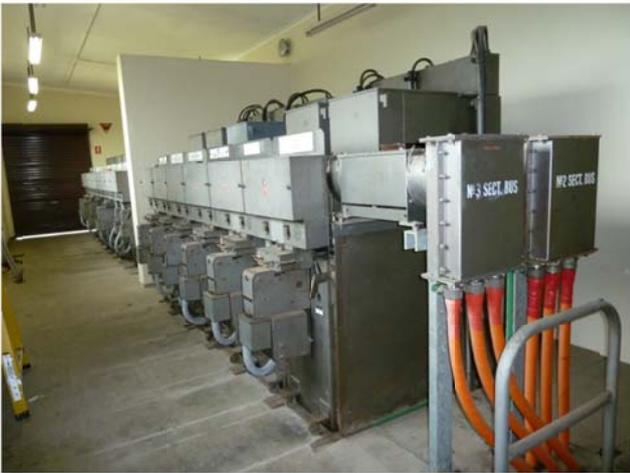
These switchboards contain a compound insulated busbar. Over time the compound can leak and result in partial discharge activity inside the switchboard. However, a transient earth voltage (TEV) and acoustic test performed in 2012 found no significant partial discharge activity from within the switchboard at Marayong ZS.

Five of the breakers are in poor condition due to low insulation resistance and high contact resistance. A further three are considered to be close to poor condition and will likely become poor in the short term. Therefore these circuit breakers require renewal in the short term

There is a history of B18 (and J18, J22) circuit breakers in Endeavour Energy (at Port Kembla ZS) and Ausgrid (at Pymble ZS) failing to clear low level faults which result in an internal arc to the tank of the breaker. If the arc is not cleared quickly by instantaneous frame leakage or bus-bar protection, there is a risk of the breaker exploding and causing a substation fire. Marayong does not have instantaneous frame leakage or busbar protection and therefore there is an elevated risk of a circuit breaker failure and subsequent substation fire at this location.

The 11kV Westinghouse HQ switchboard

truck replacement. Therefore, it is recommended that the 11kV switchboard at Marayong ZS be replaced in the short term.

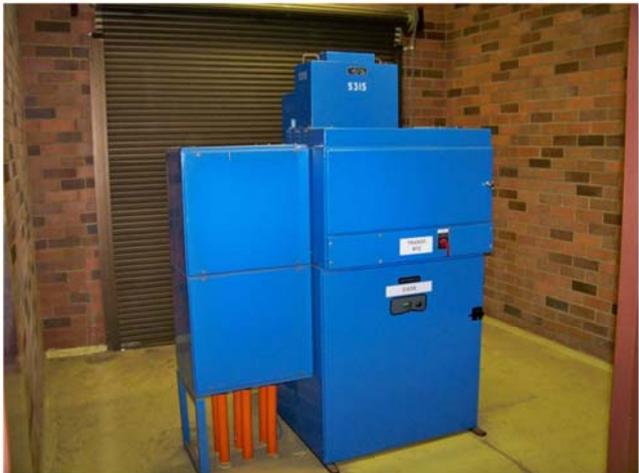
The three transformer circuit breakers are Reyrolle LMT bulk-oil units which were installed at Marayong ZS in 1980 when the control building was extended. These units are located in their own individual switch-rooms and are connected by cable to the Westinghouse switchboard. The ex-transformer breakers in the switchboard are now used as feeder breakers. Transformer No. 3 circuit breaker has high contact resistance, however, overall the Reyrolle LMT units are currently in satisfactory condition.

Note that the other oil switchgear in the control building, the three Reyrolle LMT 11kV transformer circuit breakers present the same types of risks as the 11kV Westinghouse HQ switchboard noted in the risk assessment but with a slightly reduced likelihood of occurrence because the LMT equipment is younger and in better condition and does not have a history of failure to clear faults. However, it is still oil filled switchgear in a control building and therefore should be replaced with vacuum equipment which is preferably also arc-fault contained in line with current standards of safety.

1 of 3 Reyrolle LMT 11kV transformer circuit breakers in dedicated room

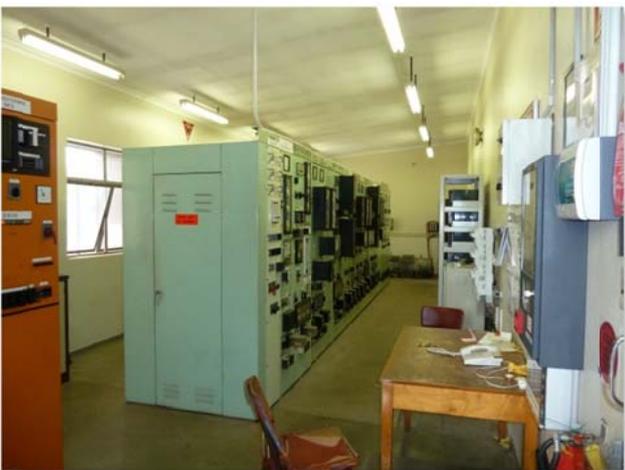
The 33kV and 11kV feeder protection is mainly comprised of the original electro-mechanical relays from circa 1964. Although some relays have been replaced between 1990 and 2004. This equipment is currently performing satisfactorily.

Protection tunnel board in control room

This equipment is mounted on a tunnel board which should be refurbished or replaced with standard panels when major protection replacement works are required at the site.

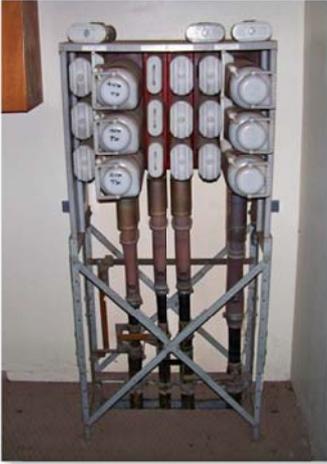
The auxiliary switchgear is Magnefix MD4 commissioned in 1964. There have been a number of failures of MD4 switchgear in the distribution network and in August 2015 an MD4 auxiliary switchboard failed at Prospect ZS causing damage to the control room and a prolonged outage of the substation. There is ongoing concern about the safety of MD4 equipment in the high fault level environment of a zone substation and as a result, MD4's are being progressively replaced with metal clad, arc-fault contained vacuum switchgear in zone substations under Program *TS009 Auxiliary switchgear replacement*. Marayong has been omitted from this program so that the replacement of the 11kV auxiliary switchgear can be carried out in conjunction with the redevelopment of the substation.

11kV MD4 auxiliary Switchgear

Therefore it is proposed that the auxiliary switchgear be replaced in the short term.

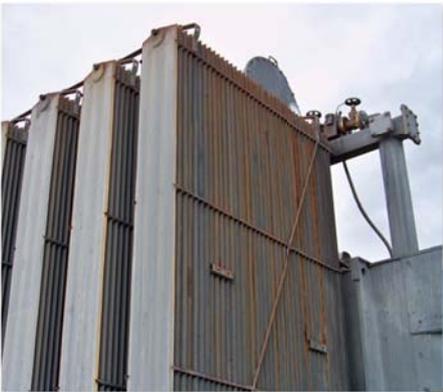
As shown in the table, the winding paper in Transformer No.3 is in poor condition placing the transformer at imminent risk of failure should it experience a close up 11kV feeder fault which is not cleared rapidly. The oil in Transformer No. 3 is also in very poor condition and requires action in the short term. Transformers No.1 and 2 also have poor oil quality and all three transformers are suffering from low insulation resistance and oil leaks with noticeable bulging of the main tank and tap-changer gaskets. Further, Transformer No. 1 has significant corrosion on its radiator fins.

Power transformers with rusting radiator fins and oil leaks

Therefore the condition assessment recommends that Transformer No. 3 is replaced in the short term. It is estimated that the other transformers will remain serviceable for approximately five years. Given the age of these units it is considered that refurbishment of these units will not provide a beneficial extension of their life and therefore replacement as part of any major redevelopment works in the substation should be considered.

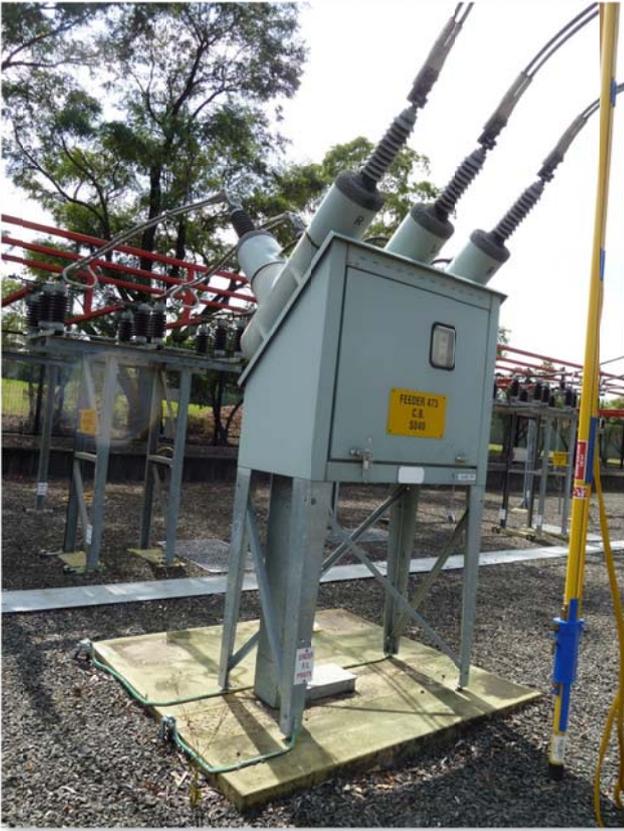
These circuit breakers are in good condition, however, there are some dents on the bushing turrets. It is expected these have been caused by stones thrown at them from over the substation fence as evidenced by the stones on the ground around the circuit breakers.

1 of 5 33kV Aereva OX36 SF₆ circuit breakers to be removed to spares
