Jemena Electricity Networks (Vic) Ltd

Replace Footscray East (FE) Zone Substation Switchgear

2020 and 2021 Business Case

BAA-RSA-800111

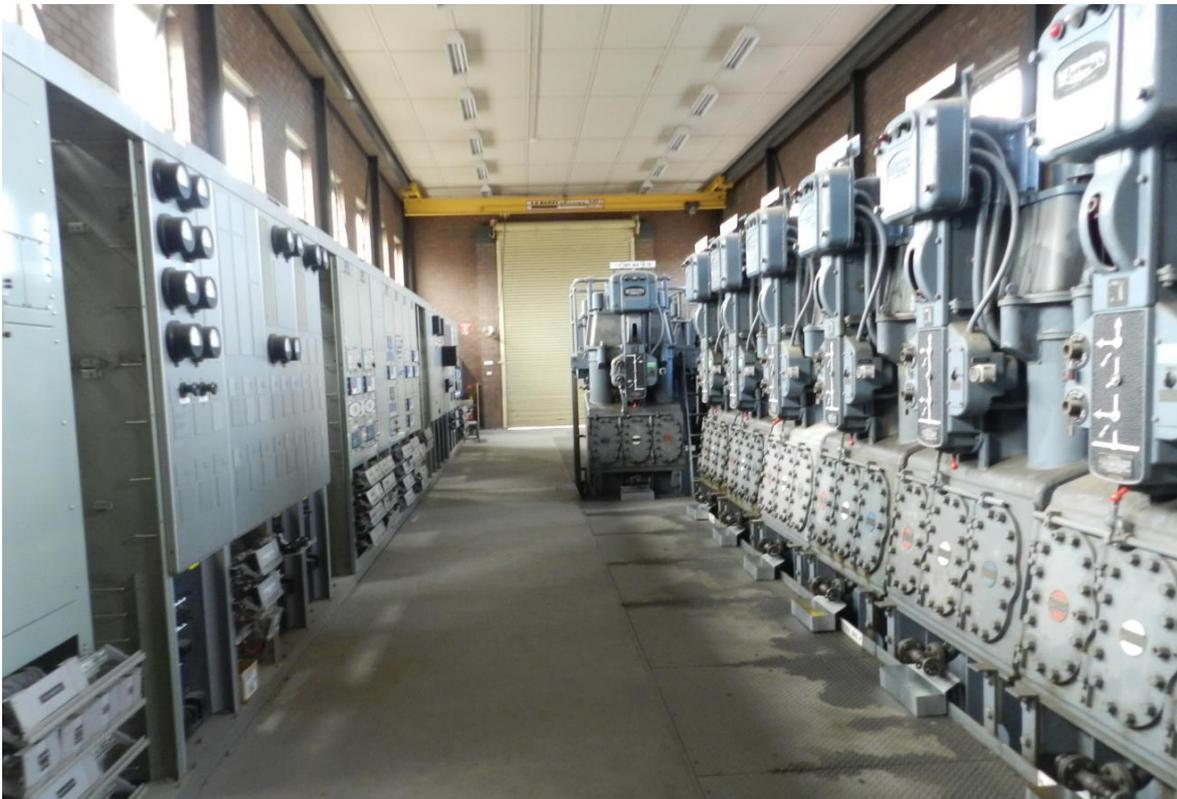
Figure 2–3: FE 22kV Switchgear

The 22kV switchgear installed at FE is briefly described in Table 2-1 and Figure 2-3. This switchgear is unique to JEN's Zone Substations FE and FW, and is not installed anywhere else in Australia. Enquiries made to the UK did not reveal any information regarding this type of switchgear. The switchgear is metalclad enclosed consisting of a fixed CB compartment and internal isolators and earth switches, immersed in a thick insulating oil. The 22kV buses are constructed in sections underneath the checker plate floor, and enters each CB compartment. Each busbar section consists of a bushing which enters a tee connection box and is filled with thick insulating oil.

1. **Condition monitoring tests conducted on the indoor 22kV buses at FE indicates that partial discharge (PD) is present above service voltage. This indicates that insulation degradation has occurred. The same switchgear at FW is also showing signs of insulation failure. The condition monitoring tests conducted on the indoor 22kV buses at zone substation FW indicates that PD may be present during normal operating conditions. The damage due to PD cannot be stopped or reversed and its behaviour cannot be predicted. Over voltage excursions due to lightning strikes on the network or switching surges can accelerate the insulation degradation further. This will increase the level of PD. The presence of PD will continue to degrade the insulation which will ultimately cause the insulation to fail catastrophically. This is a critical issue. The switchgear has been subjected to condition monitoring tests in 2008 as well as 2018. The results clearly show further degradation of the primary insulation.**

The dielectric dissipation factor of the FE 22kV switchgear is considered Poor when compared to the switchgear at FW. This indicates the insulation has absorbed moisture over time and increased leakage current. Both buses on FE switchgear show about 2-3 times higher leakage current. The PI (polarisation index) results also support the insulation deterioration with low insulation resistance results (PI below 1.5). However the PD test results from 2018 show that PD is present above service voltage and considered to be Poor due to its magnitude and increase from previous test conducted in 2008.

It is recommended that Option 5 be adopted and the two 22kV metalclad buses, the 1-2 66kV bus tie CB and 66kV insulators be replaced with new modern equivalents and installing them to current standards, together with protection and control schemes. In addition a new WMTS No.1 line CB will be installed. The main switchroom and control room building built in 1967 will be utilised to accommodate the new 22kV switchgear and protection equipment, rather than construct a new separate building. The building has various defects that will be repaired, and in addition will be made compliant to current building standards.

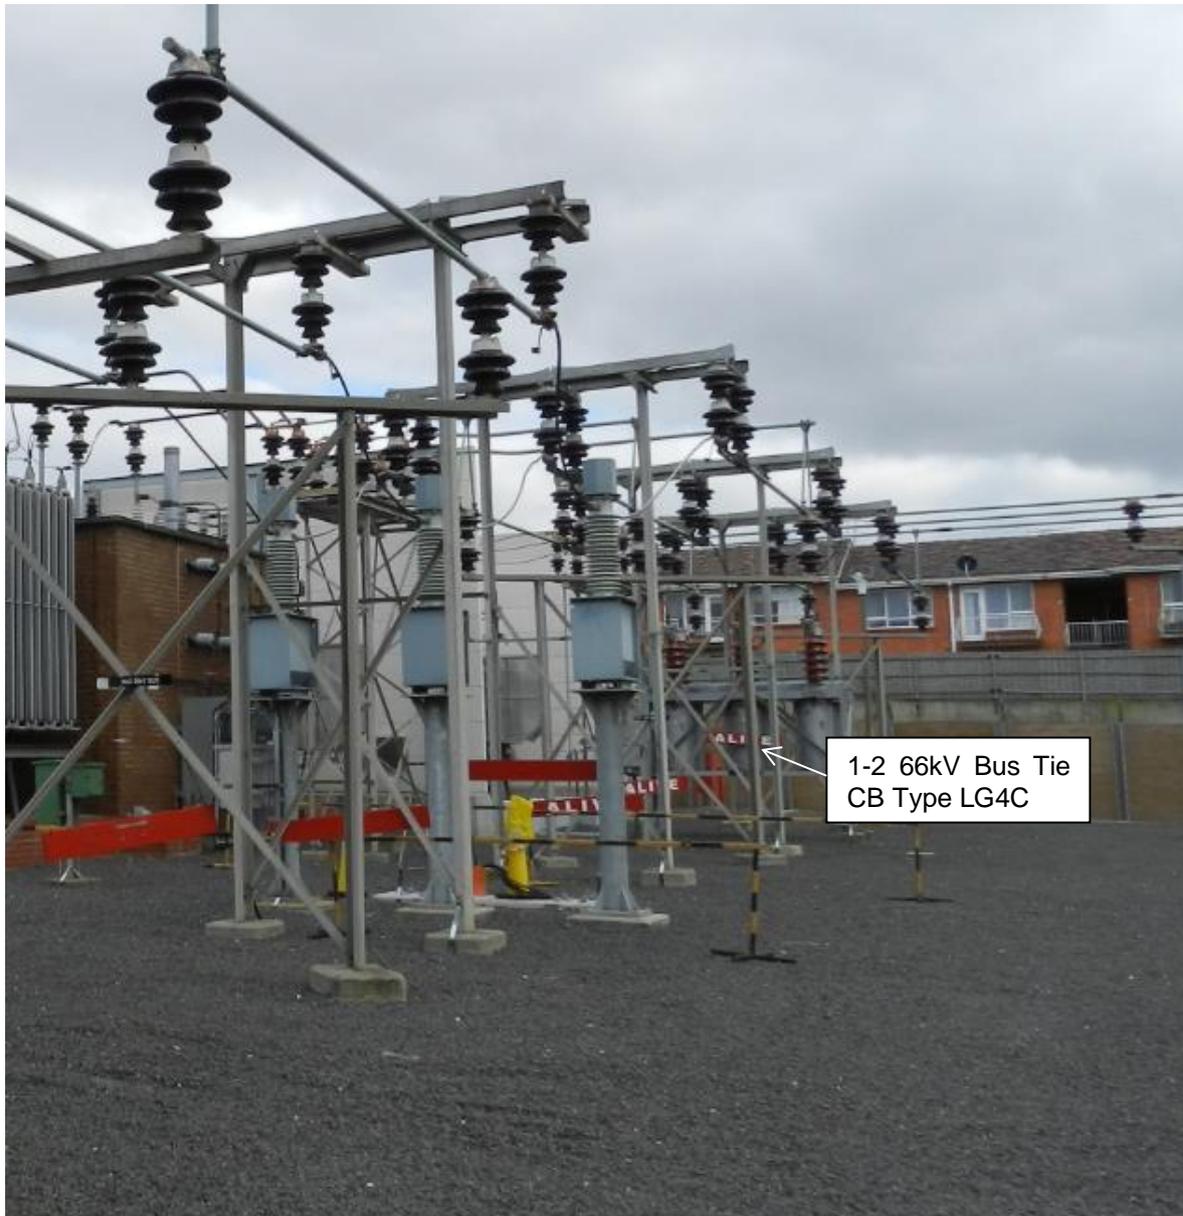
Figure 2-4: FE 66kV Bus Tie CB and 66kV insulators

8. The 66kV Bus Tie Circuit Breaker represents a family of breakers with history of mechanical failure and catastrophic bushing failures. This CB Type LG4C is no longer supported by a manufacturer and spare components are no longer available. This is also a critical issue.

There has been one recorded defect on 1-2 66kV bus tie circuit breaker where the 66kV bushing was replaced, and there are records of this type of CB with a history of defects and catastrophic failures.

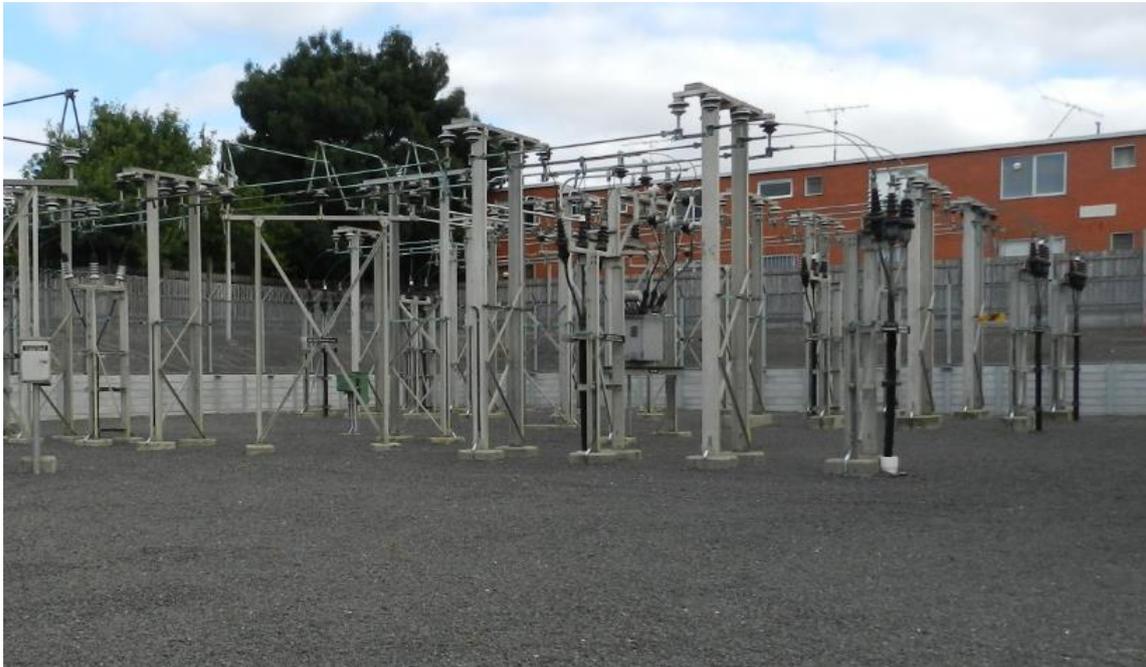
Figure 2–5: FE 22kV Transfer Bus

7. 22kV Outdoor Transfer bus: There are known defects associated with pin and cap 22kV insulators which are prone to failure. There have been two serious incidents within other electricity business. In one instance a 22kV insulator sheared off and the HV dropper came in contact with a person below. This is not an issue that is driving the replacement of the indoor switchgear, however the new proposed 22kV switchgear provides an opportunity to the remove outdoor 22kV transfer buses together with the associated safety risk. See Appendix E for further details: 22kV Pin and Cap insulator Failure.

There have been two recent incidents associated with the failure of 22kV pin and cap type insulators within Victoria (Refer to Appendix E) as follows:

6. In circumstances similar to the arrangement in Figure 2–5, an insulator had sheared from the pin, and resulted in the bus dropping to 1m above ground level. The bus remained alive and was found by an employee.
7. An isolator was opened using a HV switch stick when an insulator had sheared from the pin. The live conductor then fell onto an employee's shoulder.

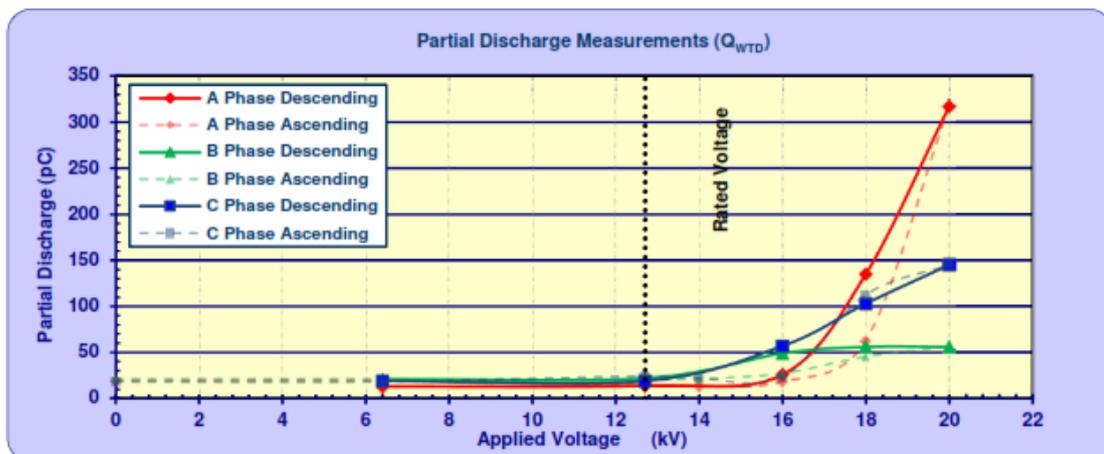
Figure 2–6: FE No.1 22kV Bus Partial Discharge measurements

Zone substation FE: The PD inception and extinction level for the No.1 22kV Bus was measured at 16.0kV and 14.0kV respectively. The results for the No.2 22kV bus is 18.0kV and 16.0kV respectively. Although the phase to ground operating voltage is nominally 12.7kV, and PD levels do not appear during normal operating conditions there is a risk of a phase to ground fault sometime in the future as the insulation degrades further. See Figure 2–6 and Figure 2–7 below. The PD levels above service voltage levels range from 20pC to 628pC, which is above industry and Australian Standards (AS 62271 series).

This will increase the level of PD greater than the last test report. In reference to Figure 2–6 below, as the test voltage is increased as shown on the 'x' axis, the PD levels increase rapidly on certain phases. Over voltage excursions above network voltages levels can occur for short durations as a result of lightning strikes on the network or switching surges. In addition when feeder faults occur, healthy phase voltages increase to line voltages (22kV nominal) due to the Neutral Earthing Resistor effect. These events can accelerate the insulation degradation further, and PD levels can then increase when measured at normal system voltage levels. This will increase the level of PD greater than the last test report, and increase the risk of electrical flashover as the asset ages further.

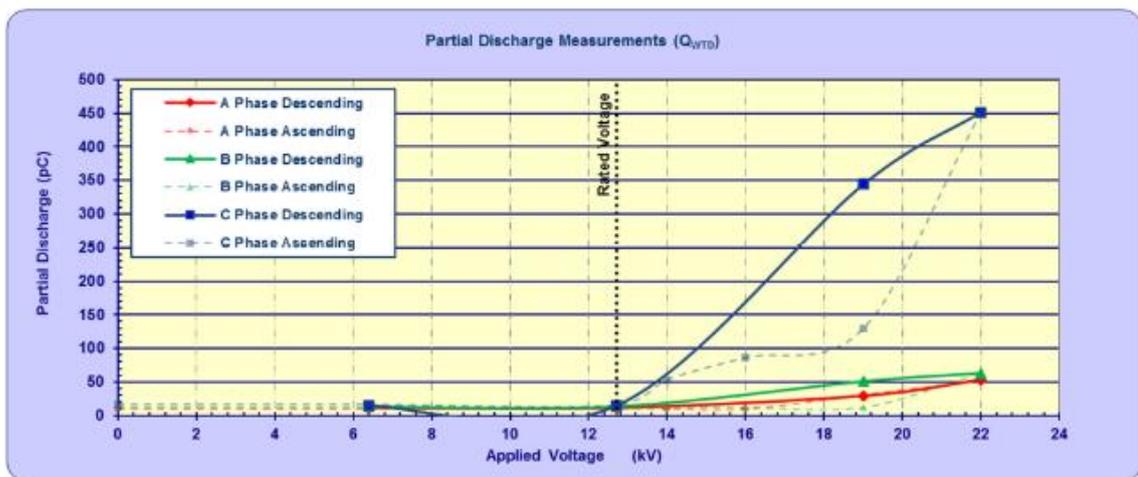
Figure 2–8: FW No.2 22kV Bus Partial Discharge measurements

Zone substation FW: The PD inception and extinction level for the No.1 and No.2 22kV Buses was measured at 16.4kV and 14.3kV respectively. Since the phase to ground operating voltage is nominally 12.7kV, this indicates PD may appear during normal operating conditions and there is a risk of a phase to ground fault. See Figure 2–8 below. The PD inception and extinction level for the No.3 Bus Red Phase was measured at 14.0kV, and 9.5kV

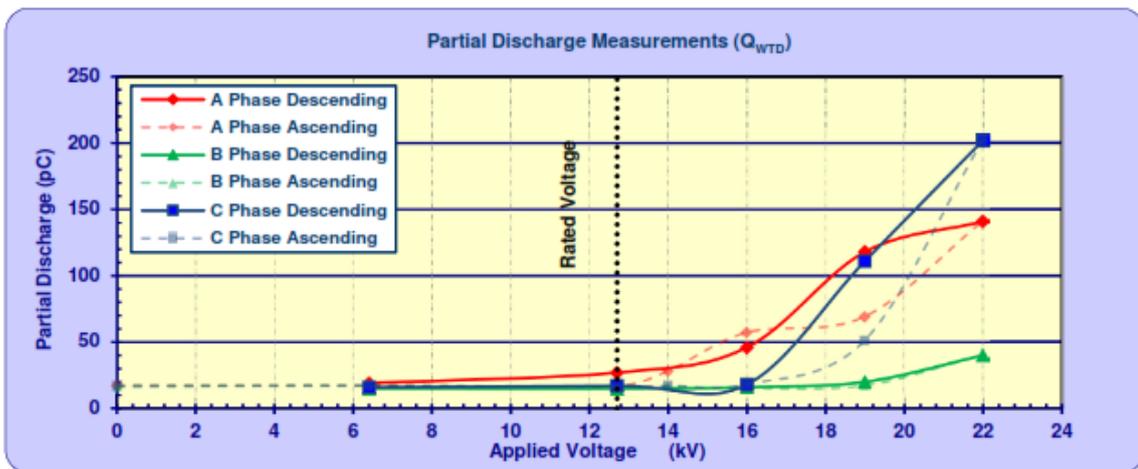
Figure 2–9: FW No.3 22kV Bus Partial Discharge measurements

respectively. This indicates PD may appear during normal operating conditions and there is a risk of a phase to ground fault. See Figure 2–9 below.

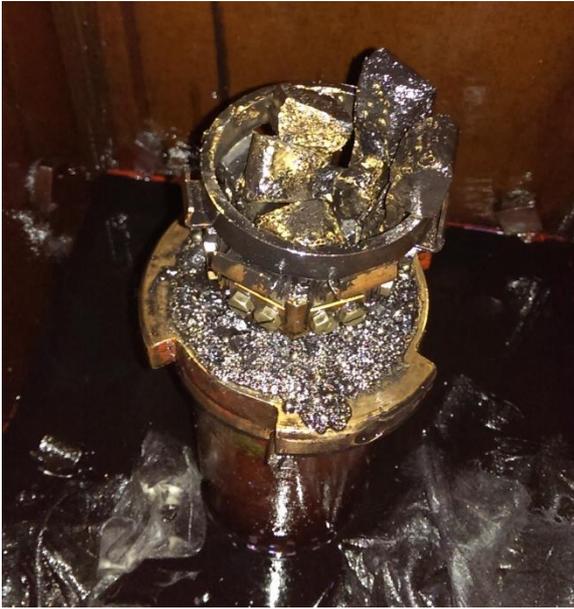
Picture 1: The 22kV white phase fixed contact suffered significant damage. Due to the extent of the damage it is difficult to ascertain the cause but it is anticipated that a small spring that sits behind a contact finger has lost compression and created a high resistance connection.

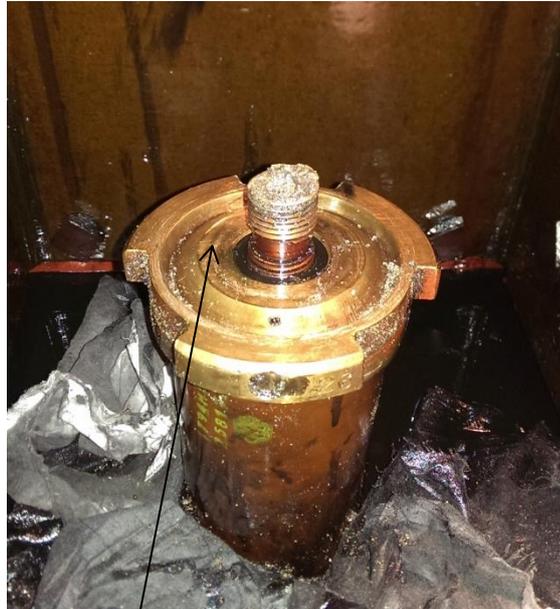
Picture 2: The white phase fixed contact cluster is removed from the shaft. The heat generated from the contact failure caused 2 threads to melt away. Local judgement ascertained that the current carrying capability is not through the thread but primarily through the base of the contact as indicated by the arrow. Therefore the old thread was retained and new contacts were installed.

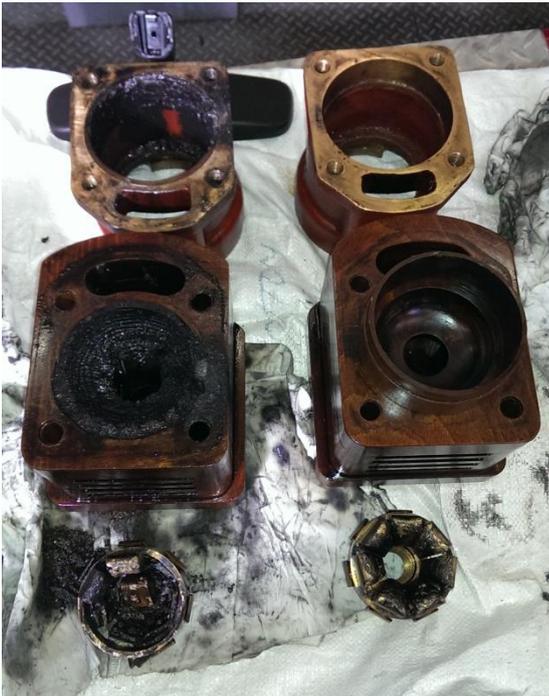
Picture 3: The failed white phase contact and associated turbulator are on the left of the picture.

The red phase healthy contact and associated turbulators are on the right side of the picture for

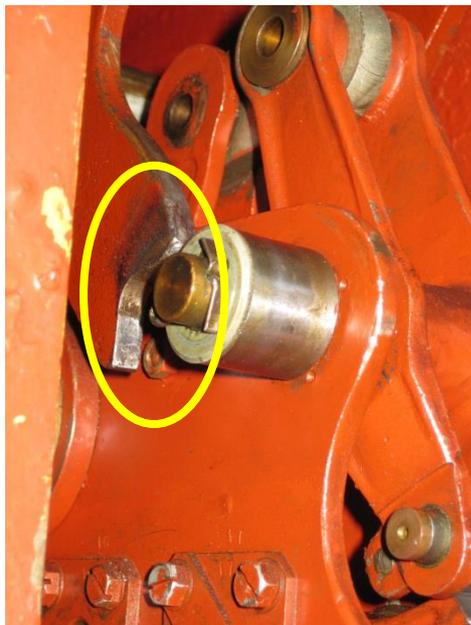
Photo 2: Worn Hold on Catch

FE5 CB will remain out of service until the “Hold on Catch” plate can be replaced.

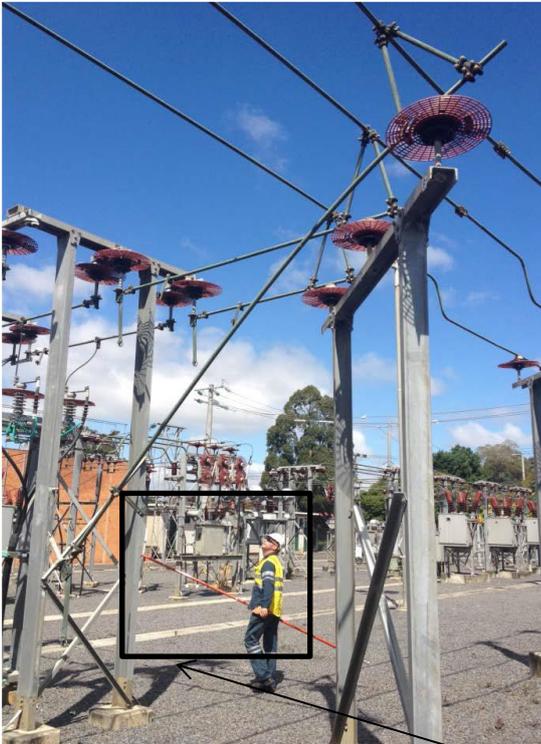
Figure 6: Failed Pin & Cap Insulator

As Porcelain has very high compressive strength (80,000 psi), sixteen times greater than its tensile strength (5,000psi). Cap and pin insulators have a design flaw which can subject them to tensile forces generated between two or more porcelain shells from two possible sources which can lead to cracking and eventual failure: “growth” within the cement joint and thermal expansion differences. Station post insulators are designed to take advantage of porcelain’s compressive strength by avoiding conditions which put them in tension. Each station post section employs a large, single piece of porcelain in contrast to the cap and pin that is composed of one to three individual porcelain shells nested together and joined by cement. The simpler design and the use of fewer cemented joints means that station posts are more rigid and exhibit less deflection under load than cap and pin insulators, which is an important feature in switch applications.

Live 22kV bus section approximately 1m above ground level. Attached to pin which had separated from an insulator

22kV insulator pin separated from porcelain and hanging from live bus

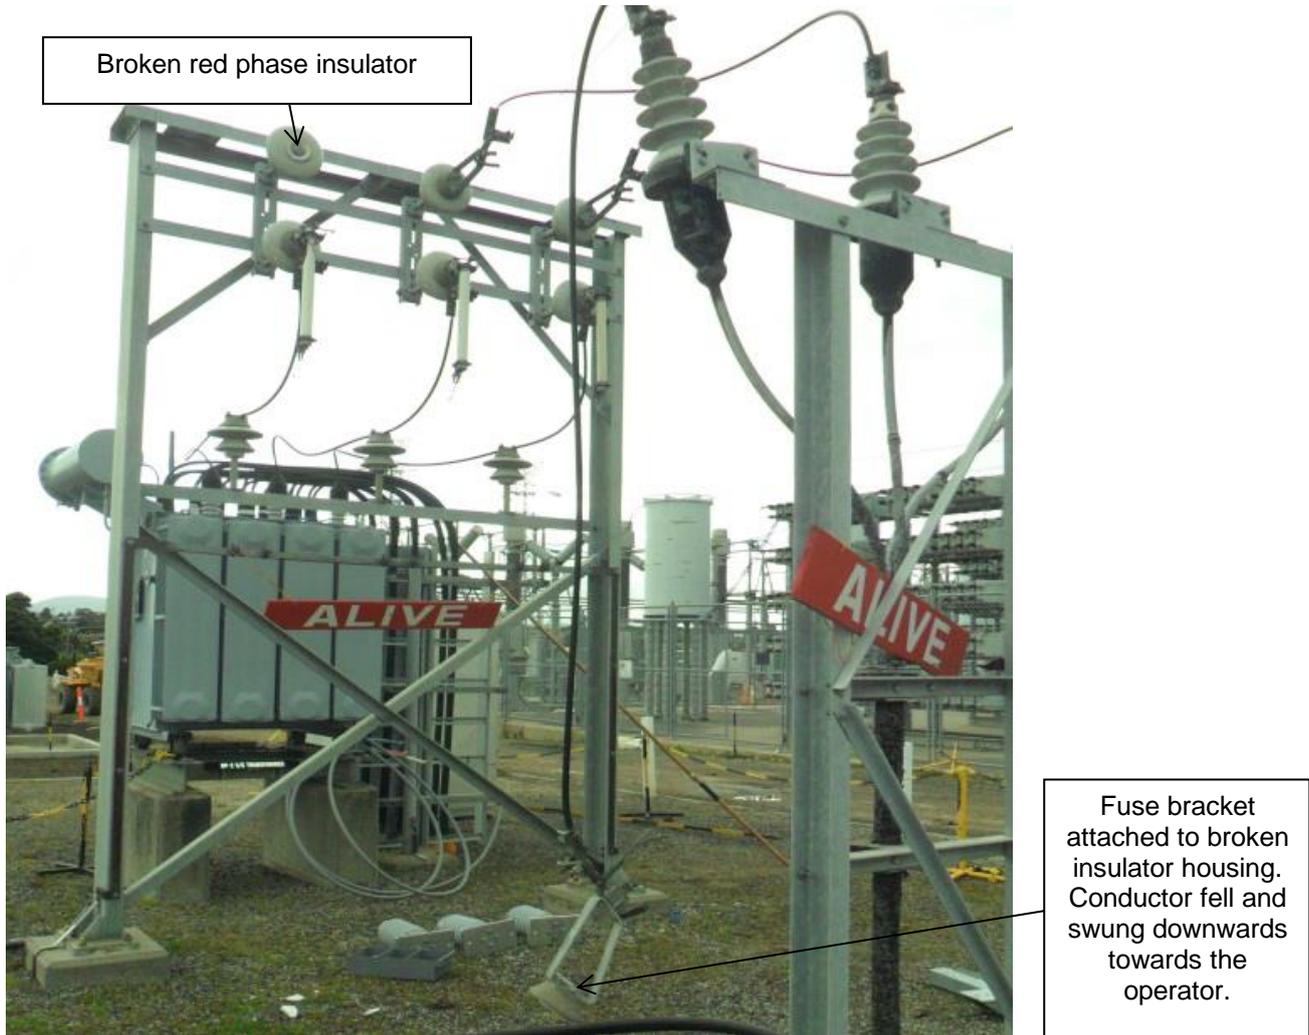
During planned cable cut over work at Rowville Terminal Station on the 29/10/13 a stations operator was operating three phase 22kv Powder filled fuse units. After opening the blue and white phases he opened the red phase. As he opened the red phase fuse unit the insulator broke, dropping the conductor towards the operator.

The operator fell to the ground and the conductor made contact with his right hand. Project and delivery partner employees who witnessed the incident made the area safe and provided assistance. An ambulance was immediately called to the site. WorkSafe and ESV were notified.
