Building Condition Review and CAPEX Plan

BGIS - TransGrid – Orange Regional Depot Centre

04 December 2020

Project No. EB1110

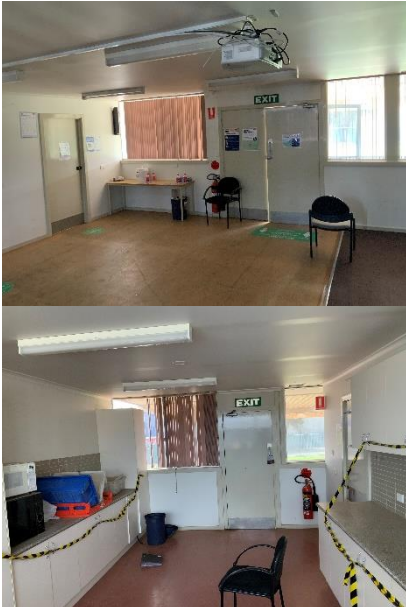
<p>(b) Plan view</p> </div>	<p>Doors to the pavilion building are not provided with compliant door hardware.</p>

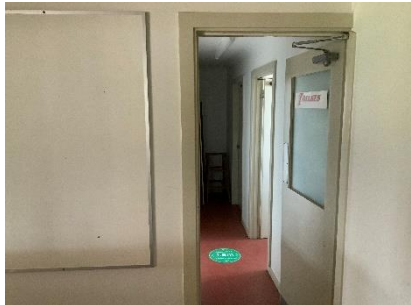
<p>Doors and corridors within the pavilion do not comply with AS1428.1</p>
