Building Condition Review and CAPEX Plan

BGIS - TransGrid – Tamworth Regional Depot Centre

07 December 2020

Project No. EB1110

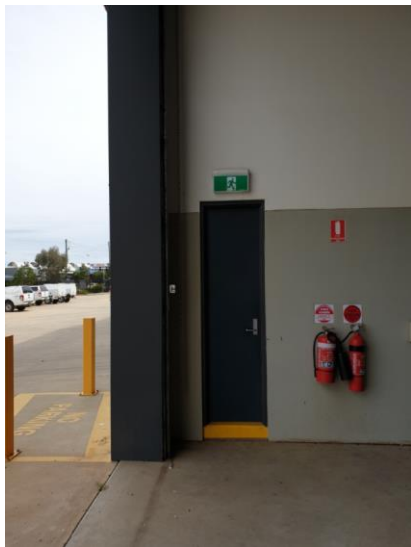
Clause	Description	Comment	Status
	to 2 exits is available, in which case, the maximum distance to 1 exit cannot exceed 40m.		
D1.5	<p>Distance between alternative exits</p> <p>The following travel distance limits apply:</p> <ul style="list-style-type: none"> • ≤ 20m to a single exit or to a point of choice to alternative egress paths, and • ≤ 40m to the closest alternative exit; • ≤ 60m travel distance between alternative exits and not less than 9m between alternative exits; • Exit paths to alternative exits should not converge at any point to be less than 6m apart. 		Complies
D1.6	<p>Dimensions of exits and paths of travel to exits</p> <p>In a required exit or path of travel to an exit—</p> <p>(a) the unobstructed height throughout must be not less than 2 m, except the unobstructed height of any doorway may be reduced to not less than 1980 mm; and</p> <p>(b) the unobstructed width of each exit or path of travel to an exit, except for doorways, must be not less than 1 m</p>	<p>The doorway between the wash bay and trailer store of Building 2 was measured to be less than the required 750mm (approx. 568mm)</p>

<p>Note, Clause D2.19 permits roller shutters to be used as exit doors serving a part of the workshop / wash bay with a floor area of not more than 200m². Exit sign to be adjusted should the roller shutter form the required exit from the wash bay.</p>	Does not comply

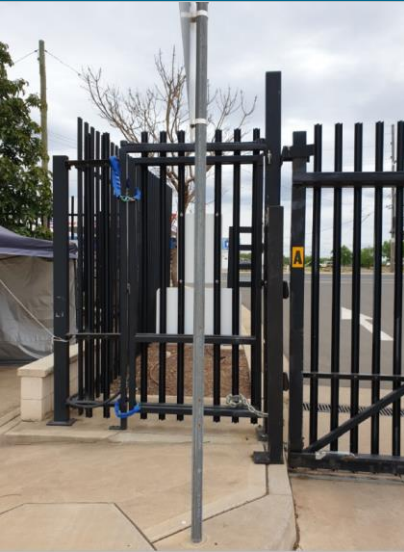
D1.7	Travel via fire-isolated exits		N/A
D1.8	<p>External stairways or ramps in lieu of fire-isolated exits</p> <p>External stairs or ramps may be used instead of fire-isolated stairs to a building under 25m in effective height, subject to:</p> <ul style="list-style-type: none"> ▪ Stair to be non-combustible construction. ▪ Exit doors onto the stair to be 1-hour fire rated. • Exit paths via the stair must be shielded if within 6m of openings in external wall of building. 		N/A
D1.9	Travel by non-fire-isolated stairways or ramps		Complies
D1.10	<p>Discharge from exits</p> <p>An exit must not be blocked nor be capable of being blocked at its point of discharge.</p>	The gate providing access to the road was locked with a chain and padlock.	Does not comply

<p data-bbox="831 801 1236 981">The gates are required to be openable without a key should be obtained. Site personnel advised the gates unlock on fire trip. Confirmation that the gates are not locked and are openable without a key should be obtained.</p>	
D1.11	Horizontal exits		N/A
D1.12	Non-required stairways, ramps or escalators		N/A
D1.13	Number of persons accommodated		Noted
D1.14	Measurement of distances		Noted
D1.15	Method of measurement		Noted
D1.16	<p data-bbox="316 1346 794 1402">Plant rooms, lift machine rooms and electricity network substations: Concession</p> <p data-bbox="316 1413 794 1469">A ladder may be used in lieu of a stairway as an exit from:</p> <ul style="list-style-type: none"> <li data-bbox="316 1480 794 1536">a) a plant room with a floor area not more than 100m², or <li data-bbox="316 1547 794 1599">b) all but one point of egress from a plant room with a floor area not more than 200m². 		No issues identified

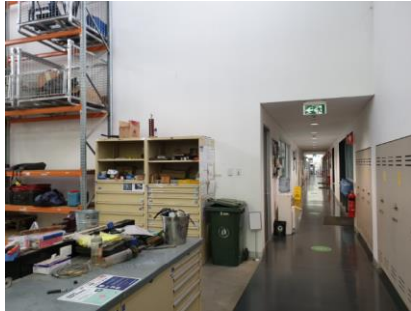
E4.3	Measurement of distances		Noted
E4.4	<p>Design and operation of emergency lighting</p> <p>Emergency lighting must comply with AS2293.1</p>	A service consultant should be consulted if a detailed assessment is required	
E4.5	<p>Exit signs</p> <p>Exit signs are to be provided in accordance with Clause E4.5 of the BCA.</p> <p>Exit signs must be clearly visible to person approaching the exit and must be installed on, above or adjacent to;</p> <ol style="list-style-type: none"> 1. A door providing direct egress from a storey to a stairway, passageway or ramp serving as a required exit. 2. A door from an enclosed stairway, passageway or ramp at every level of discharge to a road or open space. 3. A horizontal exit 4. A door serving as or forming part of a required exit in a storey required to be provided with emergency lighting. 	<p>Exit signs were not provided to Building 1 – workshop 2.</p> <p>Exit signs were not provided to the Building 1 – tech service workshop and mains workspace.</p> <p>The doorway separating the corridor and workshop 1 within Building 1 should be provided with an exit sign. It was unclear where the direction sign was directing occupancy.</p>

Does Not comply
