Building Condition Review and CAPEX Plan

BGIS - TransGrid – Wagga Wagga Regional Depot Centre

11 December 2020

Project No. EB1110

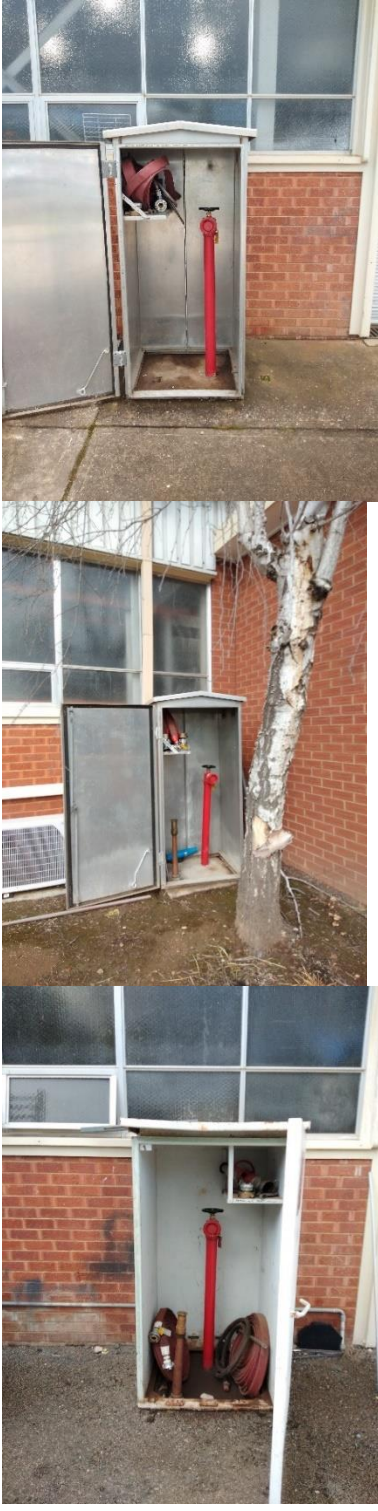
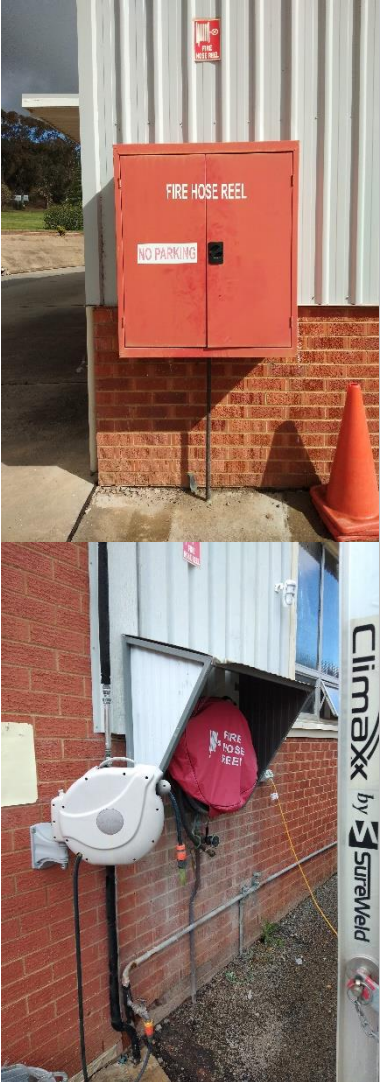
<p>External hydrants are located within 10m of the building and are not protected by a fire rated wall 3m high and 2m either side of the hydrant outlet.</p>	<p>The hydrant system is required to comply with AS2419.1-2005. A detailed assessment from the fire services engineer should be undertaken to identify any shortfalls with the system.</p> <p>Hydrant system is to be modified to ensure compliance and fire rated walls constructed to protect the external hydrants from the building they serve.</p>

Item	DTS Clause	Description of Non-compliance	Requirement to Satisfy BCA
10.	E1.4	<p>There are a couple of external hose reels provided to the Workshop. The cupboard to one hose reel was not able to be opened. Full coverage to the building would not be achieved from the hose reels provided.</p>

<p>A detailed assessment of the hose reels by the fire services engineer should be undertaken to confirm compliance with AS2441-2005.</p> <p>The cupboard to the hose reel should be repaired. Additional hose reels are to be installed to achieve full coverage in accordance with AS2441.</p>
11.	E4.4 & E4.5	<p>Exit signs and emergency lighting is not provided within the Wash Bay or the Pavilion.</p>	<p>A detailed assessment by the fire services consultant should be undertaken to determine the required emergency lighting and exit signage.</p>

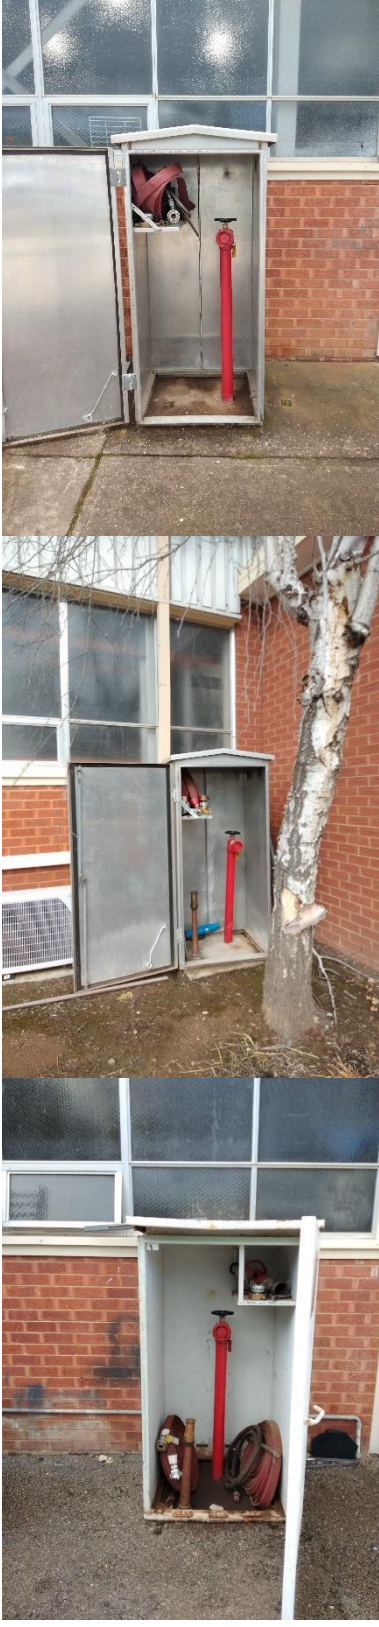
<p>External hydrants are located within 10m of the building and are not protected by a fire rated wall 3m high and 2m either side of the hydrant outlet.</p>	<p>The hydrant system is required to comply with AS2419.1-2005. A detailed assessment from the fire services engineer should be undertaken to identify any shortfalls with the system.</p> <p>Hydrant system is to be modified to ensure compliance and fire rated walls constructed to protect the external hydrants from the building they serve.</p>

10.	E1.4	<p>There are a couple of external hose reels provided to the workshop. The cupboard to one hose reel was not able to be opened. Full coverage to the</p>	<p>A detailed assessment of the hose reels by the fire services engineer should be undertaken to confirm compliance with AS2441-2005.</p>

Item	DTS Clause	Description of Non-compliance	Requirement to Satisfy BCA
		<p>building would not be achieved from the hose reels provided.</p>  	<p>The cupboard to the hose reel should be repaired. Additional hose reels are to be installed to achieve full coverage in accordance with AS2441.</p>
11.	E4.4 & E4.5	<p>Exit signs and emergency lighting is not provided within wash bay or pavilion</p>	<p>A detailed assessment by the fire services consultant should be undertaken to determine required emergency lighting and exit signage.</p>

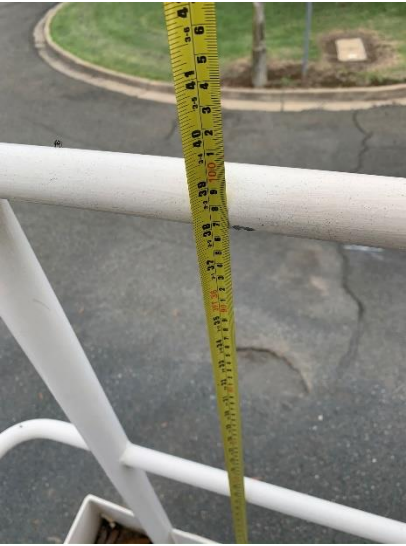
Clause	Description	Comment	Status
	<ul style="list-style-type: none"> ▪ In a building required to be accessible and the doorway opens to a road or open space and is provided with a threshold ramp or step ramp in accordance with AS1428.1, • Or in any other case a single 190mm step is permitted at doors leading to the exterior. 		
D2.16	Barriers to prevent falls Requirements apply to the provision and design of barriers at locations where a person could fall 1m or more.	The balustrade to the external stairs serving level 1 of the administration building has horizontal rails with gaps greater than 125mm.

Does not comply
D2.17	Handrails Handrails to exits including parts of fire isolated exit serving an area required to be accessible to people with disabilities must comply with Clause 12 of AS1428.1, viz: <ul style="list-style-type: none"> • Handrails not to obstruct circulation space • 30-50mm diameter • 865-1000mm above nosing line of stairs • 865-1000mm above ramps and landings • Consistent height throughout • 50mm grip clearance and no obstructions to handhold • Continuous at internal (return) landings • Provided with handrail extensions and 180 degree curled ends 	Handrails are not provided to the external stairway just outside the mess room.

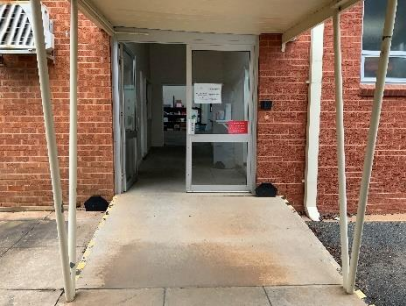
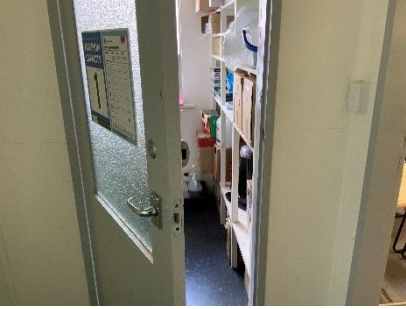
D3.3	<p>Parts of the building to be accessible</p> <p>All parts of the building must be accessible to people with a disability except for areas where access would be inappropriate due to the particular use or areas that would pose a health or safety risk to people with a disability.</p> <p>Every ramp, except a fire isolated ramp, must comply with Clause 10 if AS 1428.1.</p> <p>Every stairway, except a fire isolated stairway, must comply with Clause 11 of AS 1428.1.</p> <p>Access ways must have passing spaces and turning spaces complying with AS 1428.1.</p> <p>A ramp or passenger lift need not be provided to serve a storey or level other than the entrance storey of a class 5, 6, 7b or 8 building containing not more than 3 storeys and with a floor area of each storey, excluding the entrance floor, of not more than 200m².</p> <p>Pile height or pile thickness of carpets shall comply with the requirements of this Clause and AS 1428.1.</p>	<p>Access to level 1 of the administration building is not provided.</p> <p>The majority of the doors within the administration building are less than the minimum 850mm wide.</p> <p>There are no ambulant facilities provided</p>

<p>Does not comply</p>
