Building Condition Review and CAPEX Plan

BGIS - TransGrid – Yass Regional Depot Centre

10 December 2020

Project No. EB1110

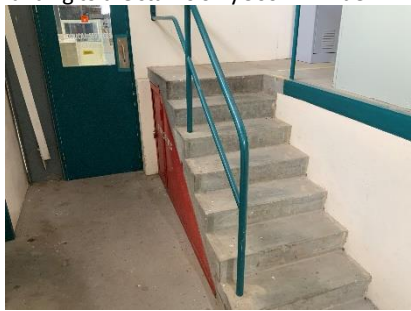
D1.6	Dimensions of exits and paths of travel to exits	The stair to the raised floor within the workshop is less than 1000mm wide. The landing to the stair is only 900mm wide.

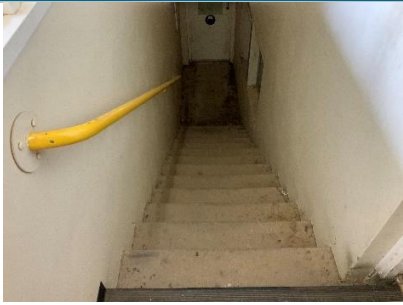
Does not comply
		The internal stair within the southern control centre is less than 1000mm wide.

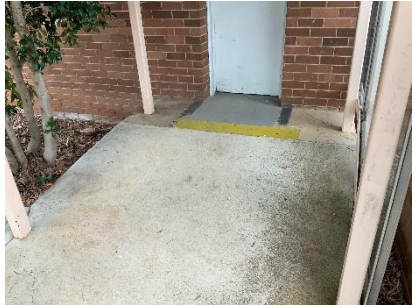
Access is not provided to the southern control centre

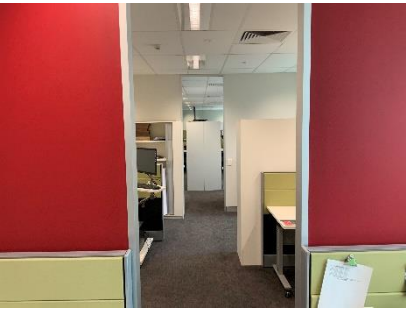
<p>The open doorways leading to the printers/copiers within the administration building are only 800mm wide when it should be 850mm.</p>

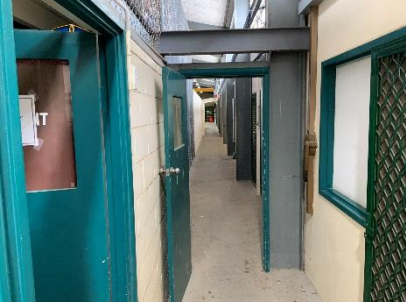
<p>The signage within the southern control centre is not the correct pictorial exit signs and they were not illuminated. There was insufficient exit signage within the building too.</p>
