POWERLINK QUEENSLAND  
REVENUE PROPOSAL

**CP.01656**

**Calliope River to Larcom Creek 275kV  
Transmission Line Refit**

**Transmission Line Condition Assessment – Report**  
**BS1515 – Mt Miller to Larcom Ck**

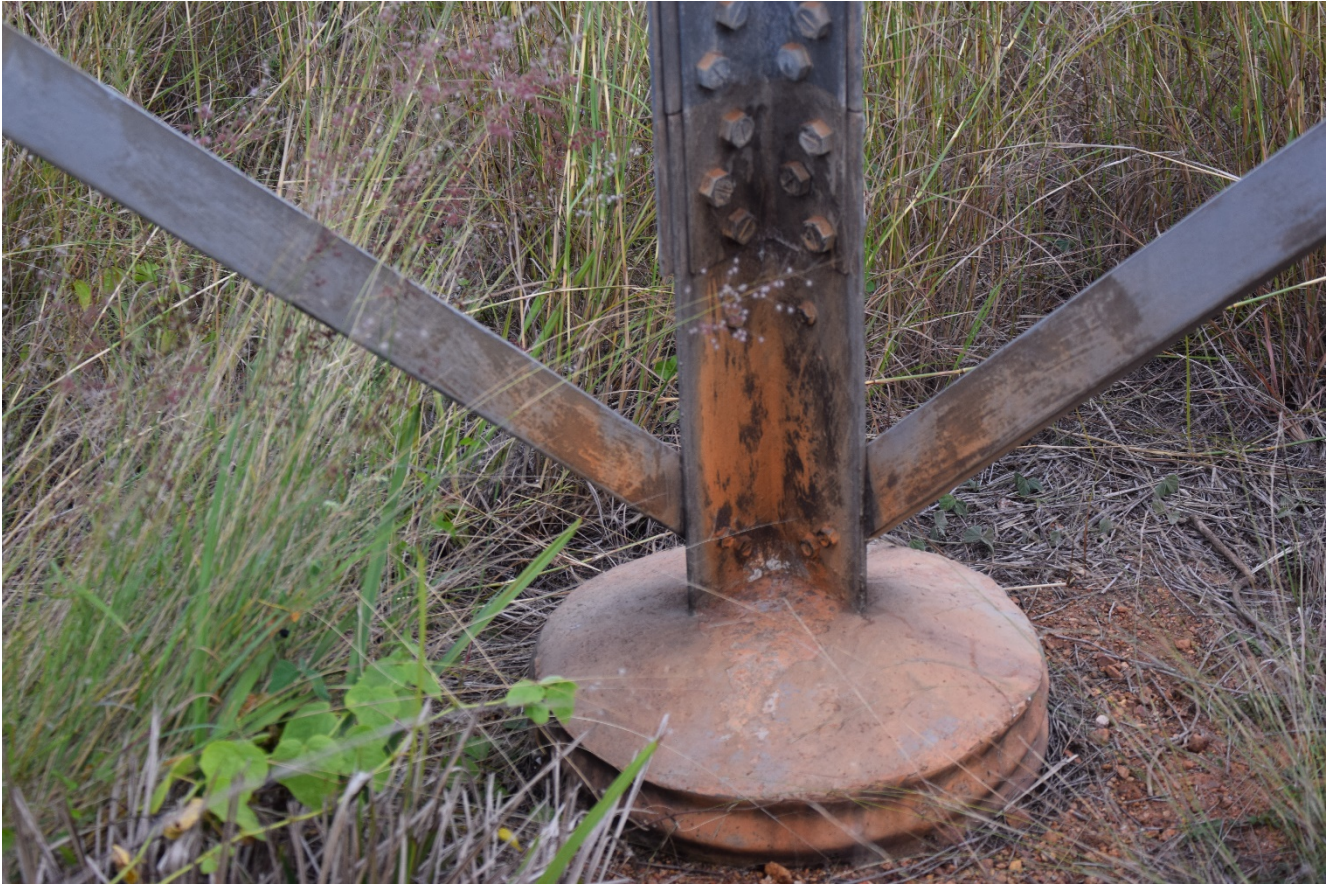
Figure 3: 1515-STR-0019 Tower Leg Condition

Structures utilise a standard steel reinforce concrete foundation as shown in Figure 3 below. No foundation issues have been identified on this built section

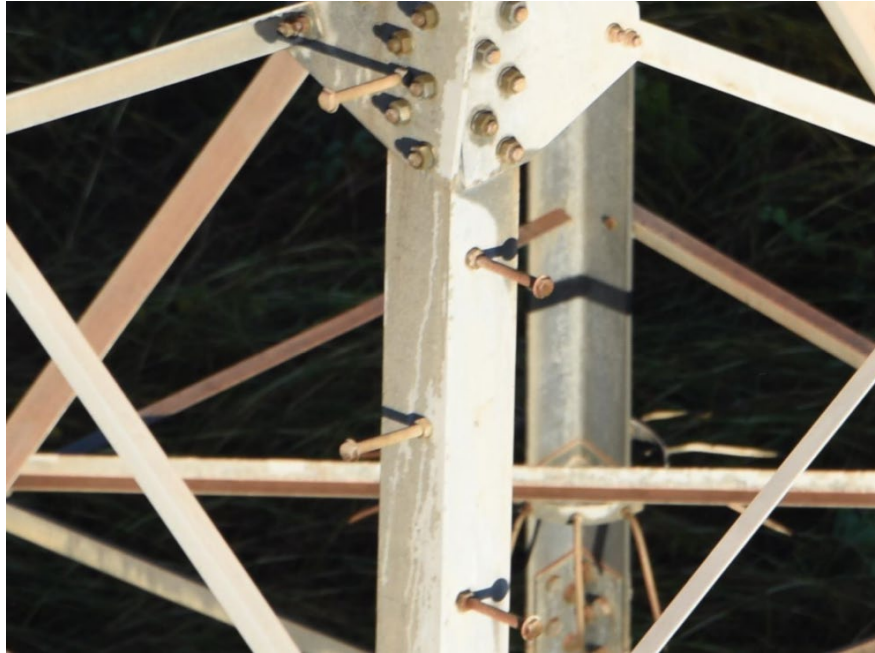
This step bolts do not meet our current standards for climbing aids which incorporate a climbing attachment point.

Figure 4: G2 & G3 corrosion shown on step bolts 1515-STR-0012

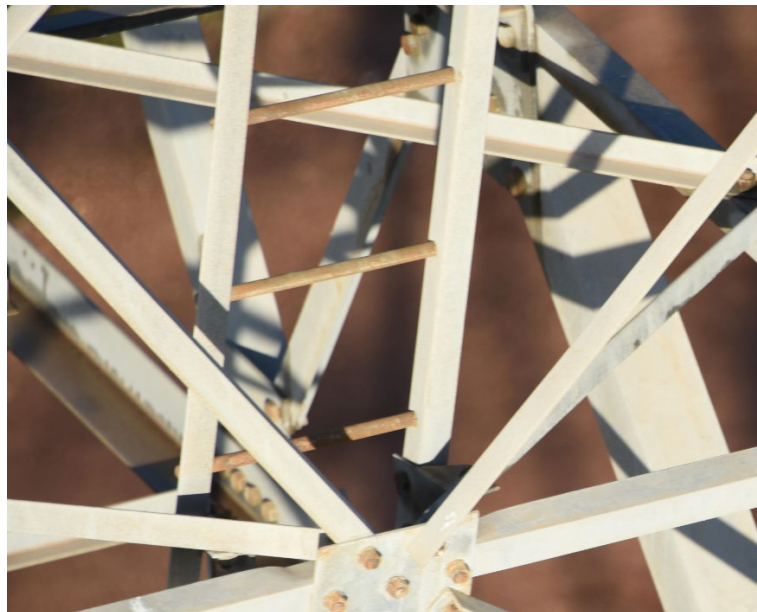
The towers also have ladders to aid climbing and they also show signs of G2 and G3 corrosion.

Figure 5: G2 & G3 Corrosion on ladder 1515-STR-0012

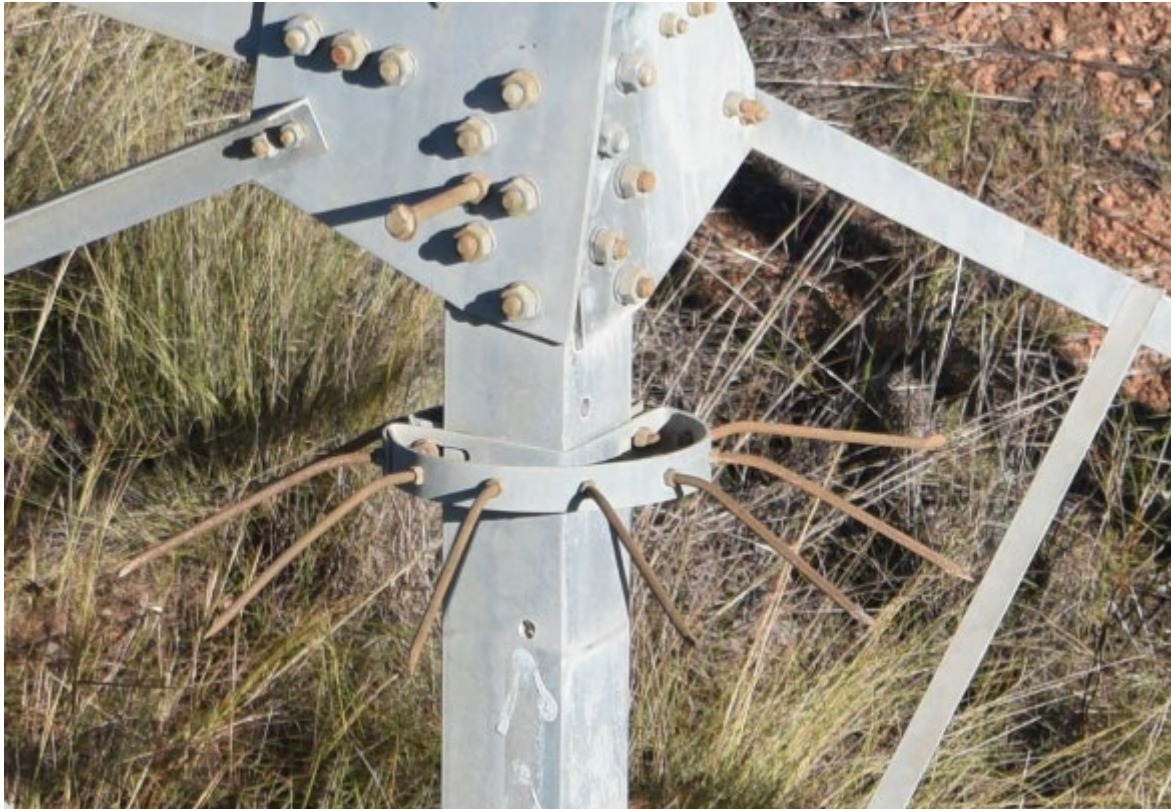
Figure 6: 1515-STR-0017 ACB Crown of Thorns

These towers don't have the standard barb wire installed and only have "crown of thorns" as anti-climbing barrier see Figure 6 below. Grade 2 corrosion was observed on some steelwork.

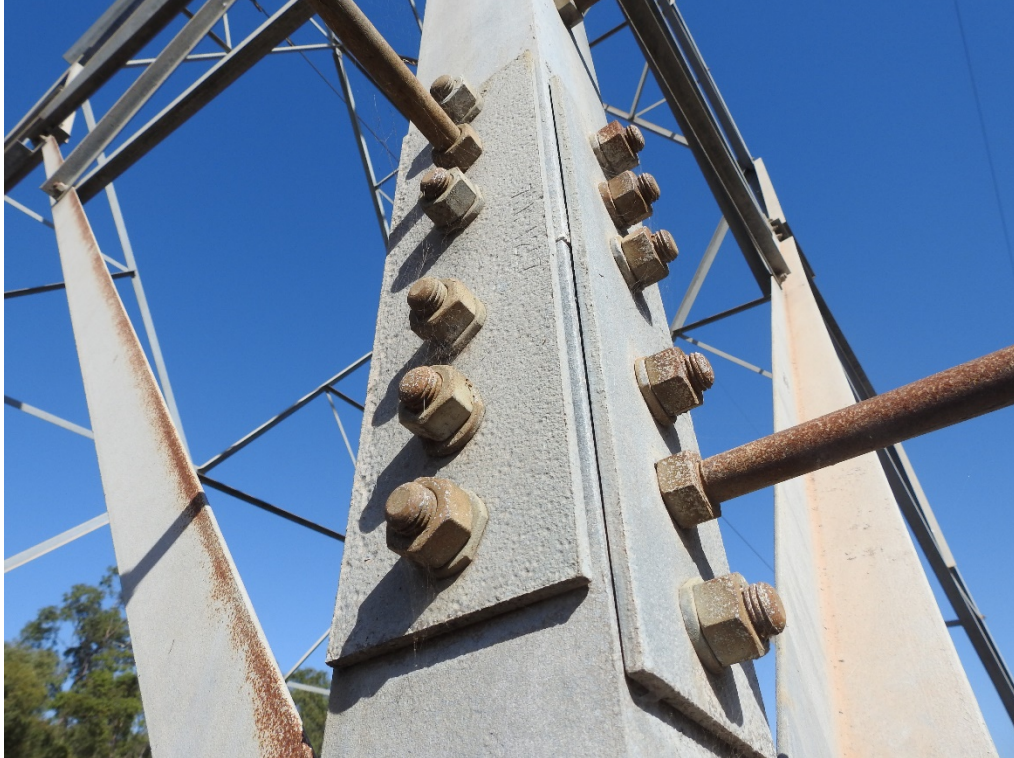
**Figure 7: 1515-STR-0013 Tower Base Corrosion**

G2 and G3 corrosion has been observed on 45% of nuts and bolts and some G4 bolts were also present. Members are showing 11% G2 level of corrosion.

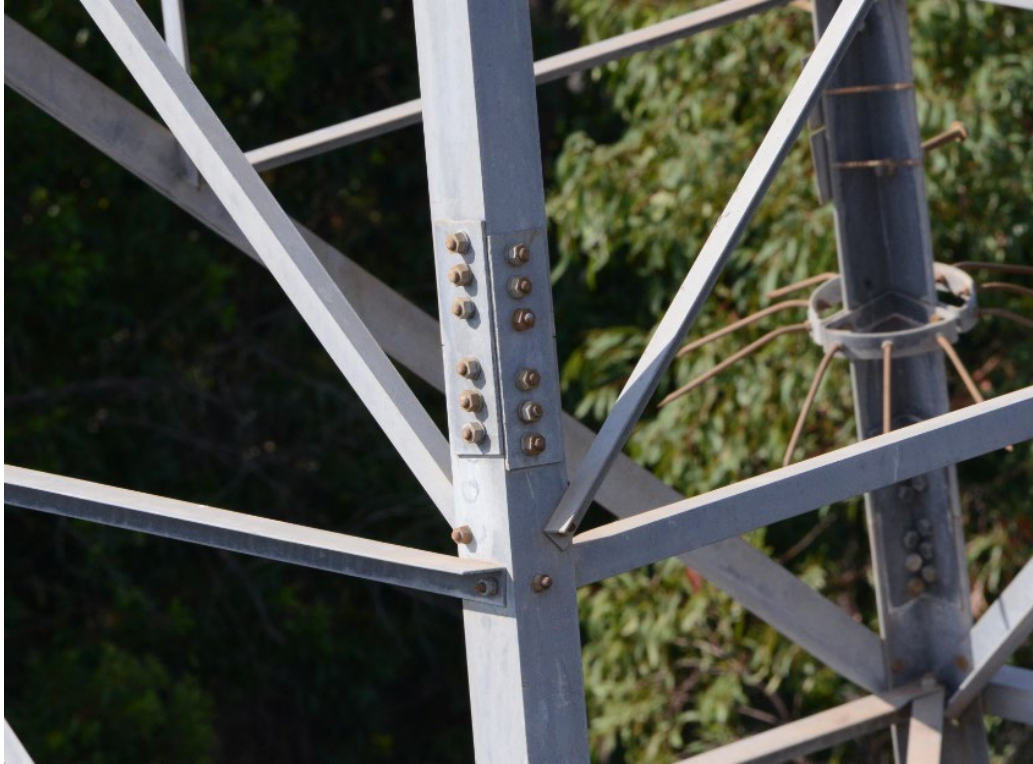
A high percentage of G2 (33%) and G3 (9%) bolt corrosion was observed. Members showed about 16% with G2 corrosion. Figure 8 shows the general condition of the tower body and the large percentage of corroded bolts.

**Figure 8: 1515-STR-0021 Tower Body corrosion**

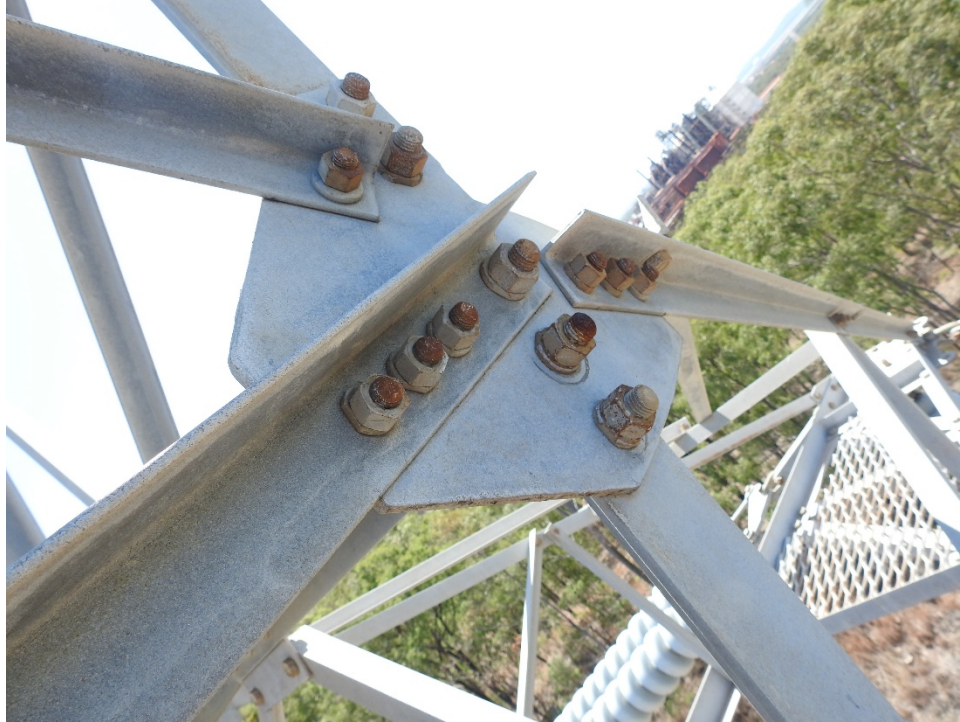
Surface rust has been observed on 13% of members with a high percentage (40%) of G2 nuts and bolts. A high percentage (15%) of G3 bolts are present with some instances of G4 bolts and G3 members.

Figure 9: 1515-STR-0017 with G2 and G3 bolts

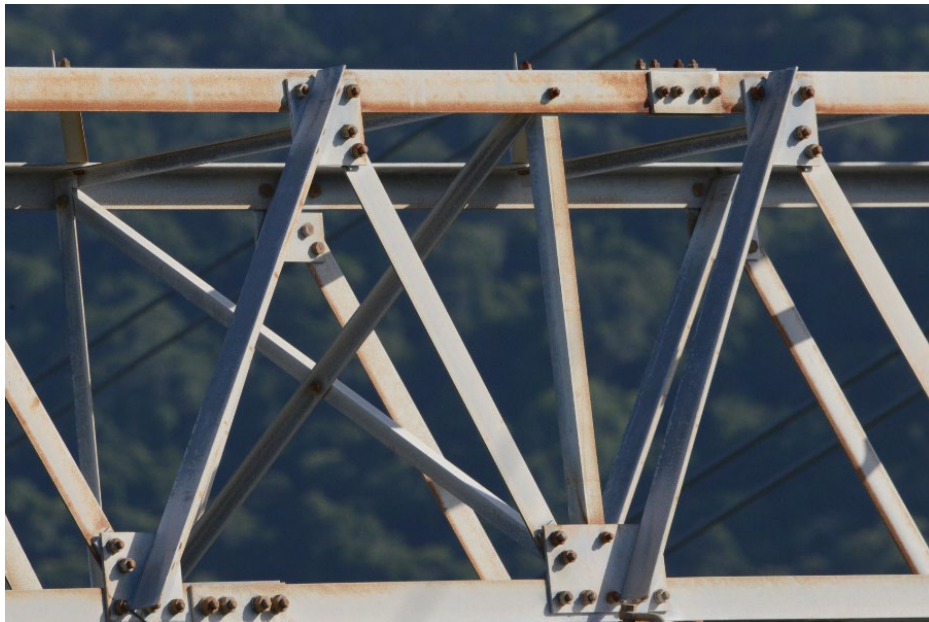
Figure 10: 1515-STR-0028 Superstructure G3 bolts and G2 members

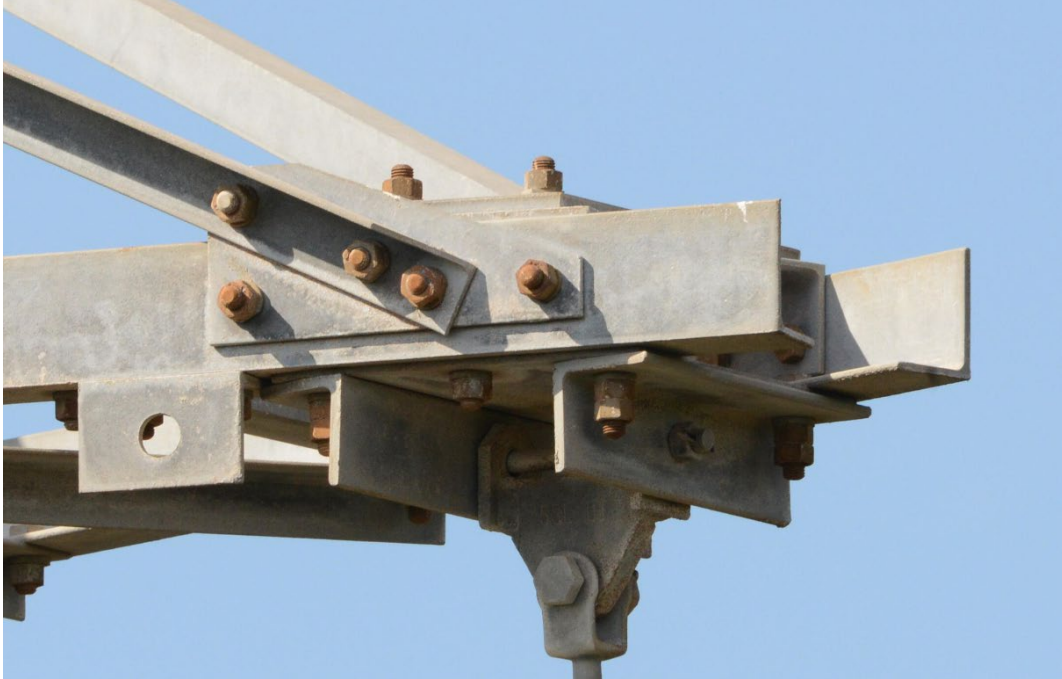
Most bolts on attachment plate show signs of corrosion with about 15% bolts reaching G3.

Figure 11: 1515-STR-05021 Attachment Zone - G2/G3 bolts

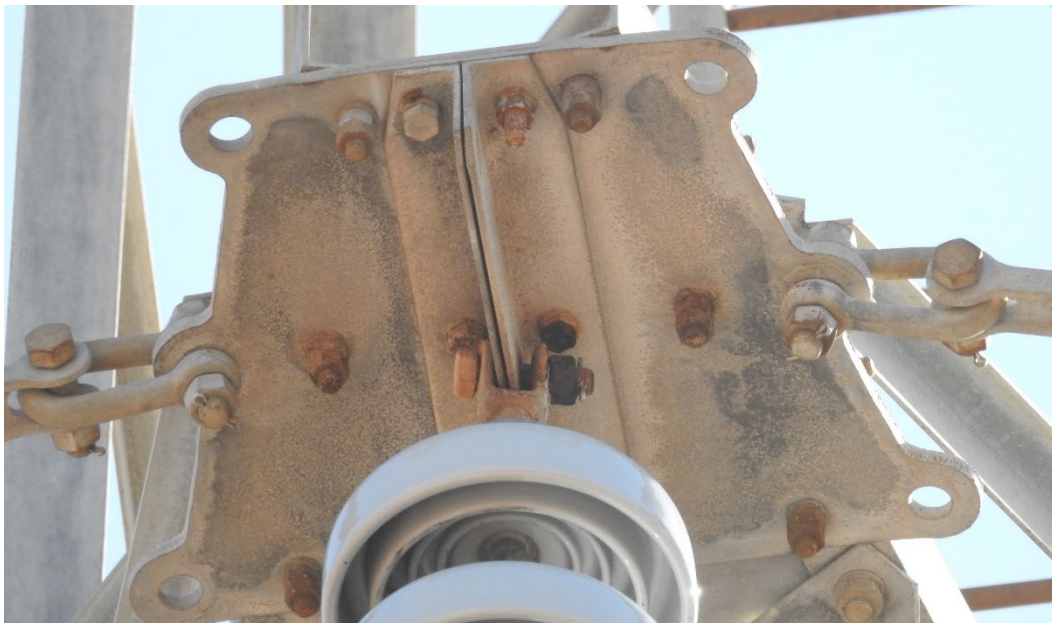
Figure 12: 1515-STR-0012 Attachment Plate bolt corrosion

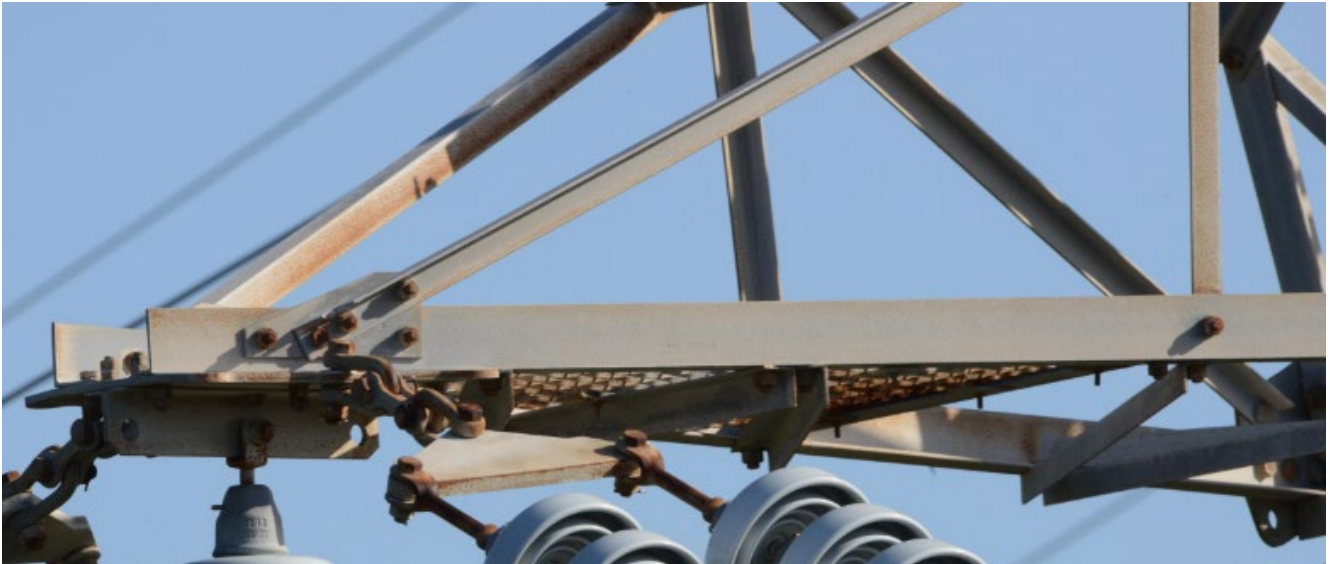
Surface rust has been observed on most cross arm nuts and bolts, with some bolts very close to grade 4. The cross arm bolts on structure 0021 and 0028 are displaying advanced grade 3 corrosion with 14% on average.

Figure 13: 1515-STR-0028 cross arm corrosion

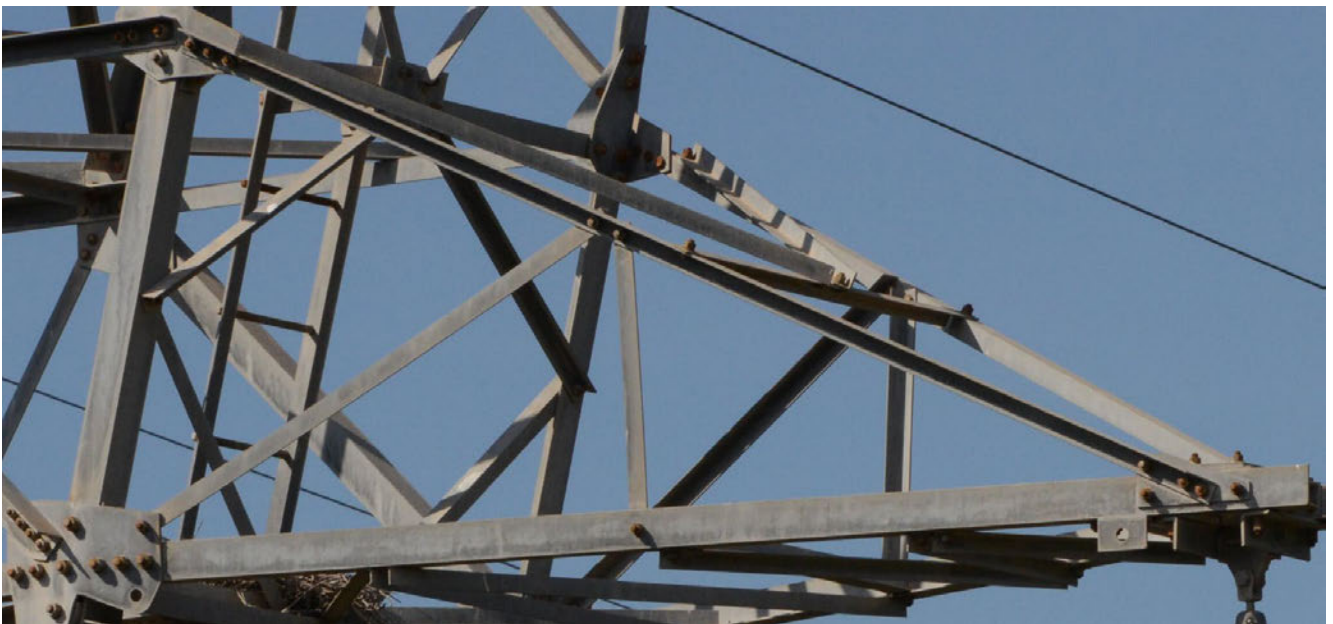
Figure 14: 1515-STR-0021 cross arm corrosion

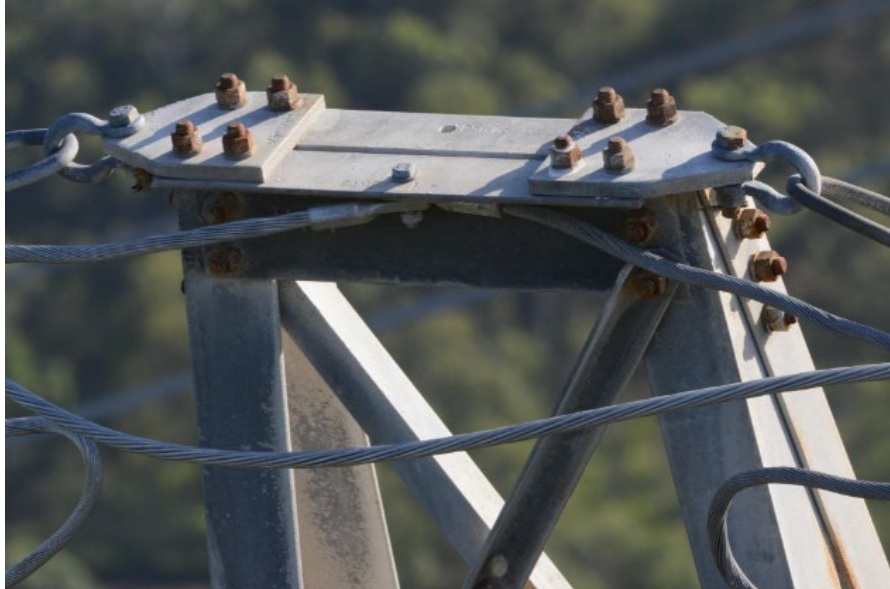
A high percentage of G3 rust has been observed on nuts and bolts as well as advanced surface corrosion on members as shown in the figures below of tower 0028.

Figure 15: 1515-STR-0028 G2/G3 corroded bolts and member on earth wire peak

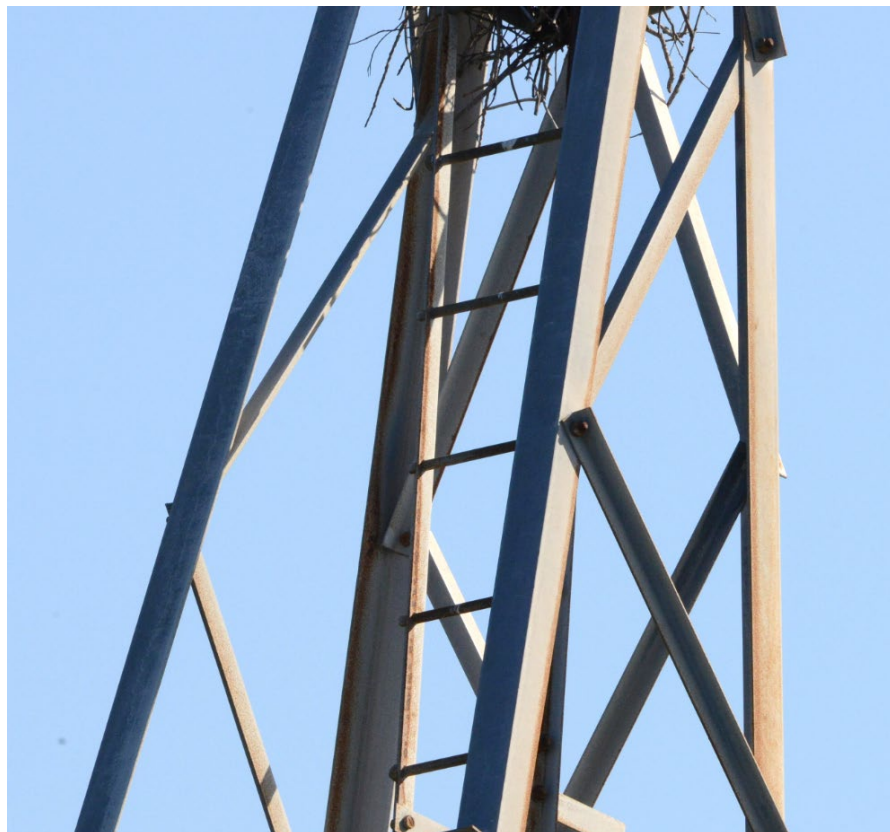
Figure 16: 1515-STR-0028 Earth wire peak with G3 corroded bolts and G2 member

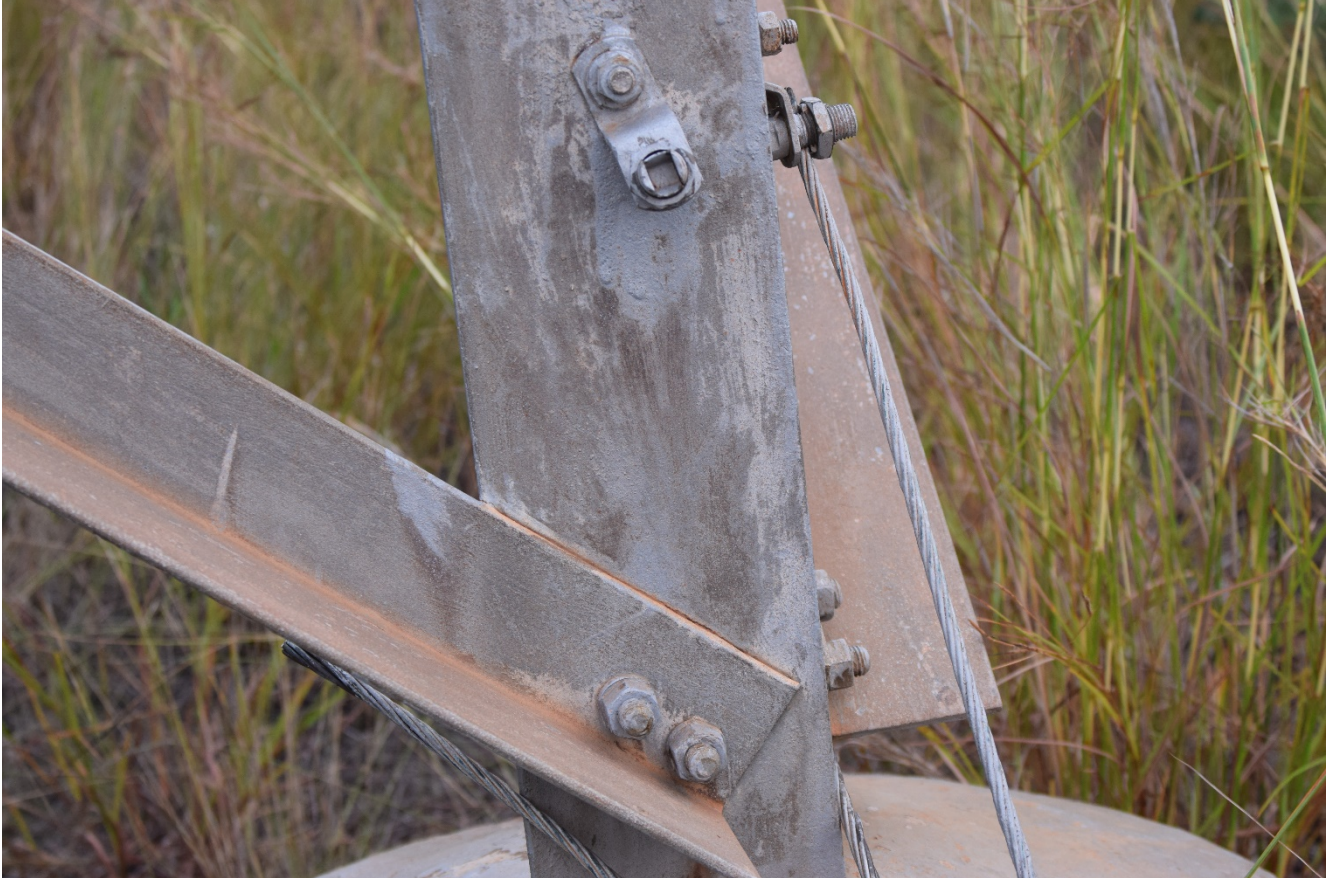
Generally the earthing is ok with some instances of earth straps not connected.

Figure 17: 1515-STR-0019 Earth strap not connected

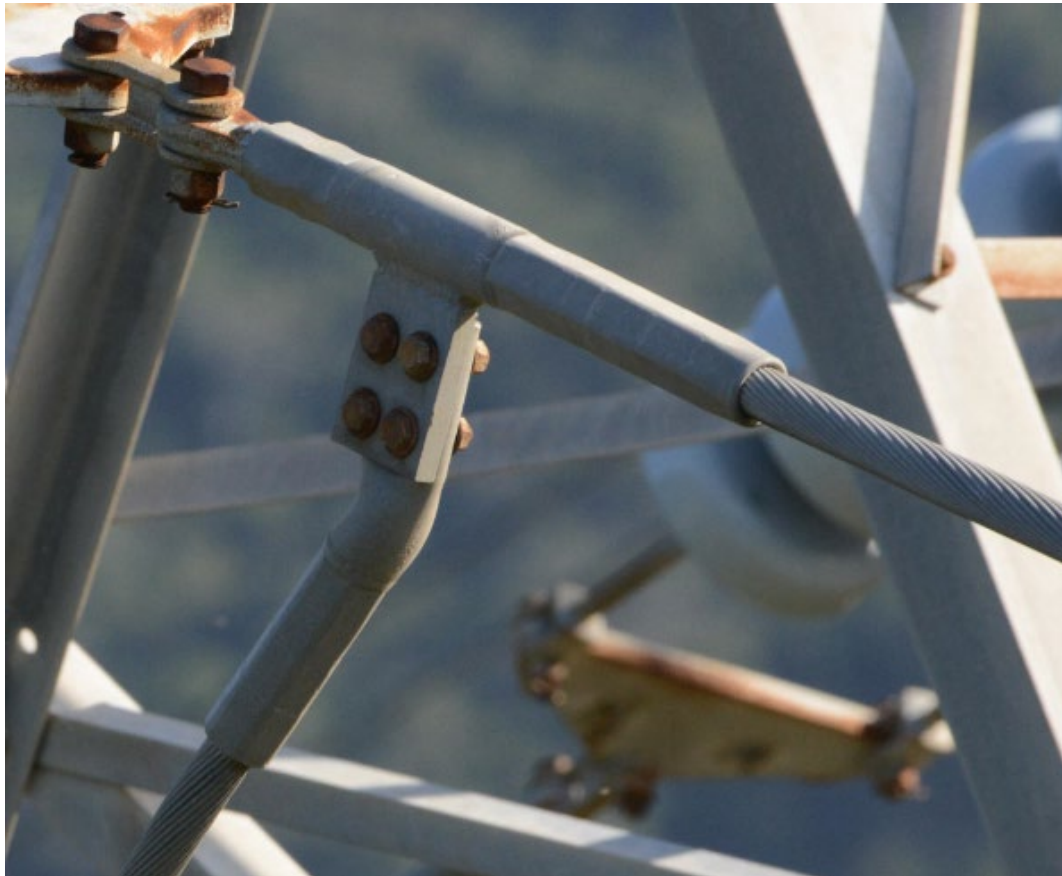
The Paw Paw ACSR/GZ conductor is terminated with a compressed dead end fitting. The end fittings are showing signs of Grade 2 corrosion.

**Figure 18: 1515-STR-0028 Compression Fitting Corrosion**

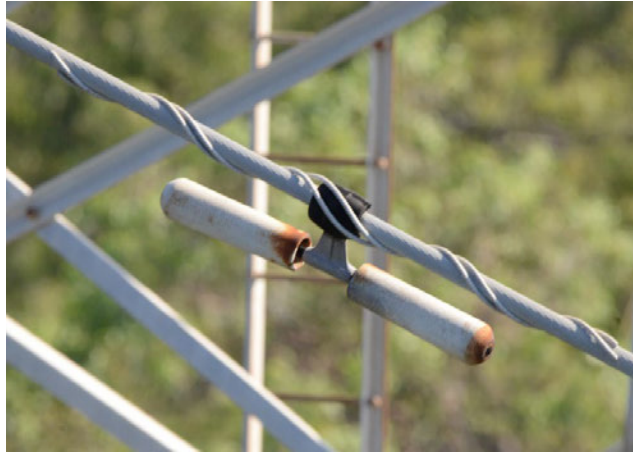
Figure 19: 1515-STR-0028 Damper showing signs of aging and corrosion

Damper age varies and some are showing signs of aging and corrosion, these should be replaced when insulators are changed on the structure.

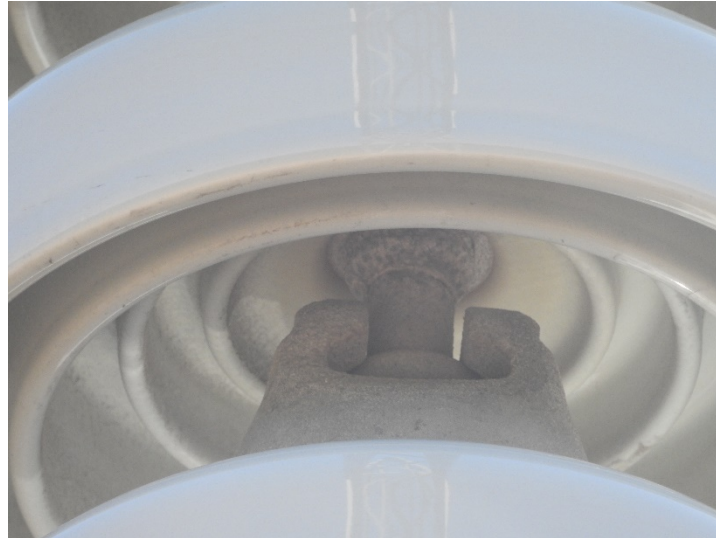
Figure 21: 1515-STR-0013 Suspension Insulator

Insulators were changed in 2008, however hardware was not changed. All suspension insulators are in good condition.

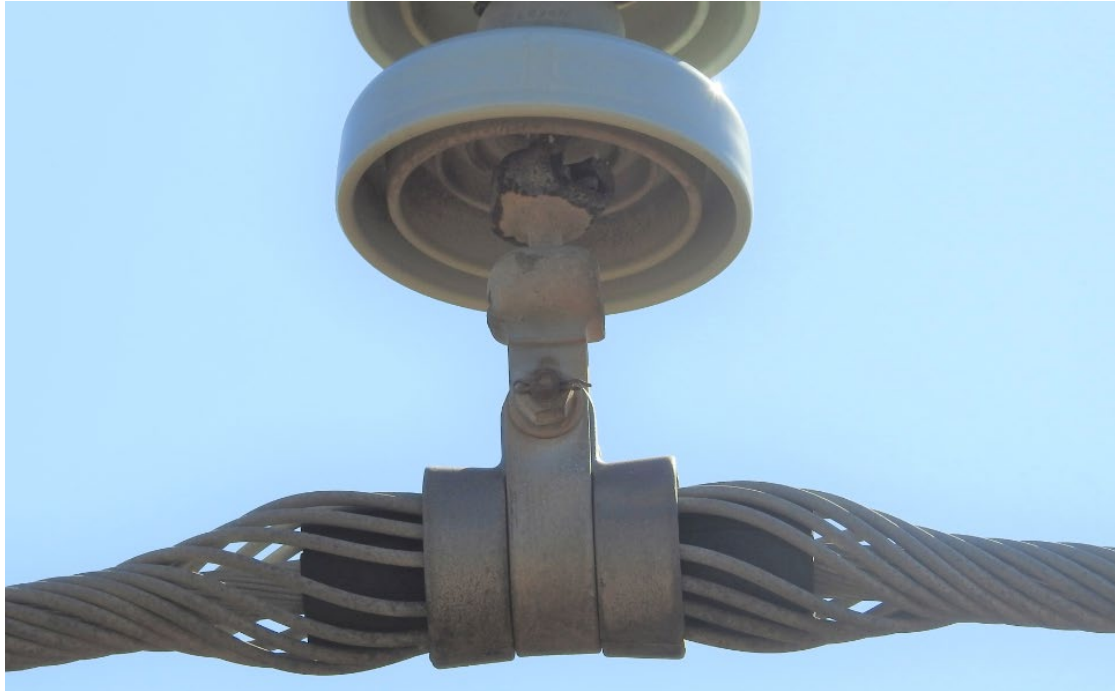
Figure 22: 1515-STR-0013 – Suspension Hardware Hot End

Insulators were changed in 2008, however hardware was not changed. 30% of suspension strings are showing high G3 on hardware.

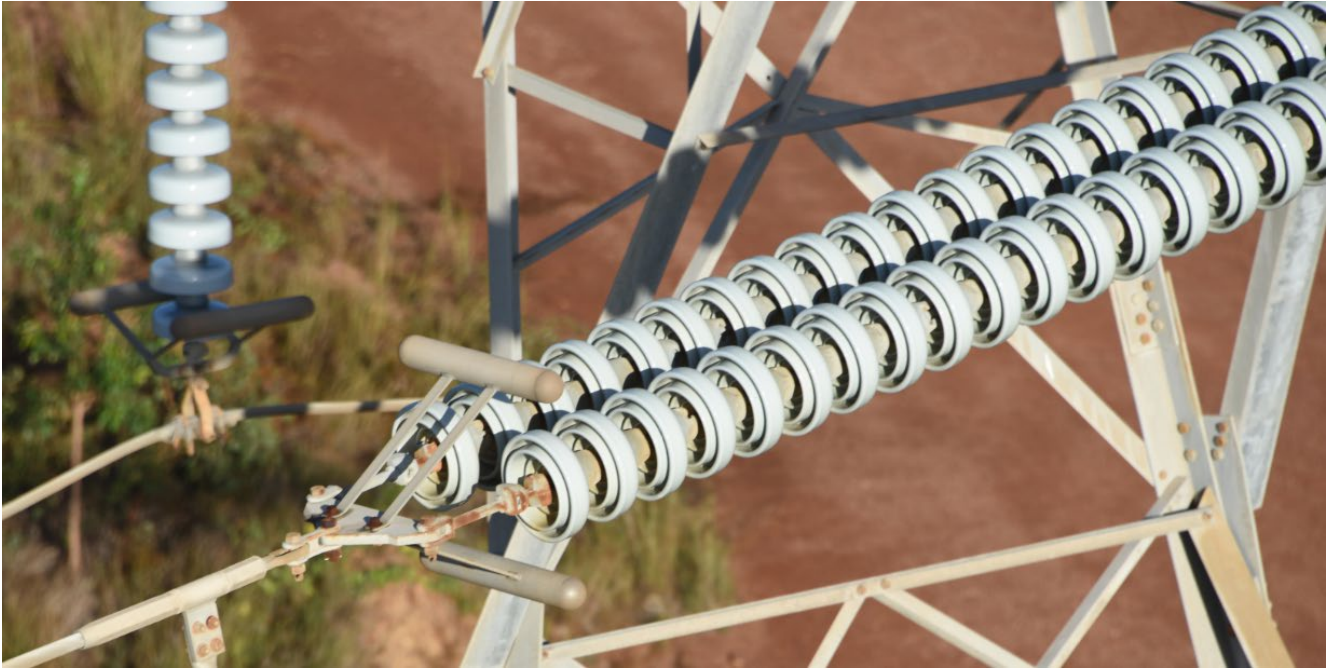
Figure 24: 1515-STR-0012 Tension Insulator String

The tension Insulators are still original (except on STR-0028 replace in 2014) with 25% showing low G3 corrosion. The replacement on STR-0028 suggests they were G4 insulators.

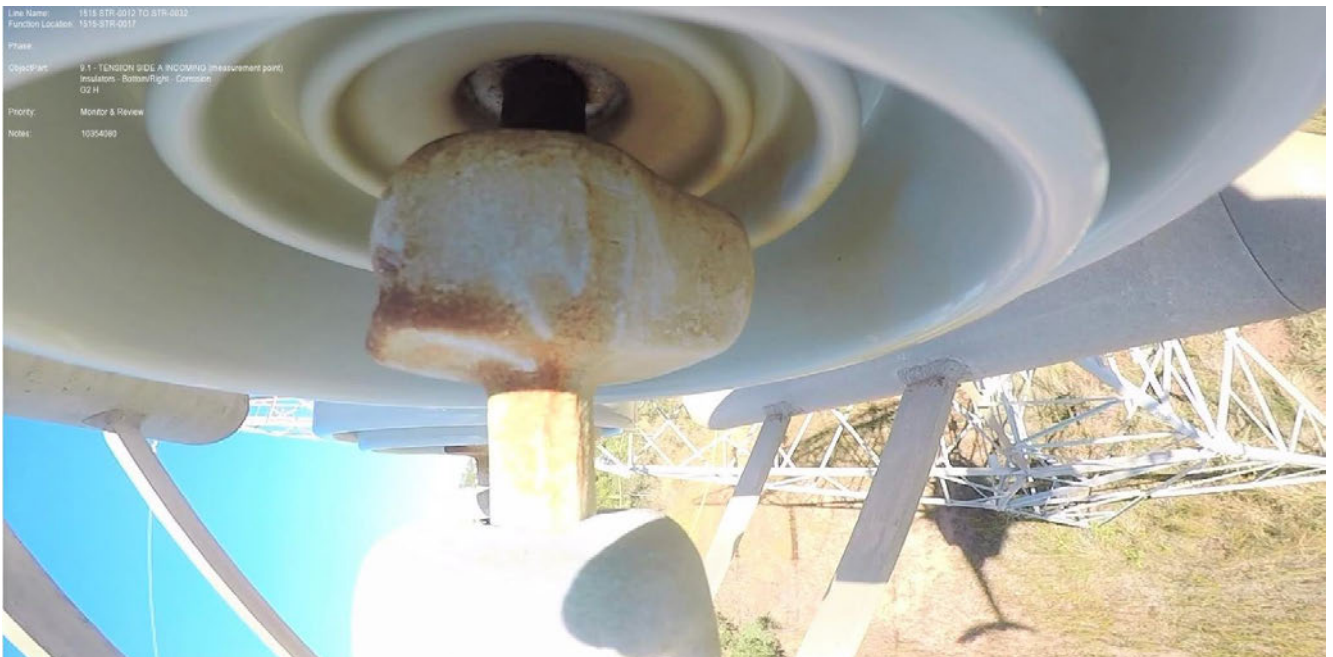
Figure 25: 1515-STR-0017 Tension Insulator G3L

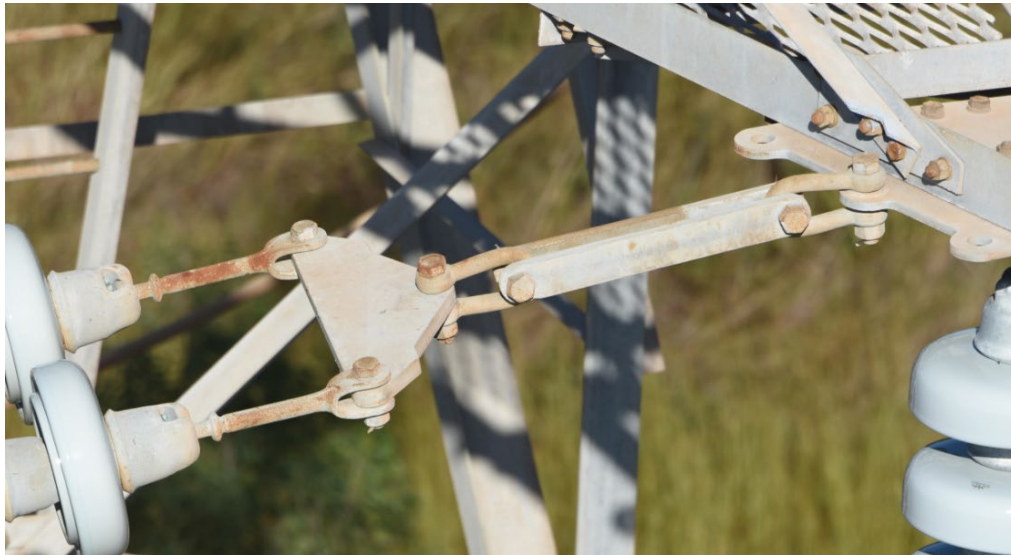
Figure 26: 1515-STR-0017 Tension Insulator Hardware – Cold End

Tension insulator hardware is displaying extensive G2 and G3 corrosion which should be replaced when the insulators are changed.

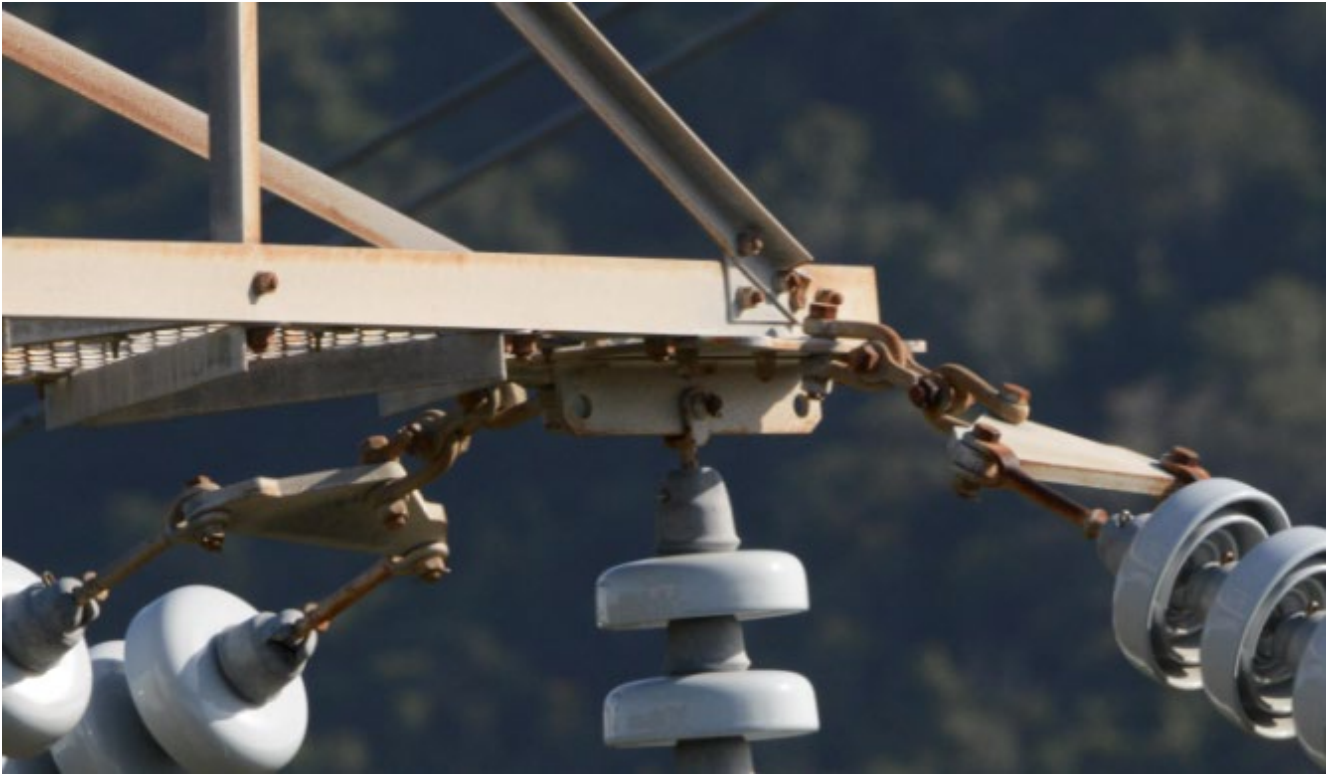
Figure 28: 1515-STR-0028 Tension Tower Attachment Location

Possibly one of the worst towers on the line is STR-0028 which had the tension insulators replaced in 2014 and the below photo was taken in 2018. High G3 hardware is of concern and should be addressed in the short term.

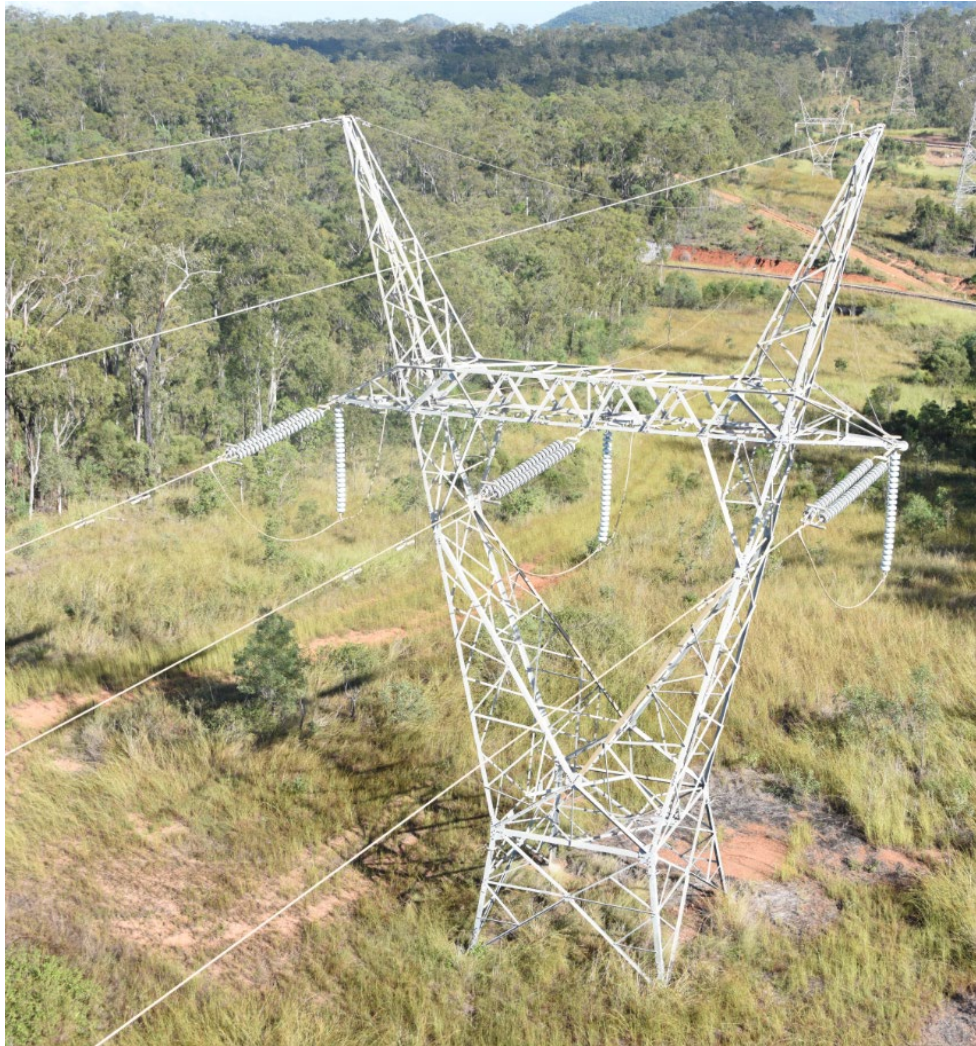
**Figure 31: 1515-STR-0017 to 0018 Easement Conditions**

The easement is in good condition with no outstanding notifications. The following two photos are examples of the easement. The easement is reasonably flat with one hilly section between towers 28 to 32.
