**POWERLINK QUEENSLAND  
REVENUE PROPOSAL**

**CP.02356**

**Lilyvale Transformers 3 and 4 Replacement**

# Transformers Condition Assessment H015 Lilyvale Substation

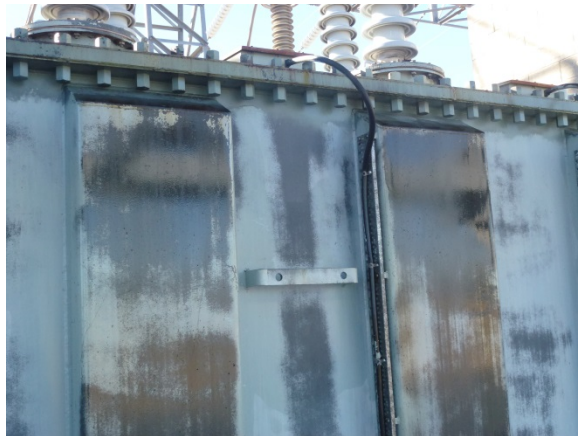
This transformer has obviously been repainted in the past and from a search of the available notifications, it was found necessary to revisit the transformer in 2011 to touch-up the main lid flange dome nuts. The repainted coating is badly oxidised as shown in Figure 2 and in some locations like the doors of the on-board cubicles, the paint is delamination off the original OEM coating.

**Figure 2:** Transformer T3 LV side of the main tank showing the oxidised repainted surfaces.

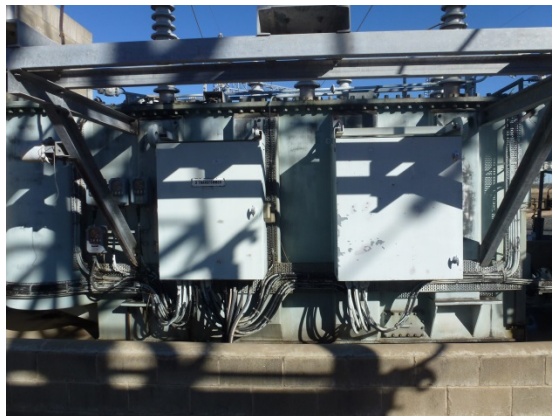
**Figure 3:** Transformer T3 HV side of the main tank showing paint delaminating off the cubicle doors.

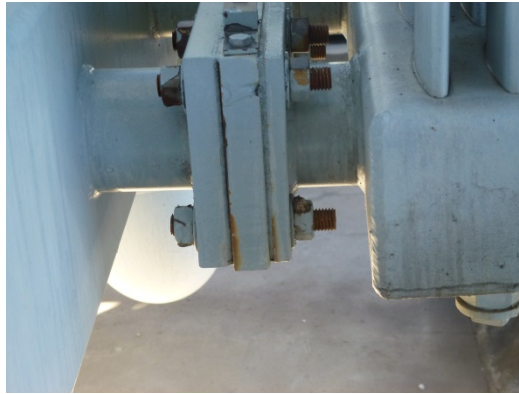
**Figure 4:** Typical type of minor corrosion visible on the transformer.

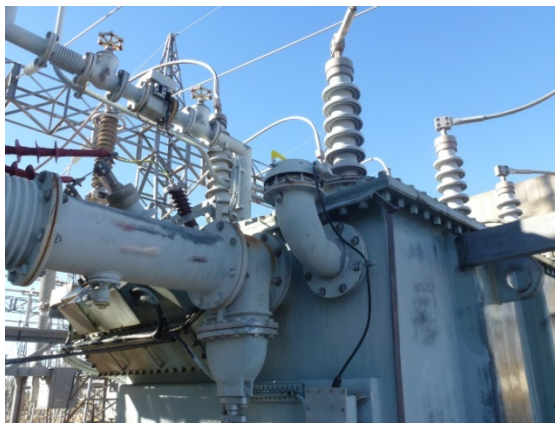
**Figure 5:** Corrosion between the mating flanges of the top main oil pipe between the main tank and the cooler bank.

Corrosion in the location shown in Figure 5 will result in another oil leak as the rust grows inwards under the gasket.

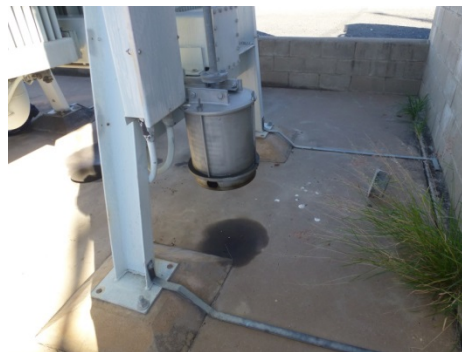
There were no signs of any structural issues associated with main supports for the cooler bank and main tank but what was noticed was the use of only two holding down bolts in each foot of the cooler bank 'A' Frame support structures. This must have been signed off when the transformer was installed years ago but is not compliant with current design practice.

**Figure 6:** Cooler bank 'A' Frame structure using only two bolts per foot pad.

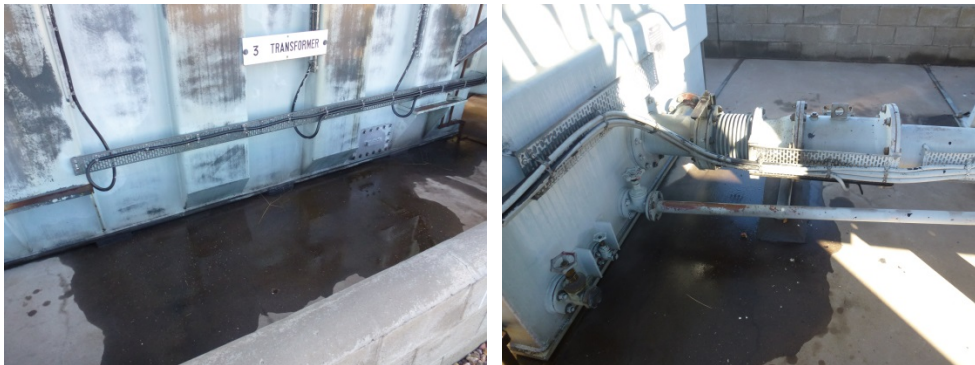
**Figure 7:** Oil leaks resulting in free oil collecting on the concrete around the main tank on the LV side as well as at the tertiary bushings end.

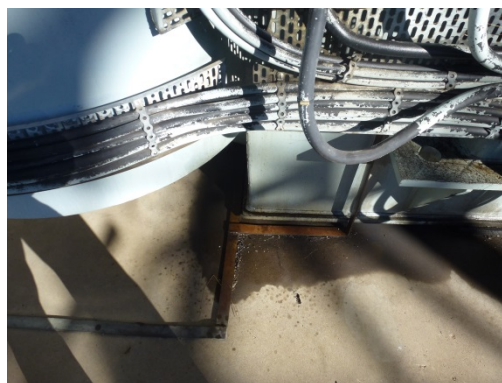
**Figure 8:** Oil leaks resulting in free oil collecting on the concrete around the main tank on the HV side.

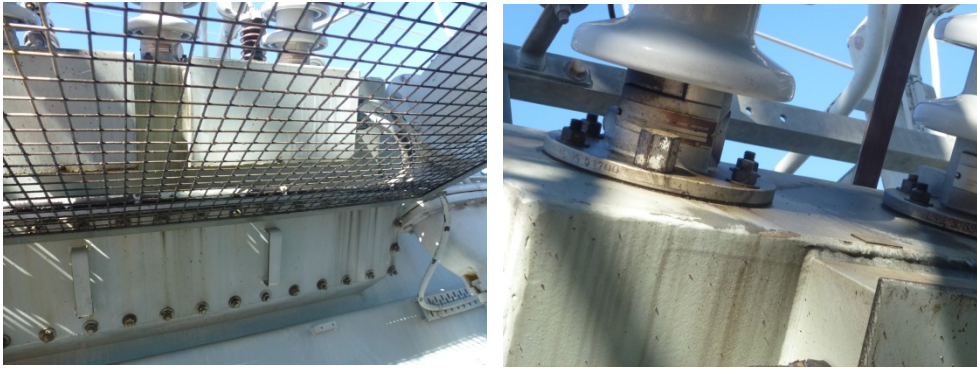
**Figure 9:** Oil leaks at tertiary bushings resulting in free oil running down the end of the main tank surface and collecting on the concrete below.

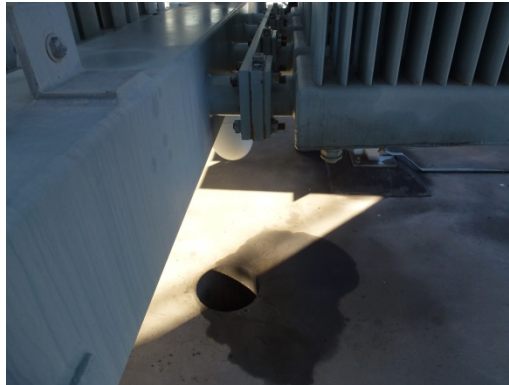
With respect to the cooler bank, there are some minor oil leaks as evidenced by the oil wetness on the concrete immediately below the cooler bank but there were no continuous oil drips evident.

**Figure 10:** Cooler bank oil leaks around some radiator panel mounting flanges / butterfly valves.

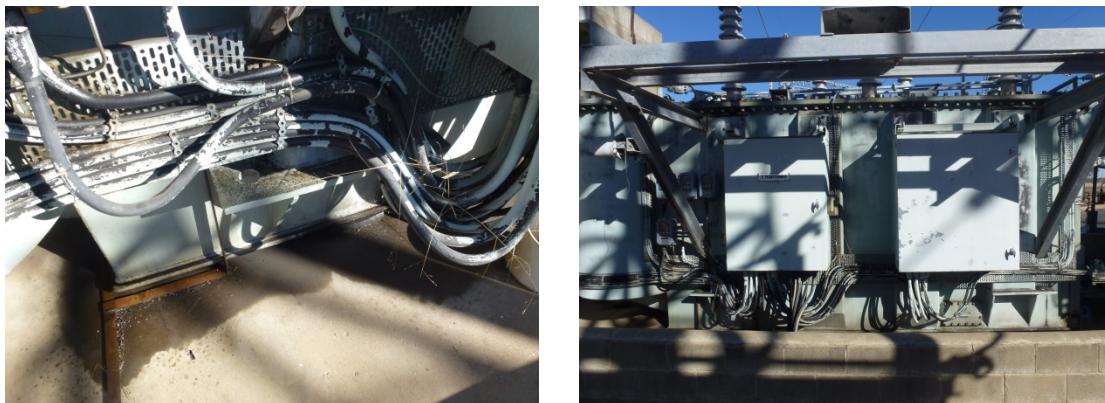
The external black PVC multi-core cables appeared to be in reasonable condition with no signs of excessive surface oxidation / cracking, however, after 34 years, the cables are sure to have taken a set and any significant cable flexing would likely create some insulation damage. The cables have also been previously painted to match the main tank colour but this paint was not designed to adhere to the outer cable PVC surface and as such, some of the paint has been progressively delaminating.

**Figure 11:** External cabling showing no signs of surface cracking but would have taken a set and should not be subjected to any significant flexing.

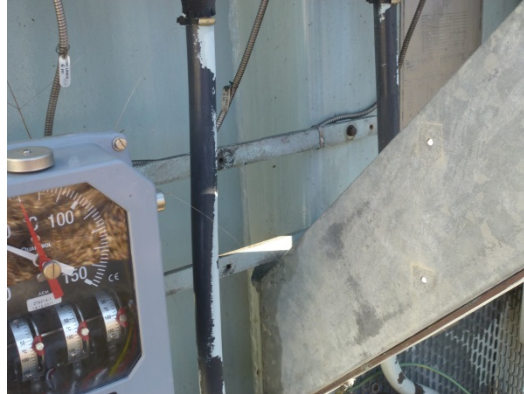
The WTIs and OTI instruments appeared to be in fairly good condition and this is possibly due to being replaced in 2011 (WTIs) and 2013 (OTI), as mentioned in the SAP notifications for this transformer.

**Figure 12:** Kihlstrom temperature measurement instrumentation appears to be in good condition following replacement in later years.

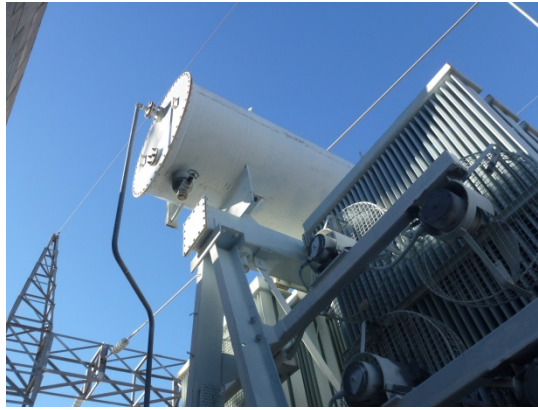
**Figure 13:** Main tank conservator original upper and lower mounting flanges for a Drycol refrigeration breather unit.

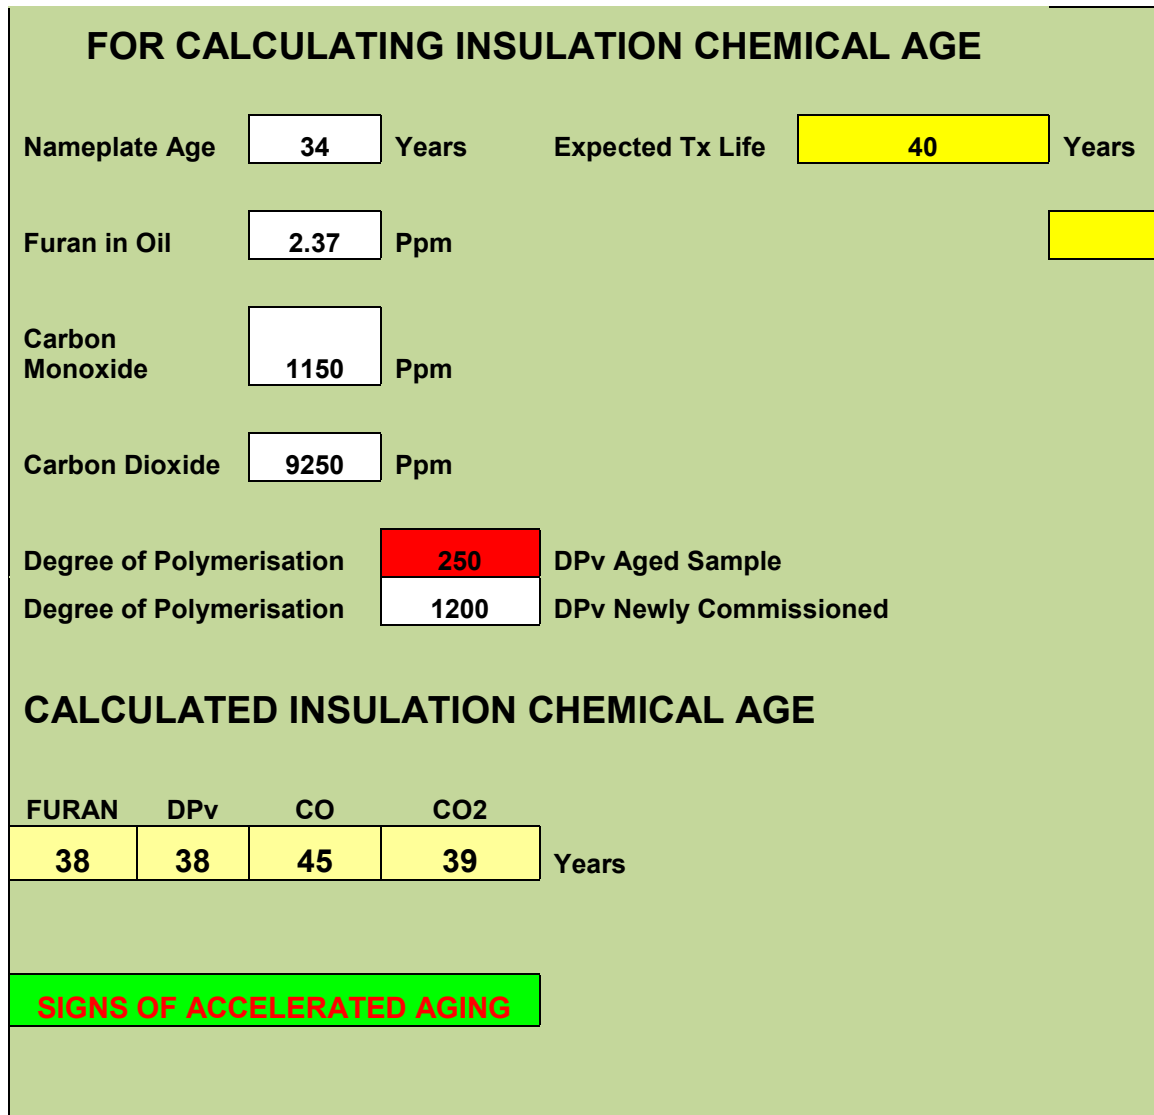
Insulation age of this transformer was calculated to be approximately 38 years as shown below in Figure 14. This is slightly above its nameplate age of 34 years and supports the higher than normal dissolved carbon dioxide gas in oil levels over its service life which suggests higher bulk insulation operating temperatures over that time.

**Figure 14:** Calculation of cellulose insulation age using a number of indirect indicators.

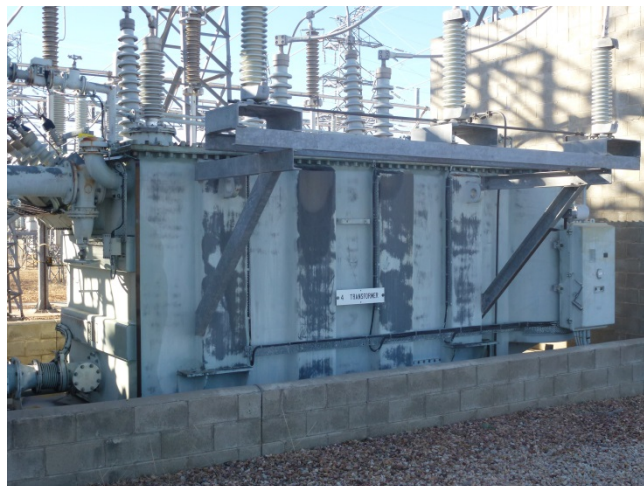
This transformer has obviously been repainted in the past and from a search of the available notifications, it was found necessary to revisit the transformer in 2011 to touch-up the main lid flange dome nuts. The repainted coating is badly oxidised as shown in Figure 15.

**Figure 15:** Transformer T4 LV side of the main tank showing the oxidised repainted surfaces.

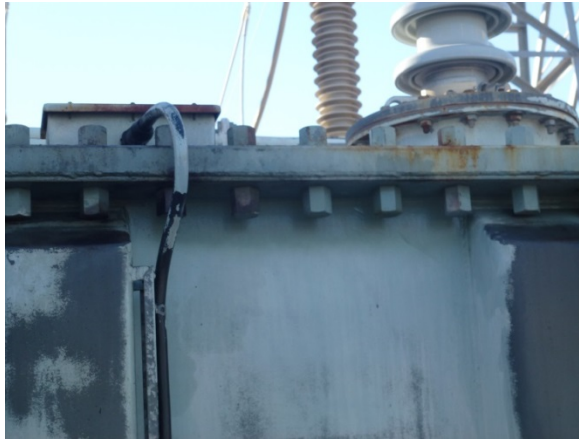
**Figure 16:** Typical type of minor corrosion visible on the transformer.

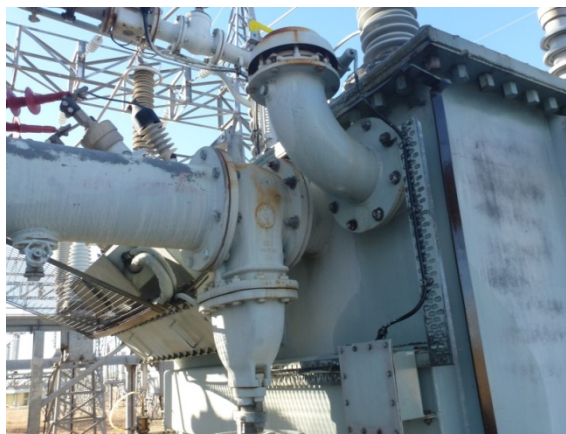
**Figure 17:** Corrosion around the flanges, valve body and PRD.

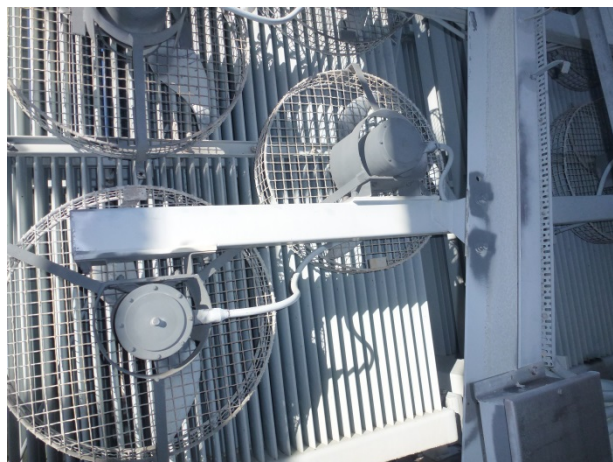
While the cooler bank paint is also oxidised with minor rusting in some locations, it is not showing oxidation to the same degree as on the main tank, pipework and conservator. A number of locations on the cooler bank fan motors and mounting brackets appear to have been coated with what appears like cold galvanising, to stop local corrosion and holes developing.

**Figure 18:** Cold galvanising paint applied to fan body, casings and mounting brackets.

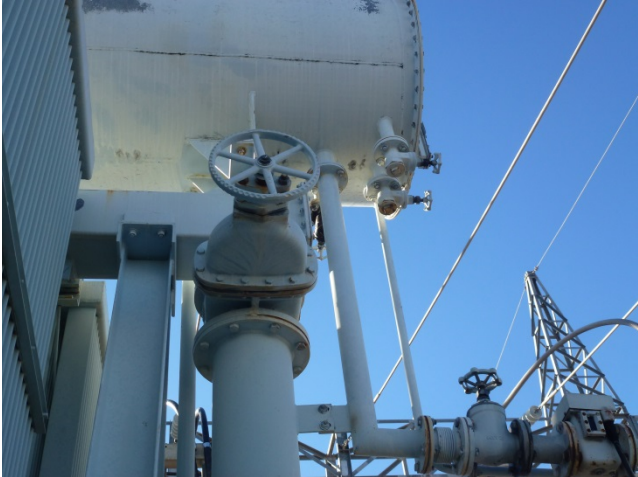
Figure 19: Small localised corrosion on cooler bank fittings.

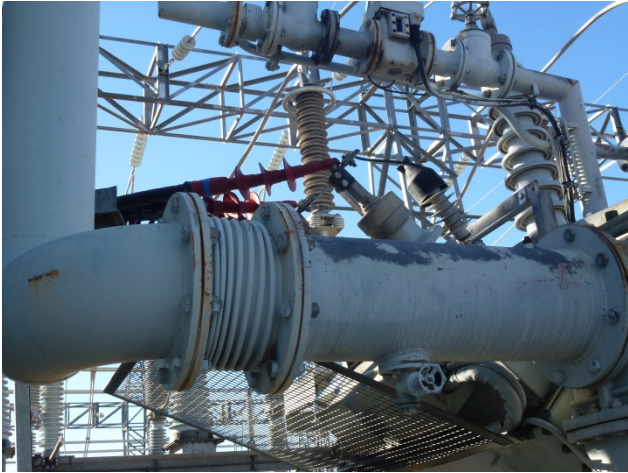
Figure 20: Small localised corrosion on main oil pipe & fittings.

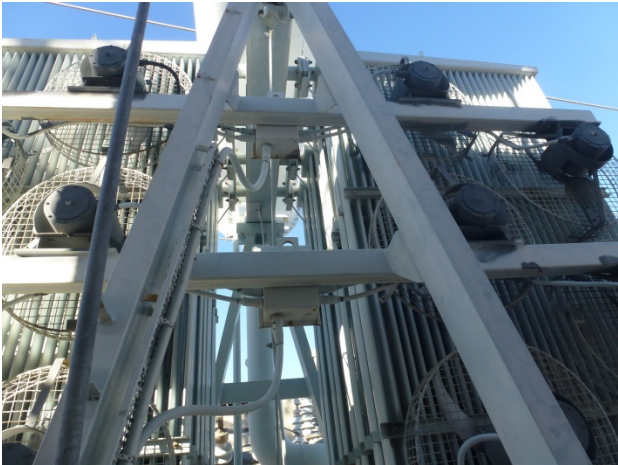
Figure 21: Small localised corrosion on cooler bank fittings.

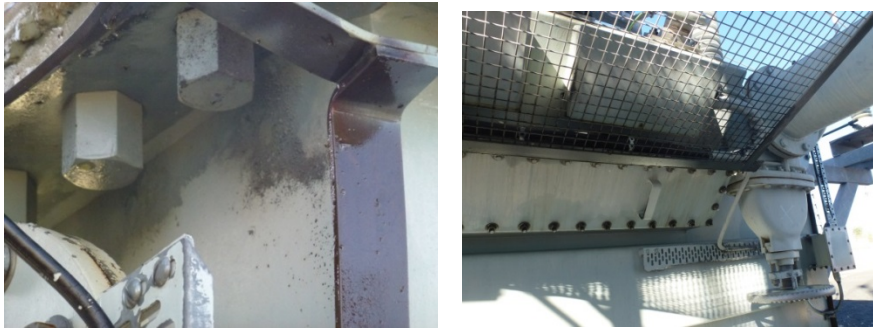
**Figure 23:** (LH) Oil leaks coming from gaskets on top of the main tank lid were dripping from the flange bolts. (RH) Oil leaks coming from the bolts which hold the cover plate for TV bushing connection access.

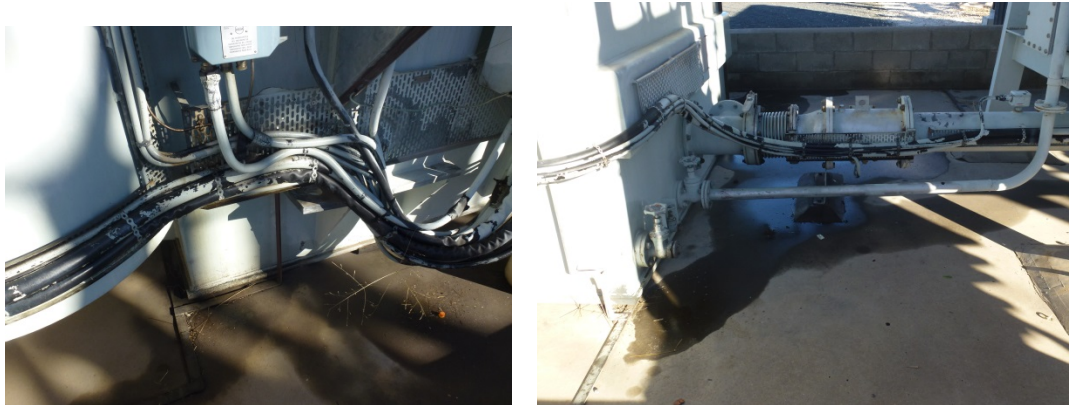
Oil was also running down the tank wall in a number of locations. A typical example is shown in Figure 24 (left hand side photo).

**Figure 24:** (LH) Oil running down the side of the main tank. (RH) Oil was also leaking from seals around the bottom main tank isolating valve.

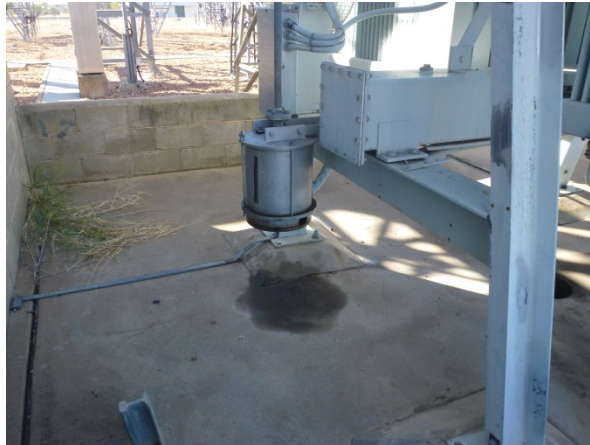
There were minimal oil leaks on the cooler bank with only two notable traces on the concrete as shown in Figure 25. One leak immediately below the conservator desiccant breather is more likely due to oil bath spillage during maintenance of the breather rather than oil being pushed out due to rapid transformer exhalation due to rapid internal transformer temperature increase.

**Figure 25:** There were minimal oil leaks on the cooler bank with only two notable traces of oil on the concrete, one being due to maintenance of the breather..

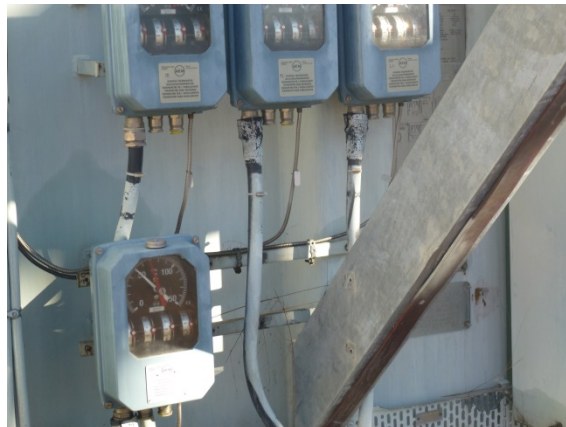
Readability of the WTIs and OTI instruments appeared to be good and this is due to being replaced in more recent times.

**Figure 26:** Kihlstrom temperature measurement instrumentation appears to be in good condition following some replacements in later years.

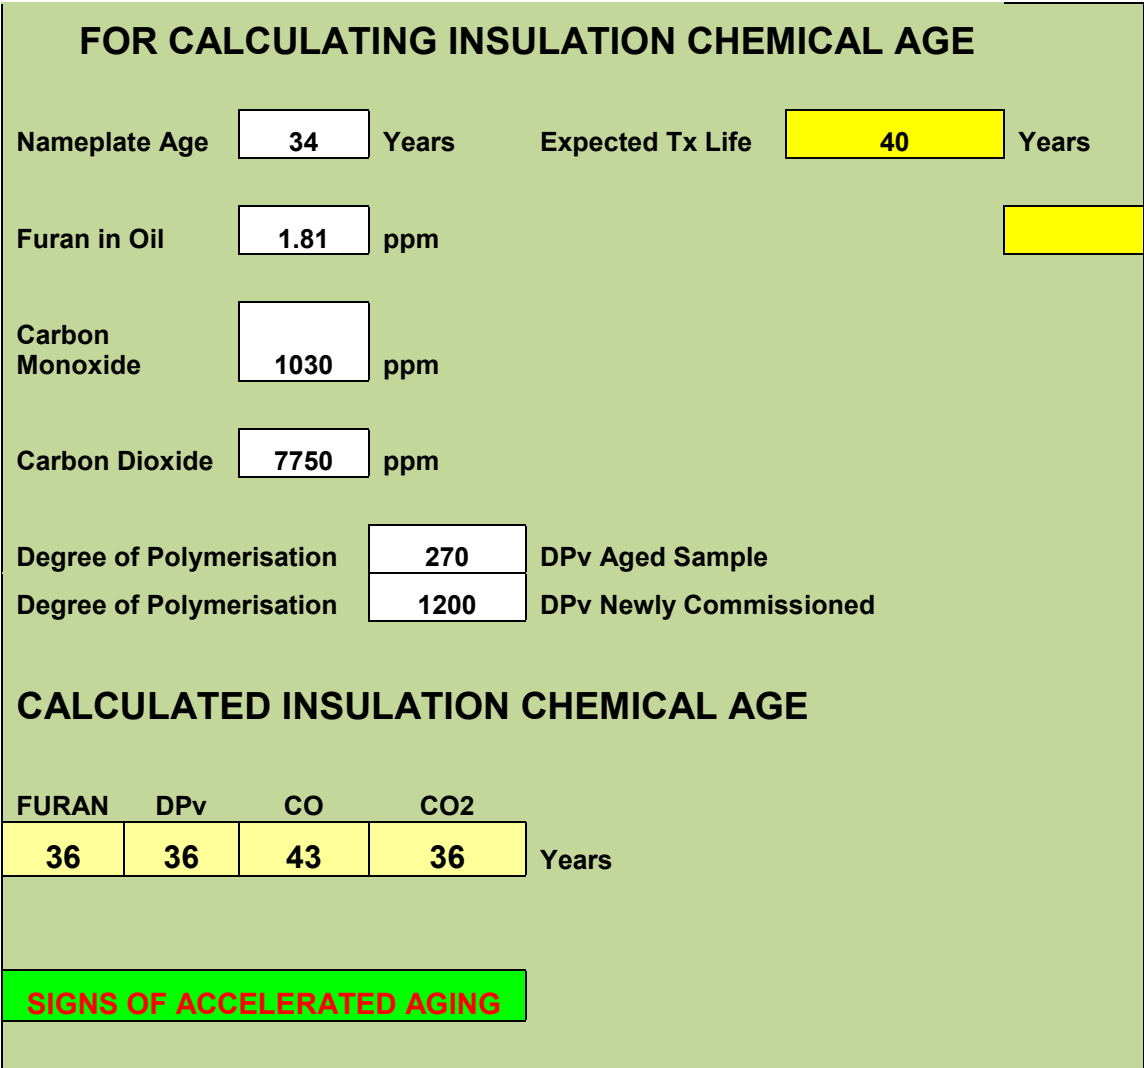
Insulation age of this transformer was calculated to be approximately 36 years as shown below in Figure 27. This is slightly above (but not too bad) its nameplate age of 34 years and supports the higher than normal dissolved carbon dioxide gas in oil levels over its service life which suggests higher bulk insulation operating temperatures over that time.

**Figure 27:** Calculation of cellulose insulation age using a number of indirect indicators.

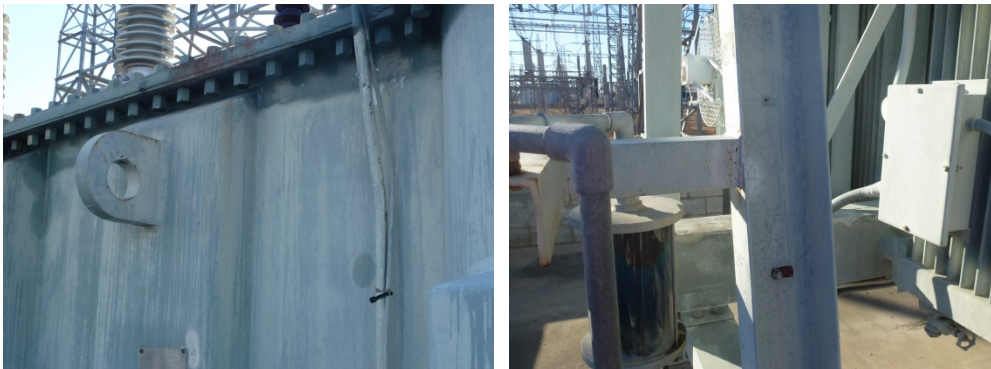
From first appearances, even though this transformer has obviously been repainted in the past and given touch-ups over time, it appears more run down than its neighbouring T3 & T4, with much more minor distributed surface & fitting corrosion and badly oxidised paint. Extensive cracking in the paint surface was also noticed on the cooler bank 'A' frame support structures. This is going to allow captive water pools under the paint to progress corrosion more quickly. This could be expected as it is 6 years older than T3 & T4. Overall, the cooler bank paintwork appeared just as oxidised or worse (cracking in particular locations) than the main tank paint.

**Figure 28:** (LH) Transformer T7 LV side of the main tank showing the oxidised repainted surfaces. (RH) Surface paint cracking on the cooler bank support structure.

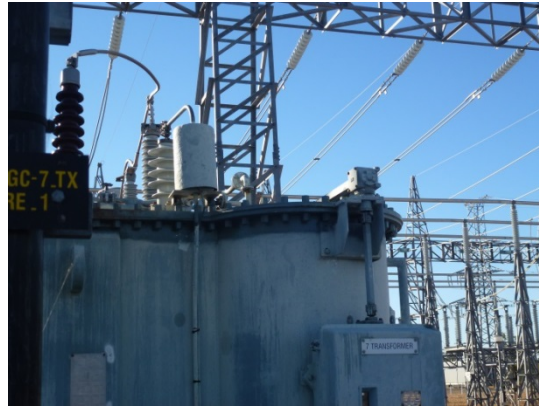
Corrosion in the area of the main tank / lid flanges has previously required the cleaning and recoating with a cold galvanising paint, as shown in Figure 28 & 29. The cold galvanising paint has been applied in a few locations around the transformer as required over time.

**Figure 29:** The dark strip around the tank / lid flange area is cold galvanising paint to combat the local corrosion.

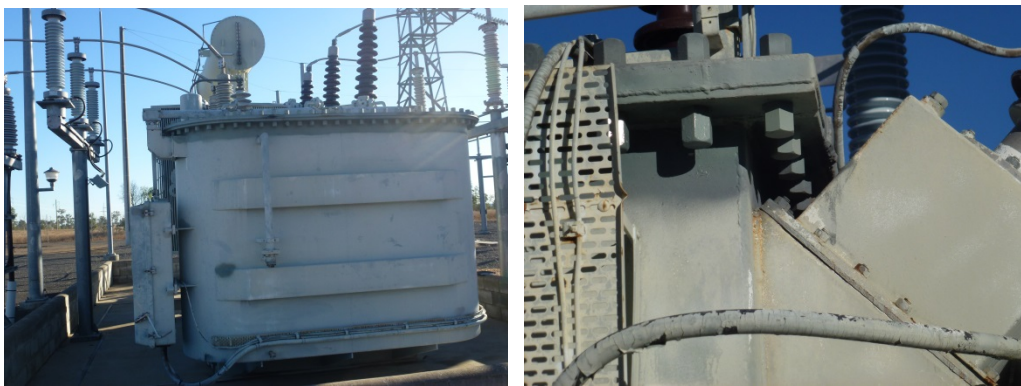
**Figure 30:** (LH) Tap changer end showing oxidised paint. (RH) Surface corrosion of weld on TV tank extension. Note also the cold galvanising on the welded lid strap.

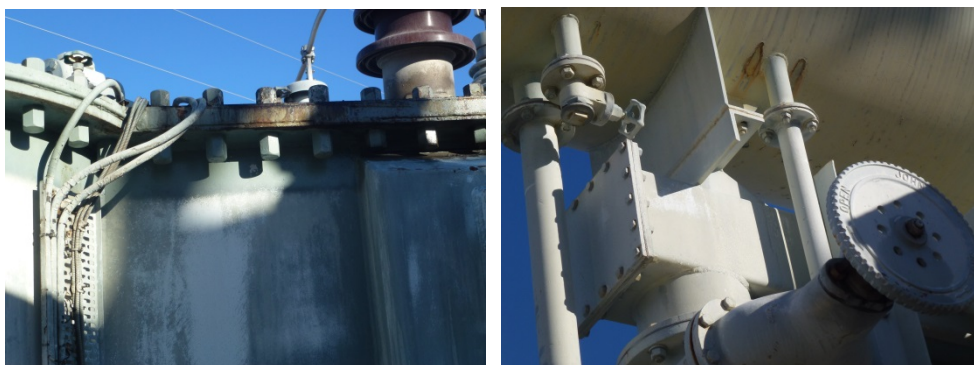
It was difficult to accurately determine but there were signs of corrosion on the underside of the main tank conservator which appeared to be the start of two future perforations. Refer to Figure 31 (RH) photo.

**Figure 31:** (LH) Corrosion of welded tank/lid strap. (RH) Corrosion on the bottom of the conservator appears like two holes forming.

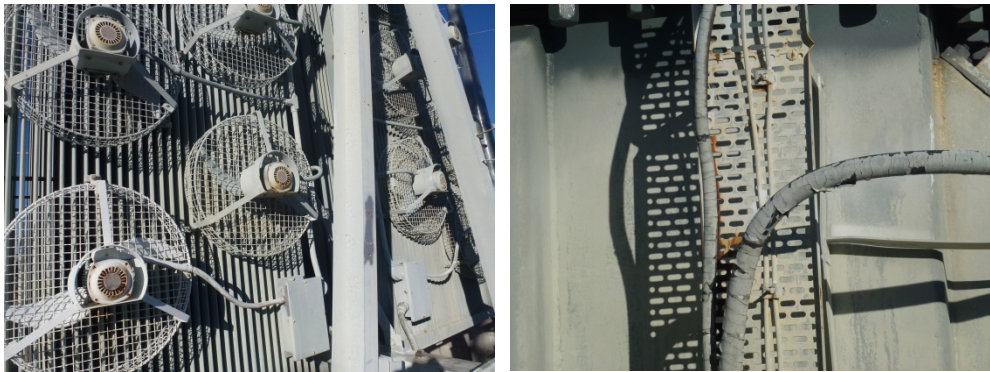
There was visible surface corrosion of the fan motor housings. Maintenance records reveal that there has been fan motor bearing issues identified in 2004. This could indicate that these old “birds wing” fans are close to their end of reliable life, depending on how often they are needed to operate.

**Figure 32:** (LH) Corrosion of the fan motor housings. (RH) Corrosion on cable trays.

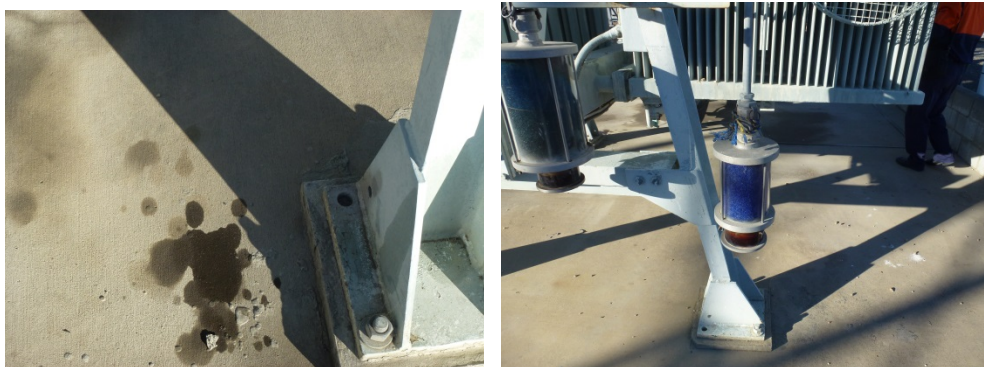
**Figure 33:** Cooler bank 'A' Frame structure using only two bolts per foot pad. No visible corrosion

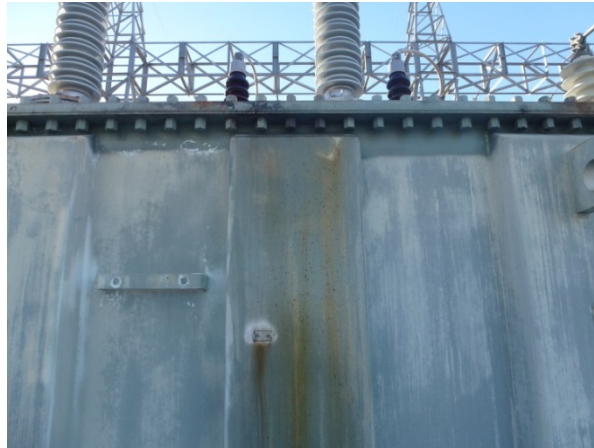
This transformer has a welded lid to tank flange, complete with dome nuts. While this transformer did have some visible signs of oil leaks, they could be classified as relatively minor in comparison to the leaks on adjacent T3 & T4 transformers. From a general overview, there was only one area on the main tank LV side wall where oil residue was tracking down the side from the lid. This is shown in Figure 34. The leak could be coming from the lid flange dome nut seals or the 'B' phase LV bushing flange seal.

**Figure 34:** Oil run noticed on the LV side of the transformer main tank.

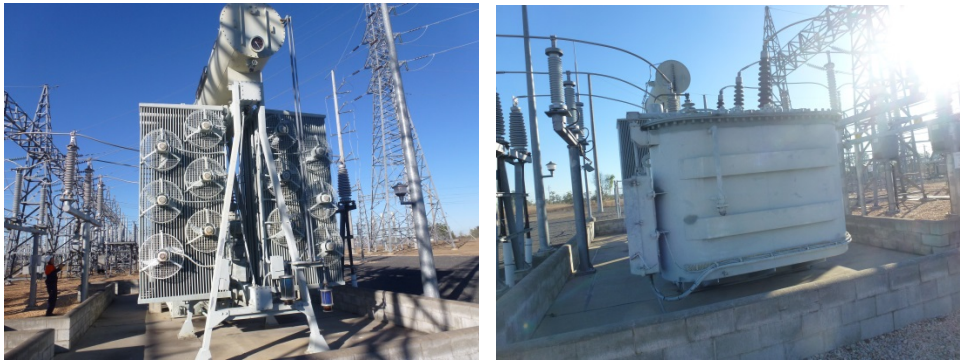
**Figure 35:** Relatively few oil leaks noticed on the concrete foundation.

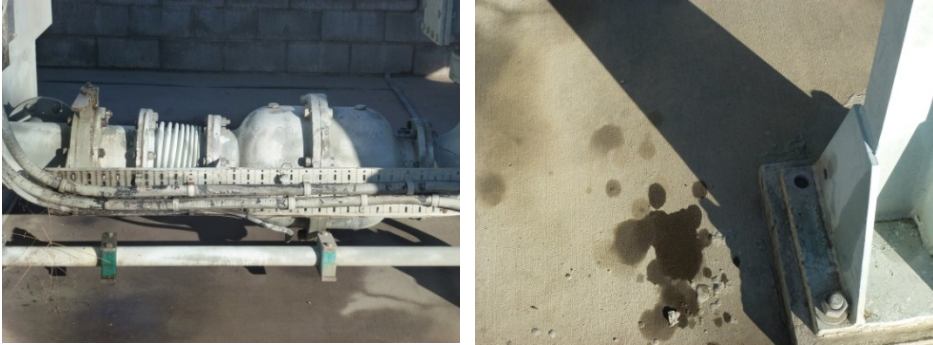
**Figure 36:** (LH) Oil leak from the lower main butterfly isolating valve adjacent to the main tank, and (RH) from OLTC conservator breather oil bath.

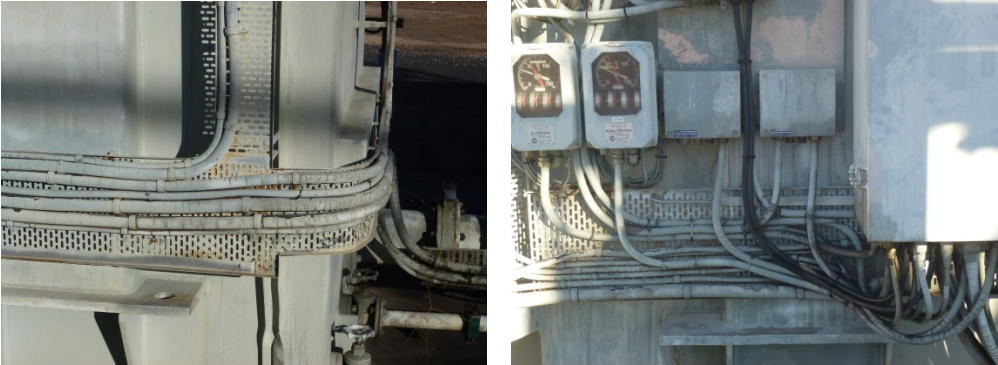
**Figure 37:** The painted multicore cables are looking aged but still serviceable.

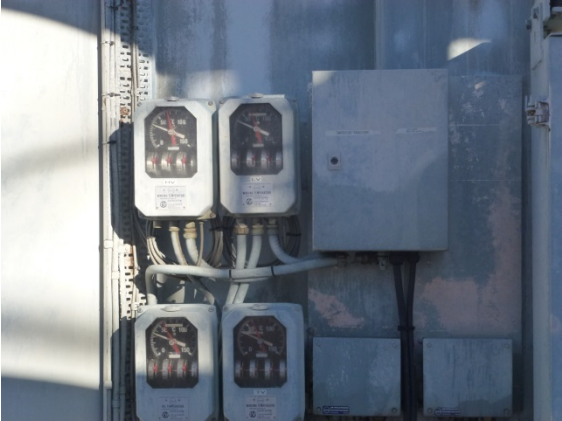
**Figure 38:** Kihlstrom temperature measurement instrumentation appears to still be readable and functioning.
