POWERLINK QUEENSLAND
REVENUE PROPOSAL

CP.02369

**Blackwater Transformers 1 and 2
Replacement**

Transformer T1 & T2 Condition Assessment T032 Blackwater Substation

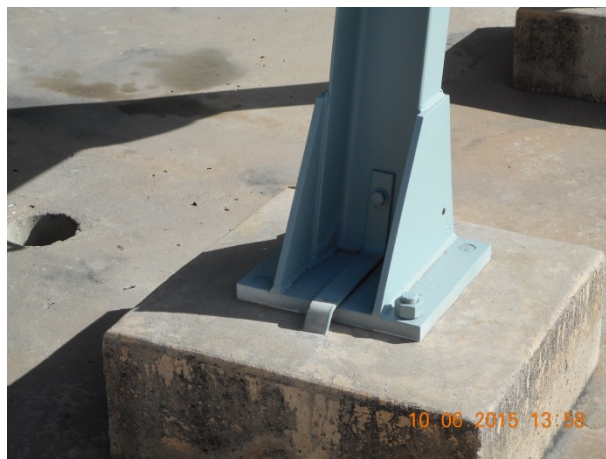
There were no obvious signs of pending structural issues on the main tank or cooler bank due to corrosion. The cooler bank ‘A’-frame support structure steel feet appeared externally to be in good condition but no assessment was performed on the hold-down bolts.

Figure 3 No visible corrosion evident around the cooler bank ‘A’-frame support structure feet.

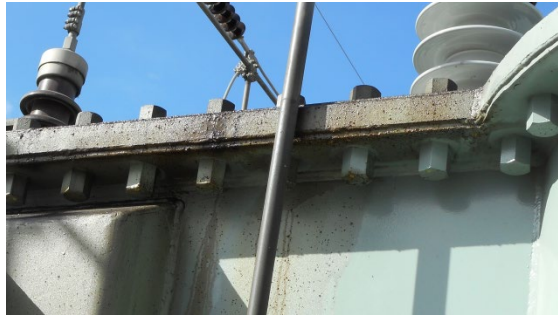
This transformer does have a welded steel strap bridging and sealing between lid and main tank flanges. Specially machined dome nuts and bolt heads which were designed with grooves to suit ‘O’-rings replaced the original conventional clamping bolts to prevent oil from bypassing the outer steel welded strap oil seal. At the present time, there appears to be no oil leaks coming from this welded strap or dome nut seals.

Figure 4 Welded steel strap between main tank and lid, complete with 'O'-ring sealed dome nuts

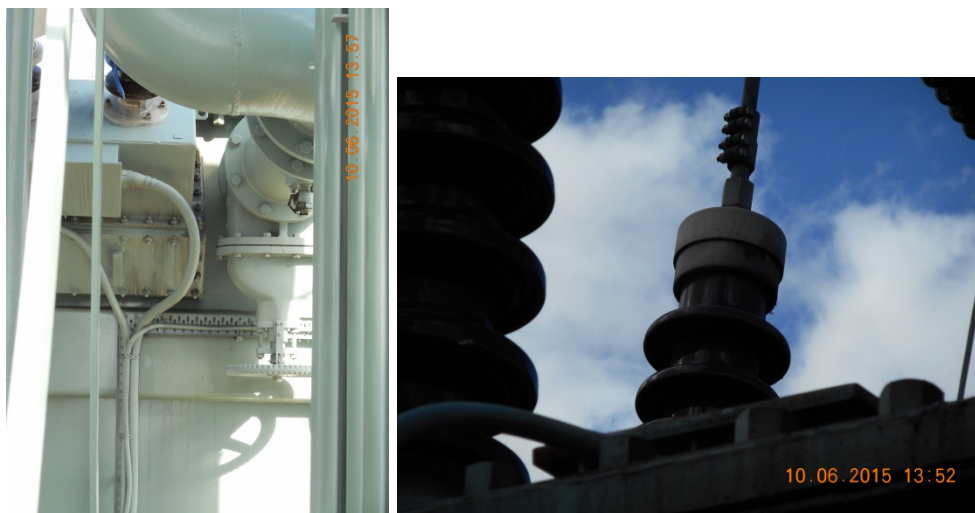
Maintenance records for this transformer indicate that frequent attention has already been given to fixing oil leaks over the years and especially prior to repainting the transformer. A number of oil leaks have reappeared since the refurbishment / repainting and are coming from the following areas.

- Main Buchholz Relay.
- TV turret box gasket.
- Bottom main butterfly valve (not gate valve) adjacent to main tank.
- Neutral bushing mounting gasket.
- LV 'B' & 'C' phase bushing turret gaskets.
- HV 'B' phase bushing top cap.
- Radiator panel top mounting flanges.
- Radiator panel cooling tube / header interface.
- Radiator panel drain valves.
- Oil leaks in sealed secondary system junction boxes allowing oil to migrate downwards within the multicore cables to the Main Control Cubicle. The oil leaks within the junction boxes are not visible externally during the visual inspection from ground level.

Figure 5 (LHS) Oil leaks from TV turret box gasket. (RHS) Oil leak at top cap of HV 'B' phase bushing

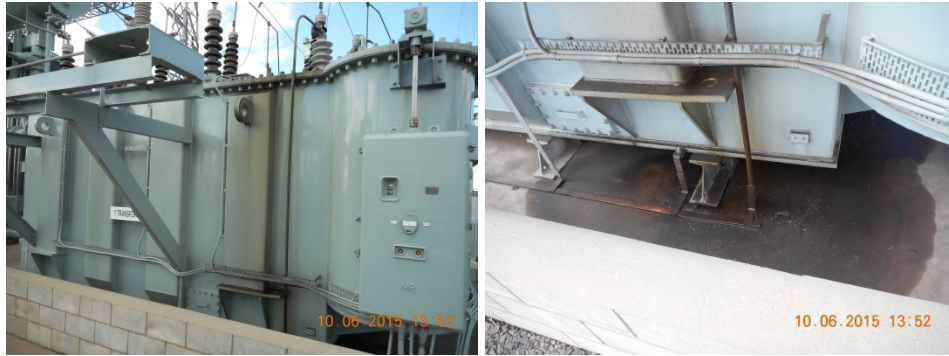
Figure 6 (LHS) Oil leak from neutral bushing mounting gasket. (RHS) Free oil pooling on concrete due to neutral bushing mounting gasket oil leak.

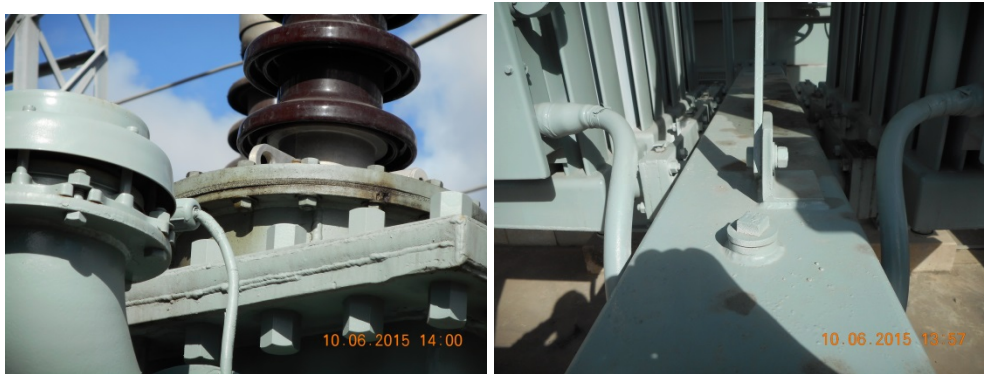
Figure 7 (LHS) HV 'B'-Phase top cap oil leak. (RHS) Oil dropping on bottom header from top radiator panel mounting gaskets.

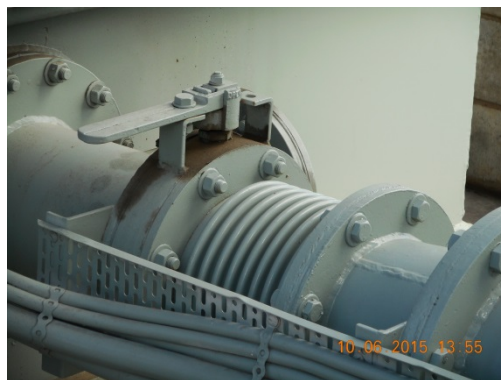
Figure 8 (LHS) Oil leak from bottom main butterfly valve (not gate valve) adjacent to main tank

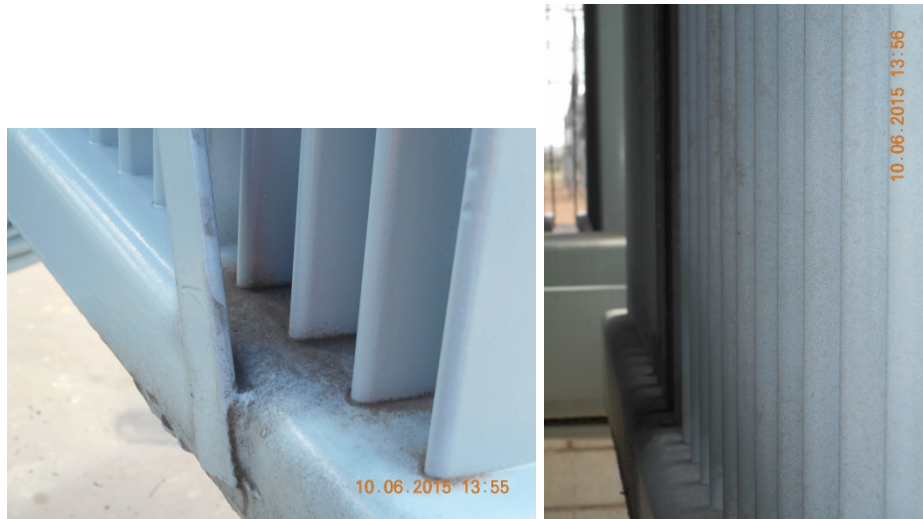
Figure 9 (LHS) Oil leak from radiator panel cooling tube to bottom header joint. (RHS) Another similar oil leak between cooling tube to bottom header.

The transformer repaint covered up other potential oil leak sites but these will progressively become more visible with time. The cooler bank radiators are close to end of serviceable life so oil leaks will become more frequent. The pre-painting surface preparation process does not appear to have neutralised all of the pre-existing corrosion and this has still been active behind the new paint coating in some locations.

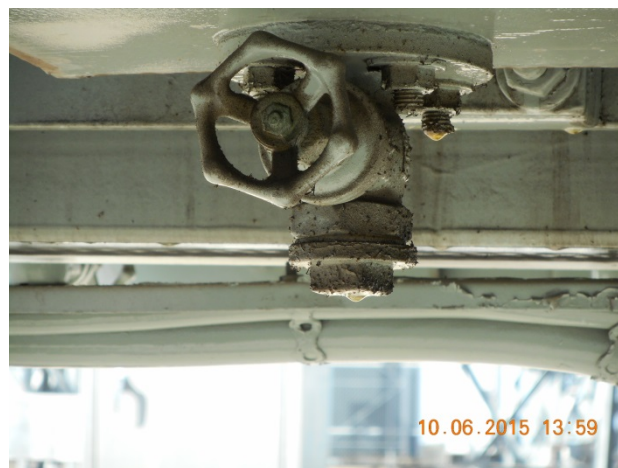
Figure 10 Oil leak from radiator panel drain valves fitted to the underside of the bottom header.

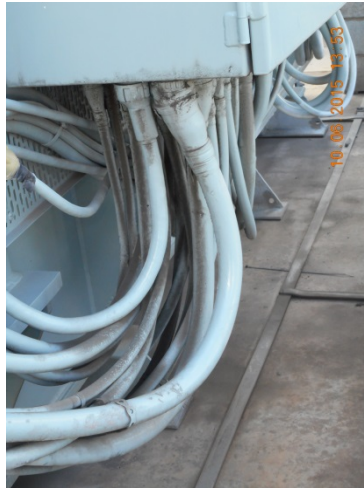
Any significant cable flexing (e.g. removal & reconnection) would likely create some insulation damage but if left physically alone, all of the multicore cables should not fail over the next several years.

Figure 11 Painted multicore cables entering the main control cubicle.

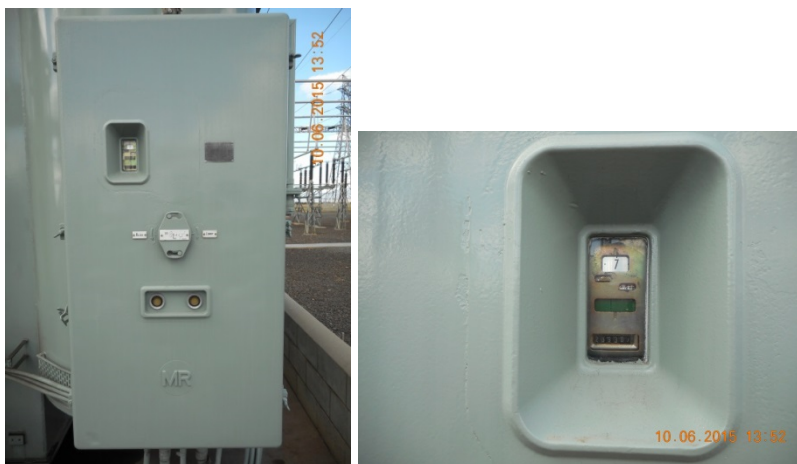
There have been issues with either the control or operation of the Reinhausen tap changer in the past, either stopping or falling out of step. With a total number of operations of 239,307, the tap changer is reaching the end of its reliable / economic life (life expectancy of approximately 300,000 operations). The high number of operations is attributed to the fact that there was interaction between Ergon SVC (controlling tap changer) and Powerlink owned SVC.

Figure 12 Reinhausen OLTC with a counter reading of 94,330 operations.

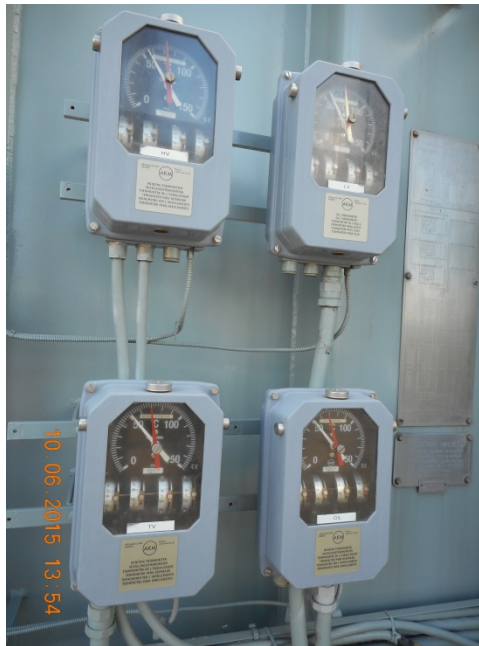
Figure 13 The three winding hot spot and one top oil temperature indicators are still readable through the viewing window.

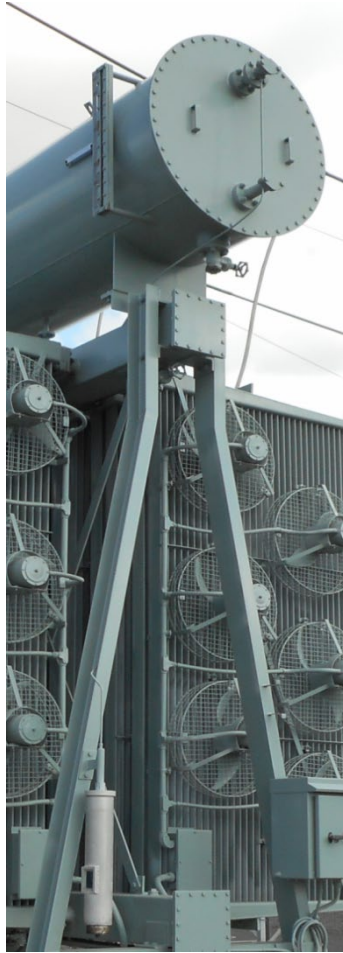
When the original Drycol refrigerant breather was removed from the main conservator around the year 2000, a small diameter air pipe was installed between the main conservator and the replacement conventional desiccant breather. Refer to figure 15 for a visual arrangement.

Figure 15 The original Drycol refrigerant breather removed from the conservator and a new, small breather pipe installed to connect to the home-made desiccant breather.

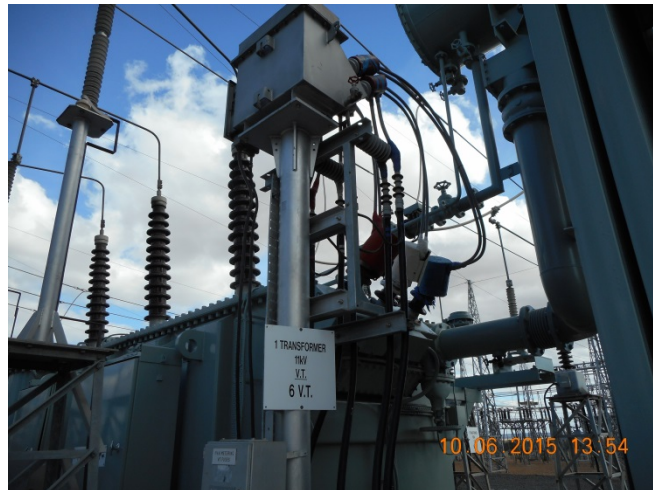
The 20MVA tertiary of this transformer is being used for supplying the T10, 11kV / 400V station services transformer as well as Ergon external load. The connection to the transformer TV bushings and adjacent metering VT is aerial but with HV cables from that point. There are electrical clearance issues in this arrangement which are mitigated by the use of insulated tapes and shrouds as shown in figure 16.

Figure 16 The TV connections for supplying the station services transformer (not in this picture) and Ergon 11kV load. The metering VT is visible on the steel post structure.

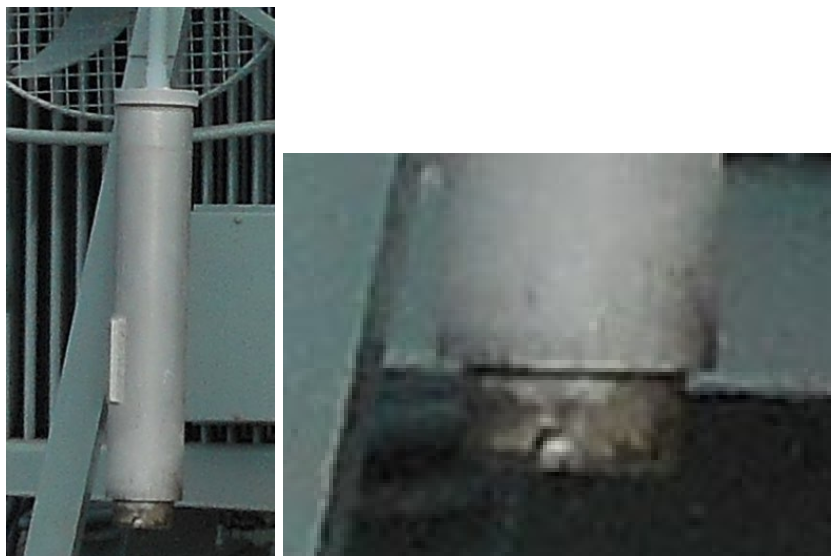
Figure 17 The “home made” main conservator desiccant breather and oil bath.

As with many transformers inspected in the field, the condition of the oil bath on the bottom of the main conservator desiccant breather makes it very difficult to determine if the oil bath needs maintaining or is able to function correctly. This problem is made worse due to the design of the home-made breather. Figure 17 above shows what was observed on this transformer.

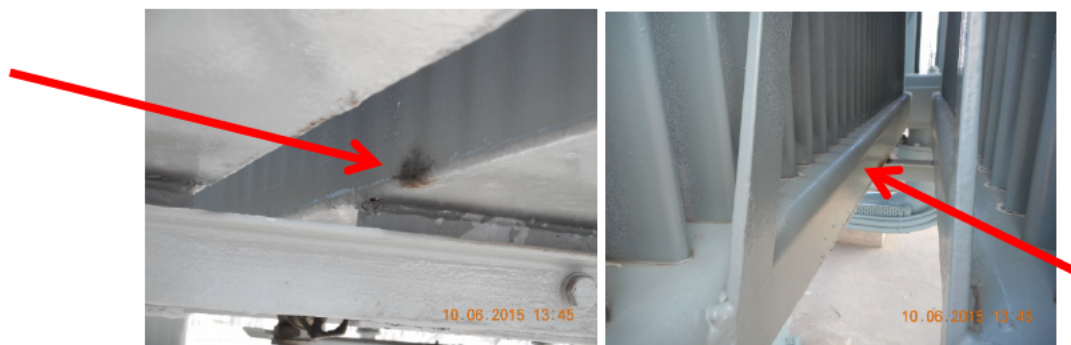
This transformer has been recently repainted in 2012 and the anti-corrosion coating still appears to be in a very good condition. As such, there is virtually no visible corrosion on the tank and fittings but the cooler bank is showing localised corrosion (pin holes) on radiator panel bottom headers which has resulted in oil leaks.

Figure 24 Localised corrosion on the shoulder weld of radiator panel bottom headers now showing a pin hole oil leak.

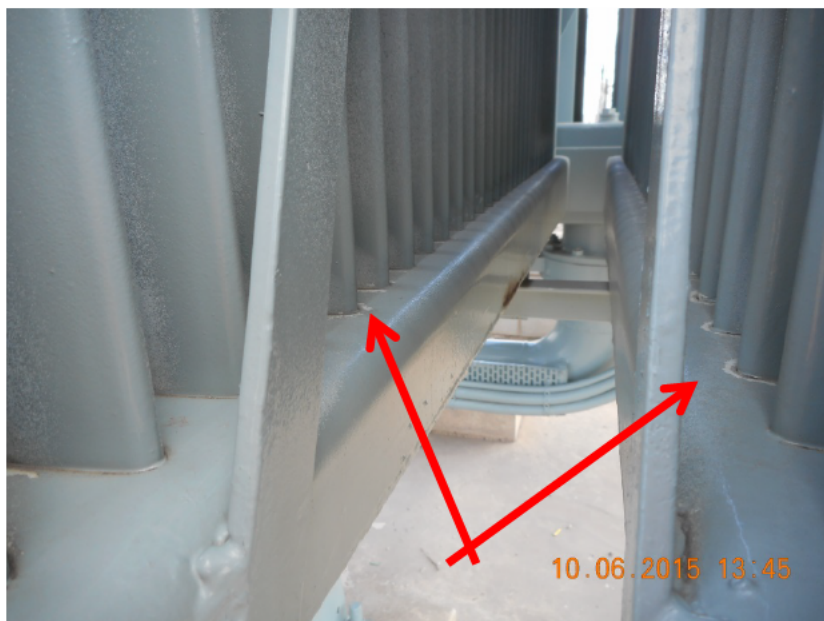
Figure 25 Residual localised corrosion where the radiator panel oval cooling tubes penetrate the bottom headers is re-emerging through the new paint.

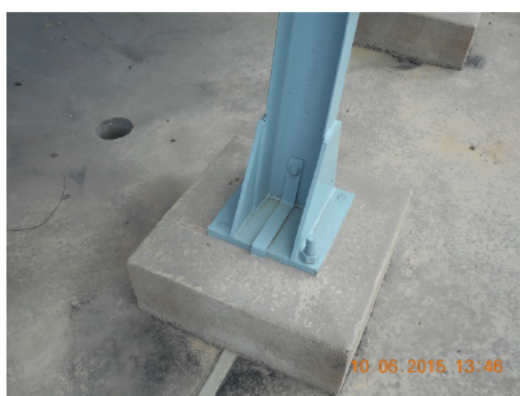
There were no obvious signs of pending structural issues on the main tank or cooler bank due to corrosion. The main oil conservator support and cooler bank ‘A’-frame support structure steel feet appeared externally to be in good condition but no assessment was performed on the hold-down bolts.

Figure 26 No visible corrosion evident around the cooler bank ‘A’-frame support structure feet.

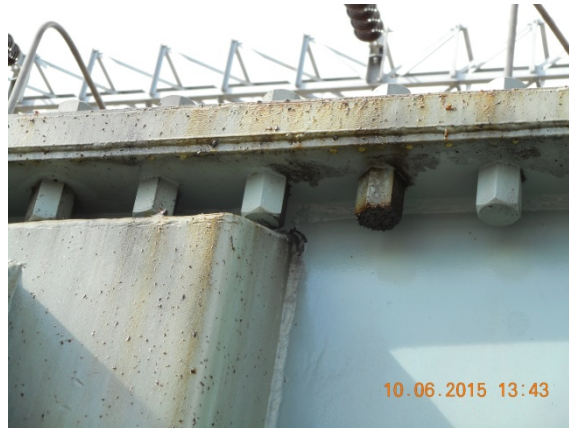
This transformer does have a welded steel strap bridging and sealing between lid and main tank flanges. Specially machined dome nuts and bolt heads which were designed with grooves to suit 'O'-rings replaced the original conventional clamping bolts to prevent oil from bypassing the outer steel welded strap oil seal. At the present time, there appears to be no oil leaks coming from this welded strap or dome nut seals. The oil visible in figure 26 is from other sources.

Figure 27 Welded steel strap between main tank and lid, complete with 'O'-ring sealed dome nuts.

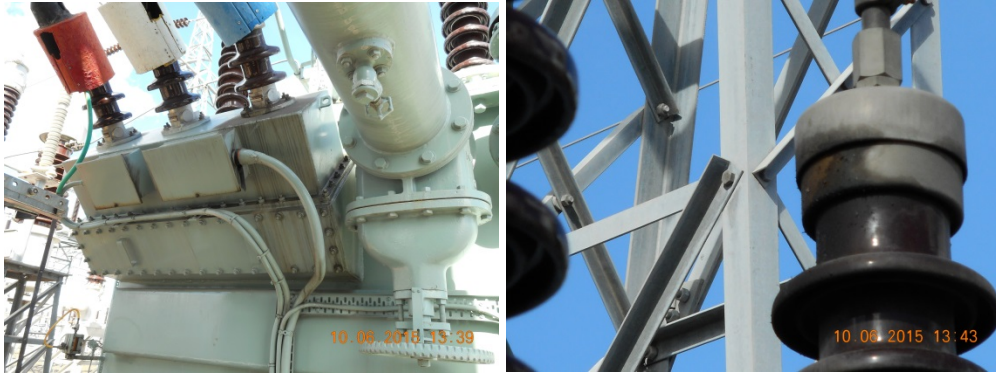
Figure 28 (LHS) Oil leaks from TV turret box gasket. (RHS) Example of an oil leak at the bushing top cap observed on 4 bushings.

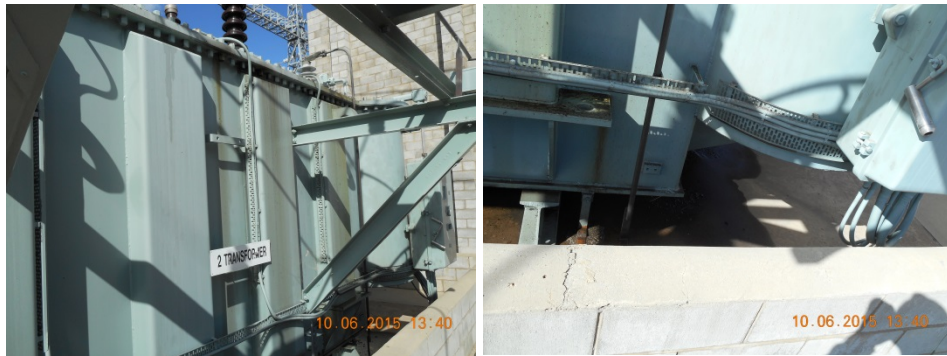
Figure 29 (LHS) Oil leak from neutral bushing mounting gasket. (RHS) Free oil pooling on concrete due to neutral bushing mounting gasket oil leak.

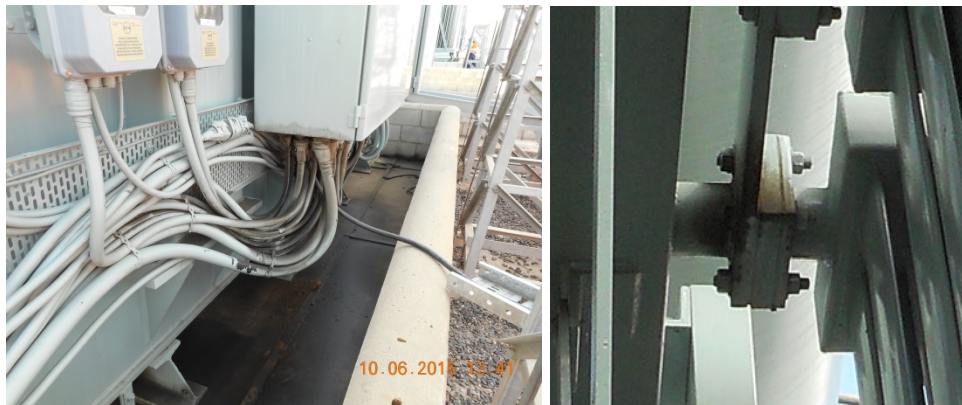
Figure 30 (LHS) HV side free oil on concrete. Appears to be coming from 'A' & 'B' phase HV bushing top cap oil leaks combined with oil from the multicore cables. (RHS) Oil dripping from top header radiator panel mounting gasket.

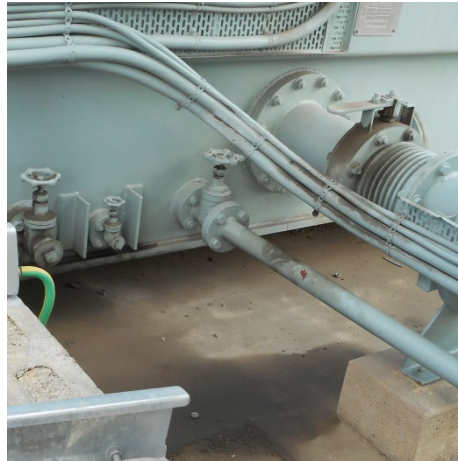
Figure 31 Oil leak from bottom main butterfly valve (not gate valve) adjacent to main tank

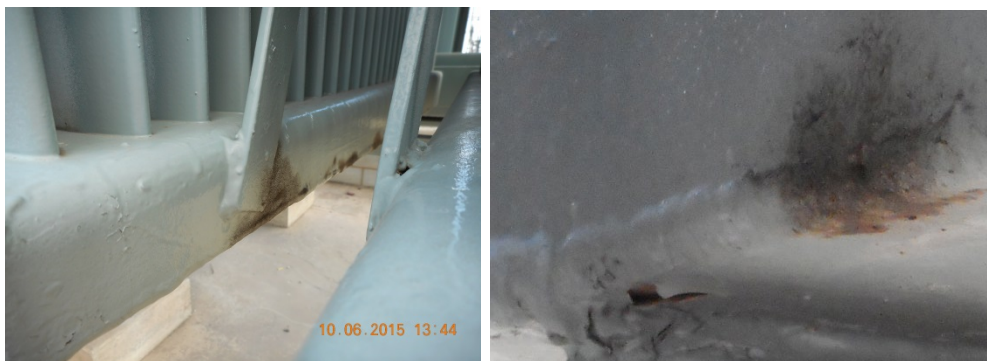
Figure 32 (LHS) Oil leak from radiator panel cooling tube to bottom header joint. (RHS) Another radiator panel oil leak on the lower shoulder weld seam of the bottom header. Note also the delaminating paint.

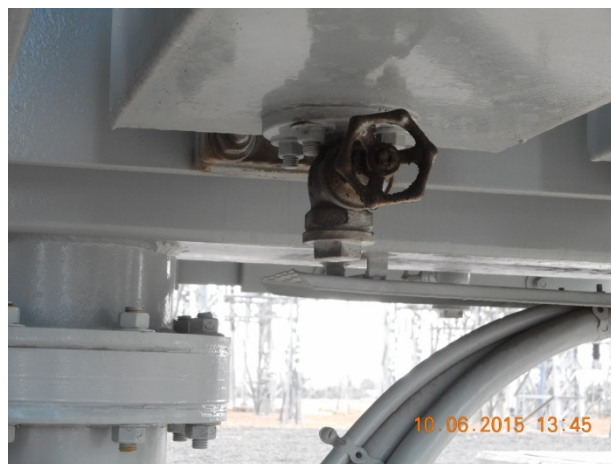
Figure 33 Oil leak from radiator panel drain valves fitted to the underside of the bottom header.

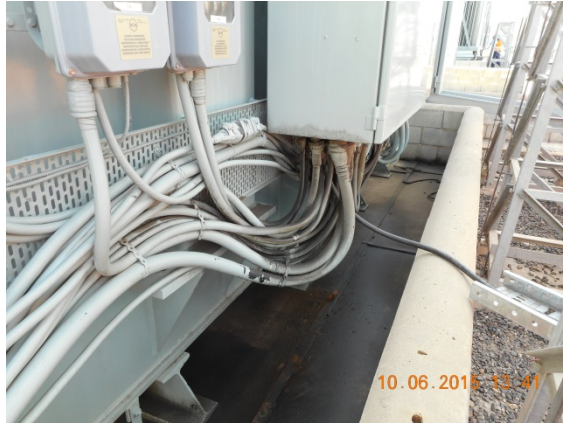
Control cables are sure to have taken a set and any significant cable flexing (e.g. removal & reconnection) would likely create some insulation damage but if left physically alone, all of the multicore cables should not fail over the next several years.

Figure 34 Painted multicore cables entering the main control cubicle.

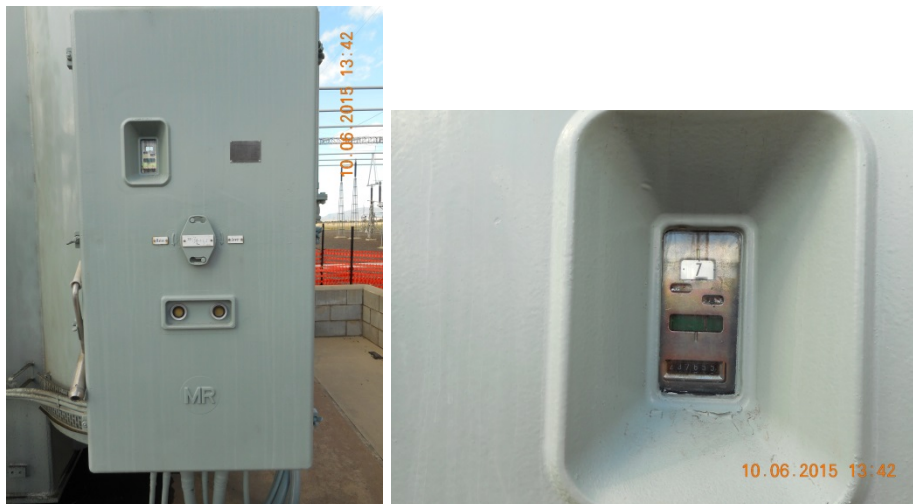
The notifications associated with this transformer show a number of issues with either the control or operation of the Reinhausen tap changer in 2001/2 and again in 2006-2009. With a total number of operations of 237,655, the tap changer is reaching the end of its reliable / economic life (life expectancy of approximately 300,000 operations).

Figure 35 Reinhausen OLTC with a counter reading of 94,330 operations.

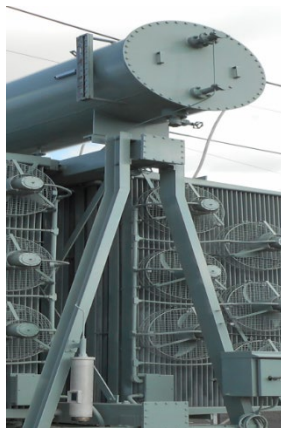
Similar to Transformer T1 When the original Drycol refrigerant breather was removed from the main conservator around the year 2000, a small diameter air pipe was installed between the main conservator and the replacement conventional desiccant breather. Refer to figure 37 for a visual arrangement.

Figure 38 The original Drycol refrigerant breather removed from the conservator and a new, small breather pipe installed to connect to the home-made desiccant breather.

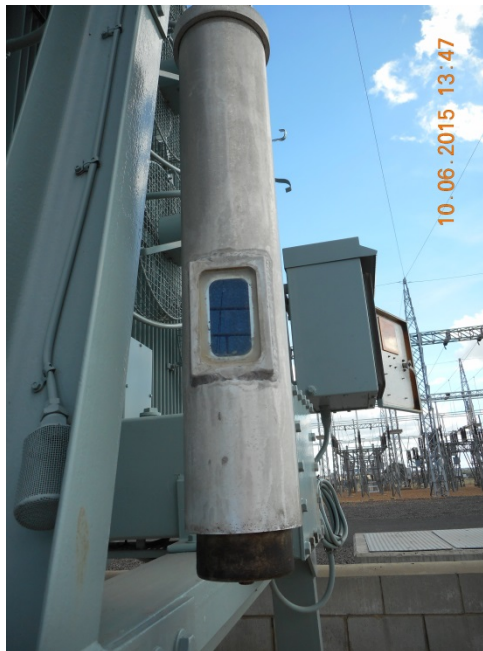
Figure 39 The “home made” main conservator desiccant breather and oil bath.
