POWERLINK QUEENSLAND
REVENUE PROPOSAL

CP.02370

Tully Transformer 2 Replacement

T2 Transformer Condition Assessment T048 Tully Substation

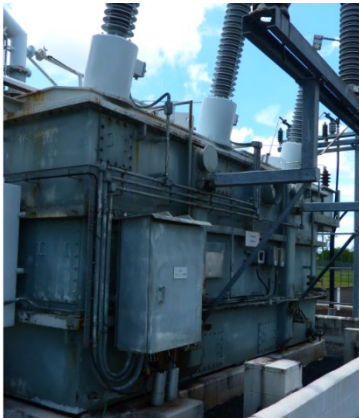
Maintenance records show this transformer has been partially painted and corrosion issues addressed on a number of places and fittings. The coating which was applied to the main tank is badly oxidised as shown in Figures 2 & 3 and in some locations the paint is flaking off the original OEM coating.

Figure 2: Transformer T2 HV side of the main tank showing paint oxidation

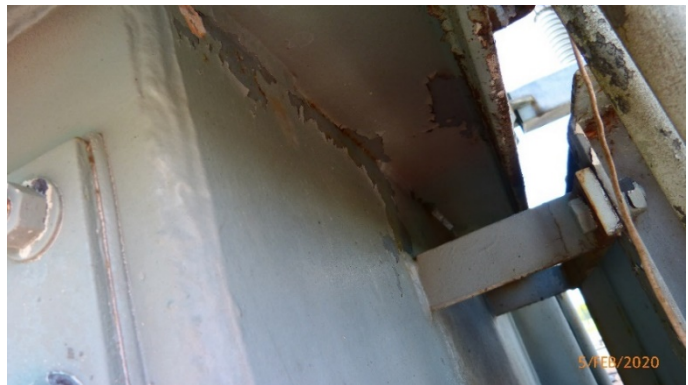
Figure 1: Transformer LV side of the main tank showing the oxidised repainted surfaces

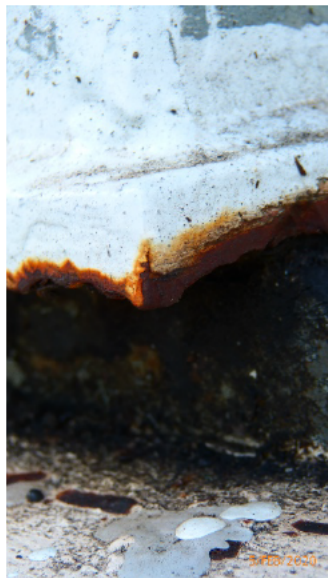
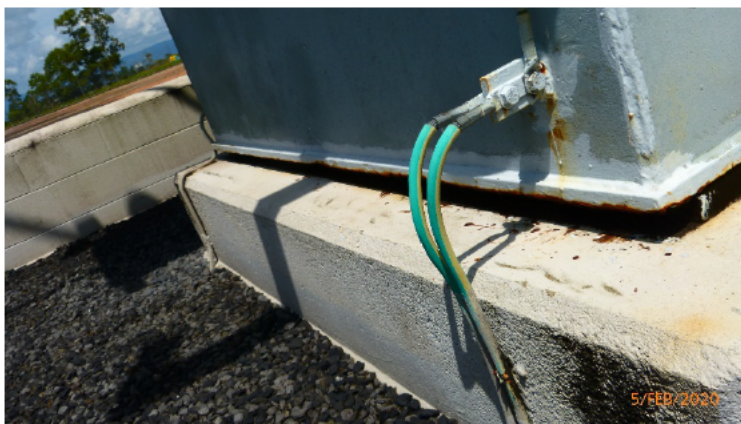
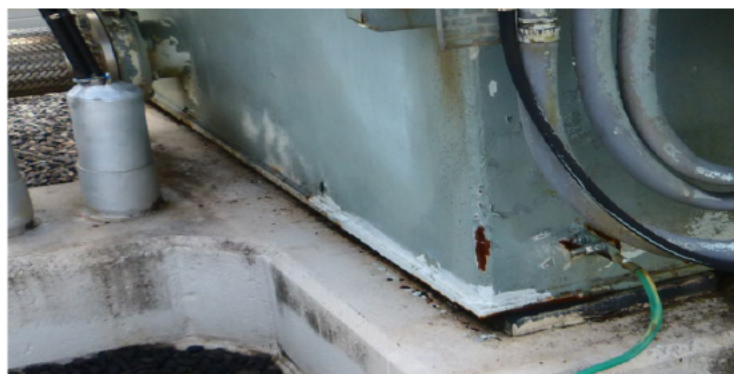
This transformer has grade 4 corrosion on the base plate as shown in Figure 4. This corrosion is at the edges of the base plate and the extent of this towards the centre of the base could not be fully assessed. However, it is likely to have spread to the main tank underneath the transformer, which places the integrity of the tank at risk. With the loss of galvanised coating, climatic conditions and extent of grade 4 corrosion present, it is estimated that corrosion could lead to significant loss of steel cross-section of the main tank within 5-10 years.

Figure 3: Grade 4 corrosion on the base plate of the transformer

Significant intervention is required for the corrosion of the base plate. Without significant intervention, the remaining service life is estimated to be 5 years – after this it is possible that the transformer tank can rupture and Powerlink can be found to be not complying with maintenance requirements under Electrical Safety Legislation and relevant Code of Practice.

Given the location and extent of the corrosion, it is not considered feasible to undertake appropriate remedial measures in-situ.

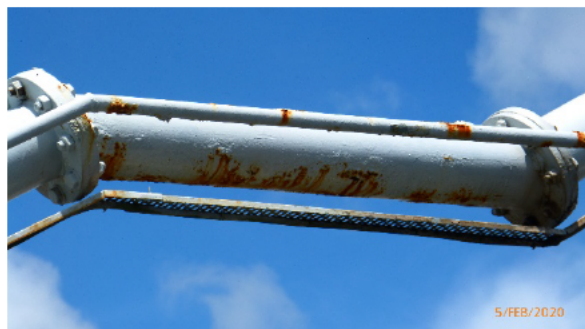
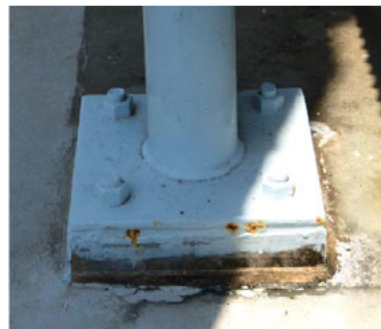
Figure 4: Corrosion on the conservator pipe work and on the base plate of A

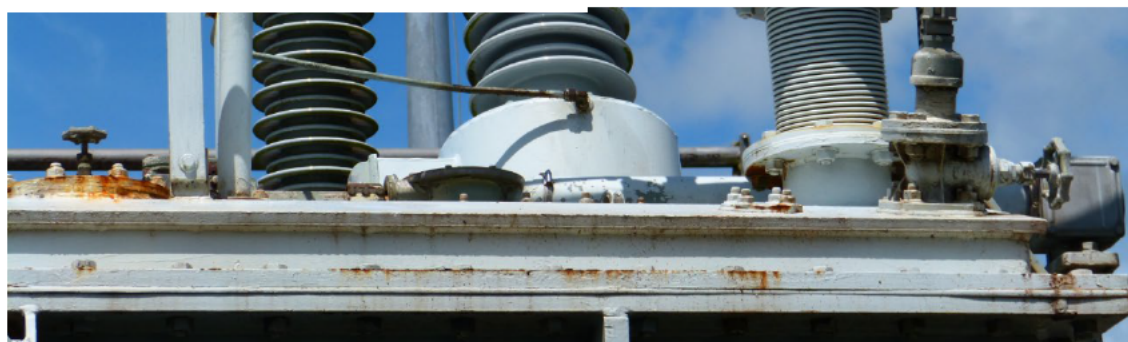
Figure 5: Corrosion on the top of the tank

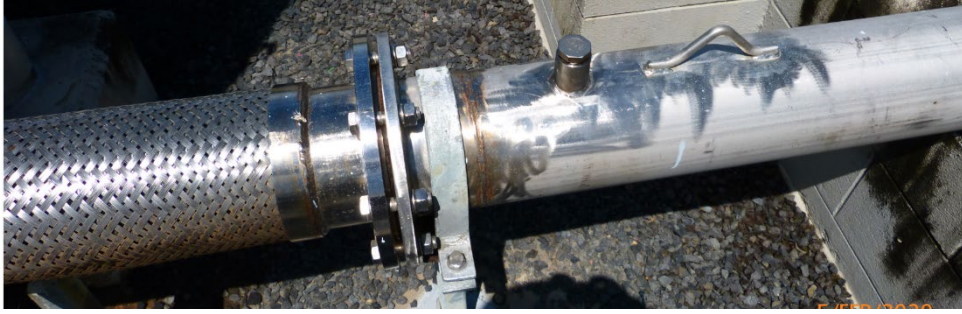
New main oil pipework has been installed in 2008 between the main tank and the cooler bank due to corrosion and oil leaks on the original pipework.

Figure 6: Main oil pipework installed in 2008.

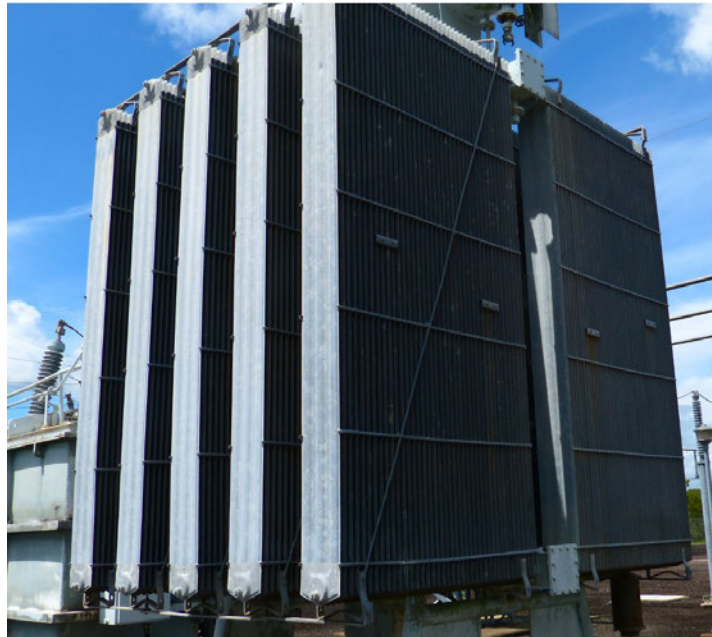
The galvanised cooler bank is in reasonable condition with minor visible sign of surface corrosion.

Figure 7: Cooler bank on the transformer

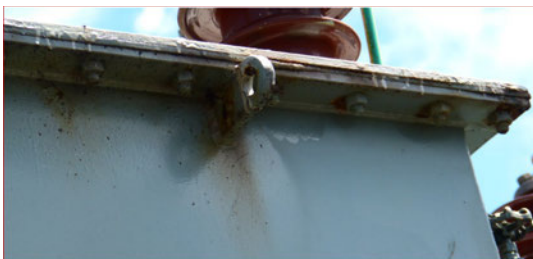
According to the maintenance records, the repair of oil leaks (replacement of seals) was last performed in 2017 and no major oil leaks are visible at present.

Figure 9: Minor oil leak

Most of the oil leaks identified on site were of a minor nature and attention is required mainly for the oil leak from top of the tank near the A phase bushing. It is assumed this can be repaired.

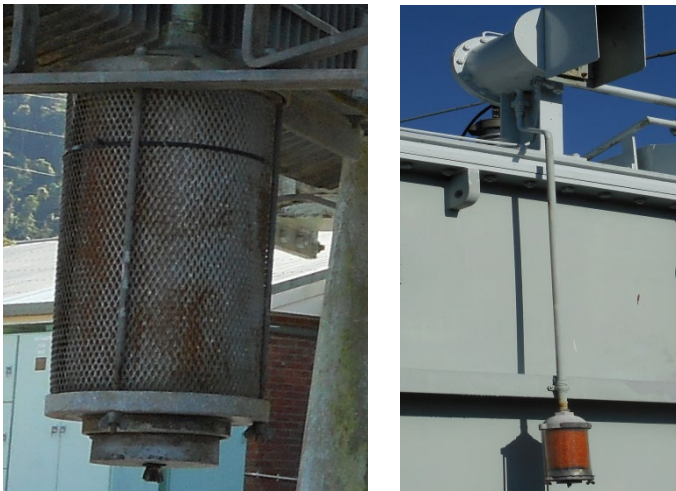
As with many transformers inspected in the field, it is impossible to visually inspect the condition of the oil bath on the bottom of the main conservator desiccant breather due to the design of the breather. This makes it very difficult to determine if the oil bath needs maintaining or is functioning correctly as a particulate filter.

Figure 10: Main tank conservator breather showing concealed oil bath and the separate VT conservator and breather

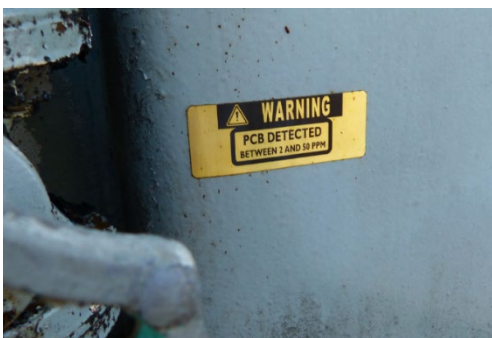
When last tested for polychlorinated biphenyl (PCB) content in 2014, 2.1 mg/kg of PCB was detected in oil. Based on this, this transformer is classified as “Contaminated” and is currently being managed through operational procedures and signage.

Figure 8: Signage for PCB contamination

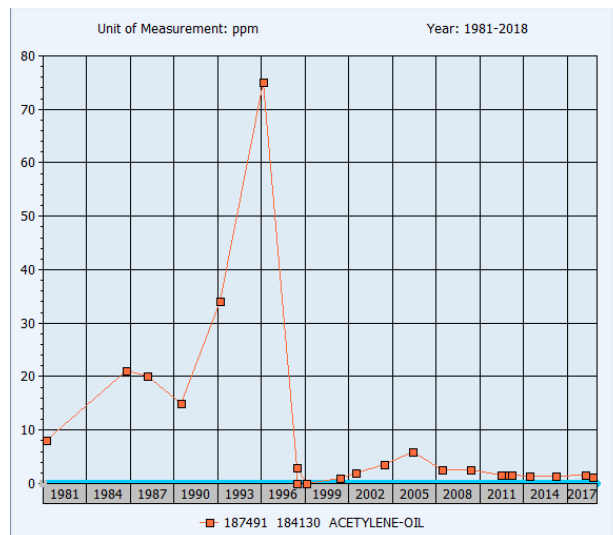
- The insulation mass on the active part appears to have been exposed to partial discharge and high temperature in 1998. This presence of abnormal partial discharge activity was in the three 132kV high voltage (HV) transformer terminal bushings after 22 years of service. These bushings were replaced with new OIP (oil impregnated paper) bushings in 1998.

Figure 12: Acetylene levels in DGA

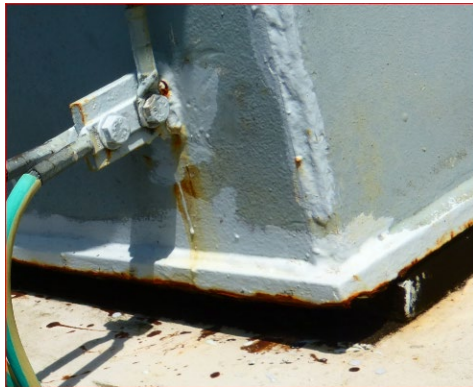
The surface paint on the main transformer tank is not in good condition and there is Grade 4 rust on the base plate. Assuming no other interventions are required for this transformer, from the anti-corrosion system condition and based on corrosion progression between 2015 and 2020 (see Figure 18 and Figure 19), it is likely that in its present state it would survive for approximately 5 years with only minor paint touch-ups.

Figure 18- Corrosion in 2020

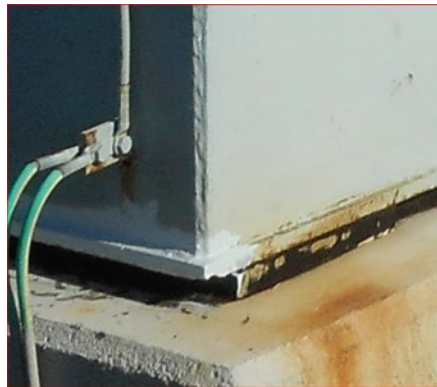
Figure 19 – Corrosion in 2015

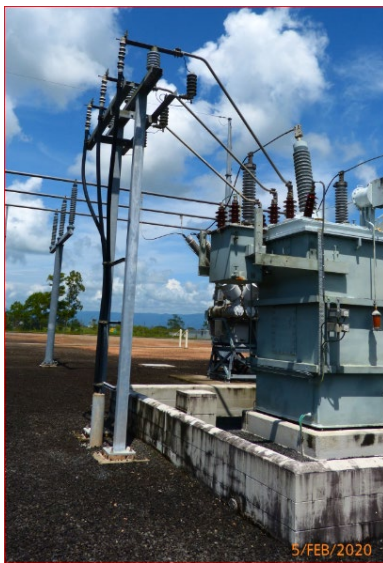
Without more substantial evidence to the contrary, the mechanical stability of the windings has to be considered as questionable, due to the drying processes used in transformer manufacturing industry in times when this transformer was manufactured. It is assumed that the exposure to through faults and over-voltages would have been present due to the close proximity of insulated cables on LV side.

Figure 21 – Insulated cables connection to T2

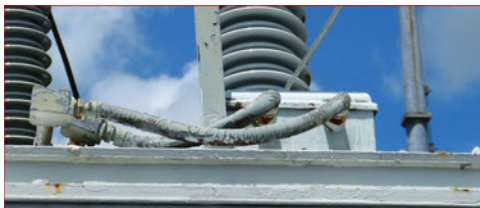
The visible condition of the secondary systems on the transformer, including external cabling, appear to require more than just normal maintenance if the transformer is to be kept for more than 5 years (Figs. 22,23,24,25). In addition, temperature indicators are also likely to require replacement

Figure 22- External cabling

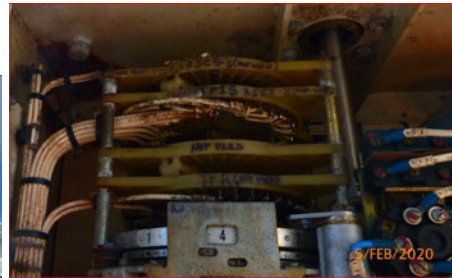
Figure 23 – Internal cabling

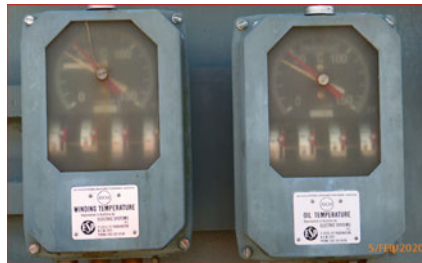
Figure 25 – Temperature Indicators (OTI and WTI)
