POWERLINK QUEENSLAND REVENUE PROPOSAL

CP.02371

Bouldercombe Transformers 1 and 2 Replacement

H010 Bouldercombe Transformer T1 & T2 Condition Assessment

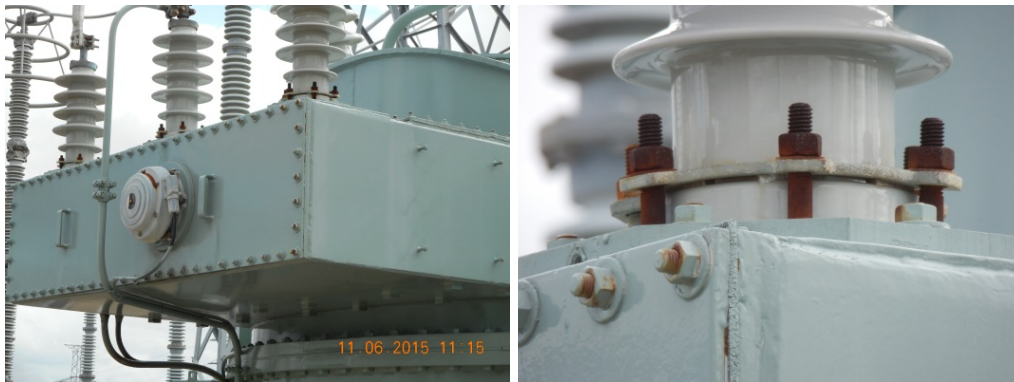
Figure 2: Corrosion of TV mounting bolts and pressure relief vent cover.

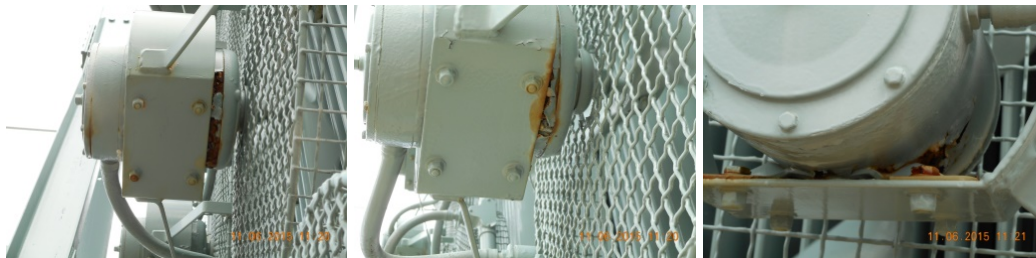
Advanced corrosion was noticed on a number of the cooler bank fan motor casings and associated fittings which will more than likely render some of these motors inoperable within 12 months.

Figure 3: Advanced corrosion of cooler bank fan motor casings.

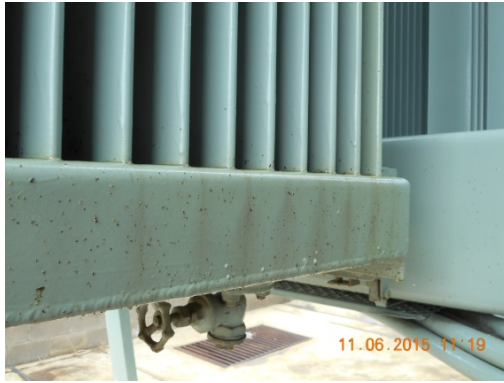
The cooler bank radiator panels are of the old oval tube design inset into top and bottom rectangular box section headers. As usual with this type of design, corrosion issues where the oval tubes enter the headers can cause oil leaks and this was certainly the case with this transformer except the new paint was covering the corrosion but numerous oil leaks were clearly evident.

Figure 4: Corrosion of cooler bank radiator panels where the oval tubes enter the headers causing oil leaks. Note insects (black dots) stuck to the oil film on the side of the bottom header.

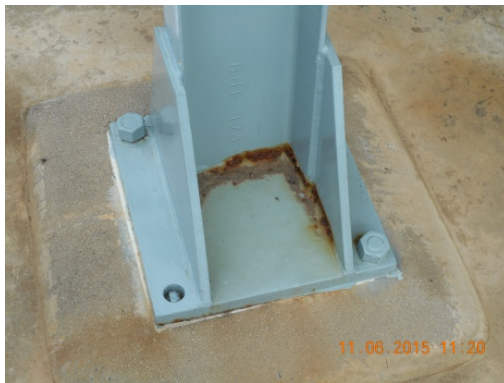
The only other location where corrosion was visible was the cooler bank 'A'-frame support structure mounting feet where the welds between the base plate and the vertical leg and web plates were being corroded away.

Figure 5: Corrosion of the cooler bank 'A'-frame support structure mounting feet welds.

This transformer has a separate cooler bank mounted on 'A'-frame support structures. The base mounting plate on the 'A'-frame support structure legs has a potential structural issue looming due to corrosion eating away the welds between the base plate and the vertical leg and web plates. While no immediate action is required, this should be programmed for repair within the next 6 months. (Refer to figure 5).

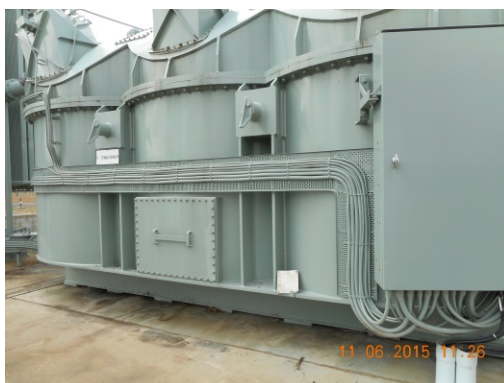
This transformer does not have a welded lid to tank but there were no noticeable oil leaks or corrosion in this locality.

Figure 6: No welded lid to main tank but no corrosion visible between mating steel flanges which sandwich the gasket.

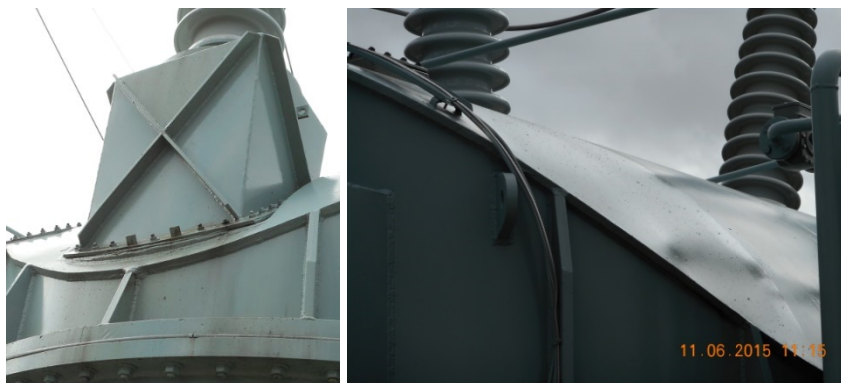
Figure 7: (LHS) Oil leak from the HV 'B'-phase bushing mounting flange gasket to turret. (RHS) Oil leaks from gaskets further up on lid.

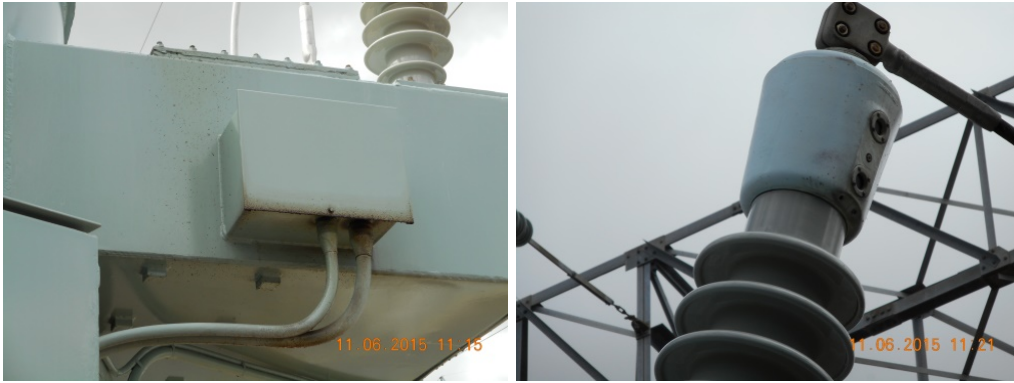
Figure 8: (LHS) Oil leak from the hatch gasket on top of the TV bushing CT chamber. (RHS) HV 'A'-phase bushing oil level indicator oil leak.

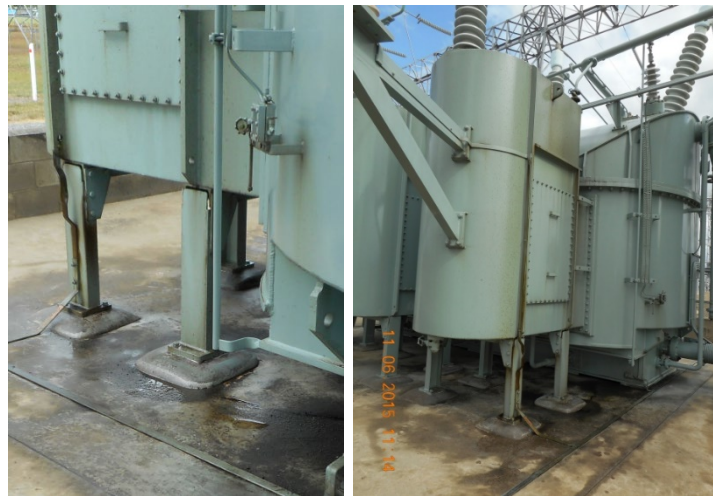
Figure 9: Typical oil leaks from the side mounted LV bushing & OLTC chambers. Note the free oil pooling on the ground.

Overall, the oil leaks on this transformer at present cannot be classified as minor since some do require attention as soon as resources are available.

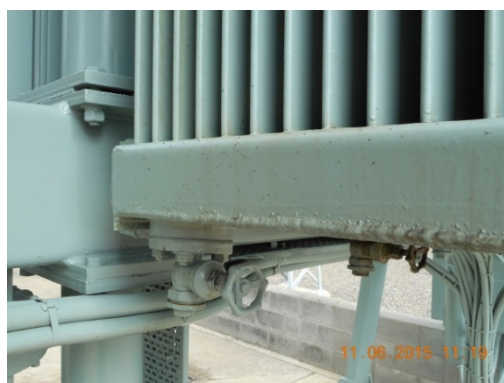
Figure 10: Typical oil leaks from where the oval tubes enter the headers. Note insects (black dots) stuck to the oil film on the side of the bottom header.

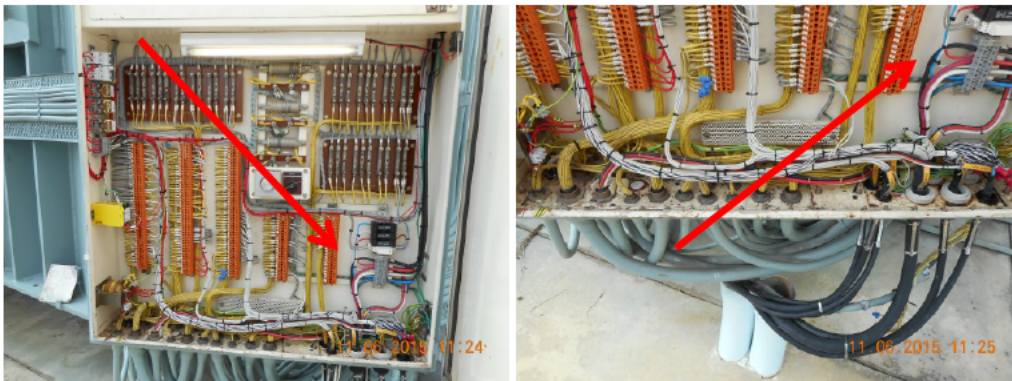
There were a couple of non-conformances which were noticed if the secondary systems is to be brought up to present day safety and technical standards. There is 400VAC supply connected to the Main Control Cubicle and is terminated on open terminals with no insulating barrier to cover them from accidental contact.

Figure 12: Unprotected 400VAC terminals inside the Main Control Cubicle without safety insulating barrier cover.

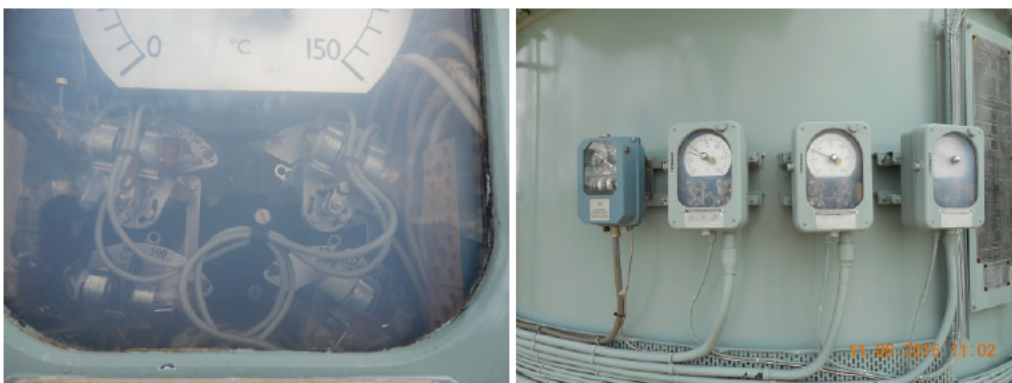
There are mercury switches in two of the three winding temperature and one top oil monitoring instruments on the side of the transformer main tank. One of the winding temperature monitoring instruments has already been replaced in 2007 according to the maintenance records.

Figure 13: Mercury switches in the 2 WTI & 1 OTI instruments for cooling control and alarm and trip signalling.

As can be seen from figure 13, the viewing windows on the three winding hot spot and one top oil temperature monitoring instruments are somewhat frosty in appearance making reading the instruments difficult. Because of the mercury switches and the frosty viewing windows in the older three instruments, the instruments should be replaced in the near future.

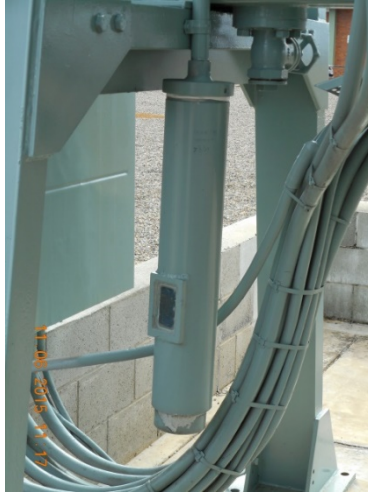
The condition of the desiccant in the conservator air breather appeared serviceable when checked through a tiny viewing window but it was not possible to see a holistic view of the desiccant due to the design of this non-standard breather. It was therefore not possible to verify if there was an air leak in the plumbing between the breather and the conservator. It was also not possible to inspect the breather oil bath condition, or even if the breather was fitted with one.

Figure 23: The conservator desiccant breather design does not allow comprehensive visual inspection for serviceability.

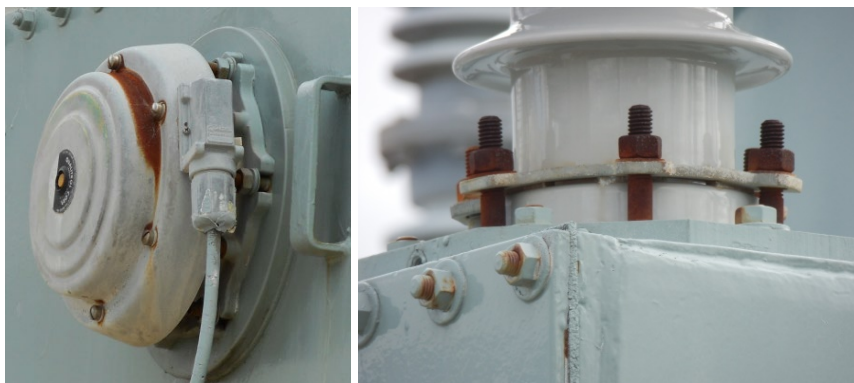
Figure 26: Corrosion of TV mounting bolts and pressure relief vent cover.

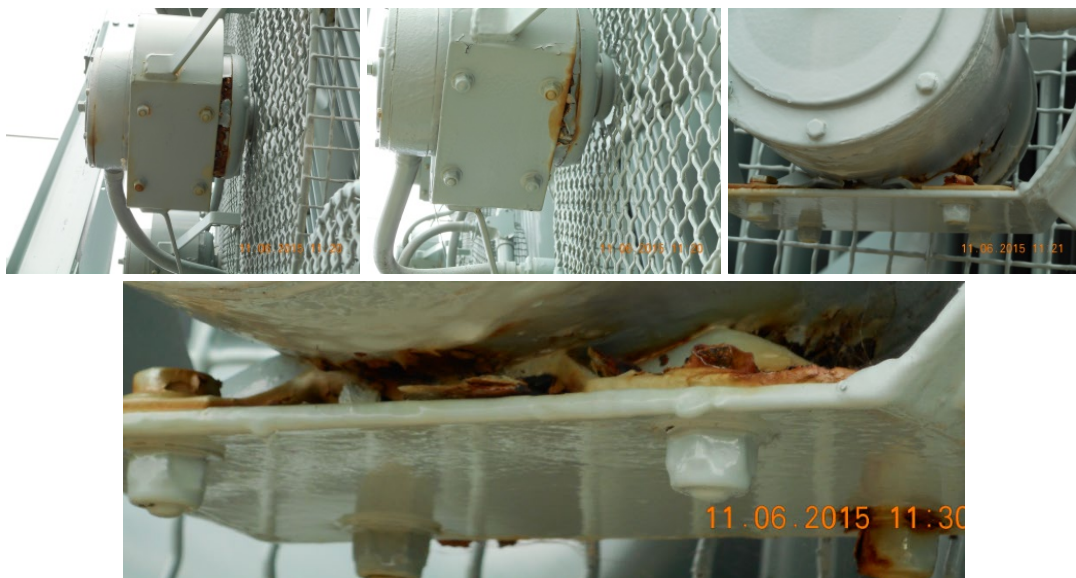
Figure 27: Advanced corrosion of cooler bank fan motor casings.

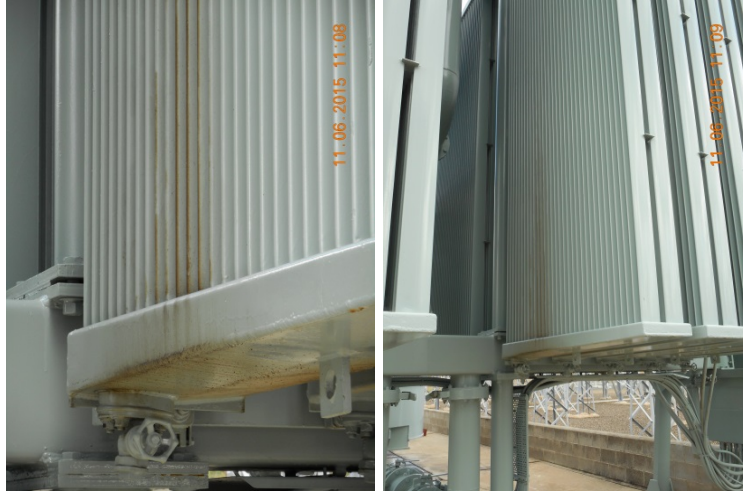
Figure 28: Corrosion of cooler bank radiator panels where the oval tubes enter the headers causing oil leaks.

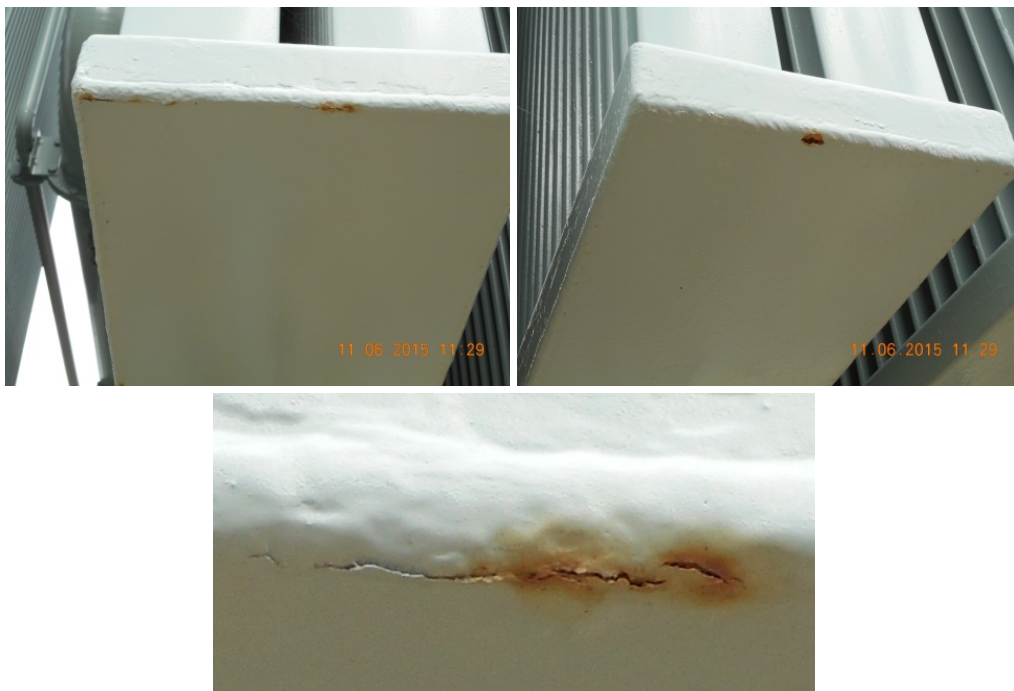
Figure 29: Corrosion of cooler bank radiator panels where the oval tubes enter the headers causing oil leaks.

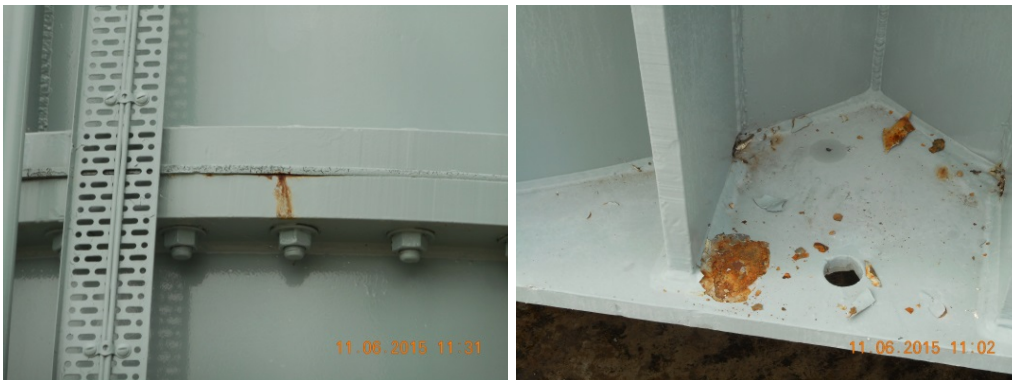
Figure 30: (LHS) Corrosion between the main tank and lid mating steel flanges. (RHS) Corrosion on a horizontal main tank stiffener plate.

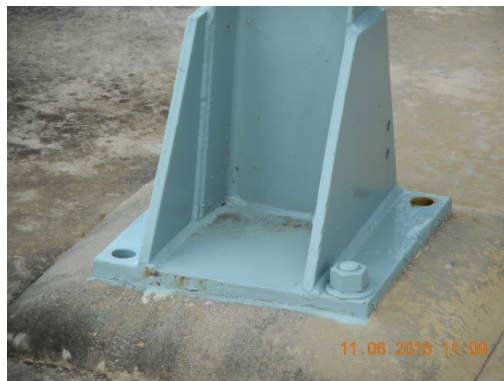
Whilst there was no serious corrosion around the mounting feet of the cooler bank 'A'-frame support structures, there were signs that corrosion was active beneath the paint coating.

Figure 31: Corrosion occurring beneath the paint of the cooler bank 'A'-frame support structure mounting feet.

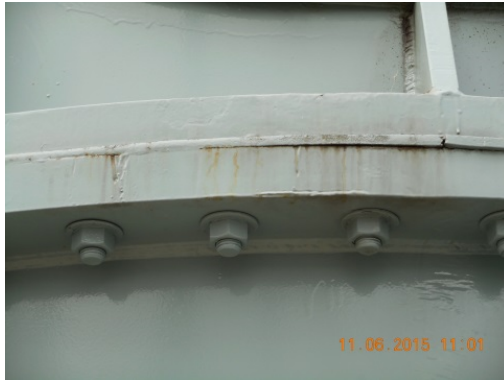
Figure 32: No welded lid to main tank but corrosion is visible in some locations as well as oil leaks.

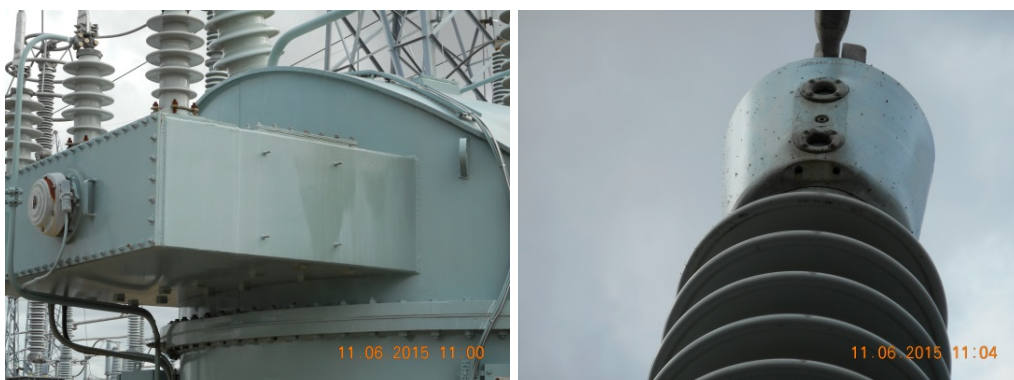
Figure 33: (LHS) Oil leak from the hatch gasket on top of the TV bushing CT chamber. (RHS) HV 'B'-phase bushing oil level indicator oil leak.

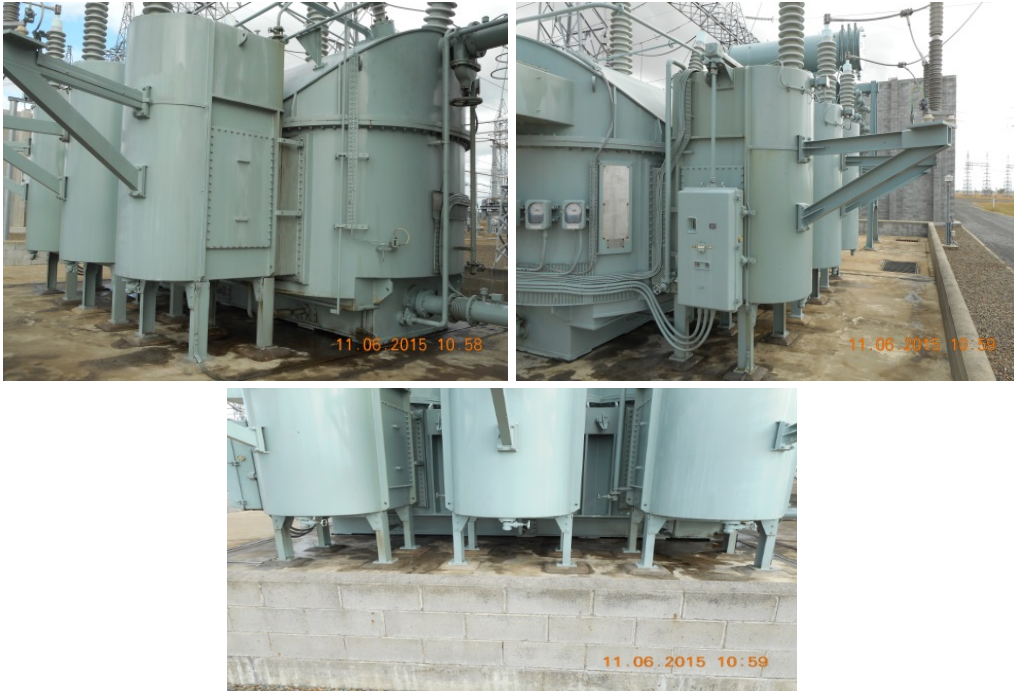
Figure 34: Typical oil leaks from the side mounted LV bushing & OLTC chambers. Note the free oil pooling on the ground.

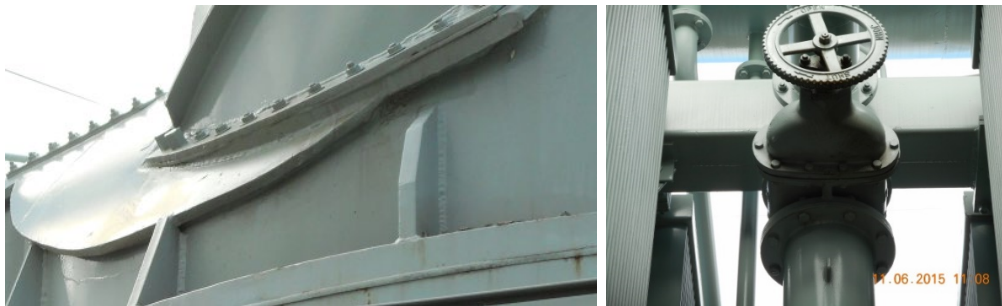
Figure 35: (LHS) 'C'-phase bushing turret to lid gasket oil leak. (RHS) Cooler bank top header gate valve oil leak.

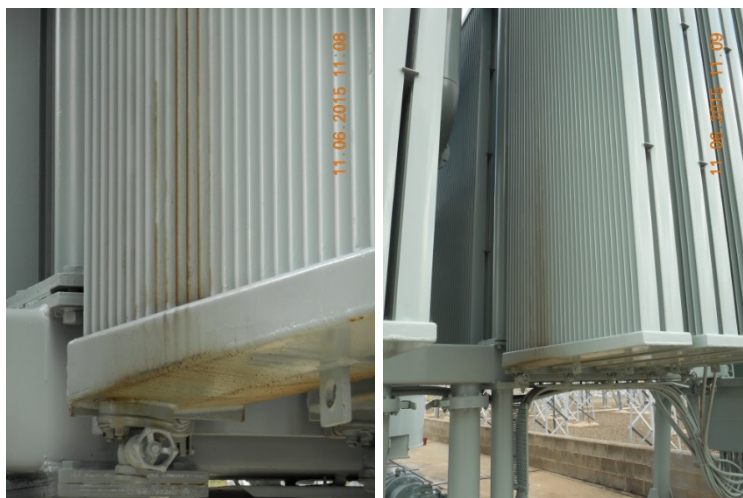
Figure 36: Typical oil leaks from where the oval tubes enter the headers.

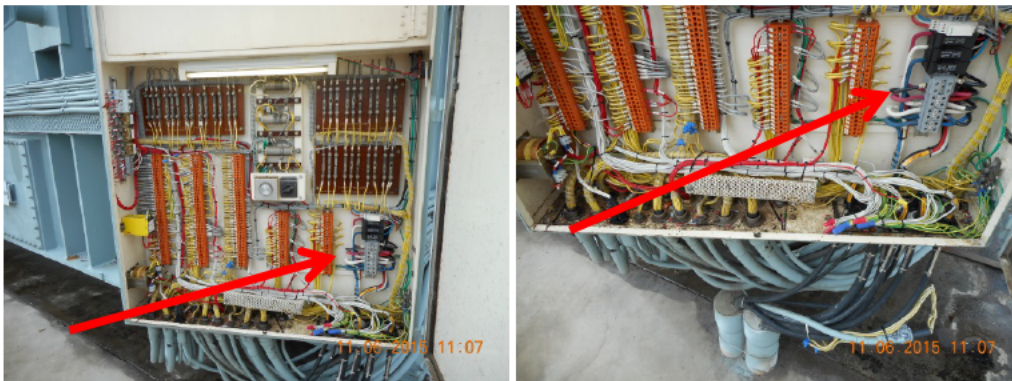
Figure 38: Unprotected 400VAC terminals inside the Main Control Cubicle without safety insulating barrier cover.

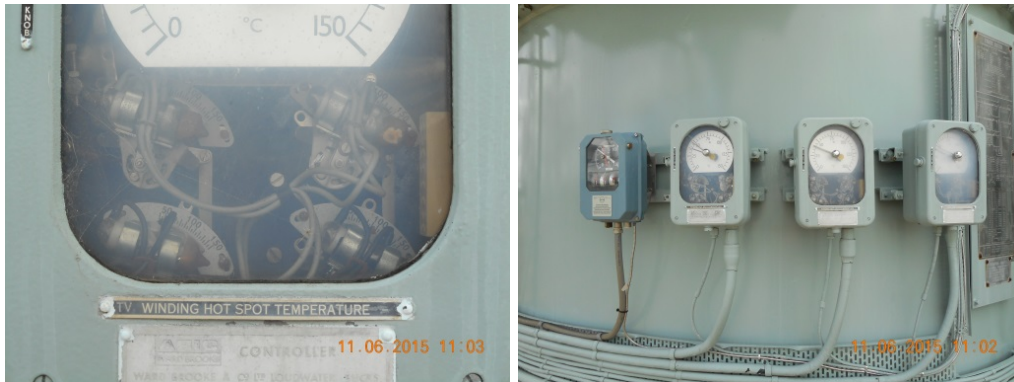
Figure 39: Mercury switches in the 2 WTI & 1 OTI instruments for cooling control and alarm and trip signalling.

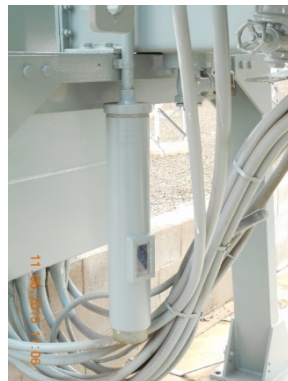
Figure 49: The conservator desiccant breather design does not allow comprehensive visual inspection for serviceability.
