POWERLINK QUEENSLAND REVENUE PROPOSAL

CP.02415

Greenbank to Mudgeeraba 275kV Transmission Line Refit

**Transmission Line Condition Assessment – Report
BS1018/1019 – Greenbank to Mudgeeraba 275kV****Transmission Line Condition Assessment – Report****BS1018 and BS 1019****Greenbank to Mudgeeraba 275kV**

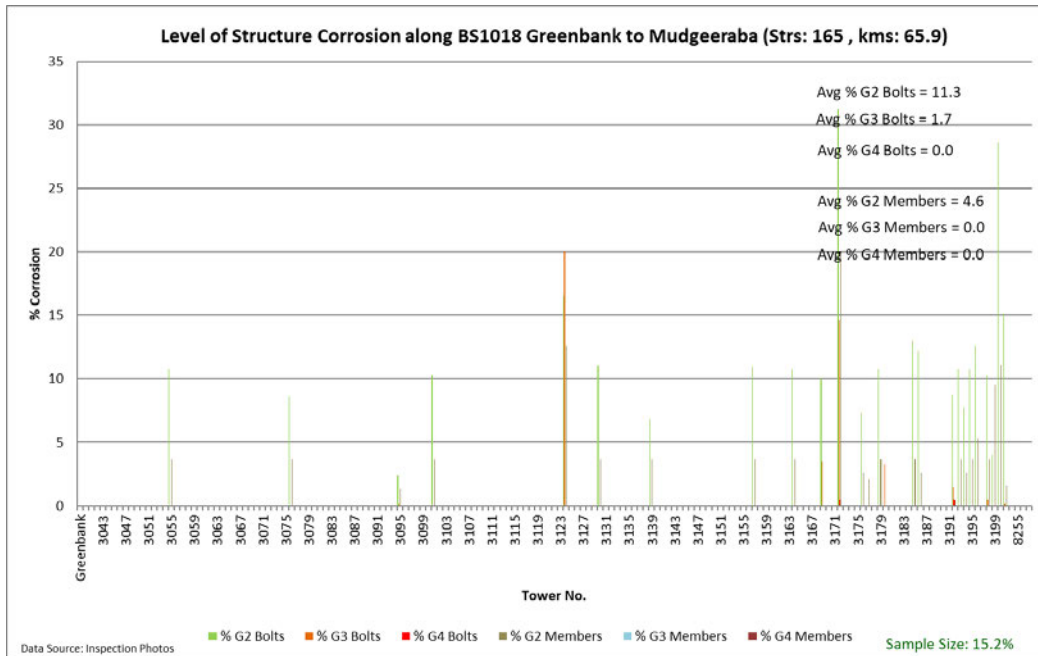
Figure 1: Structural Corrosion Level BS1018

Figure 1 below highlights the average structure corrosion level along BS1018 based on visual estimates from a sample of towers. It can be seen that the Mudgeeraba Substation (southern) end of the line appears worse than the Northern Greenbank end.

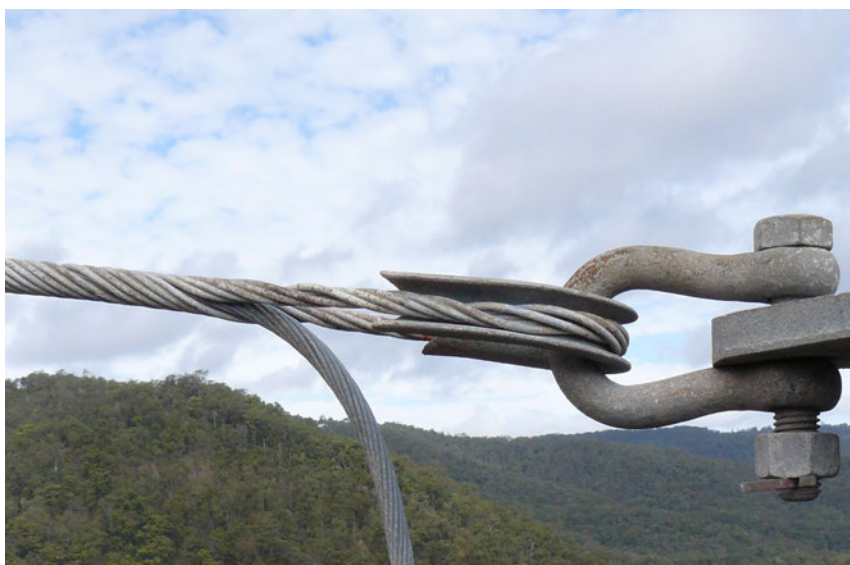
Both earthwires are satisfactory, with low levels of corrosion on wires and hardware, which will need to be addressed in the medium term. Braided earthing bonds have been installed on suspension assemblies, which are seen to be broken over a number of structures.

Figure 1: OHEW Hardware Corrosion

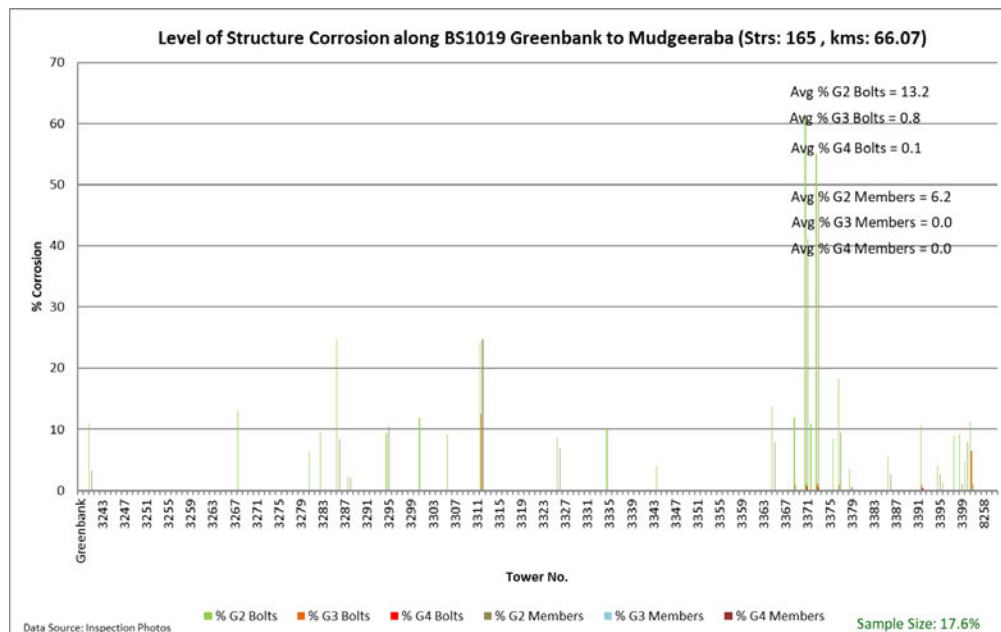
Figure 4: Structural Corrosion Level BS1019

Figure 4 below highlights the average corrosion levels along BS1019 based on visual estimates from a sample of towers. As with BS1018, the Mudgeeraba Substation (southern) end of the line, appears worse than the Northern Greenbank end.

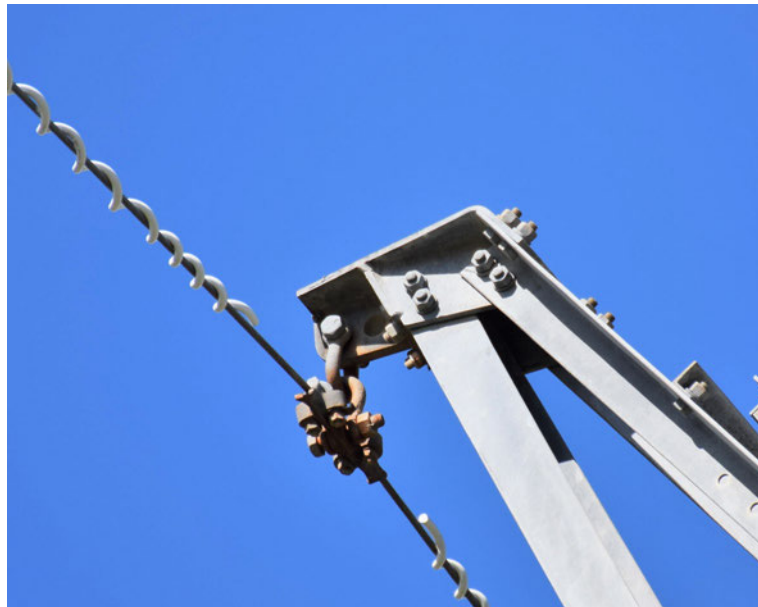
A significant number of BS1019 earth wire trunnion clamps have broken earth wire bonds, which were originally copper braids.

Figure 2: 1019-STR-3383 Earthing Bond Broken

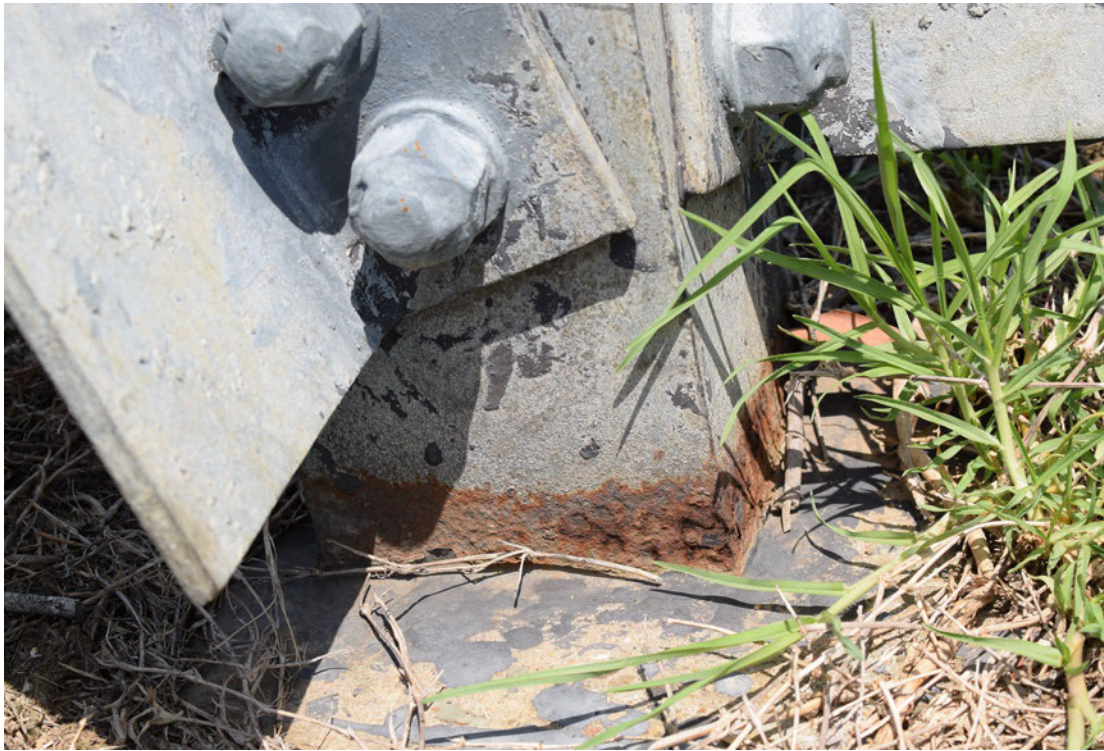
Figure 17: 1018-STR-3192 Interface Corrosion

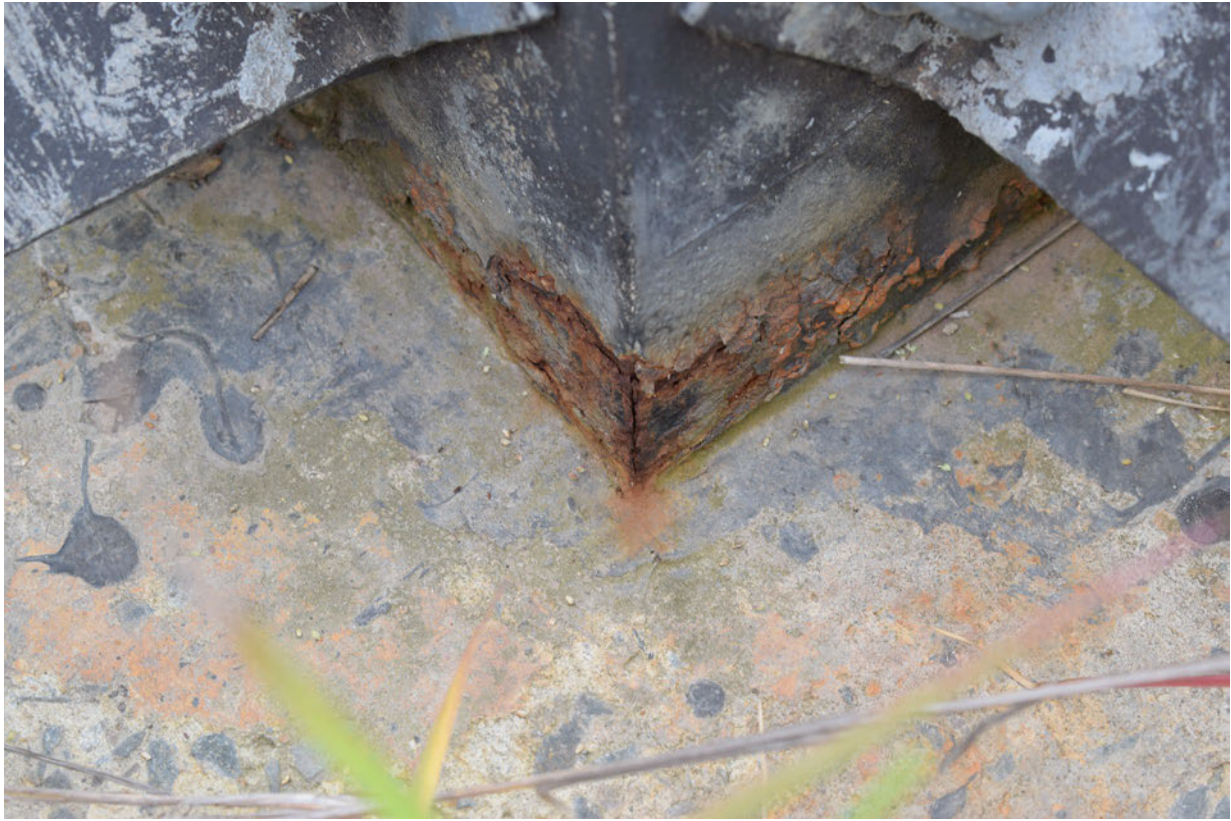
Figure 21: 1019-STR-3401 Interface Corrosion

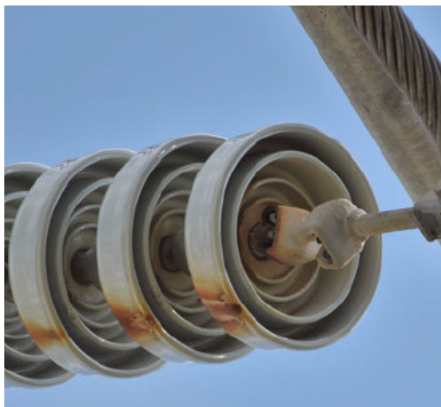
Figure 25: 1018-STR-3199 Suspension V-String Insulator Corrosion

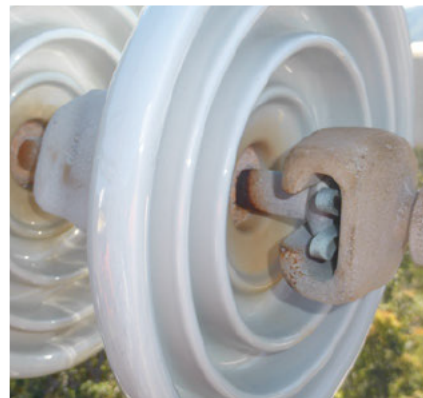
Figure 26: 1018-STR-3112 Tension Insulator Corrosion

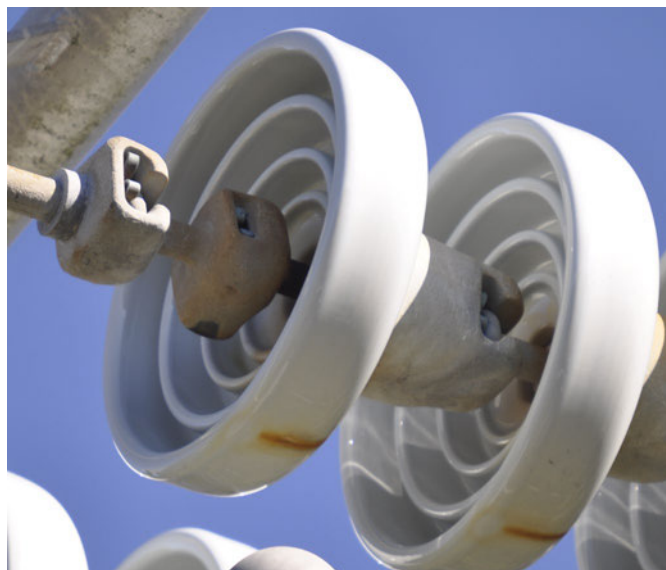
| Insulator String Function | Comment |
|---|--|
| Bridging | <p>Also under OR.02120, all BS 1019 bridging strings were replaced in 2017 prior to the Gold Coast Commonwealth Games. Bridging insulator hardware is original, and will require replacement due to corrosion in the 2020s.</p> |

Figure 27: 1019-STR-3372 Tension String
