POWERLINK QUEENSLAND
REVENUE PROPOSAL

Tarong Transformers 2 and 3 Replacement

CP.02584 – Tarong Transformers 2 and 3 Replacement

H018 Tarong Transformer T1, T2, T3 & T4 Condition Assessment

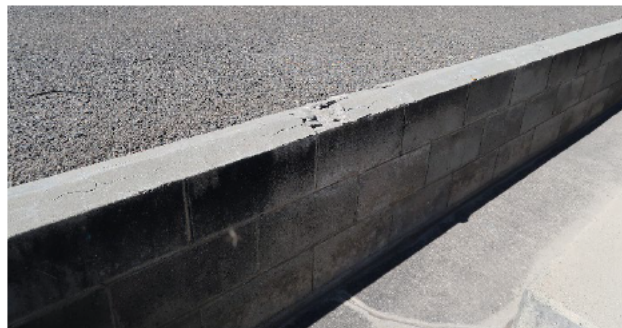
There were no potential structural issues emerging on this transformer, apart from those associated with bunded area floor and wall cracks.

Figure 6 - H018 T1 bund condition.

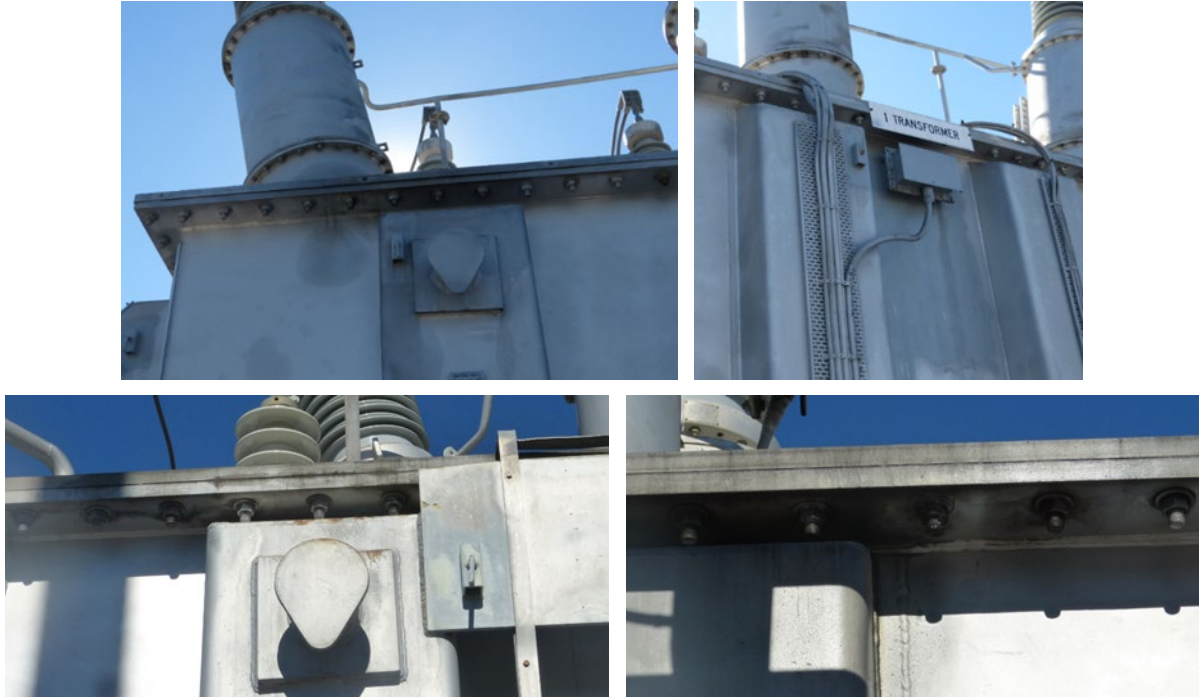
- Small oil weeps from side wall hatches.
- Oil leaking from the main tank to lid gasket.
- The various gaskets are aged and maintenance records show that oil leaks are present since 2002. Many attempts were made to prevent or reduce oil leaks. This transformer was topped up with 300 litres of oil in 2017.

Figure 7. - Oil leaking from the main tank to lid gasket

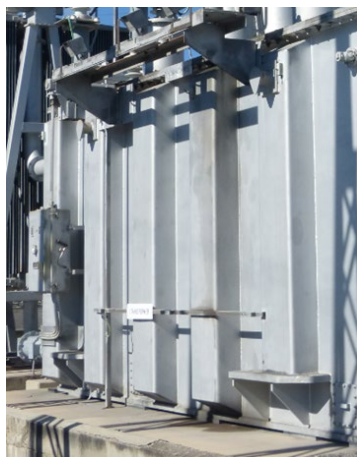
Figure 8- Oil film spreading to the bund from the main tank lid gasket.

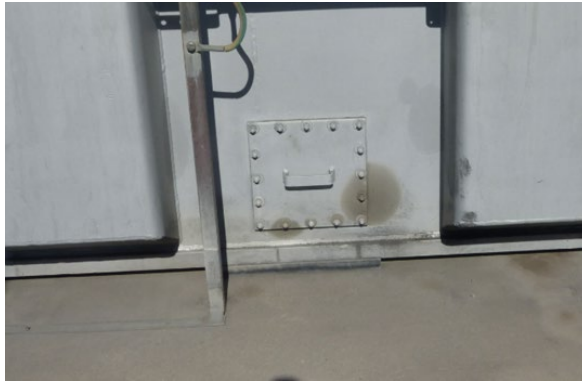
Figure 9- Oil leaks from the side wall hatch

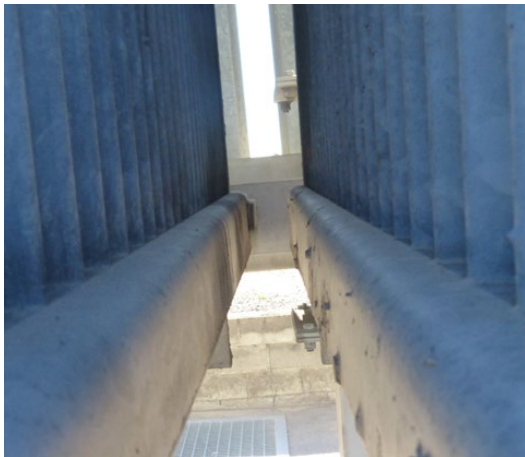
Figure 10- Oil film spreading on radiator fins

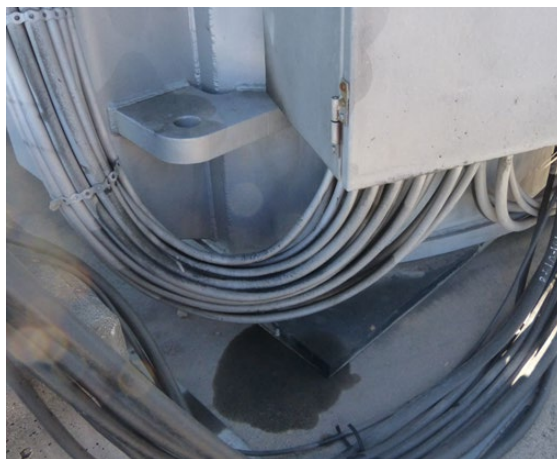
Figure 11 - Oil leaks from a radiator bank visible on the control cables located underneath

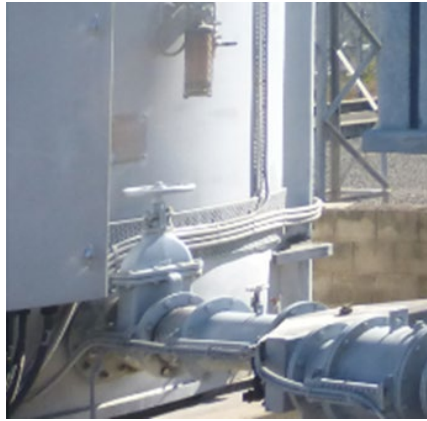
After 33 years of exposure to the elements, the external cables are set and any significant cable flexing (e.g. removal & reconnection) due to replacement of external ancillary items may create insulation damage but if left physically alone, all of the multicore cables should not fail over the next 10 years. The paint has protected them from UV to some degree.

Figure 12- Multi-core cables attach to the Main tank

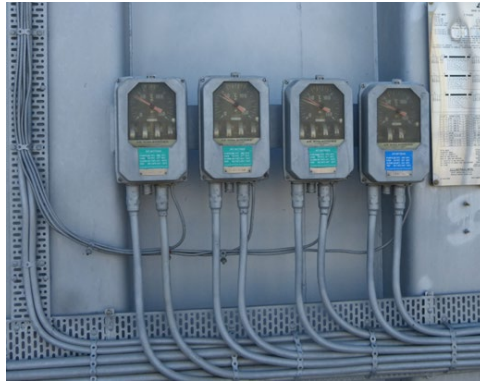
Figure 13 - HV WTI instrument, LV WTI instrument and OTI instrument. All the viewing windows are clear enabling easy instrument reading except the OTI.

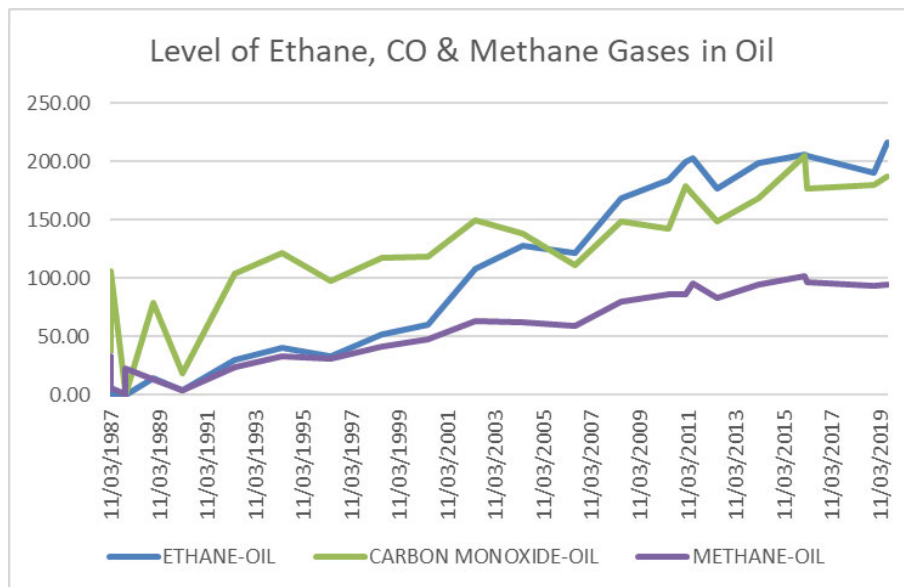
A desktop assessment was performed using the full history of Oil & Insulation Testing Laboratory test data for this transformer. Signs of mild overheating ($< 300^{\circ}\text{C}$) are visible in oil samples since 2008.

Figure 14 –Indication of overheating in transformer

Figure 14 shows the level of carbon monoxide, methane and ethane in the transformer oil. The increasing trend indicates a thermal fault at low temperature ($< 300^{\circ}\text{C}$). In order to monitor this trend, the oil sampling frequency was increased to annually from 2010. The cause for this overheating is still unknown.

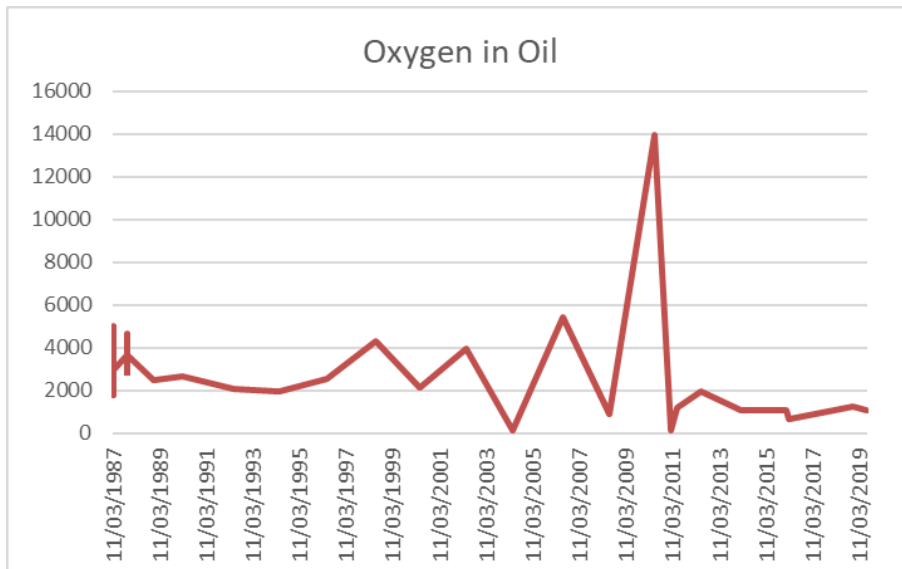
Figure 15 –Content of oxygen in oil

The graph shown in Figure 15 indicates the oxygen level in the main tank in the service history. The peak increase in oxygen level between 2008 & 2011 is likely to be linked to processes caused by mild overheating of the oil. Currently the oxygen levels are well within limits.

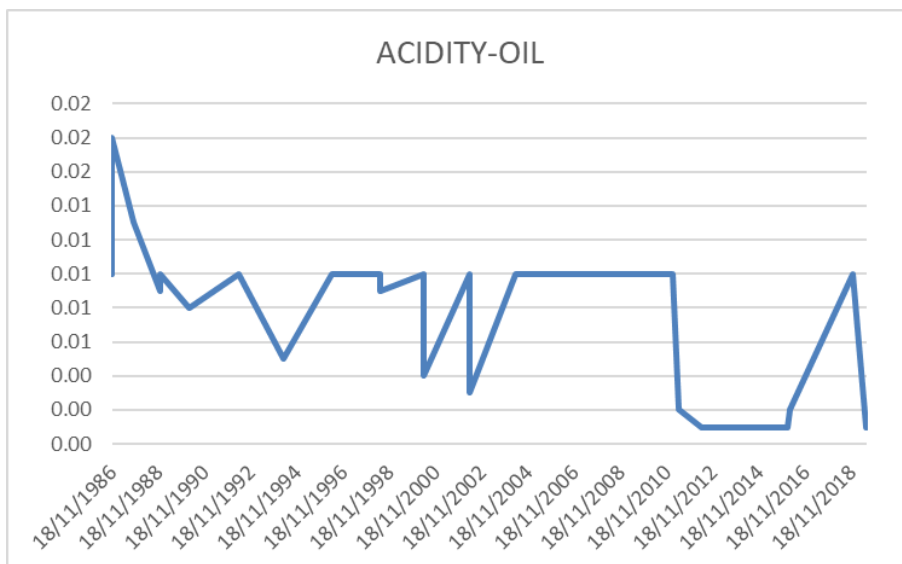
Figure 16 – Transformer T1 oil acidity

Figure 16 shows the level of acidity in the oil, which is at an acceptable level. The oil quality of this transformer has remained in reasonable condition over its life. The oil dielectric dissipation factor and dielectric strength are also within acceptable limits.

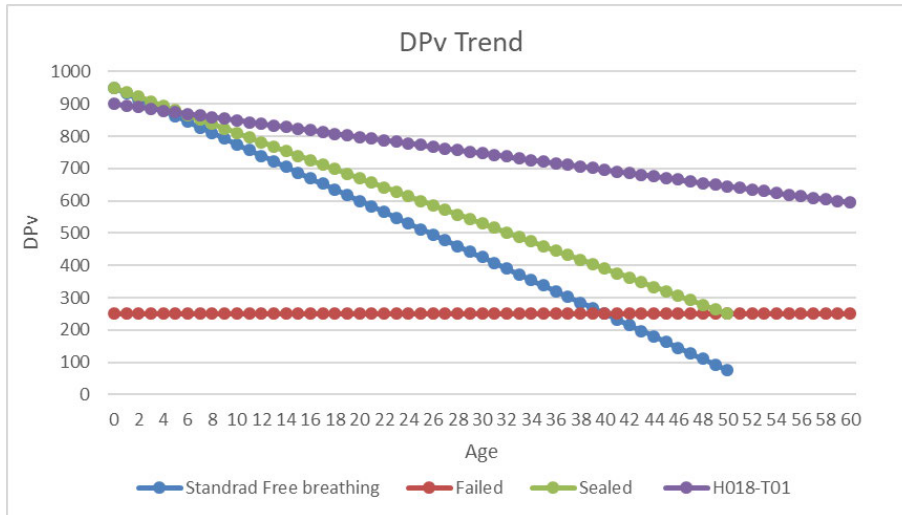
The dissolved furan in oil test data can be used to calculate approximate and average bulk cellulose insulation DP_v and its estimated trend is shown in Figure 20. Assuming that the transformer operating conditions remain the same, the trend shows that the transformer has an estimated service life of more than 50 years (Refer Figure 20).

For a typical free breathing transformer the estimated service life is 40 years. The average loading of T1 transformer being only 12 MW (only 14% of its rated capacity), the expected service life based on the paper aging only is significantly greater than theoretical design life.

Figure 20 – T1 DPv trend, typical DPv and EOL DPv

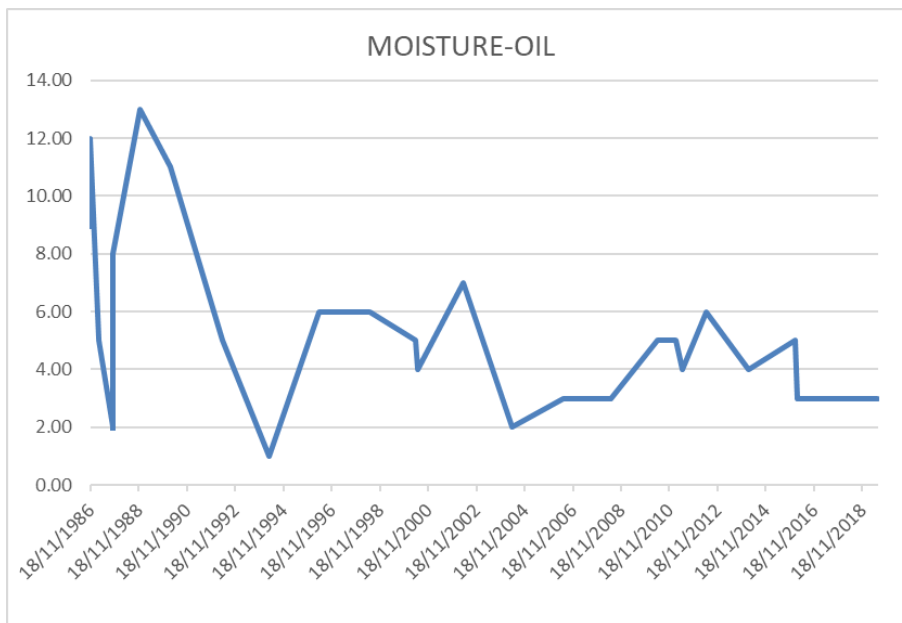
Figure 21 shows a plot of the measured moisture content in oil as measured in oil samples, starting from 1985. It seems to be relatively stable and being on average 4 mg/kg shows it has been managed well. It is worthwhile noting that with increasing oxygen levels and depending on silica gel quality in the breather, it can take a few years to detect increase in moisture level.

Figure 21 – Moisture in oil

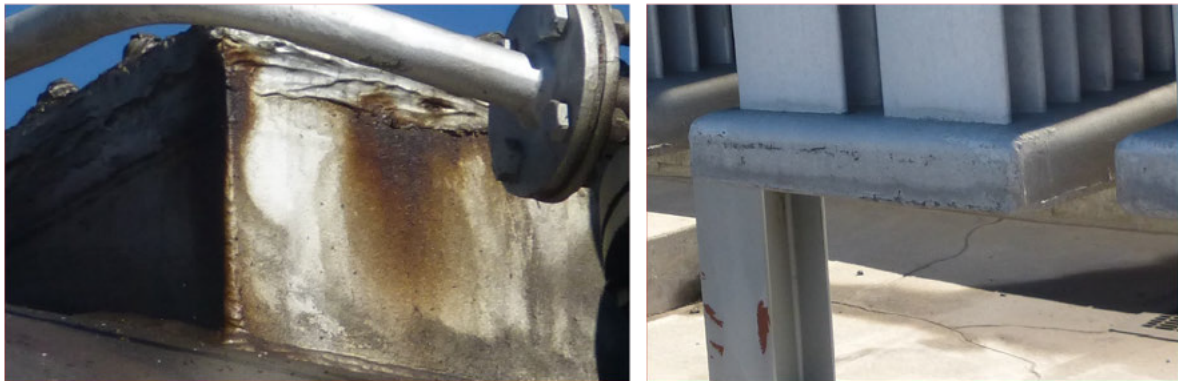
Figure 22 – Minor corrosion & galvanisation damage

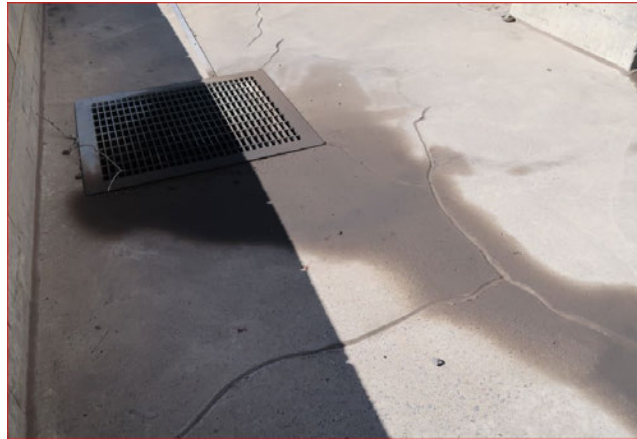
There were no potential structural issues emerging on this transformer. There are cracks in the bund floor, but these were sealed (see Figure 23).

Figure 23 – Sealed cracks in bund floor

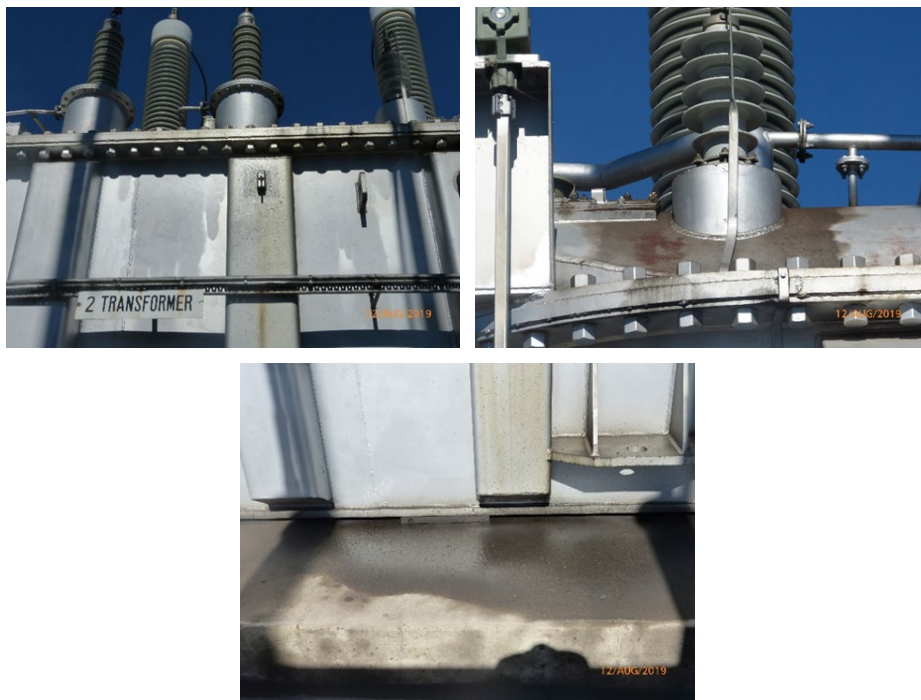
- Small oil weeps from TV bushing base.
- Oil leaking from the main tank to lid gasket.
- Many oil leaks in radiator banks.
- The various gaskets are aged and maintenance records show that oil leaks are present since 1999. Many attempts were made to prevent or reduce oil leaks. This transformer was regularly topped up with oil since 2010 with total amount of oil used being 5880 litres to date.

Figure 24 - Oil leaking from the main tank to lid gasket

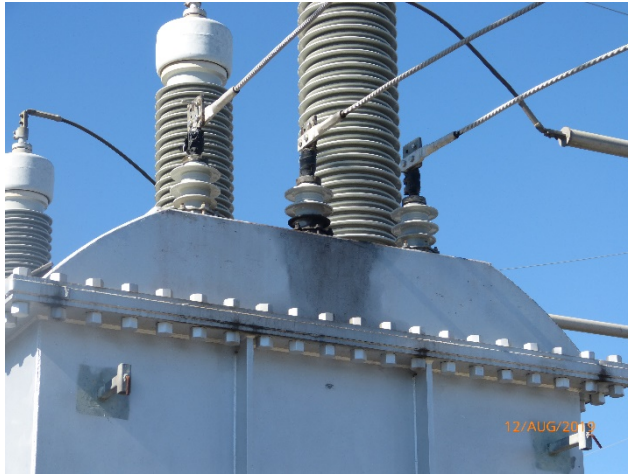
Figure 25- Oil film leaking from the TV bushing base.

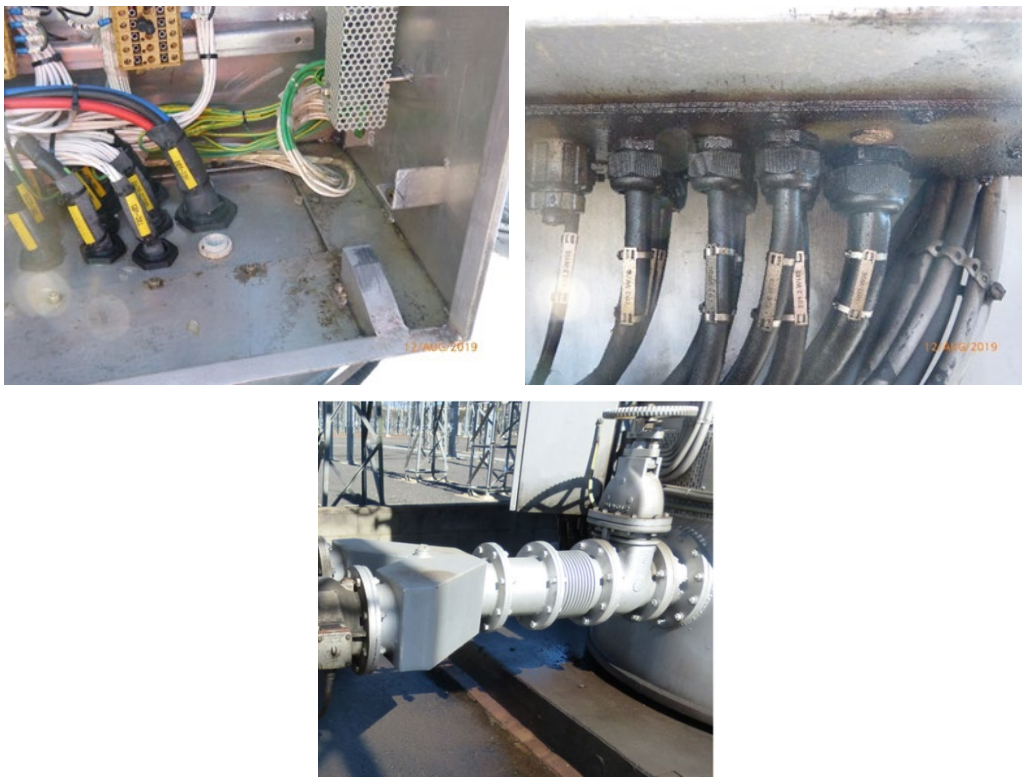
Figure 26- Oil through the cables and control box.

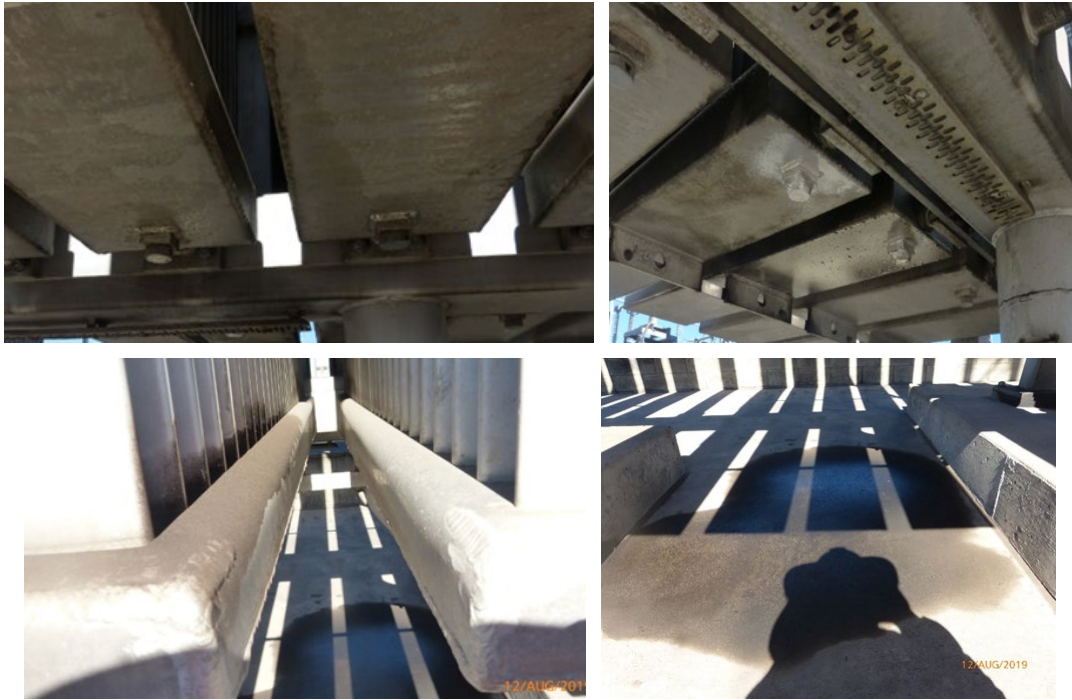
Figure 27- Oil leaks from the radiator banks

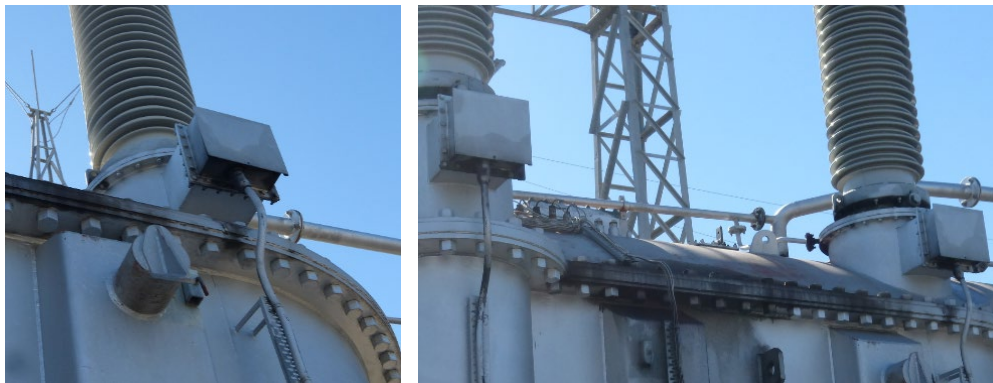
Figure 28- Oil leaking from HV bushing CT box

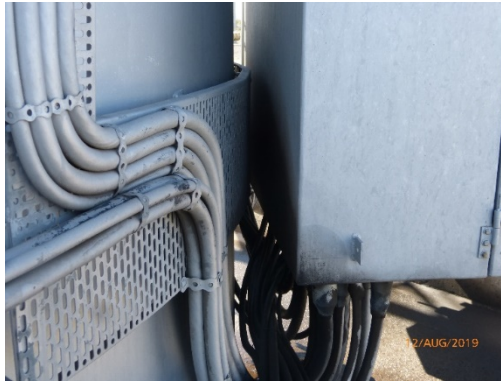
After 37 years of exposure to the elements, the external cables are set and any significant cable flexing (e.g. removal & reconnection) due to replacement of external ancillary items may create some insulation damage if left physically alone, all of the multicore cables should not fail over the next 10 years.

Figure 29- Multi-core cables attach to the Main tank

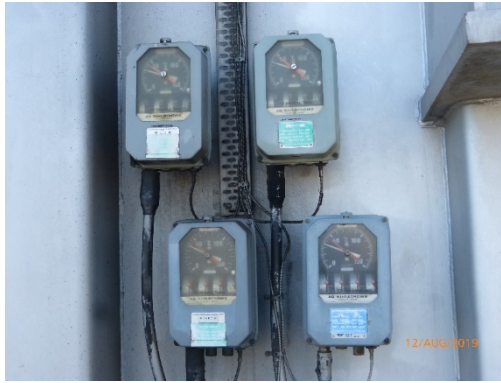
Figure 31 - HV WTI instrument, LV WTI instrument and OTI instrument. All the viewing windows are clear enabling easy instrument reading except the OTI.

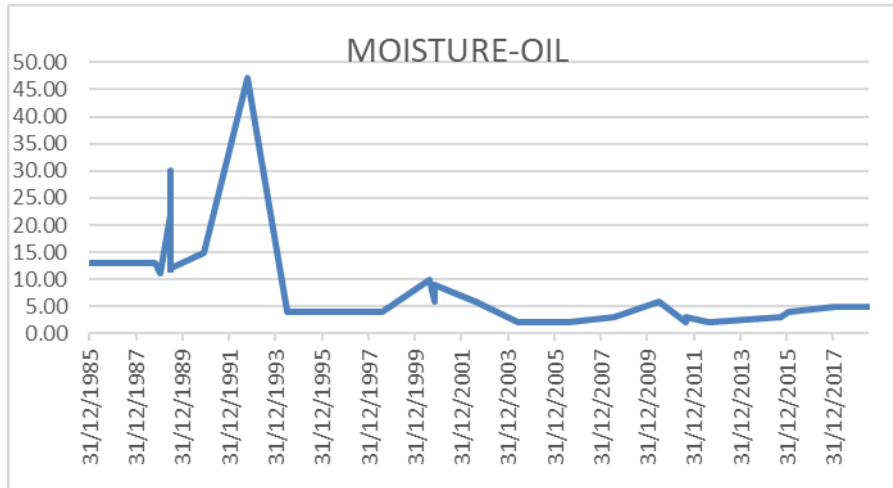
Figure 38 shows a plot of the measured moisture content in oil as measured in oil samples, starting from 1985. It seems to be relatively stable and being on average 5 mg/kg shows it has been managed well. It is worthwhile noting that with increasing oxygen level and depending on silica gel quality in the breather, it can take a few years to detect an increase in moisture level.

Figure 38 – Moisture in oil

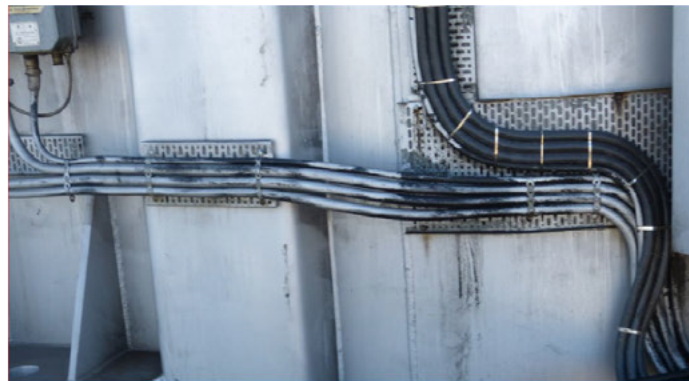
Figure 39 – paint on multicore cables.

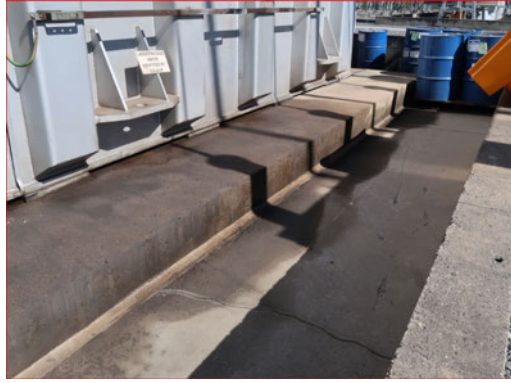
There were no potential structural issues emerging on this transformer. There are sealed cracks visible on the bund floor.

Figure 40 – Bund floor cracks

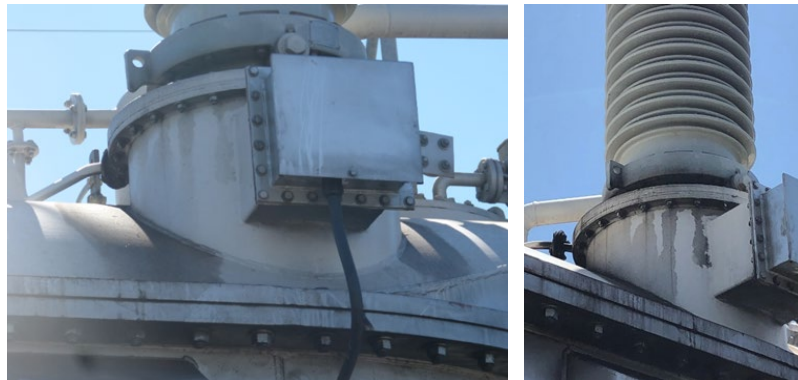
- Small oil weeps from TV bushing base.
- Oil leaks from the main tank to lid gasket.
- Many oil leaks in radiator banks
- The various gaskets are aged and maintenance records show that oil leaks are present since 2003. Many attempts were made to prevent or reduce oil leaks. There are no records available to confirm the quantity of oil added to this transformer over the years.

Figure 41 - Oil leaks from the A & C phase bushing turrets

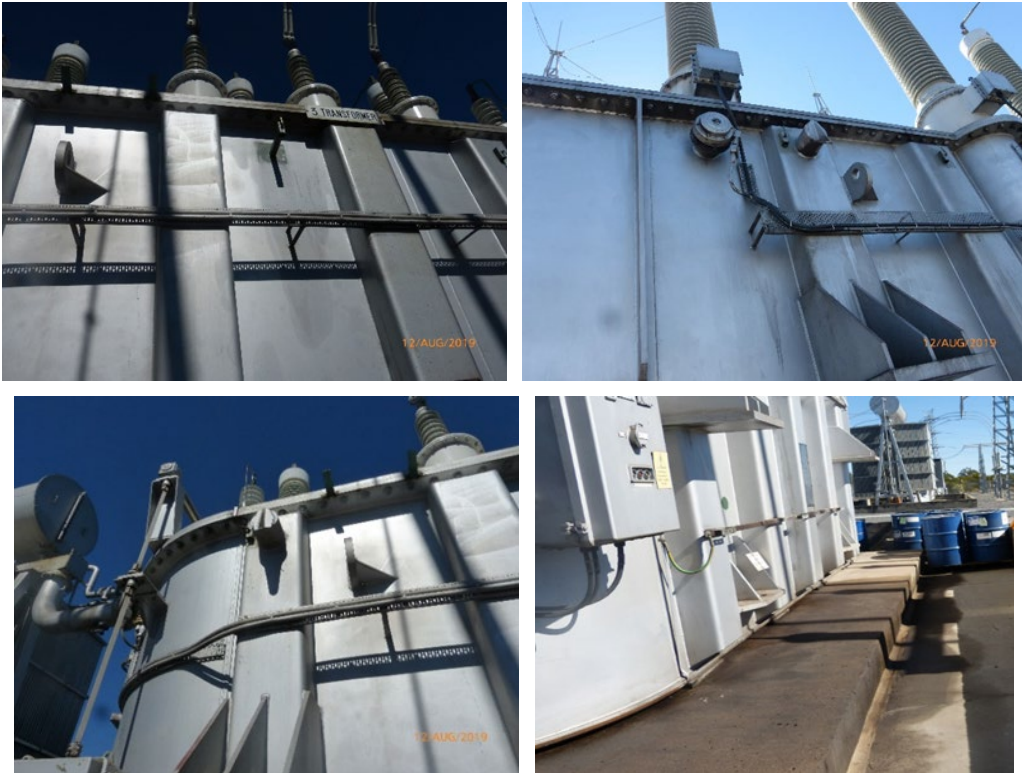
Figure 42- Oil film leaking from the top of main tank.

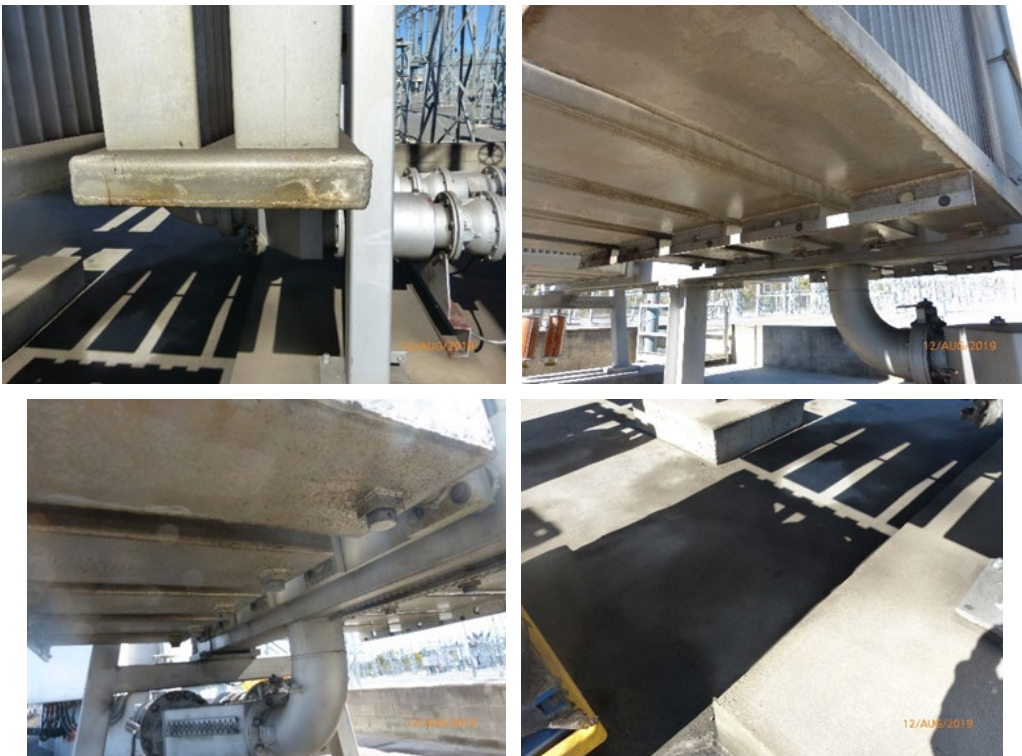
Figure 43- Oil leaks from radiator banks.

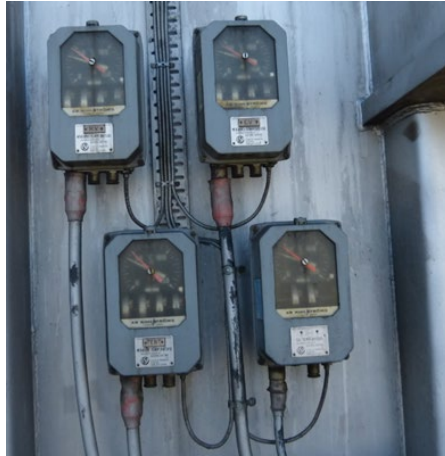
Figure 45 - HV WTI instrument, LV WTI instrument and OTI instrument.
All the viewing windows are clear enabling easy instrument reading except the OTI

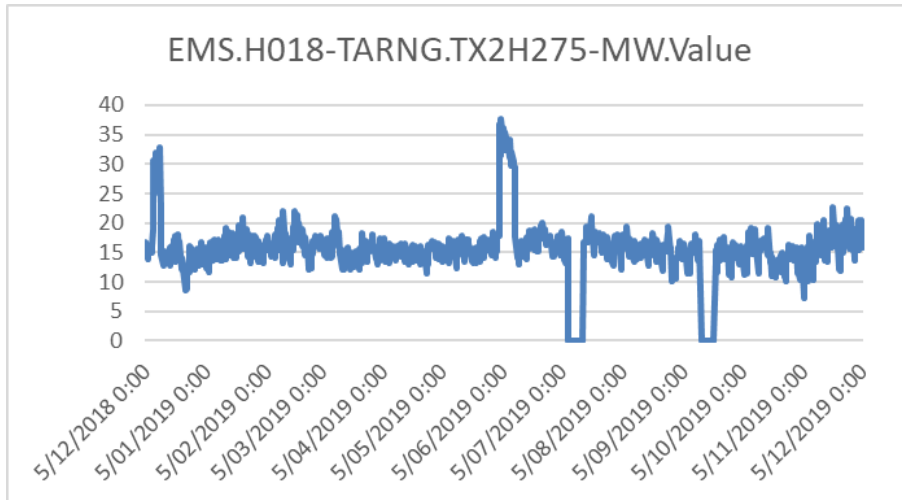
Figure 49 shows the transformer loading over the last 12 months and if this is representative of the loading over many previous years, it could explain why the dissolved furan level in the oil is relatively low for a 34 year old free breathing transformer. The peak loading in MVA on the 275kV side of the transformer over period 05/12/2018 to 05/12/2019 did not appear to exceed 40% of the nameplate ODAN rating. The average loading on the transformer for this period is 16MW.

Figure 49 -T1 transformer loading in MVA in period 5/12/2018 -5/12/2019 (the highest peak load is 36 MVA i.e 40% of ODAN nameplate rating)

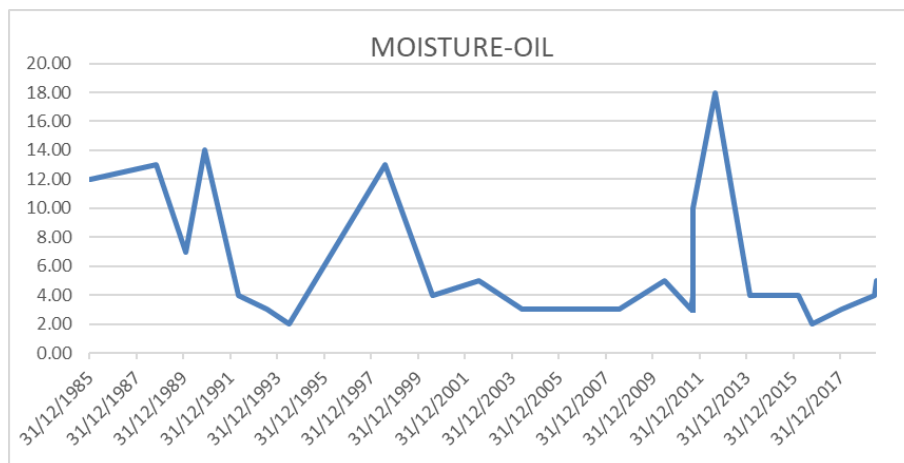
Figure 52 shows a plot of the measured moisture content in oil as measured in oil samples, starting from 1985. It seems to be relatively stable and being on average 4 mg/kg shows it has been managed well. It is worthwhile noting that with increasing oxygen level and depending on silica gel quality in the breather, it can take a few years to detect increase in moisture level.

Figure 52– Moisture in oil

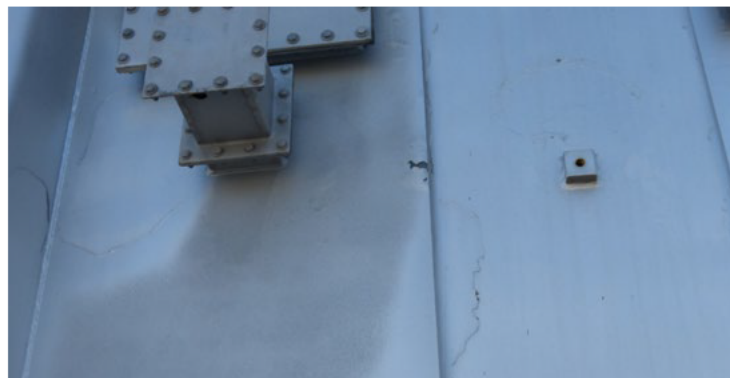
Figure 53- Flaking of paint

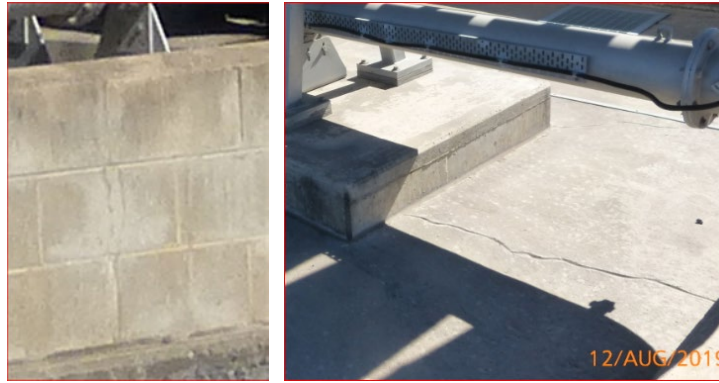
There were no potential structural issues emerging on this transformer. However, there are some cracks in bund walls and floor (resealed).

Figure 54-Bund cracks

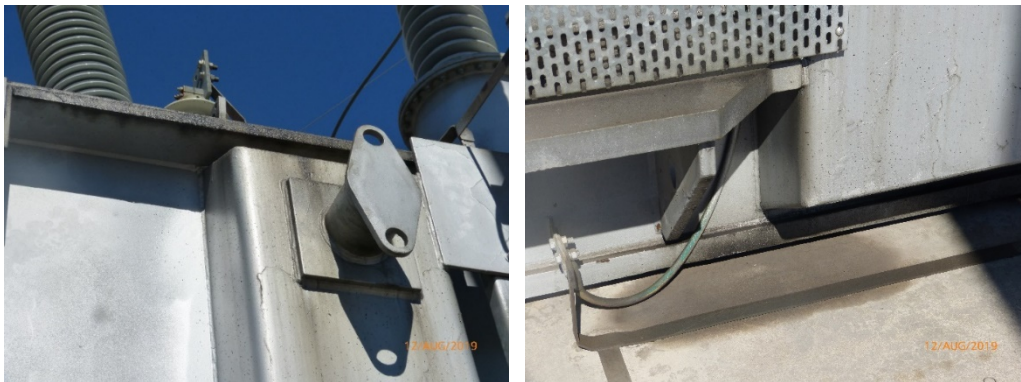
Figure 55- Oil film leaking from the top of main tank

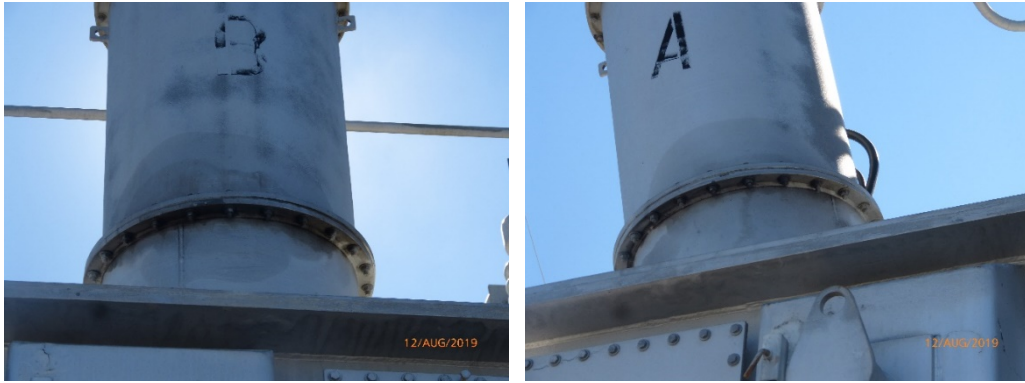
Figure 56 - Oil leaks from Bushing Turrets

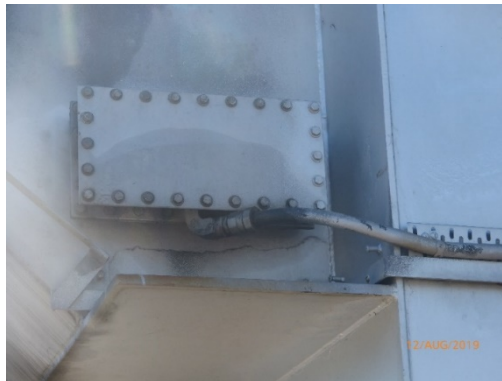
Figure 57- Oil leaks from Terminal box on tertiary bushings.

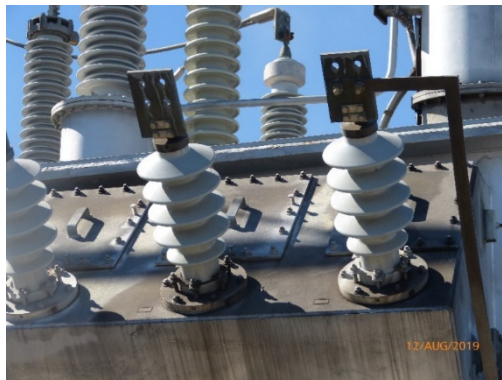
Figure 58 - Oil leaks from Terminal box on tertiary bushings

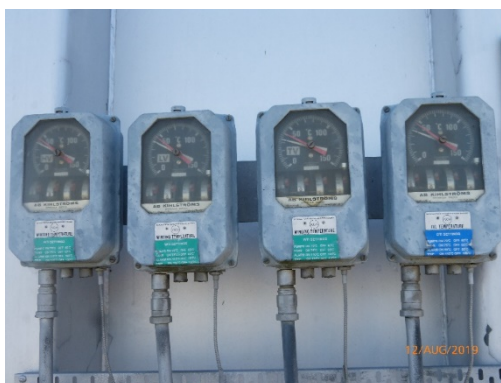
Figure 60 - HV WTI instrument, LV WTI instrument and OTI instrument.
All the viewing windows are clear enabling easy instrument reading except the OTI
