CP.02750

**Ross to Chalumbin 275kV Transmission
Line Refit**

**Transmission Line Condition Assessment – Report**
Built Section 1220 – Ross to Chalumbin 275kV**Transmission Line Condition Assessment Report****Built Section 1220**
Ross to Chalumbin 275kV

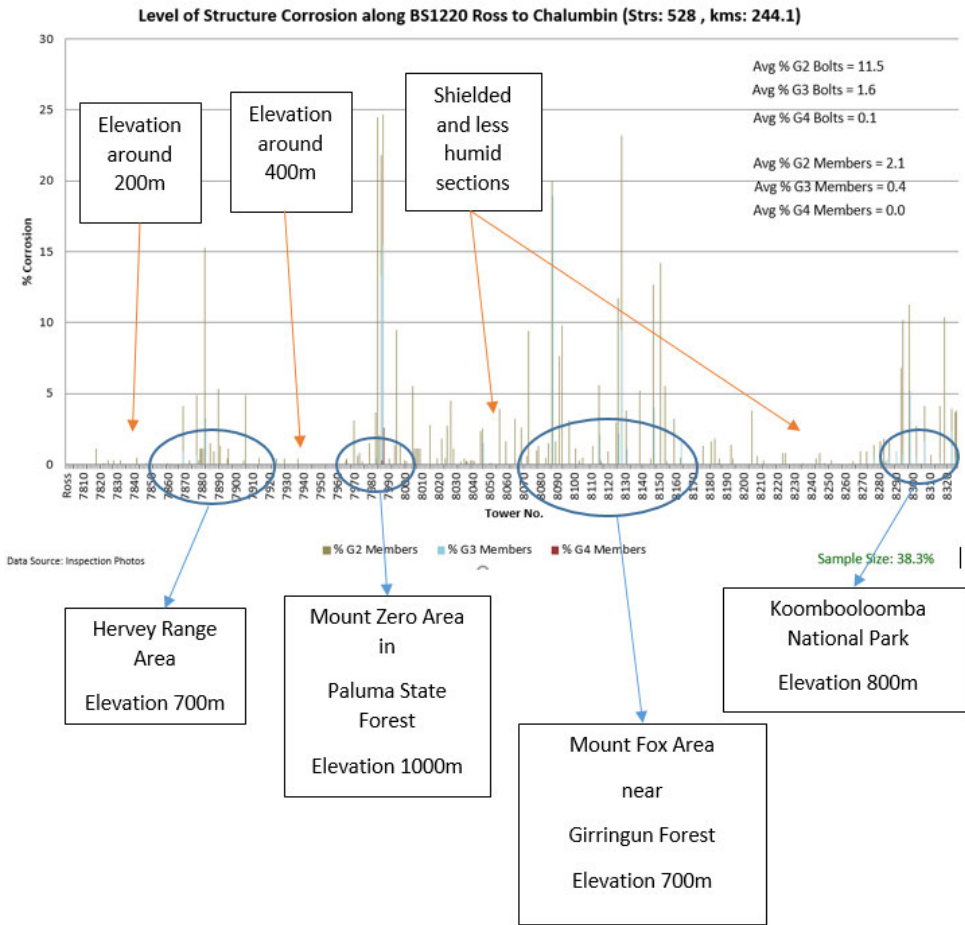
Figure 3: Line sections with towers exhibiting higher member corrosion levels

As a result, particularly in approximately six more exposed and elevated locations, galvanised tower bolts and members are exhibiting significant evidence of grade 3 and grade 4 corrosion. Between these areas of poor condition, corrosion levels vary from low to medium; relatively normal for the age of the line. Given the criticality and length of the feeders, and the difficulties of access to maintain the line in serviceable condition, it is necessary to consider when and how to maintain these structures in order to avoid reaching the point where extensive replacement of steelwork is necessary. If left untreated the maintenance costs could drive replacement of structures.

Elevated sections of the line more exposed to salt laden winds appear in a more corroded condition than lower sections protected by natural shielding of terrain topography.

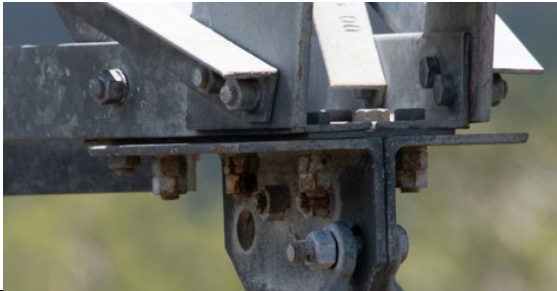
Cross Arms	Similar condition to that of the Superstructure.
Cond. Attachment	The worst area of the tower where more than 3% of bolts have G3 and G4 corrosion.
