POWERLINK QUEENSLAND
REVENUE PROPOSAL

**Davies Creek to Bayview Heights 275kV
Transmission Line Refit**

CP.02754 – Davies Creek to Bayview Heights 275kV Transmission Line Refit

**Transmission Line Condition Assessment – Report
BS1235 and BS1664 – Chalumbin to Woree****Transmission Line Condition Assessment – Report****BS1235 and BS1664
Chalumbin to Woree**

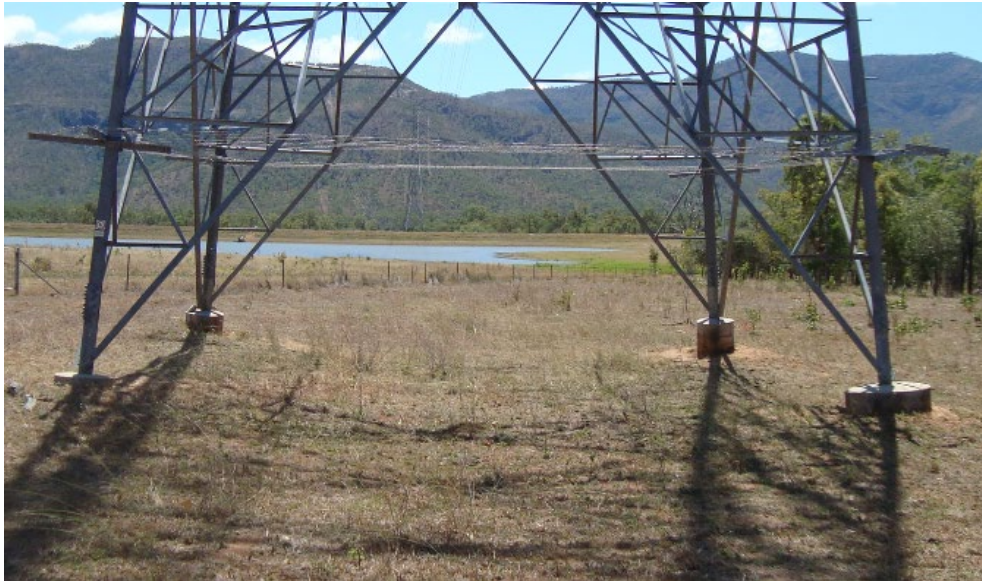
Typically interface are found to be in good condition.

Figure 5: 1235-STR-0002 typical interface condition on the line (2015)

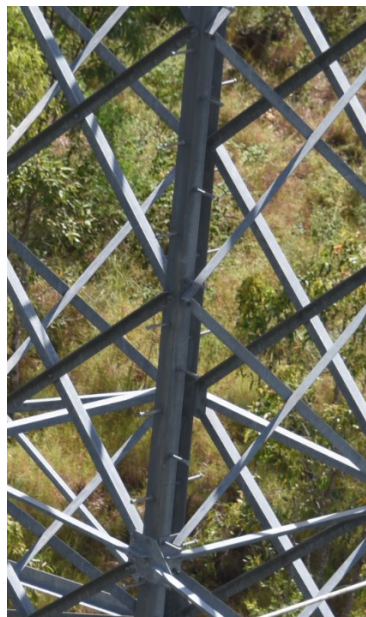
Figure 6: Grade 1 corrosion shown on step bolts 1235-STR-0034 (2018)

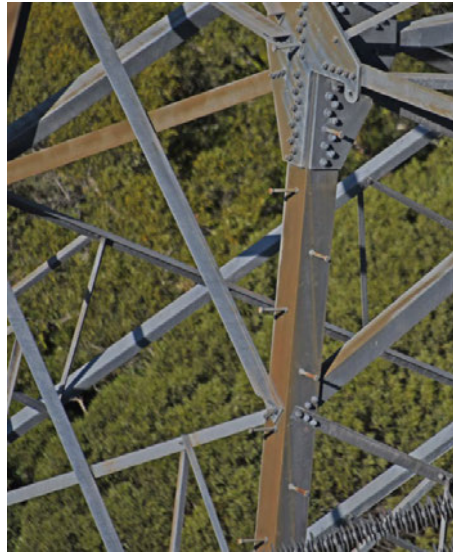
On the Wet Tropics section (BS1664), G2 corrosion has been observed on step bolts of all towers. With the common instances of G3 and even G4 corrosion levels (Figure 7).

Figure 7: Grade 2 and 3 corrosion shown on step bolts 1664-STR-0102 (2018)

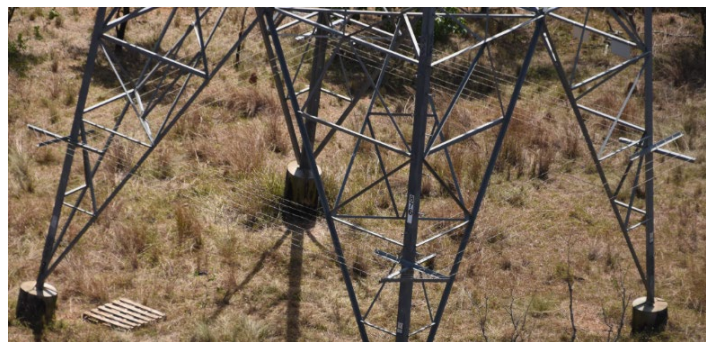
Towers have been fitted with a selection of Type A1 and A2 barbed wire type anti-climbing barriers depending on their size. All anti-climb barriers remain in a serviceable condition. Less than 10% of steel barrier frames are showing Grade 2 corrosion (Figure 8). At the time of this report, there are no open notifications for broken barbwires on the line.

Figure 8: STR-0045; ACB barbed wire typical for towers on the line (2018)

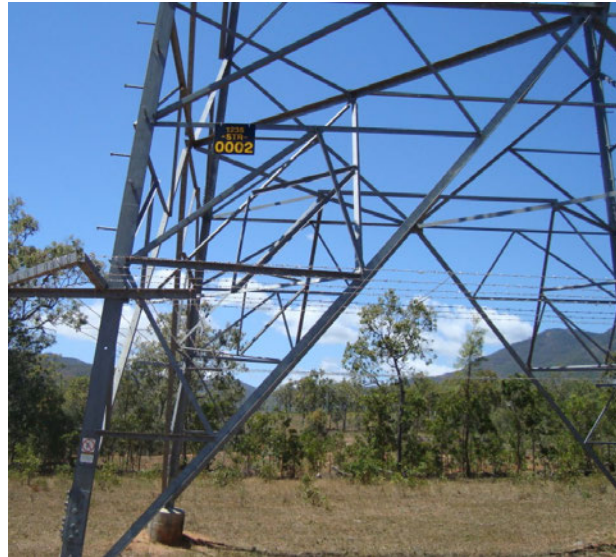
On South West section (BS1235) there is a minimal corrosion evident on the bolts and members at the tower bases with most sheltered light members and bolts at corrosion Grade 1. Heavy members remain unaffected (see Figure 9).

Figure 9: STR-0002; Sample of corrosion on tower base bolts (2015)

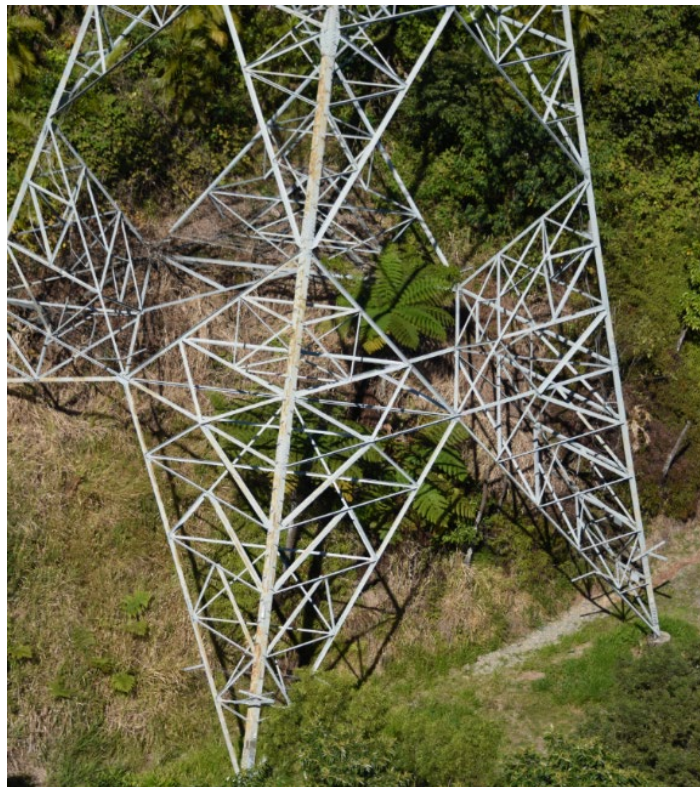
The Wet Tropics section (BS1664) is showing evidence of emerging G3 corrosion levels.

Figure 10: STR-01017; Sample of corrosion on tower base members

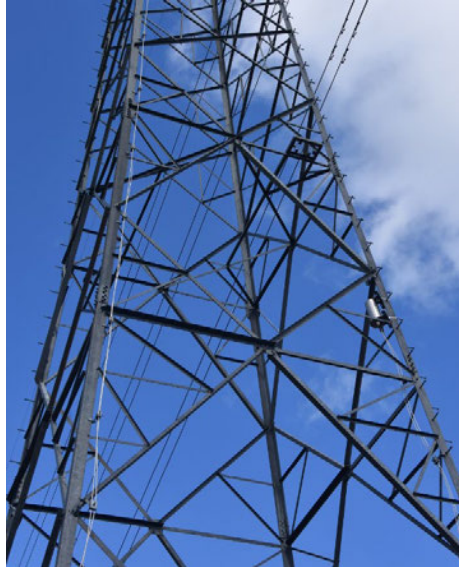
Early G2 corrosion of the light body members has been observed on some towers. No evidence of G3 corrosion on the bolts (shown below in Figure 11).

Figure 11: STR-0050 Tower body in good condition (2018)

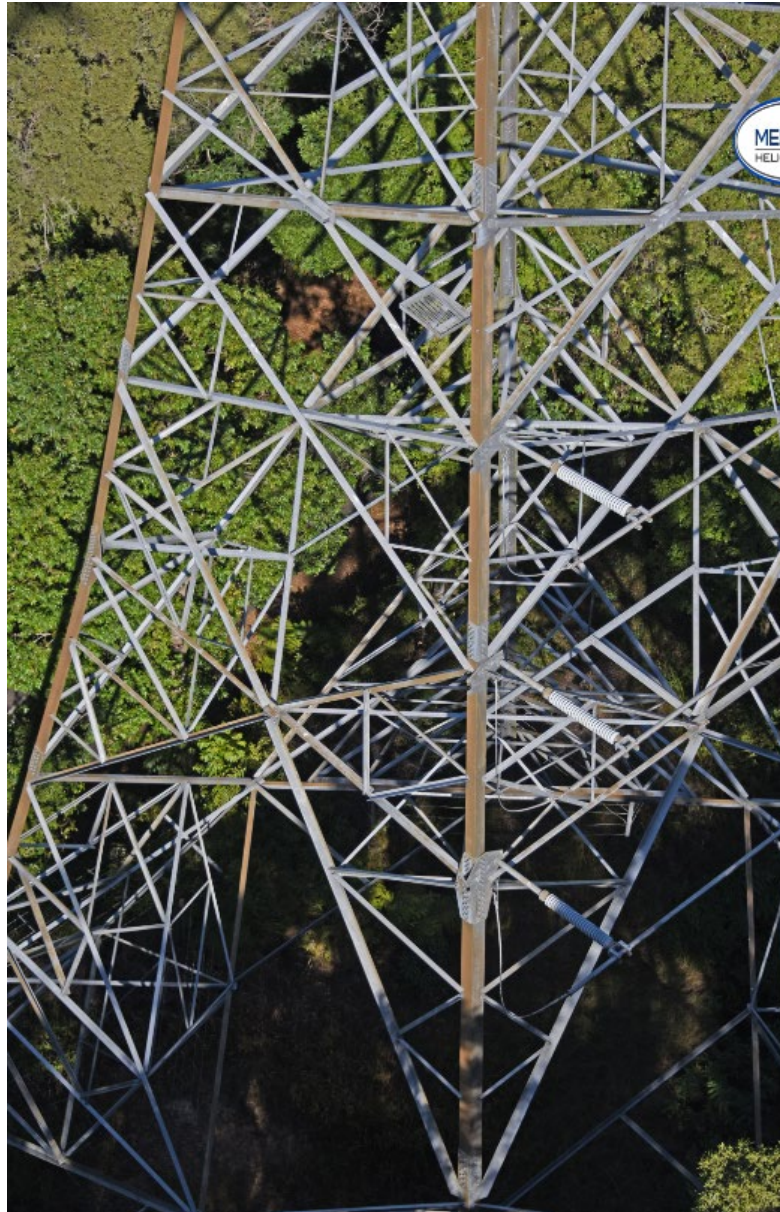
Figure 12: STR-0108 Tower body with widespread surface corrosion of smaller members and bronzing of larger members

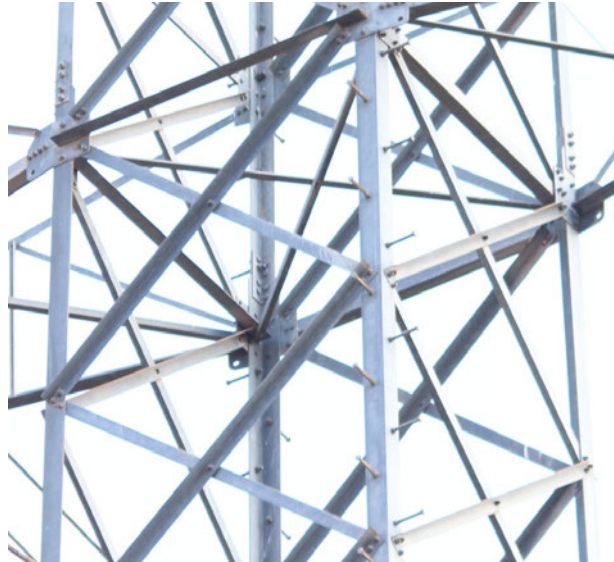
Within the south western section, some G2 corrosion of the light members and bolts has been observed. The onset of G3 corrosion was observed on the bolts of one tower only (shown below in Figure 13).

Figure 13: STR-0021 with G3 bolts and G2 on members (2018)

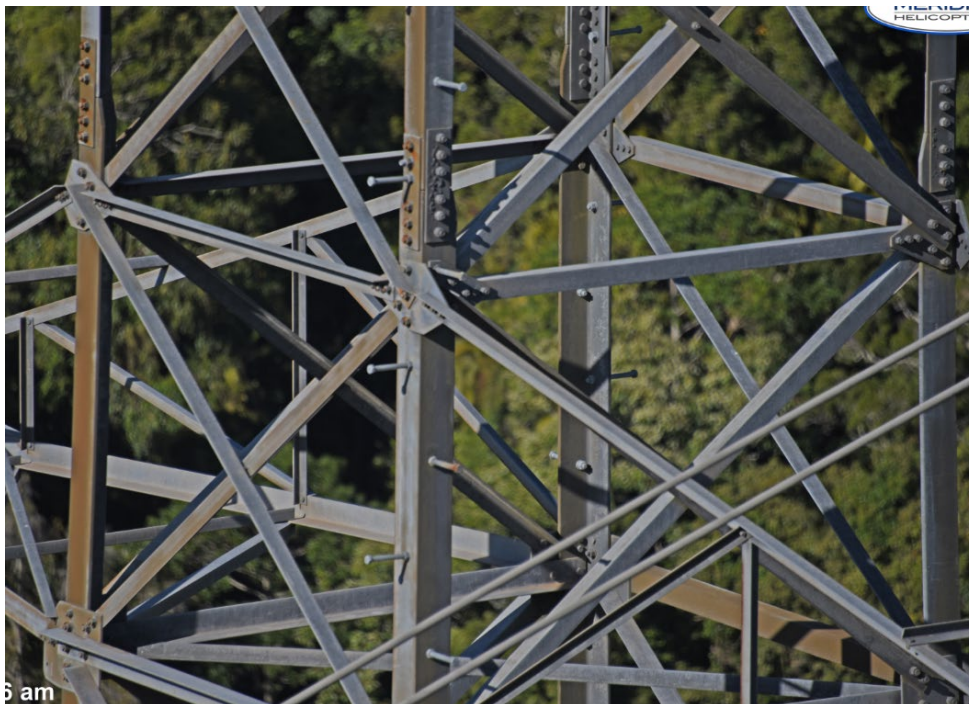
G2 and G3 corrosion is widespread on the superstructure bolts with close to 2% of bolts at corrosion level G4 (shown below in Figure 14).

Figure 14: 1235-STR-0101 with G3 and G4 bolts and G2 on members (2018)

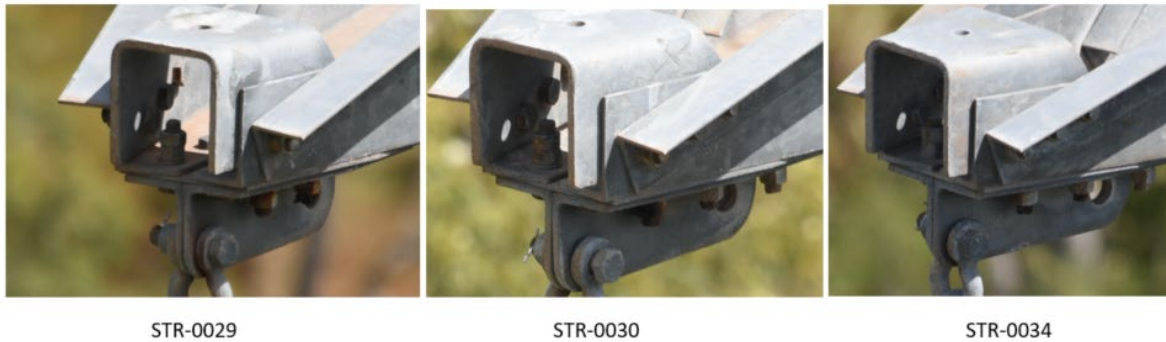
It has been observed that bolt corrosion in attachment plate areas is more extensive compared to other tower fasteners on this section of the line, with grade 2 or 3 corrosion observed on almost 7% and grade 4 corrosion starting to emerge on attachment plate nuts and bolts.

Figure 15: Examples of G4L corrosion in Attachment Zone fasteners (2018)

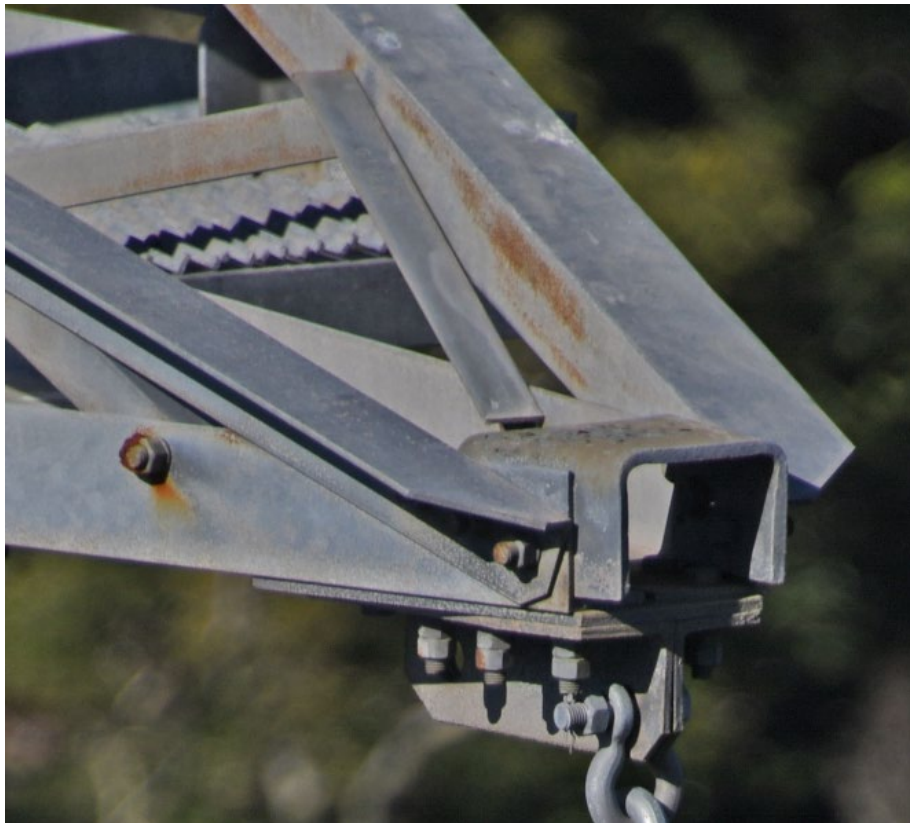
The bolt corrosion in attachment plate areas is in better condition than expected considering average condition of the whole tower. Around 9% of bolts in the attachment areas were observed to be G3 or G4.

Figure 16: STR-0101 Attachment Zone - Wet Tropics representation (2018)

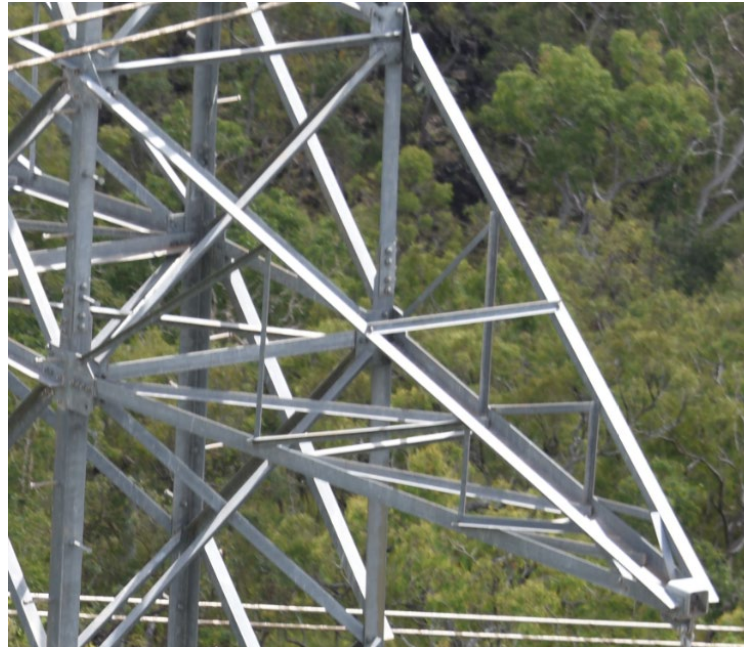
The cross-arms fasteners and members commonly exhibit Grade 1 or Grade 2 corrosion with very rare instances of Grade 3 and 4. The larger cross-arm members are relatively unaffected by corrosion at this stage.

Figure 17: STR-0030 cross arm corrosion (2018)

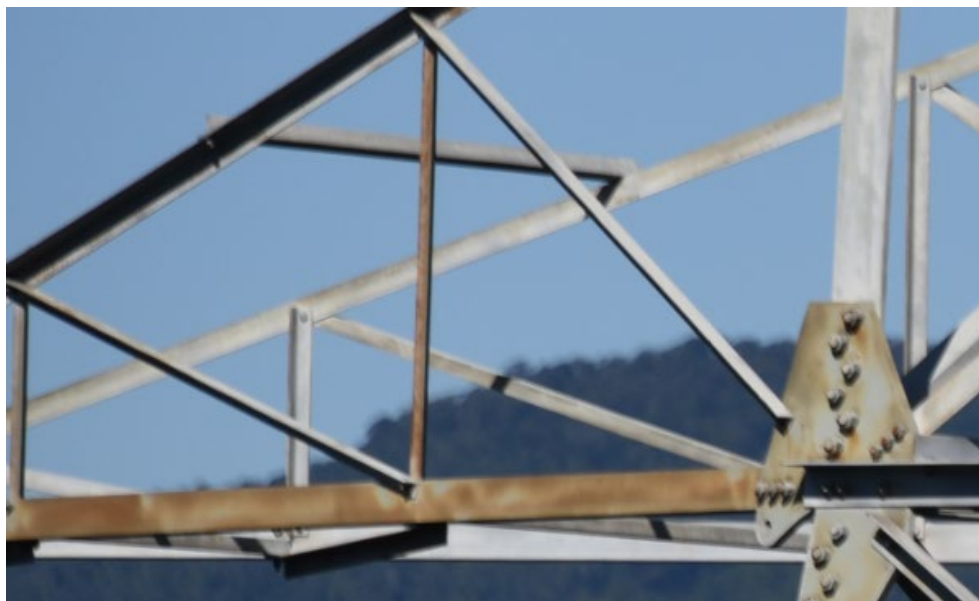
On this section of the line there are more than 2% of bolts and close to 2% of members exhibiting Grade 4 corrosion.

Figure 18: STR-0115 cross arm corrosion (2018)

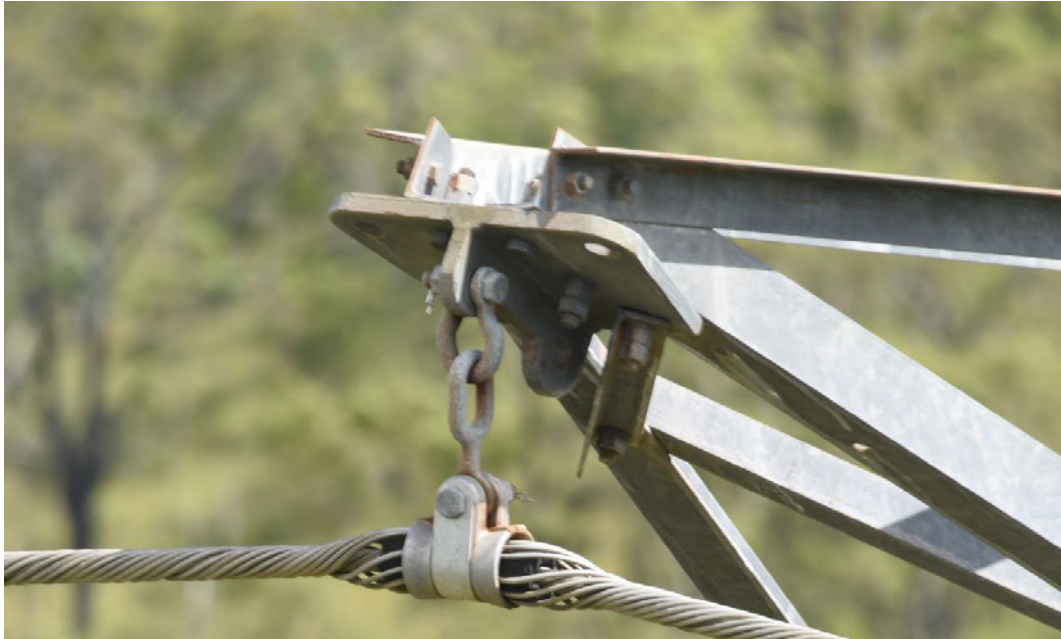
Light surface rust and sometimes advanced G2 corroded nuts and bolts were observed on earthwire peaks of the towers on the South West section (BS1235) of the line.

Figure 19: STR-0030 Earth Peak corrosion (2018)

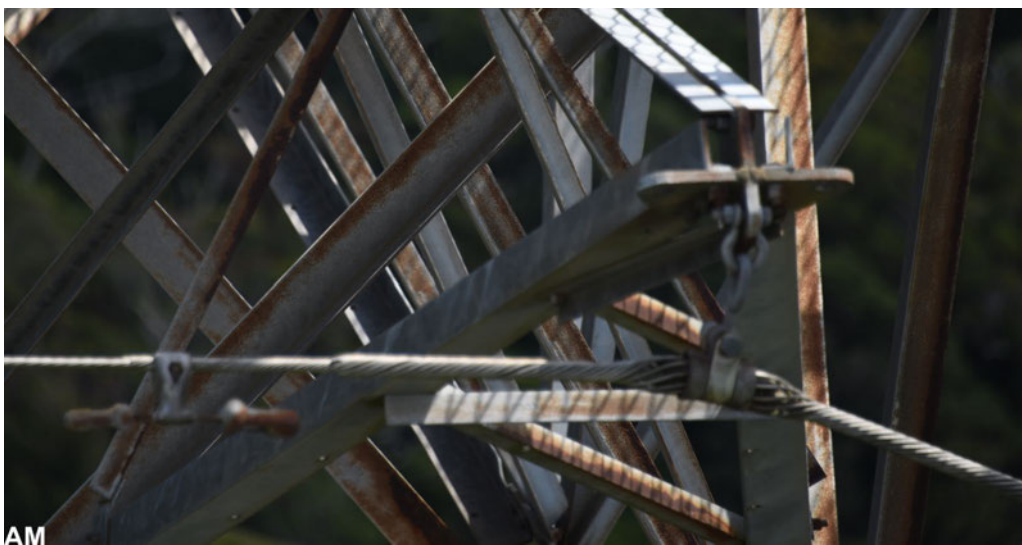
Surface rust consistent with advanced G3 corrosion on members, nuts and bolts is present on earthwire peaks of the towers on the Wet Tropics section (BS1664) of the line.

Figure 20: STR-0101 Corrosion on Earth Peak (2018)

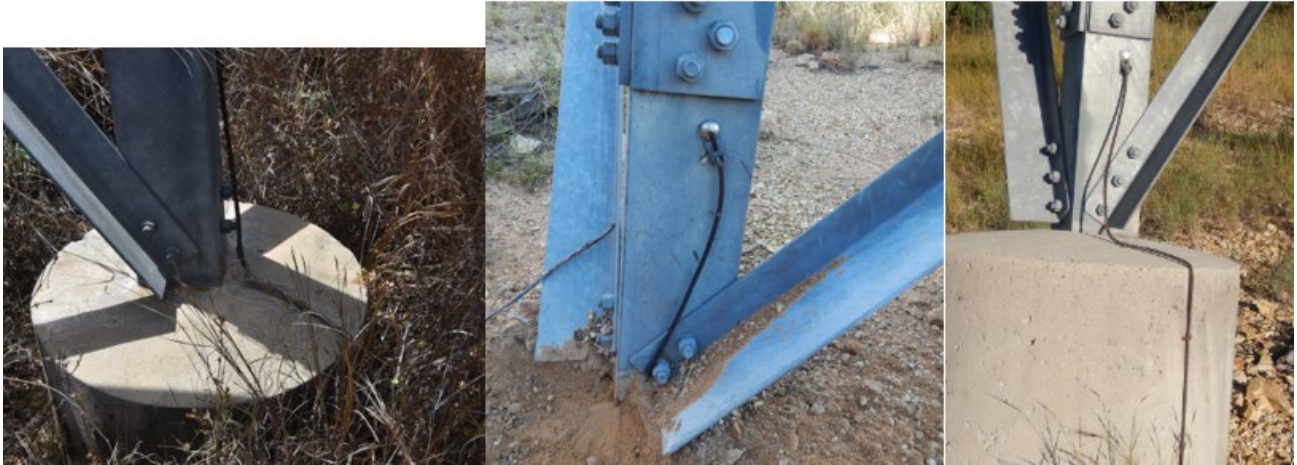
Earth cables and connectors are generally in good condition with no open notifications for ground earthing and only one G3 notification for a corroded connecting bolt.

Figure 21: BS1235 Examples earthing (2016)

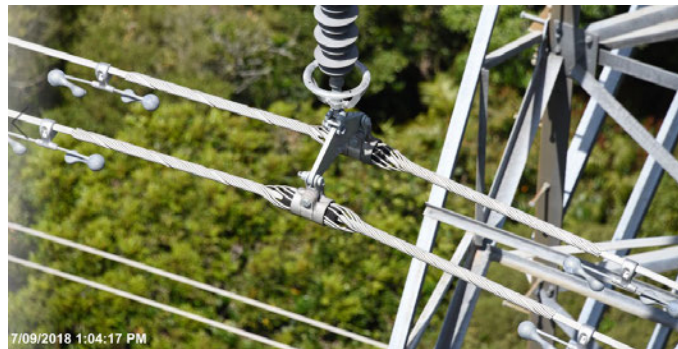
Vibration dampers were replaced along with NCI insulators in 2016 and are in good condition.

Figure 23: STR-0099 Vibration Dampers and AGSU (2018)

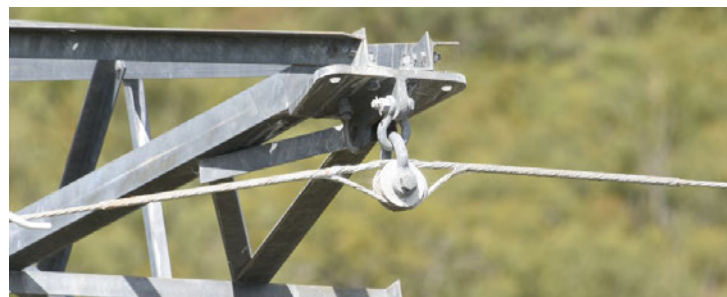
The earthwire on the South West section (BS1235) is in good condition exhibiting the appearance of weathered galvanising. 'Twingrip' connectors used to secure the earth wire to the earthwire peak exhibit G2 corrosion level on some towers.

Figure 24: STR-0057 Example of earthwire and twingrip from the line (2018)

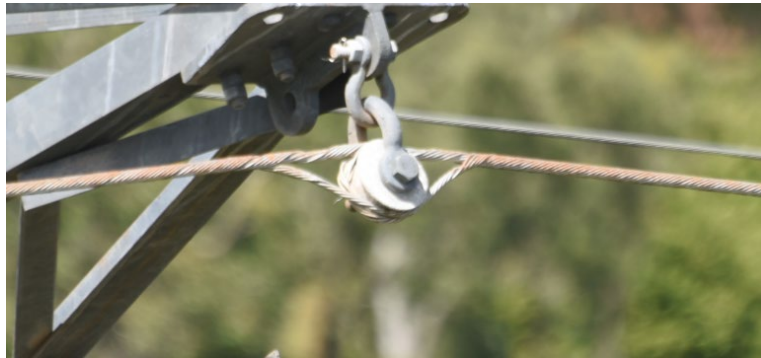
Figure 25: STR-0029 with corroded OHEW hardware (2018)

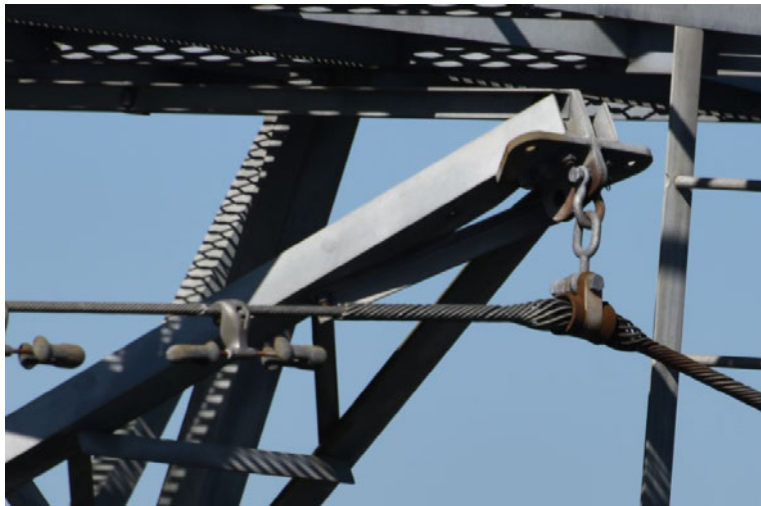
On some towers AGSU housing and/or shackles are deteriorated to the low G3 levels. Similar corrosion levels are observed on OPGW vibration damper messenger wires.

Figure 26: STR-0115 with corroded OPGW hardware and dampers (2018)

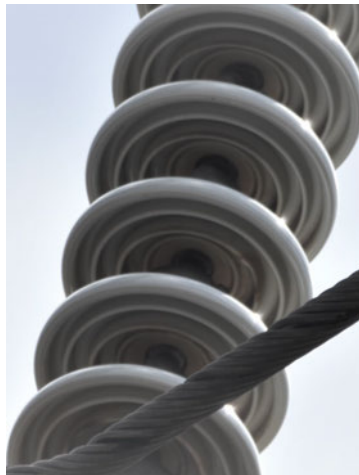
Figure 27: STR-0026 (2018)

Feeder 876 and 8902 had suspension insulators replaced in 2011 with 125kN NGK FOG discs (18 Discs per string) and are in very good condition.

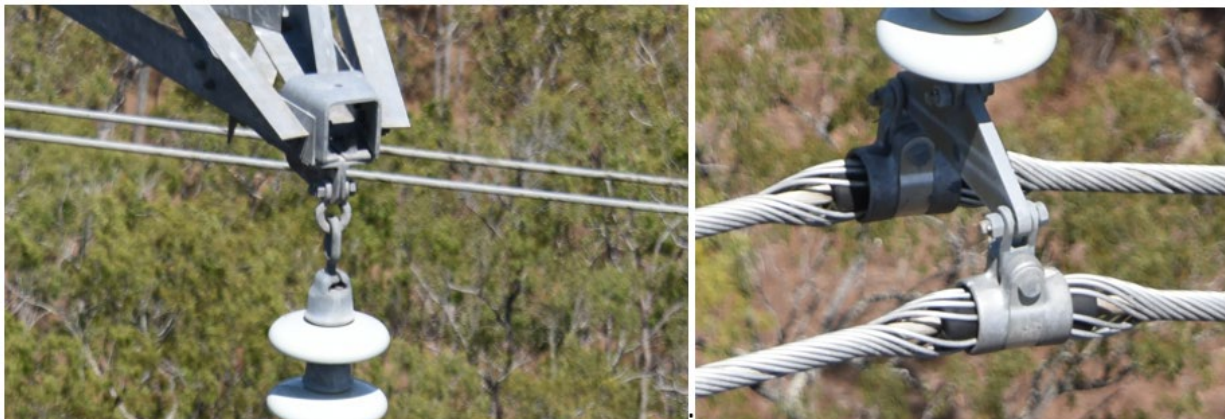
Hardware is displaying mostly G1 and G2L corrosion with rare instances of G2H.

Figure 28: STR-0080 – Hardware in good condition (2018)

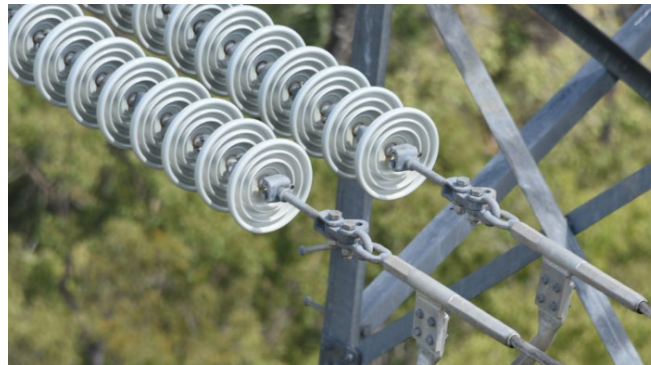
Figure 29: STR-0038 Tension Insulators (2018)

A review of the limited number of available photos did not show any pins with corrosion higher than grade G2L corrosion and mostly with G1.

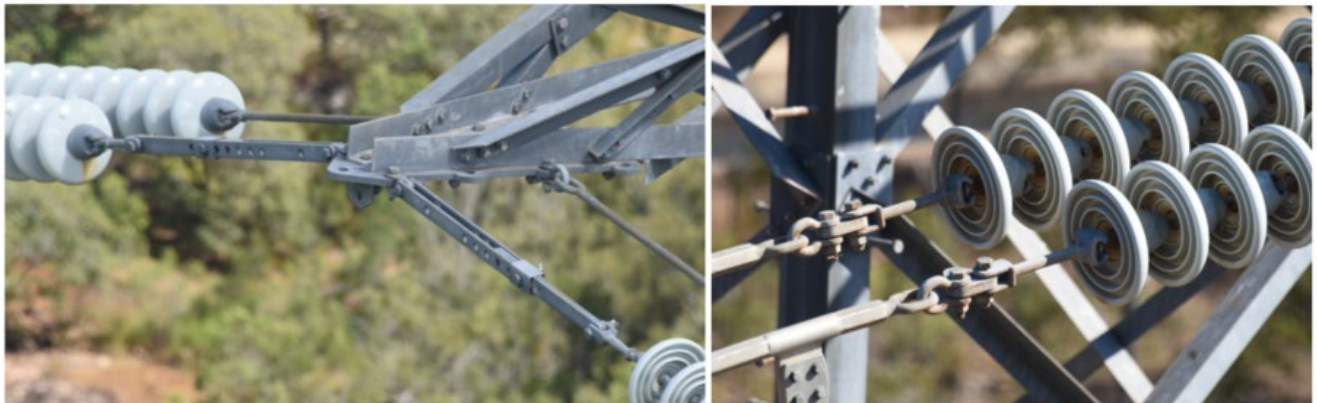
STR-0038

Hardware is in good condition with an occasional appearance of grade 2L or 2H corrosion on some towers.
