POWERLINK QUEENSLAND REVENUE PROPOSAL

CP.02778

**Calliope River to Wurdong Tee 275kV
Transmission Line Rebuild**

Transmission Line Condition Assessment – Report
Built Sections 1122 – Calliope River to Gin Gin 275kV

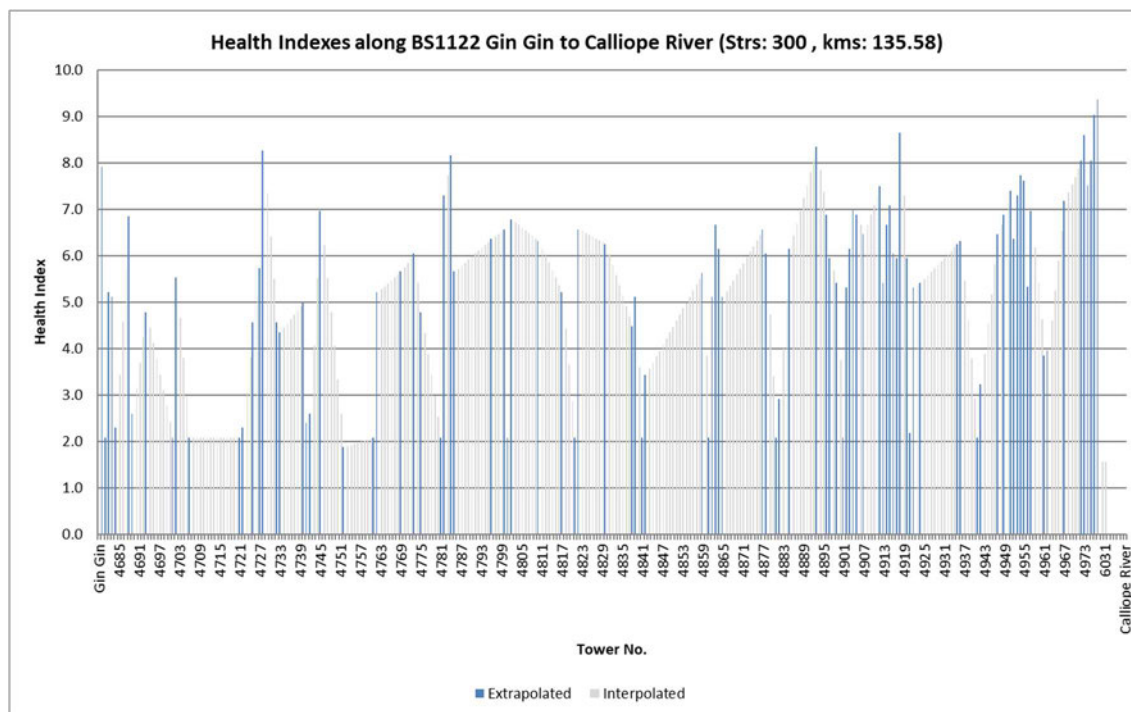
Below are health indices of structures along the built section. Extrapolated values represent measured health indices (adjusted for inspection date) and interpolated values are estimated based on the extrapolated values. These values are calculated based on visual inspection of structures between 2017 and 2019 using visual grading guides. The health indices along the line shows the northern area (right of graph) to be in the worst condition.

It is necessary to consider when and how to maintain these structures in order to avoid reaching the point where extensive replacement of steelwork is necessary. If left untreated the maintenance costs would drive replacement of structures.

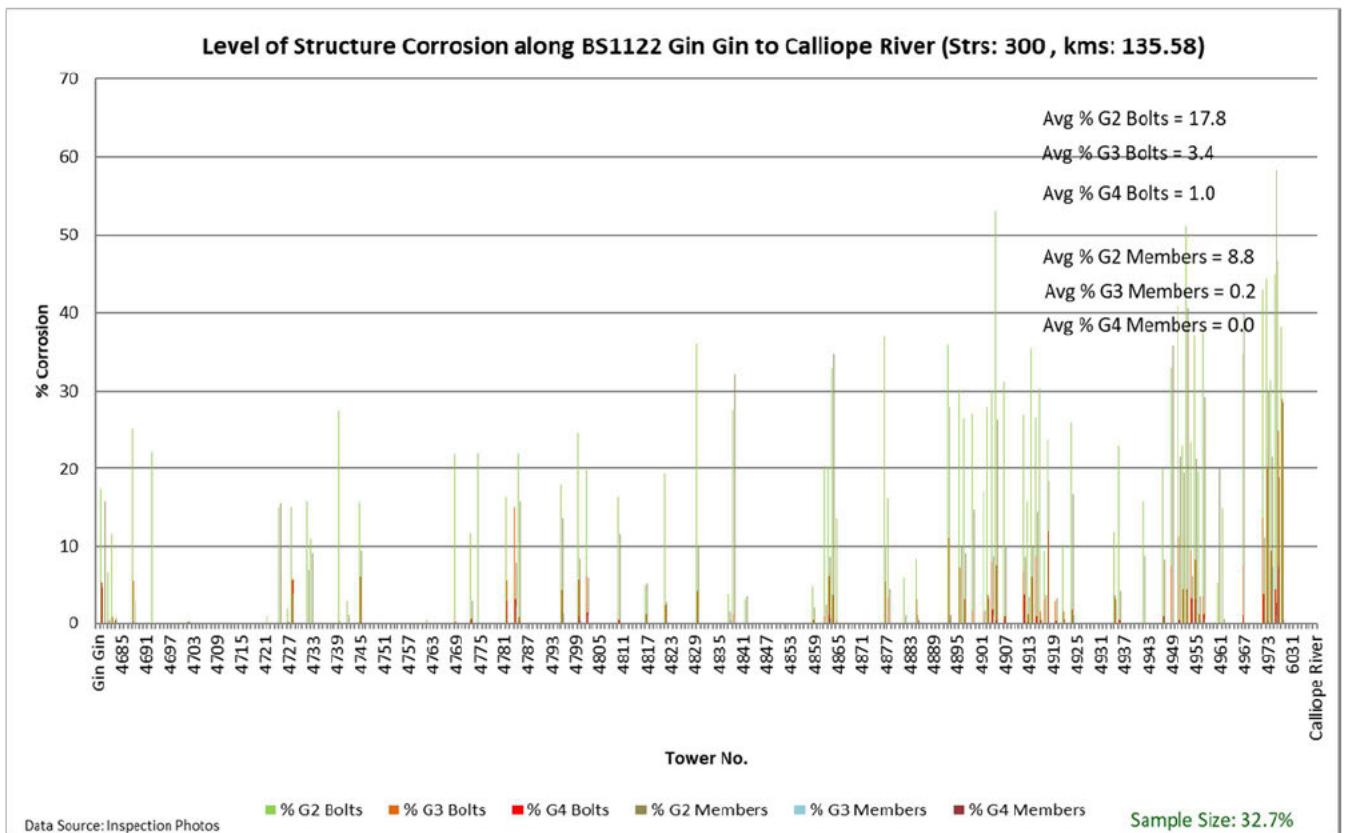
Below is the percentage corrosion of structures along the built section based on visual estimates on a sample of photos of the towers. The high spikes are the levels of grade 2 corrosion on both the fasteners and members.

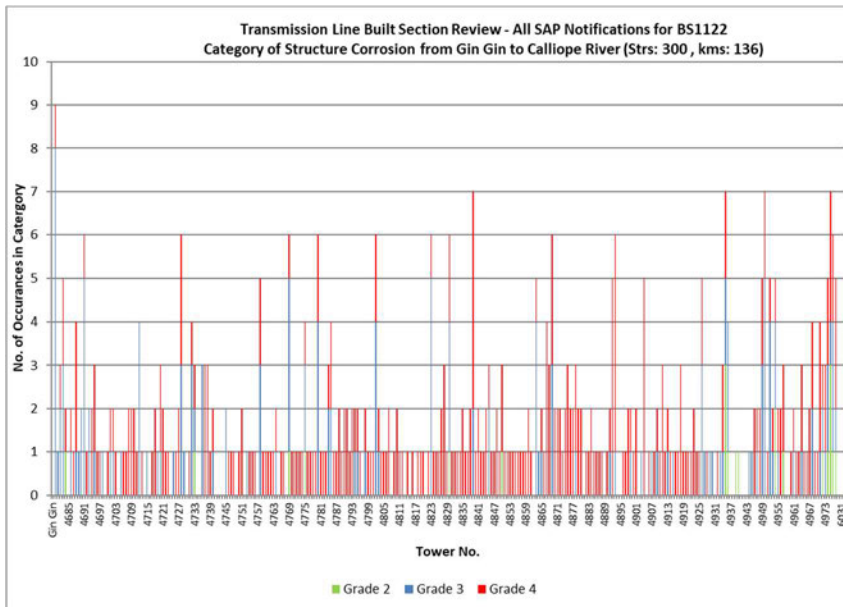
Figure 4: Graph of SAP all Notifications for Corrosion on Structures

Appendix 7 has two graphs of the number of notifications relating to corrosion. The notification graphs show reasonable correlation with the health indices and the percentages of corrosion which show the northern end as the most corroded section of line. The majority of the grade 4 corrosion relates to the bolts in the earthwire peak, conductor attachment plates, and superstructure which should be rectified during two OR projects currently underway.
