**Calvale Selective Primary Plant
Replacement**

CP.0XXXX – Calvale Selective Primary Plant Replacement

SITE CONDITION ASSESSMENT REPORT

H024 CALVALE

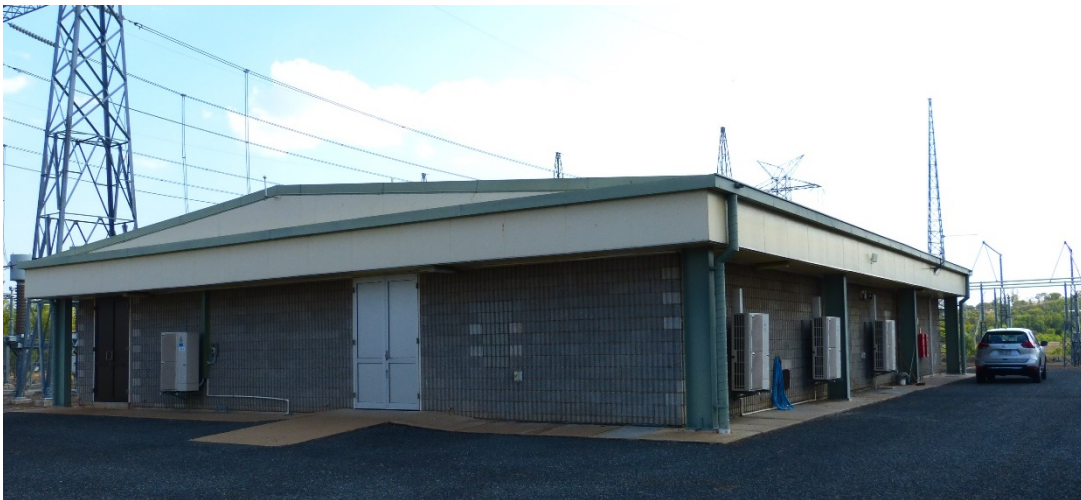
Figure 5: Control Room Building

There is one control building and a shed on this site. The original control building is brick construction with a steel metal roof and was commissioned in 1987. This building houses Powerlink 275/132kV control panels, the 125V and 50V DC supply systems and telecommunication equipment. It consists of a control/relay room, communications room, battery room, amenities room and toilet. The control, battery and comms rooms are all air conditioned. The majority of windows have bars installed. The building is reasonably well maintained and no significant issues were noticed. shown in Figure 5.

Recommendation: Based on the condition it is recommended that this brick building is fit for purpose for another 40 years with regular maintenance.

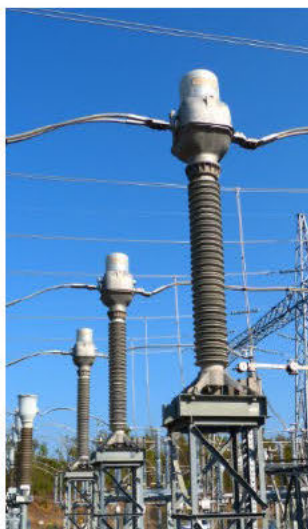
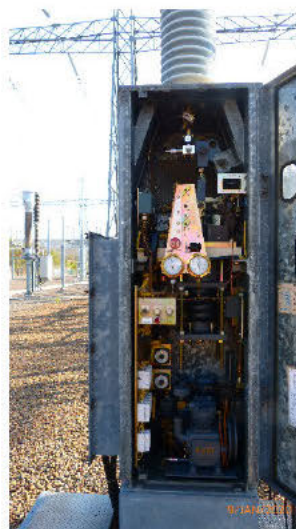
The circuit breaker in this bay is a Mitsubishi 250–SFM-340B manufactured in 1987 and installed in 1988. It has pneumatic operating mechanism with air and spring used for energy storage and SF6 gas for insulating medium. SFM type Mitsubishi CBs of this vintage have asbestos impregnated washers of friable nature associated with the heater inside the mechanism box. Mitsubishi does not produce this type of circuit breaker anymore and sourcing of spare parts has become a major issue. Wiring inside the mechanism box is cracked due to UV penetrating through viewing window.

The Haefely oil filled current transformers are in satisfactory condition considering they have been in service for 33 years, and the DGA/moisture in oil analysis is satisfactory. There are no identified issues with oil seal integrity. Current transformers with paper and oil insulation within a porcelain housing have been found to have an increased probability of explosive failure after 36 years in service, with potentially catastrophic safety consequences. Considering their age and construction, it is recommended to replace these in 5 years.

Recommendation: Based on the above observations, it is recommended that CB and CT incl. structures and foundations are replaced within the next 5 years preferably using dead tank CB. The rest of the HV plant is in good condition and no replacements are required in the next 10 year outlook.

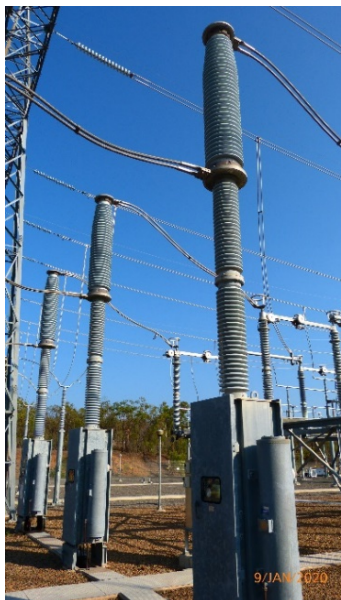
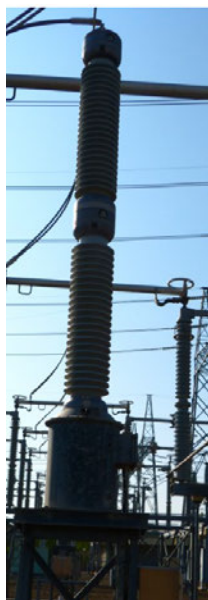
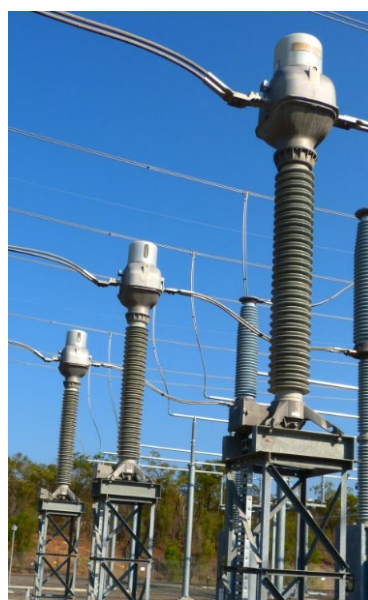
the heater inside the mechanism box. Mitsubishi does not produce this type of circuit breaker anymore and sourcing of spare parts has become a major issue. Wiring inside the mechanism box is cracked due to UV penetrating through viewing window.

Maintenance records show minor issues with wiring inside the mechanism box is cracked due to UV penetrating through viewing window and shielding installed on the cables to prevent UV damage. This CB has been in service for 33 years and it is estimated that it has a remaining service life of 5 years.

The A phase CT was replaced in 1997 and appears to be in an acceptable condition. The remaining oil filled instrument transformers are in reasonable condition considering they have been in service for 33 years, and the DGA/moisture in oil analysis is satisfactory. There are no identified issues with oil seal integrity. However, considering their age and construction, it is recommended to replace all CTs and the CVT in 5 years to manage potential safety risks.

Recommendation: Based on the above observations, it is recommended that CB, CT and CVT including structures and foundations are replaced within the next 5 years, preferably using a dead tank CB. The rest of the HV plant is in good condition and no replacements are required in the next 10 year outlook.

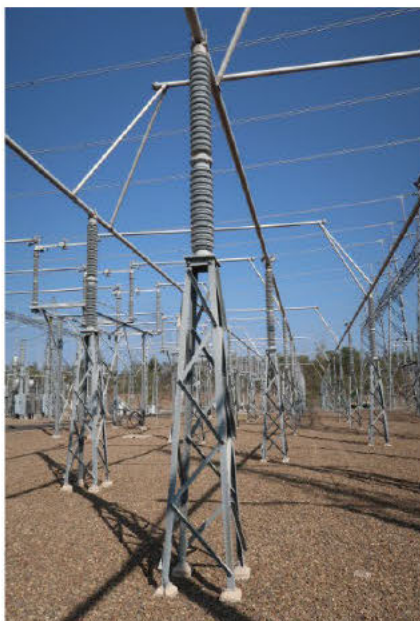
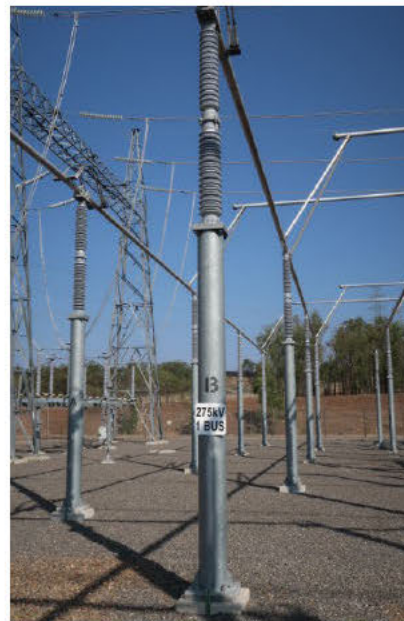
Lattice structures were used as bus supports in the initial construction while in the late 1990s and 2000s tubular structures were used. All structures are in good condition and no significant issues were found. Examples of the lattice and tubular structures are shown in Figures 15 and 16 respectively.

Recommendation: The corroded bolts on all structures are recommended to be replaced immediately. Apart from this, based on the above observations, the primary equipment in these bays is in good condition and no replacements are required in the next 10-15 year outlook.

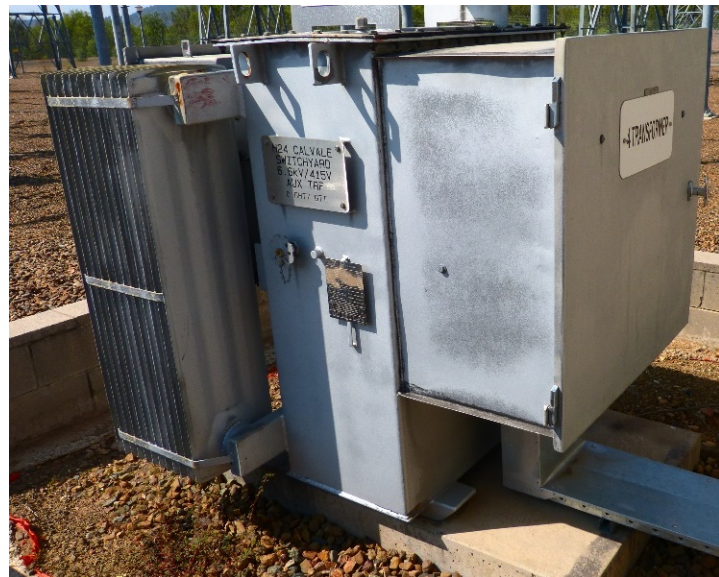
Figure 24: 4 Stn Transformer

These two station transformers are in good condition. However the 4 station transformer is 44 year old and is at the end of its technical service life where condition is expected to deteriorate rapidly.

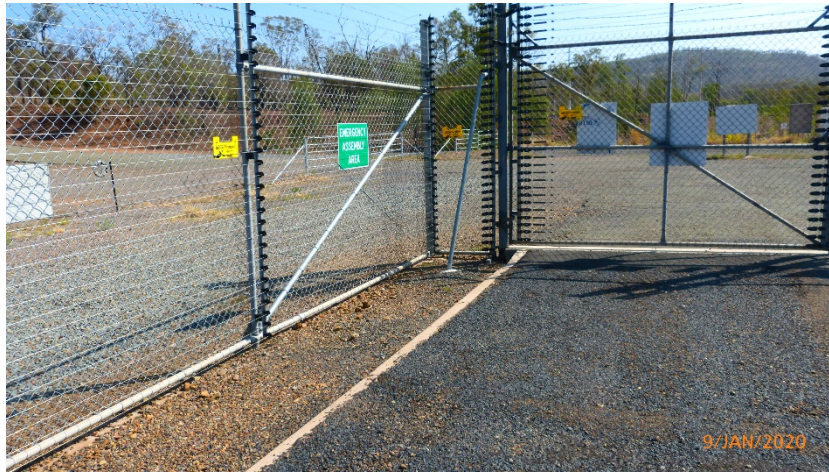
The substation internal roads are in a reasonable condition although broken in some areas. In particular the road surface is broken in the vicinity of the entry gate as shown in Figure 29.

Figure 29: Broken road surface

Recommendation: Based on the above observations and records, there is no action required in the next 10-15 year outlook, apart from normal maintenance.

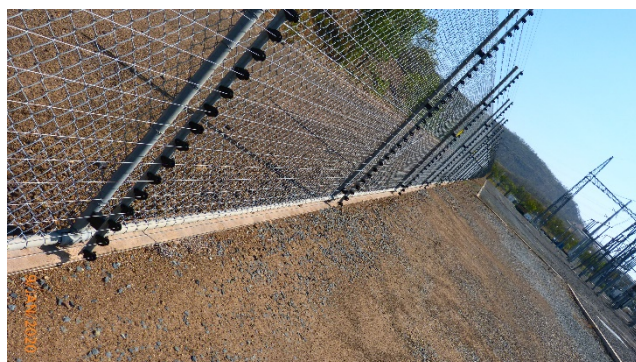
Figure 30: no tail to fence

The fence post should be connect to the main earth grid at the grid crossings, it was noticed on site that this was not the case.
