POWERLINK QUEENSLAND
REVENUE PROPOSAL

Project Pack – PUBLIC

Woree to Kamerunga 132kV Transmission
Line Rebuild

**Transmission Line Condition Assessment – Report**
BS1252 – Kamerunga to Woree**Transmission Line Condition Assessment – Report****BS1252****Kamerunga to Woree**

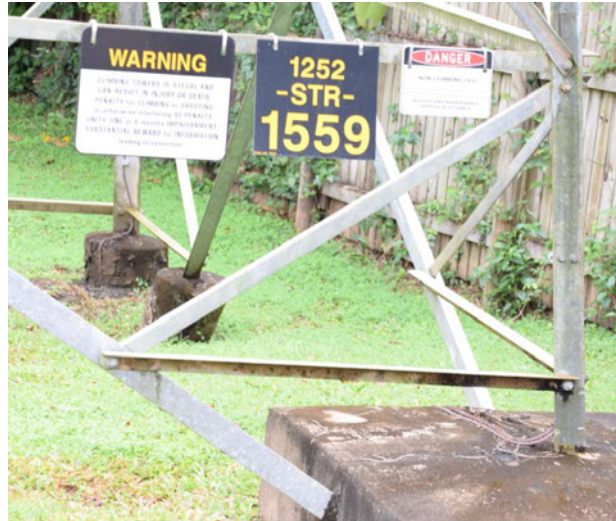
Figure 3: 1252-STR-1559 TOWER LEGS (2019)

Originally installed grillage foundations were reinforced in 2012 by installing micropiles and connecting pile caps. The design brief was to achieve a life extension of 15 years. Foundations and concrete interfaces generally appear to be in good condition (Figure 3).

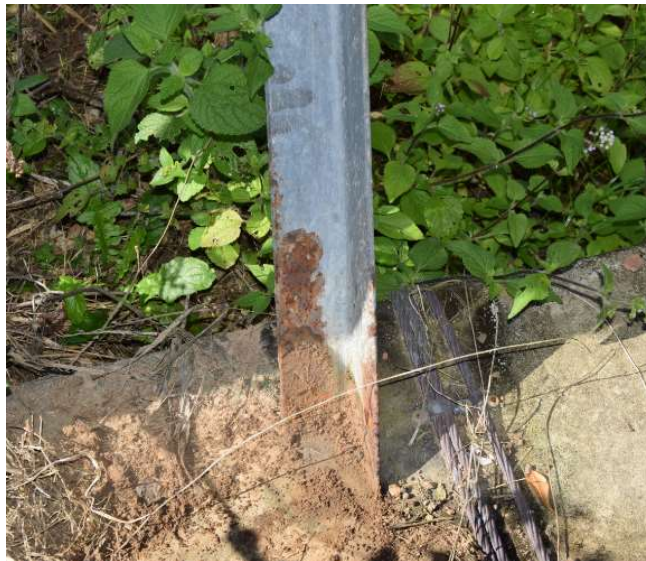
Figure 4: 1252-STR-1557 TOWER LEG (2019)

A small number of cases of G3 corrosion are noted in the interface area (Figure 4).

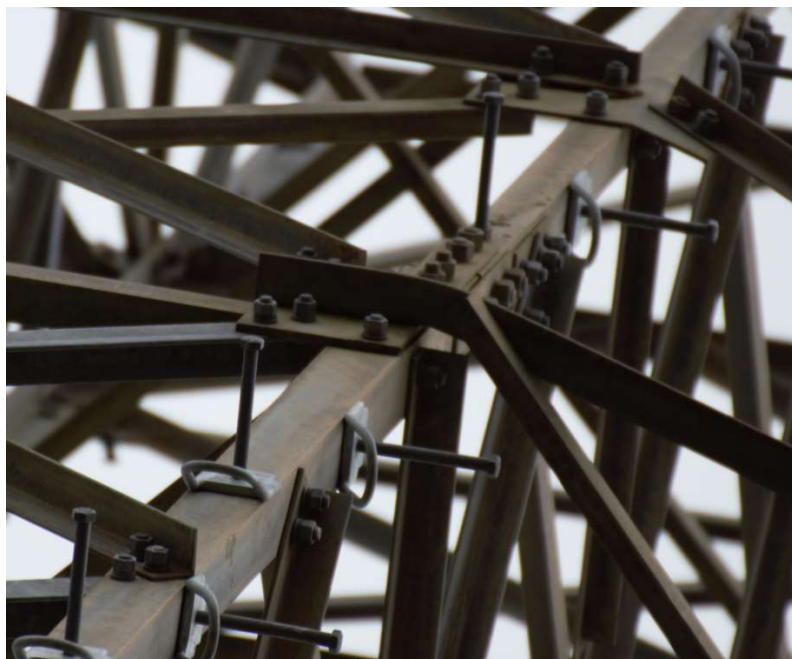
Corrosion of climbing aids was not observed on any of the sampled towers (seen in Figure 5)

Figure 5: Typical corrosion free climbing aids - example STR - 1528 (2019)

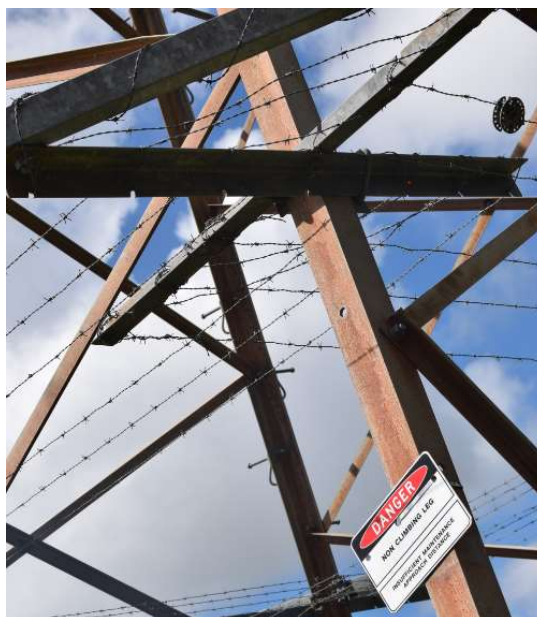
No corrosion or damage was noted on supporting steel members nor barbed wires.

Figure 6 Typical corrosion free anti-climbing device supports - example STR - 1546 (2019)

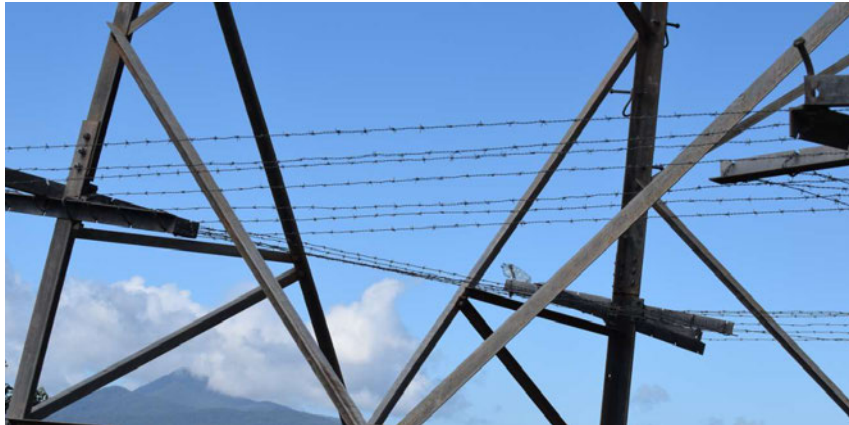
Figure 7: Climbing devices replaced - example STR - 1549 (2019)

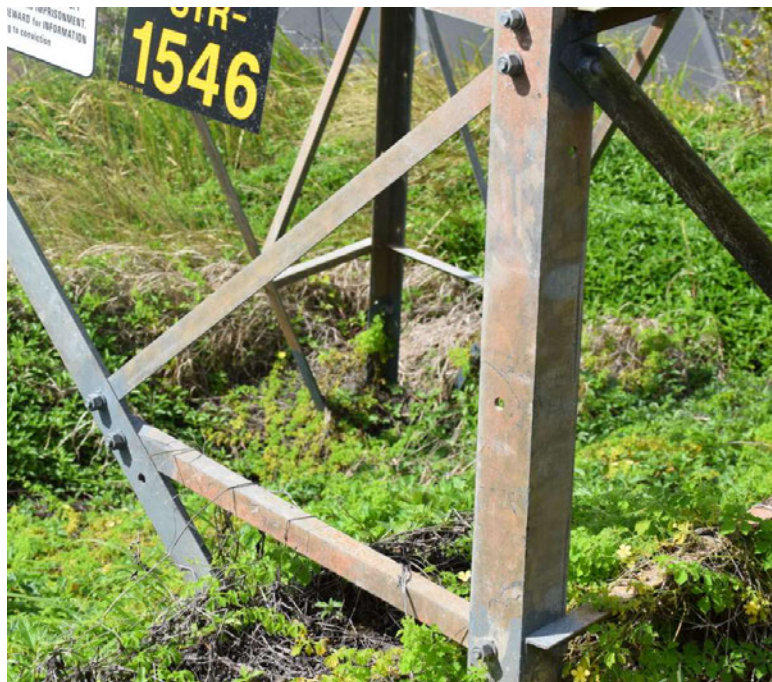
Surface rust has been observed on approximately 20% of members, while, as a result of extensive bolt replacements during the project in 2015, bolts are in good condition.

Figure 8: Typical example of corrosion with bolts in better condition than members- example STR - 1546 (2019)

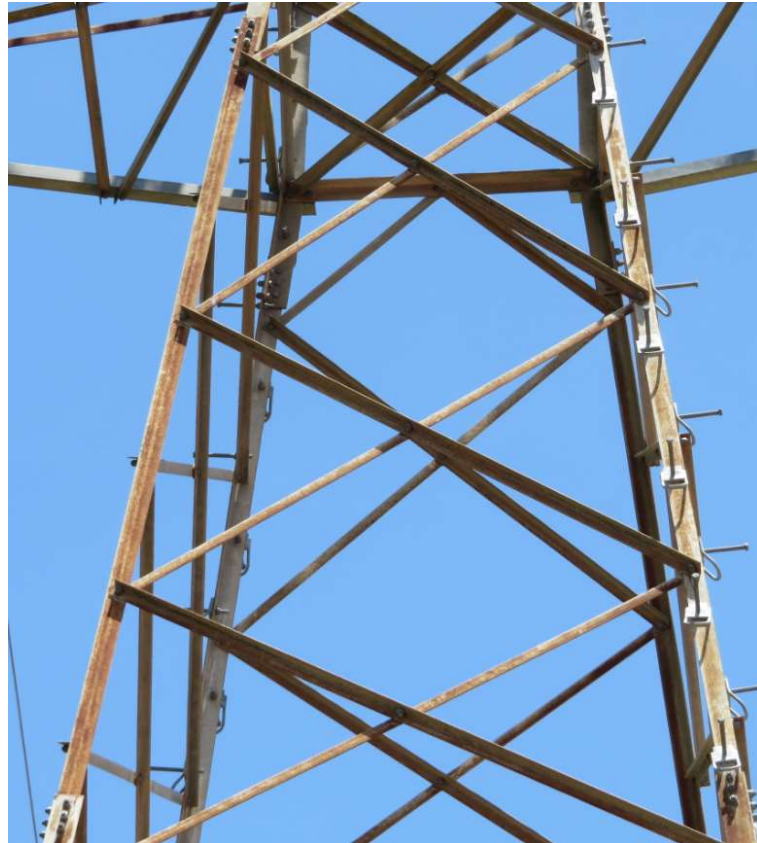
Surface rust has been observed on approximately 35% of members, while, as a result of extensive bolt replacements during the project in 2015, bolts are in good condition with only one tower (STR - 1565) exhibiting a high percentage of the G3 bolts in the body area.

Figure 9: Instances of G3 corrosion on the body members - example STR - 1547 (2018)

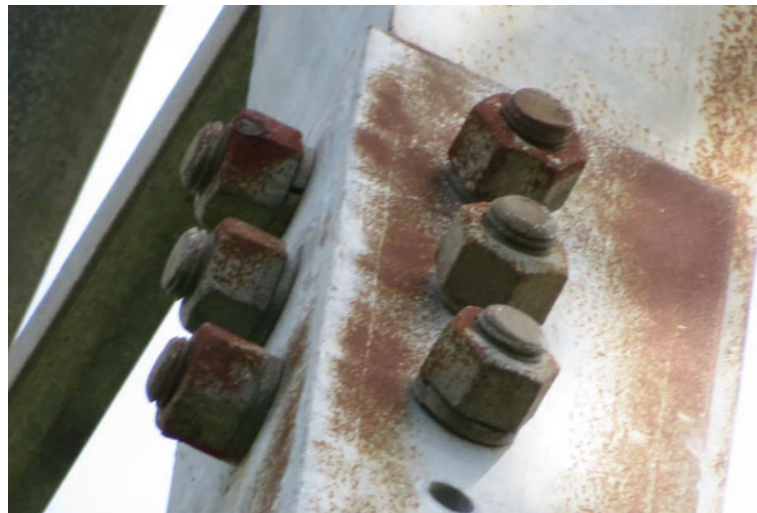
Figure 10: Rare instances of G3 bolt corrosion are more pronounced on tower STR - 1565 (2019)

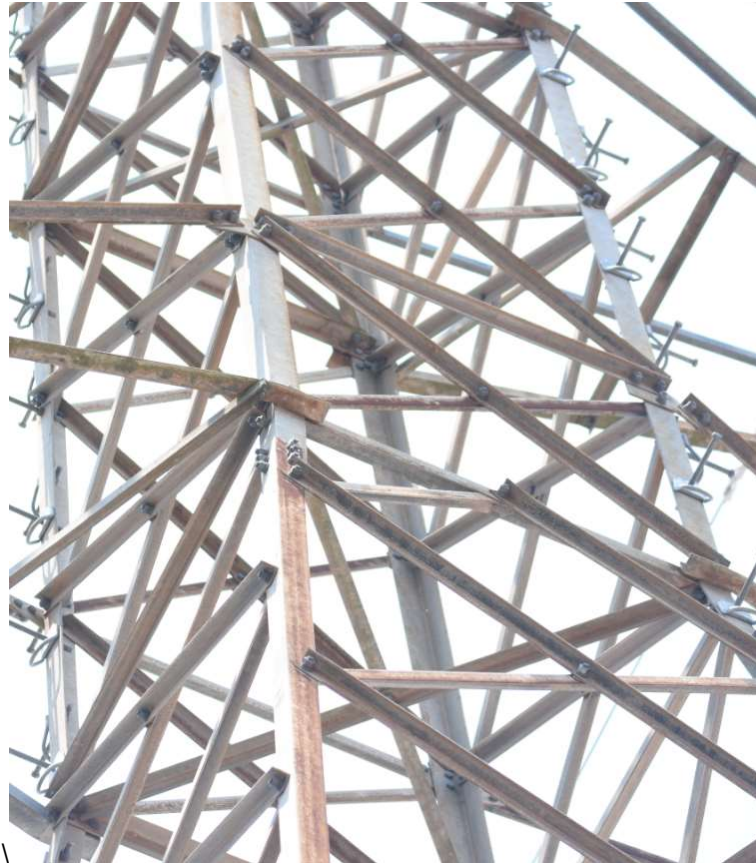
Surface rust has been observed on approximately 30% of members, while, as a result of extensive bolt replacements during the project in 2015, bolts are in generally good condition with only a small number of G3 bolts observed in the superstructures.

Figure 11: Typical example of corrosion with bolts in better condition than members STR - 1547 (2018)

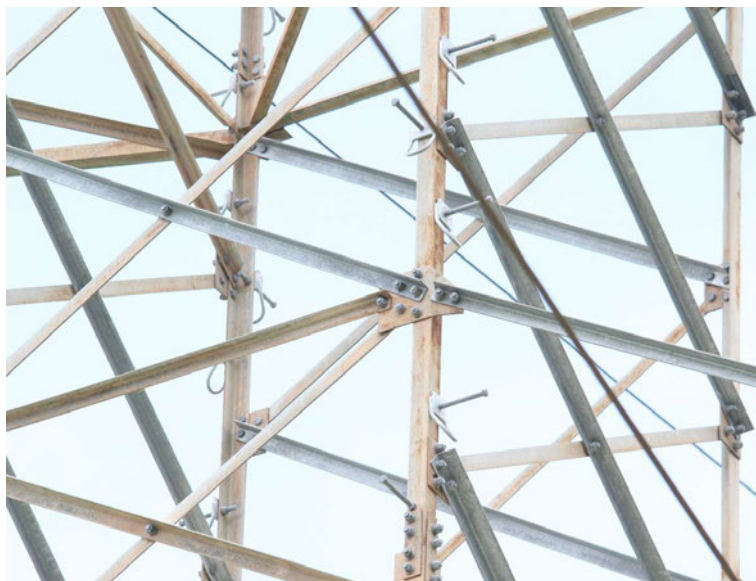
Figure 12: Replaced bolts and members in superstructure of tower STR - 1544 (2019)

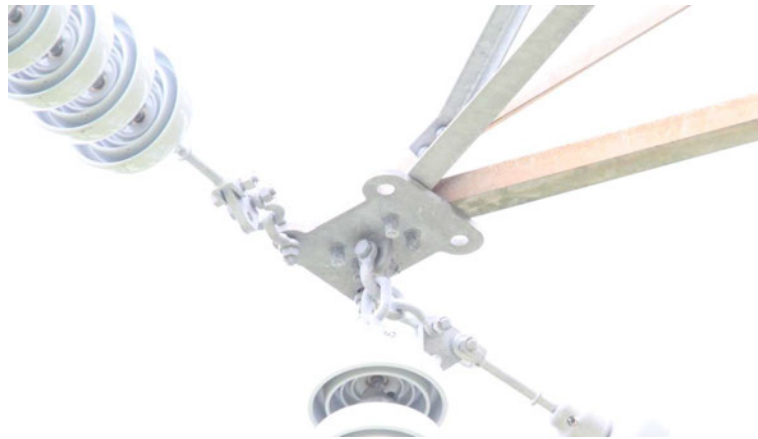
Most of bolts in the attachment area have been replaced, sometimes complete with attachment plates.

Figure 13: Replaced components in the conductor attachment area of tension tower STR - 1544 (2019)

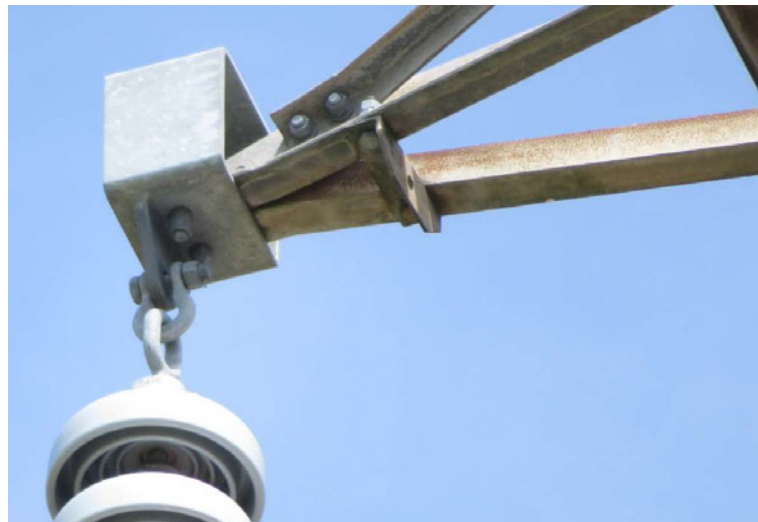
Figure 14: Replaced components in the conductor attachment area of suspension tower STR - 1544 (2019)

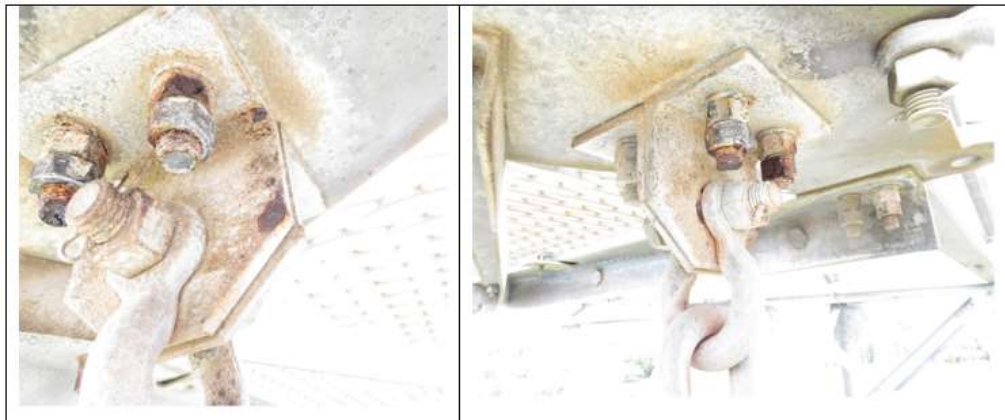
Figure 15: A small number of towers will need maintenance as in example of tower STR - 0163 (2019)

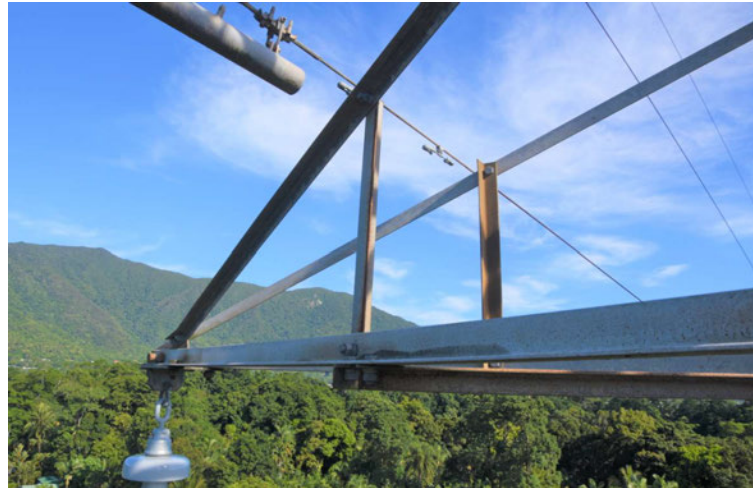
Grade 3 rust is observed on about 4% of the original (not replaced) members. Corrosion modelling indicates that the remaining original members will begin to reach corrosion grade 4, and will begin to compromise structural integrity and asset reliability in less than seven years.

Figure 16: Replaced and original components in the crossarm of suspension tower STR - 1540 (2017)

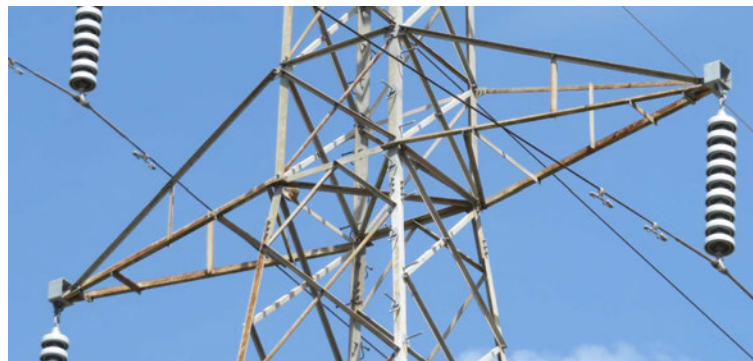
Figure 17: Typical appearance of crossarm of suspension tower STR - 1536 (2018)

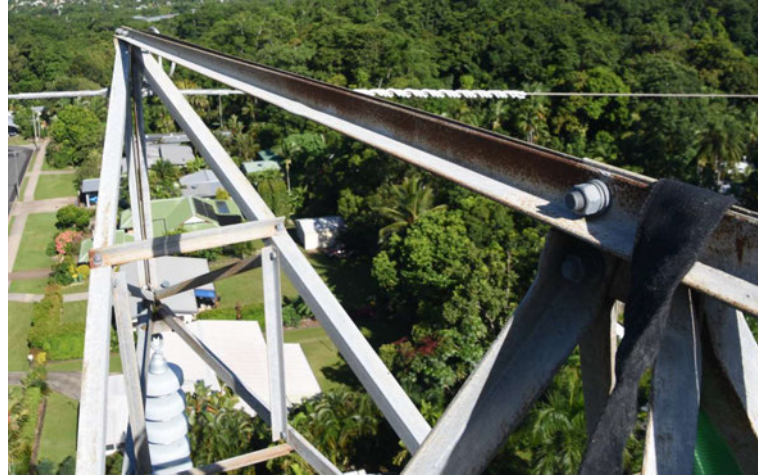
On some towers, Grade 3 corrosion is observed on 10 to 20% of the original (not replaced) earth wire peak members. Corrosion modelling indicates that grade 4 corroded members will start compromising structural integrity and adversely affect asset reliability in less than seven years. The replacement of the earthwire peak members will be extremely difficult due to the design that inter connects top crossarms and earthwire peak, particularly as access tracks are not suitable for deployment of the heavy cranes required for the member replacement.

Figure 18: Typical example of corrosion on earthwire peak; STR - 1540 (2017)

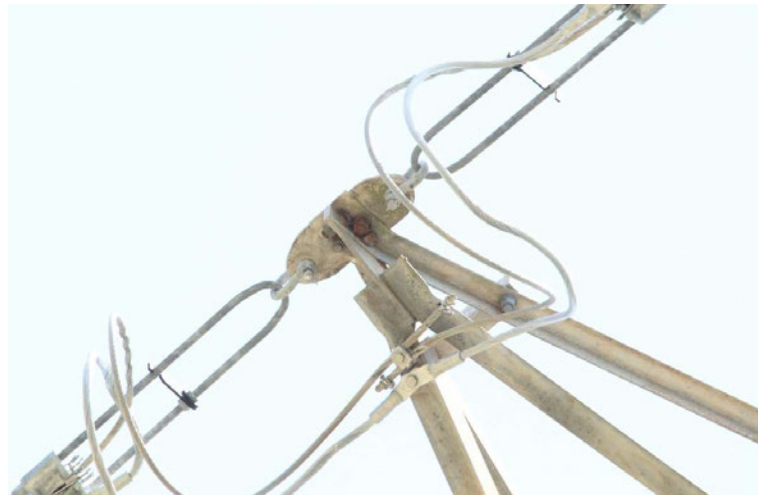
Figure 19: Small number of bolts recorded with G3/4 corrosion in earthwire peaks; example - STR - 1538 (2018)

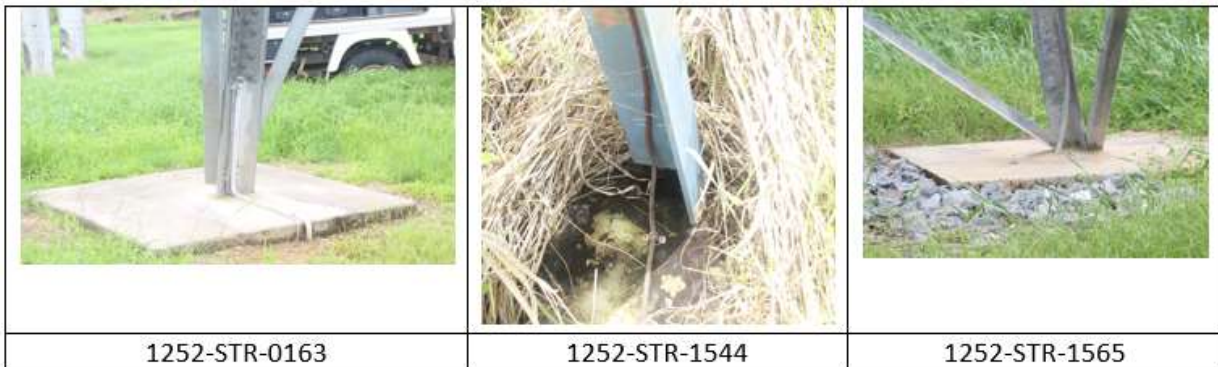
Earth straps appear to be in the good condition and it is likely they were all replaced during the foundation upgrade project in 2012.

Figure 20: Examples of earth straps in good condition (2019)

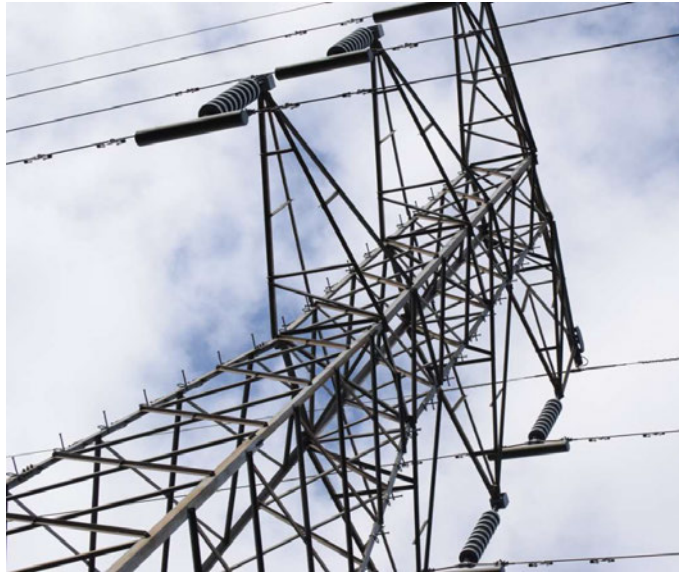
Dampers were replaced in 2016 under project OR.01730 together with insulators and insulator hardware.

Figure 21: STR-1553 Example of dampers in good condition shown (2019)

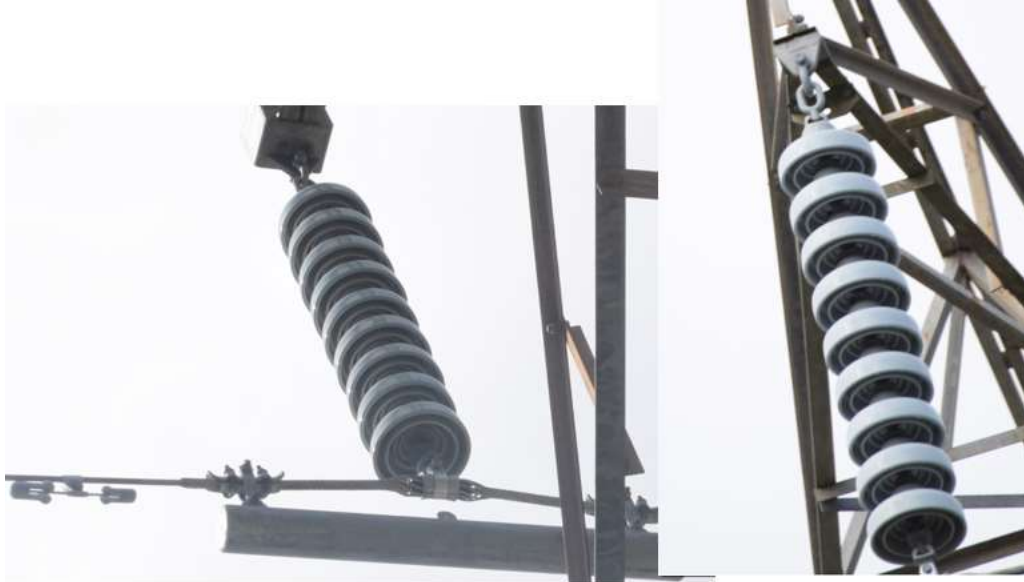
Figure 22: Suspension Insulators in good condition - examples (2019)

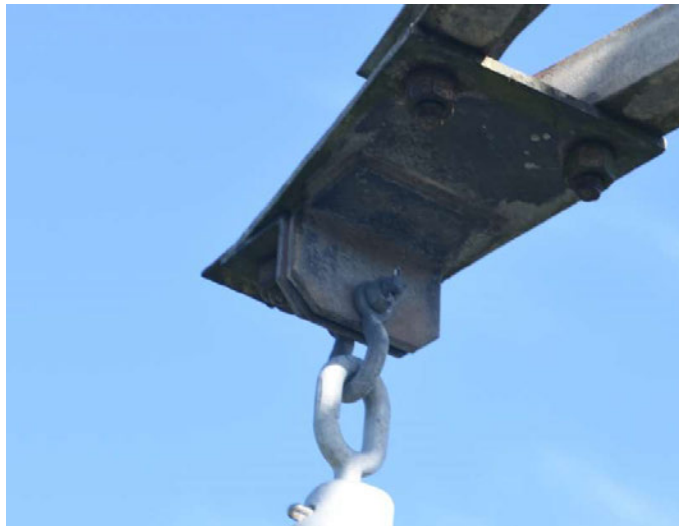
Figure 23: STR-1540 – Cold end hardware in good corrosion (2018)

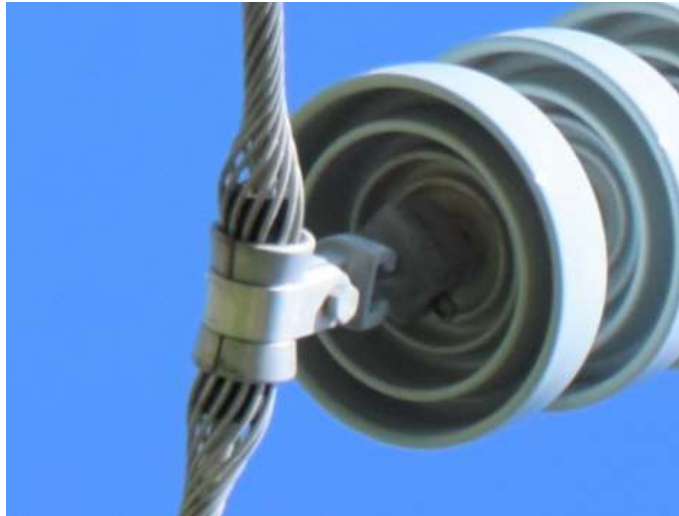
Figure 24: STR-1551 – Cold end hardware in good corrosion (2019)
