NEED/OPPORTUNITY STATEMENT (NOS)

TL Silmalec Fitting Condition Phase 2

NOS- 000000001590 revision 2.0

Project reason: Capability - Asset Replacement for end of life condition

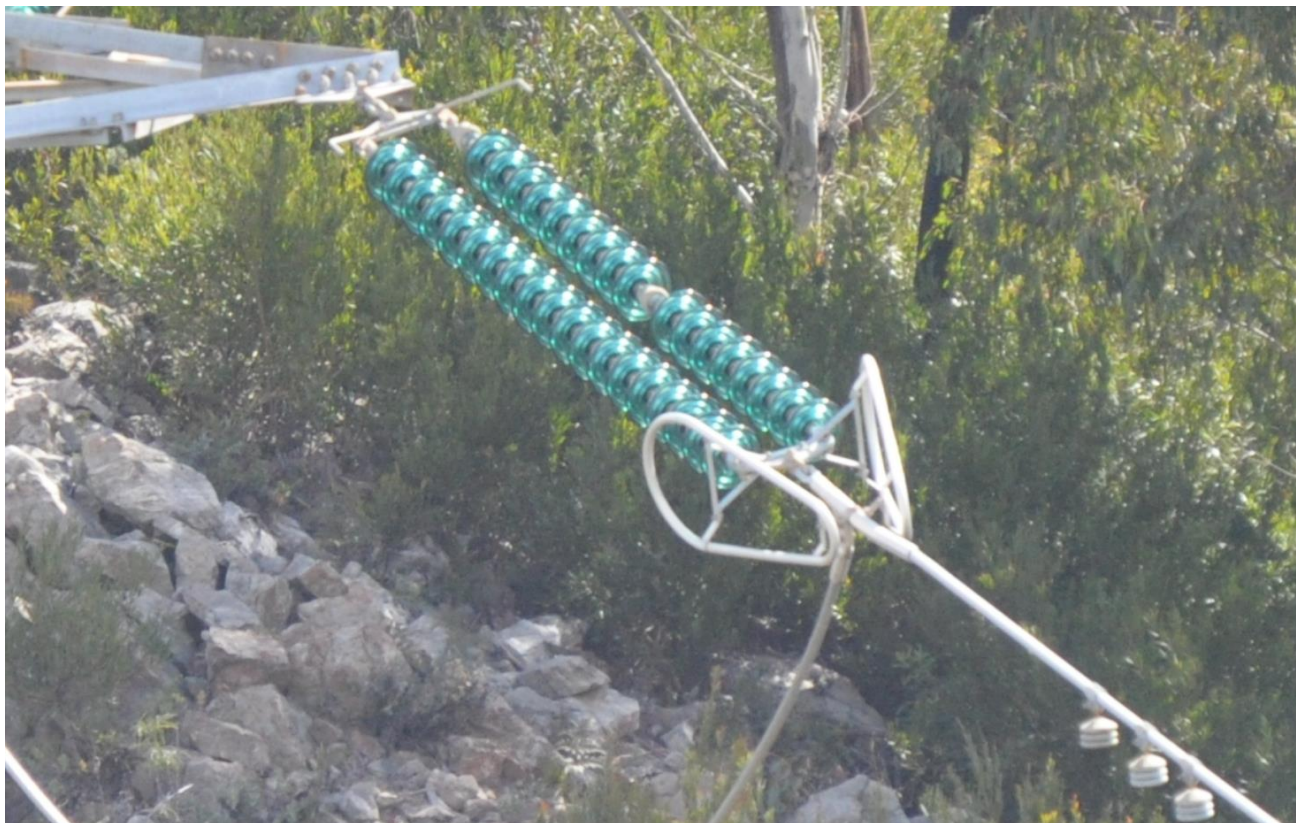
Attachment 1 Example of bowed deadend

In 2015, a deadend failed on U7 T/L on Structure 1 in span 1-2. Metallurgical examination of the failed fitting showed points of stress and cracking which grew until there was an eventual fatigue failure. A further metallurgical examination of five other deadends removed from U7 following site dye penetrant testing showed that cracking they exhibited was due to stress corrosion cracking. The indication from these failures in this manner and the identification of some level of cracking on other deadends through dye penetrant is that these fittings may be reaching end of life. It is probable that bowing of the deadends (refer Attachment 1) during installation (due to difficulties associated with handling and terminating conductor of this larger size) has exacerbated the formation of cracks.

The remaining deadends and midspan joints for lines generally strung at lower tensions ($< 48\text{kN}$) still require remediation. A summary of these transmission lines along with their respective number of deadend fittings and midspan joints is listed in Table 1. In addition, all “Elgra” vibration dampers on these spans are to be replaced in conjunction with the conductor deadends and midspan joints.
