Options Evaluation Report (OER)

Line 11- Sydney South – Dapto – Tower Replacement
OER- 000000001600 revision 4.0

Project reason: Capability - Asset Replacement for end of life condition

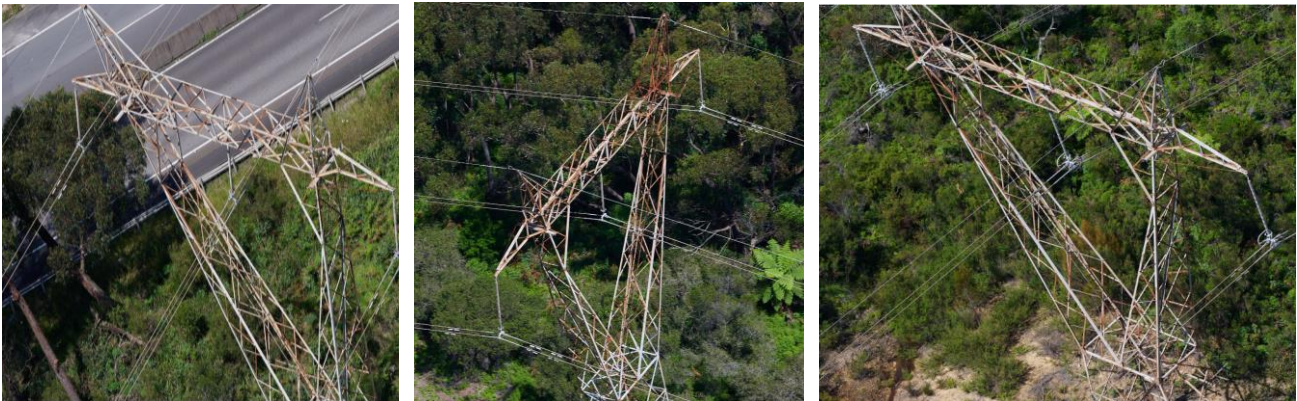
Figure 2 – Photos of Deterioration of structures

All 127 suspension towers on Line 11 have been identified as having condition issues with the structure and/or other components. Of these, 55 towers have been identified as having priority condition issues, that is, the tower has one or more members that have been identified as having a condition issue with the worst possible ratings.

The most significant element of concern is the condition of the conductor fittings, earthwire fittings and corona rings due to corrosion. These items generally had a significantly thinner layer of galvanising at the time of manufacturing compared with other steelwork on the tower. Fasteners also have no galvanising on the nut thread. Failure of these fitting attachments can result in fallen conductors.
