# OPTIONS EVALUATION REPORT (OER)

Line 963 - Refurb

OER- N2606 revision 1.0

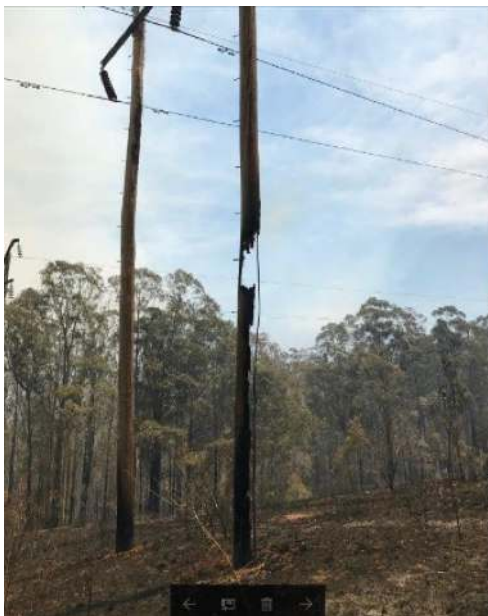
**Figure 1: Line 963 Structure 446 Fire Damage**

Line 963 was impacted by the Hillville Fire in November 2019. The fire impacted a total of 42 structures between Structures 435 and 475 (35 of them wood poles structures) over a route length of 13.7km. One pole (Structure 446) was significantly damaged by the fire, and had to be replaced at the time.

<sup>3</sup> It is noted that Structure 446 is again included, as the immediate repairs to restore the line into service only addressed the pole which suffered extensive damage. The other pole on the structure remains with the burnt condition issues.

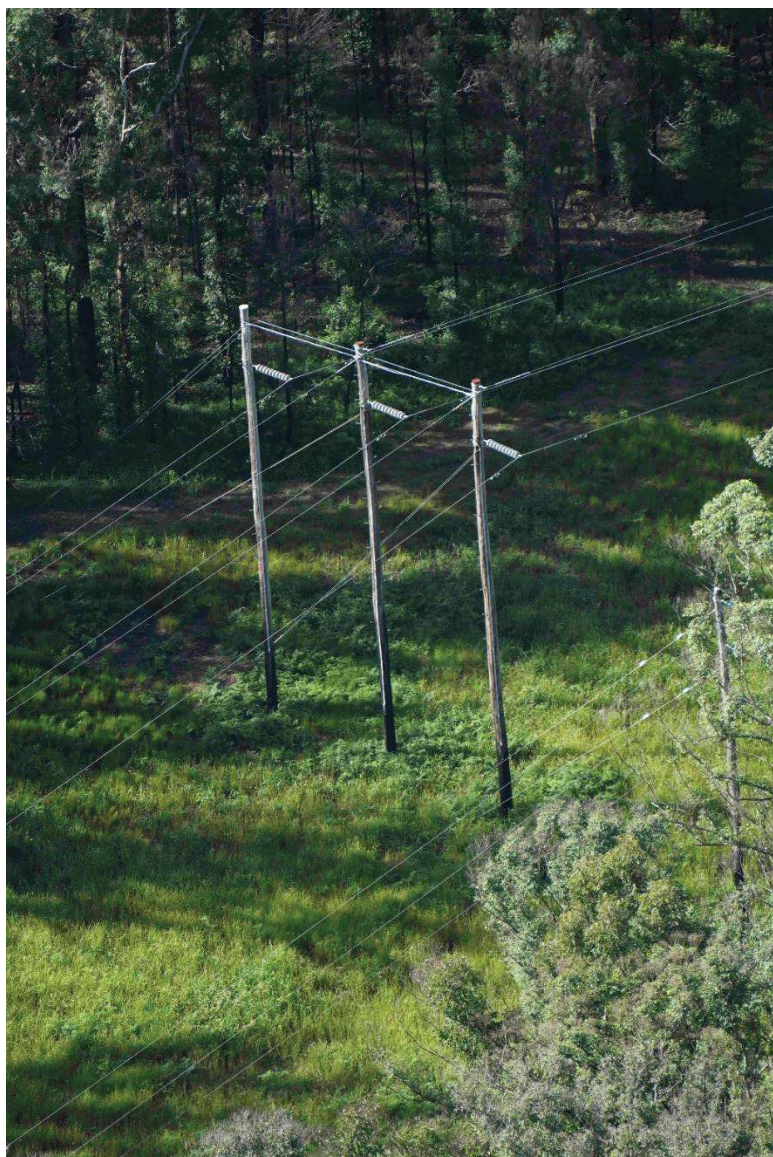
**Figure 2: Structure 451 with Fire Damage**

service at the time. Subsequent inspections of the sections impacted by the fire identified eight structures as burnt and charred (Structures 445, 446<sup>3</sup>, 449, 451, 452, 457, 460, 462). The fire damage affects the outer annulus of the pole at the region in the vicinity of the ground line and above. This is the main load bearing area of the structure, and damage to this section of the pole can impact its structural integrity. This may also provide a vector for advanced deterioration through termite and rot attack.

Total number of bushfire impacted structures to be replaced is 8.
