# AER Category Expenditure Justification – Zone Substation Other Buildings

## AER Category Expenditure Explanatory Statement

### ZONE SUBSTATION SV SPRINGVALE INSPECTION OF CONTROL BUILDING

### ZONE SUBSTATION DN DANDENONG INSPECTION OF CONTROL BUILDINGS

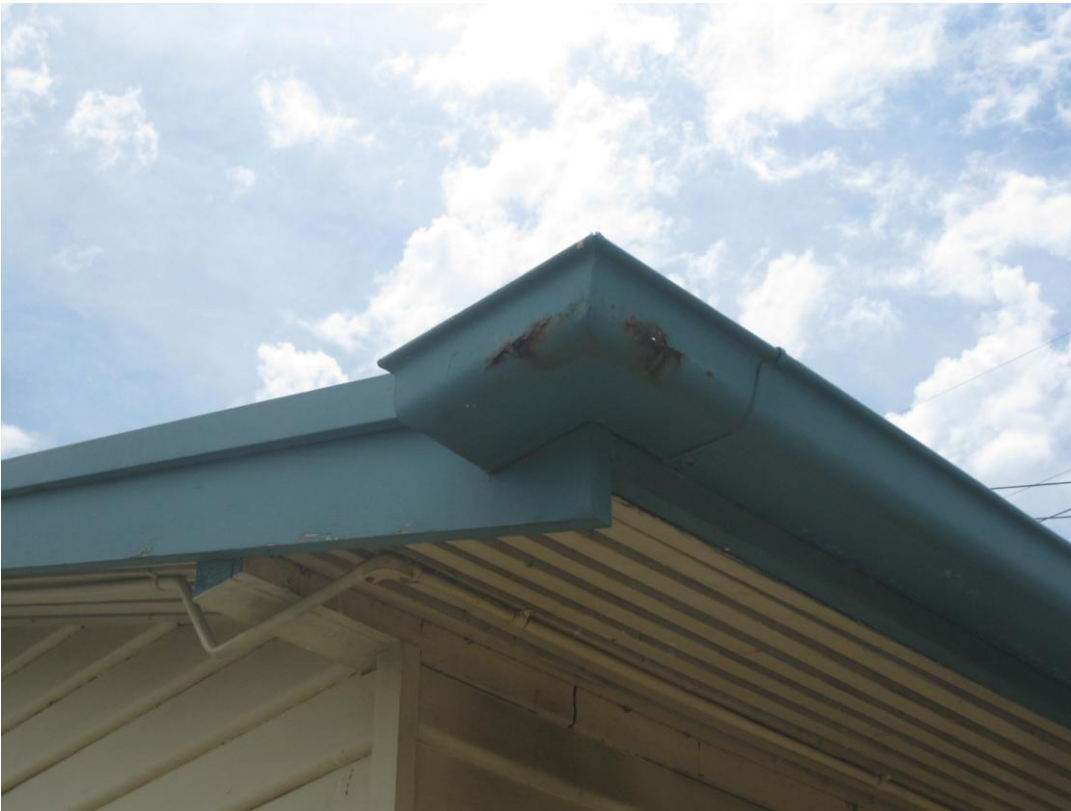
ITEM	DESCRIPTION	CONDITION	RECOMMENDATION
<u>Control Building</u> Roof –	<p>Galvanised corrugated sheet roof with centre ridge and roof sloped to longitudinal walls.</p> <p>Quad gutters and round Metal down pipes.</p> <p><u>Eaves</u> Lined with bird wire held in place with spaced timber battens nailed to the underside of roof joists. <b>Refer To Photo No.2</b></p> <p><u>Ceiling</u> 'Canite' sheeting.</p>	<p>Roof in satisfactory condition.</p> <p>At S-W corner roof gutter is corroded. <b>Refer To Photo No.1</b> Down pipes are corroded. Top Corrosion of DP – <b>Refer To Photo No.2</b> Base corrosion of DP's causing wash away of yard surface fines. <b>Refer to Photo Nos.7 &amp; 8</b></p> <p>There are holes and gaps in eaves mesh allowing or vermin to nest in roof cavity.</p> <p>'Canite' ceiling sheets have dropped and distorted. <b>Refer To Photo No.3</b></p> <p>Remainder if ceiling is in good condition.</p>	<p>Replace all corroded gutters and downpipes.</p> <p>Block all openings in eaves .</p> <p>Panels needs to be replaced with plaster or cement sheets.</p>

Photo No.1 - Control Room - Corrosion of roof gutter.

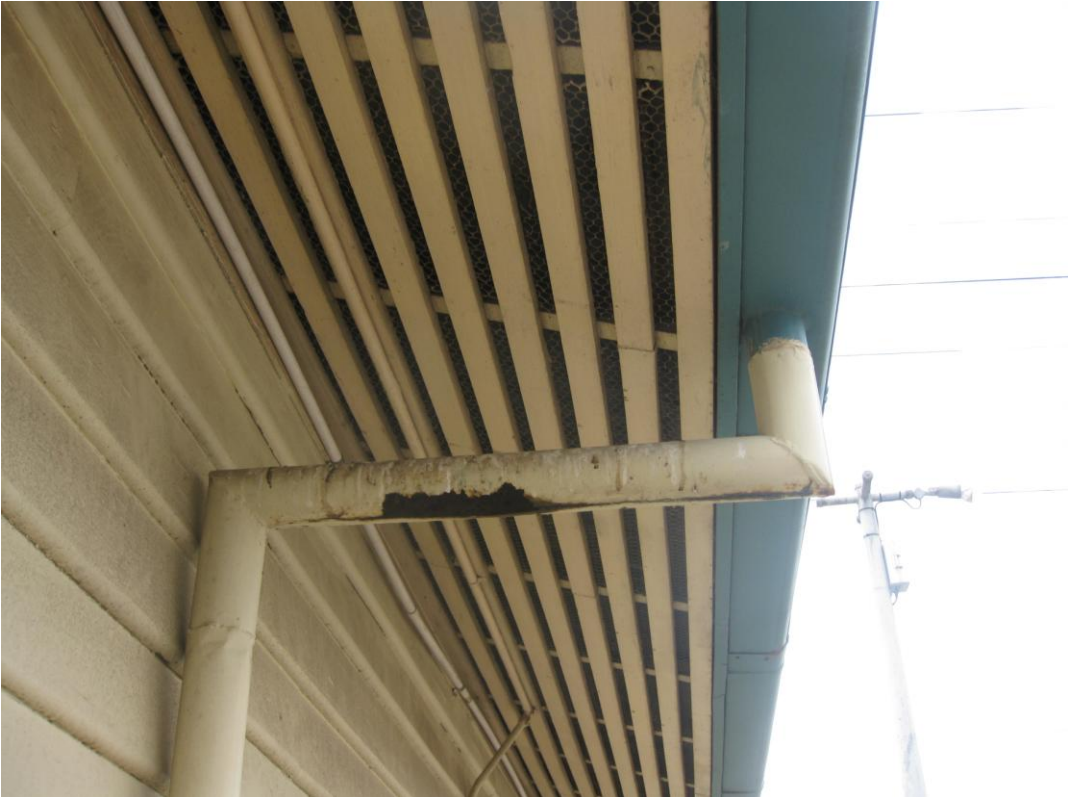
Photo No.2 – Control Room – Corroded downpipe.

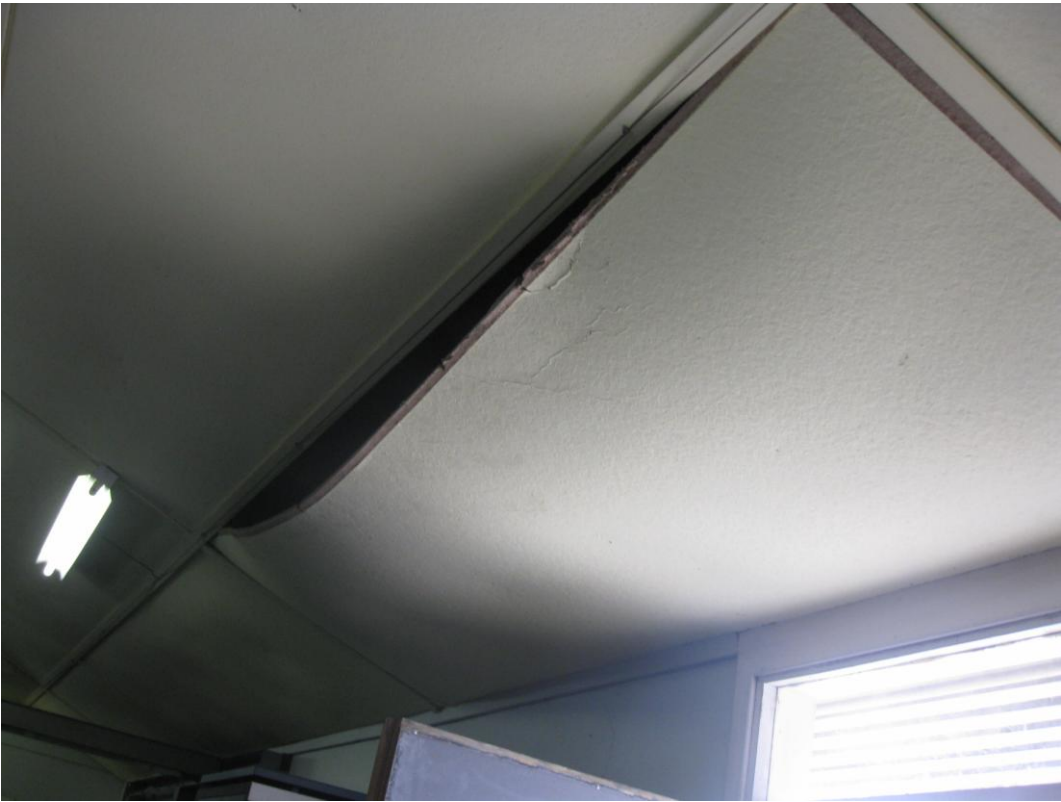
Photo No.3 – Control Room - ‘Canite’ ceiling panel sagged and distorted.

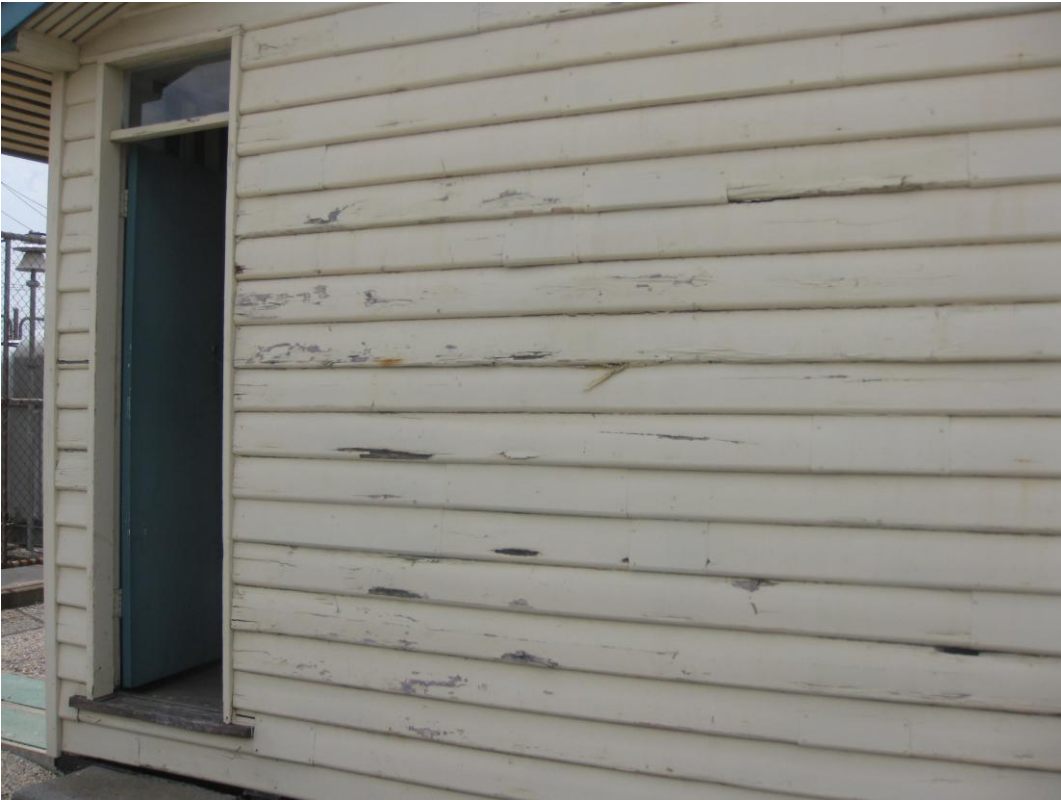
ITEM	DESCRIPTION	CONDITION	RECOMMENDATION
Walls –	Timber stud walls - <u>External Lining</u> – Timber weatherboards sheeting.	West wall has peeling paint and rotting weatherboards. <b>Refer to Photo No.4</b>	Weatherboards on this wall need replacing. Consideration to using an alternative colorbond profiled wall sheeting could be considered.
	<u>Internal Lining</u> – 'Masonite' and Cement Sheeting - may be 'Asbestos Cement " sheet.	Weatherboards at N-E corner are rotting. Metal sheet repair covers have previously been installed at corner but rot has extended past these repairs. <b>Refer to Photo No.5</b>	Further metal sheet repairs required or remove sections of damaged weatherboards back to sound timber and install new weatherboards.
Floor -	Timber floor structure – bearers and joists supported on stumps. Flooring – T & G Timber floor.	Floor structure is considered sound. There is no movement and floor appears level. Floor boards are in good condition.

Photo No.4 - Control Room – West wall peeling paint and rot in weatherboards.

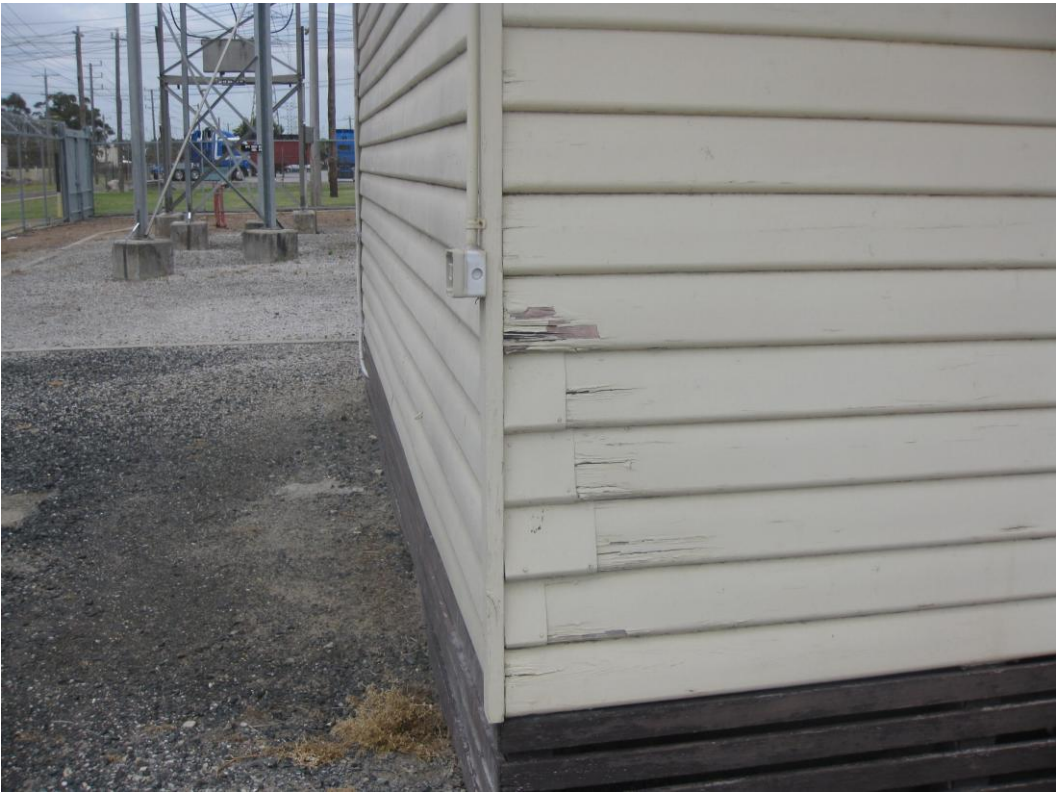
Photo No.5- Control Room – N-E corner weatherboards rotting.

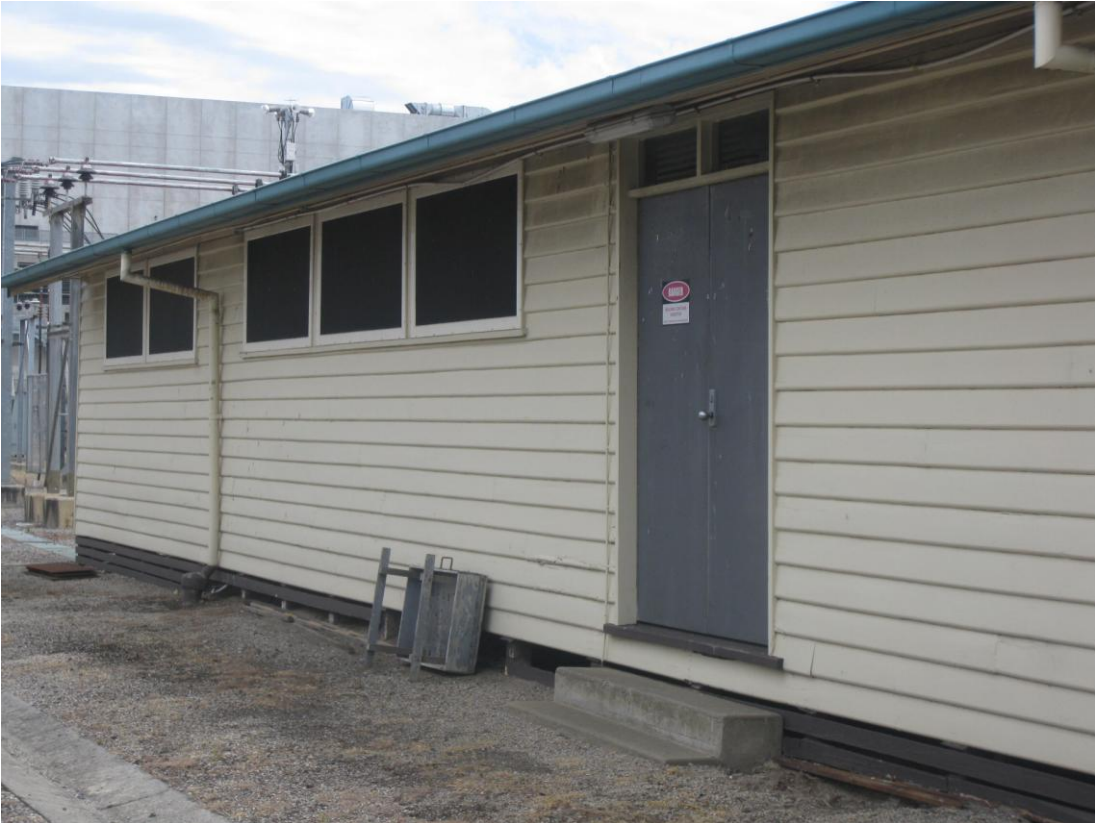
Doors –	Metal clad solid core doors with timber door frames..	Doors generally in good condition. The door on West wall – door and timber sill loose. This door is not considered secure.	The West wall door and sill requires maintenance to ensure they are firmly and securely fixed in place.
		Door frames are satisfactory.	
		Door hardware – standard dead locks (except WC) - satisfactory.	
Windows –	Timber framed windows External fly wires attached.	Window and frames are considered to be in good condition.	
Base Boards to sub-floor area -	Spaced Timber boards spanning between and fixed to exterior stumps.	Some base boards are missing . <b>Refer to Photo No.6</b>	The base boards are more for aesthetics and restrict access to exposed cables under the floor. Missing boards can be replaced if considered necessary.

Photo No.6 – Missing base boards.

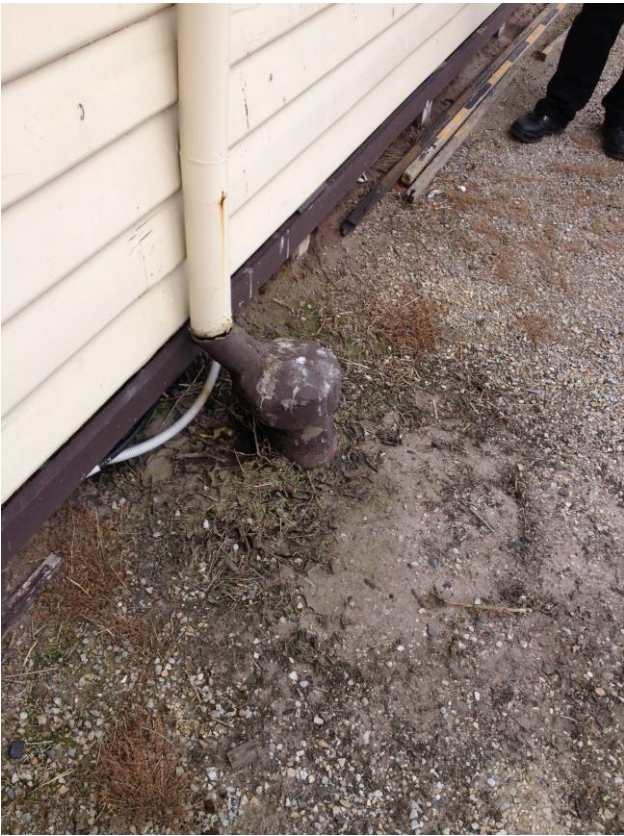
Photo No.7 – Control Room – Leaking Down Pipe causing yard surface wash away.

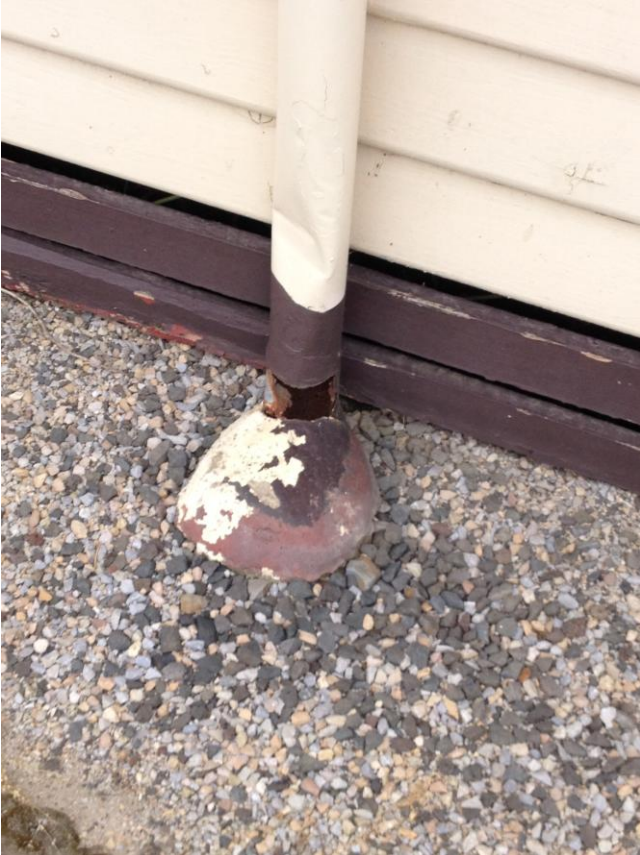
Photo No.8 – Control Room – Corroded Down Pipe causing wash away of yard surfacing fines.

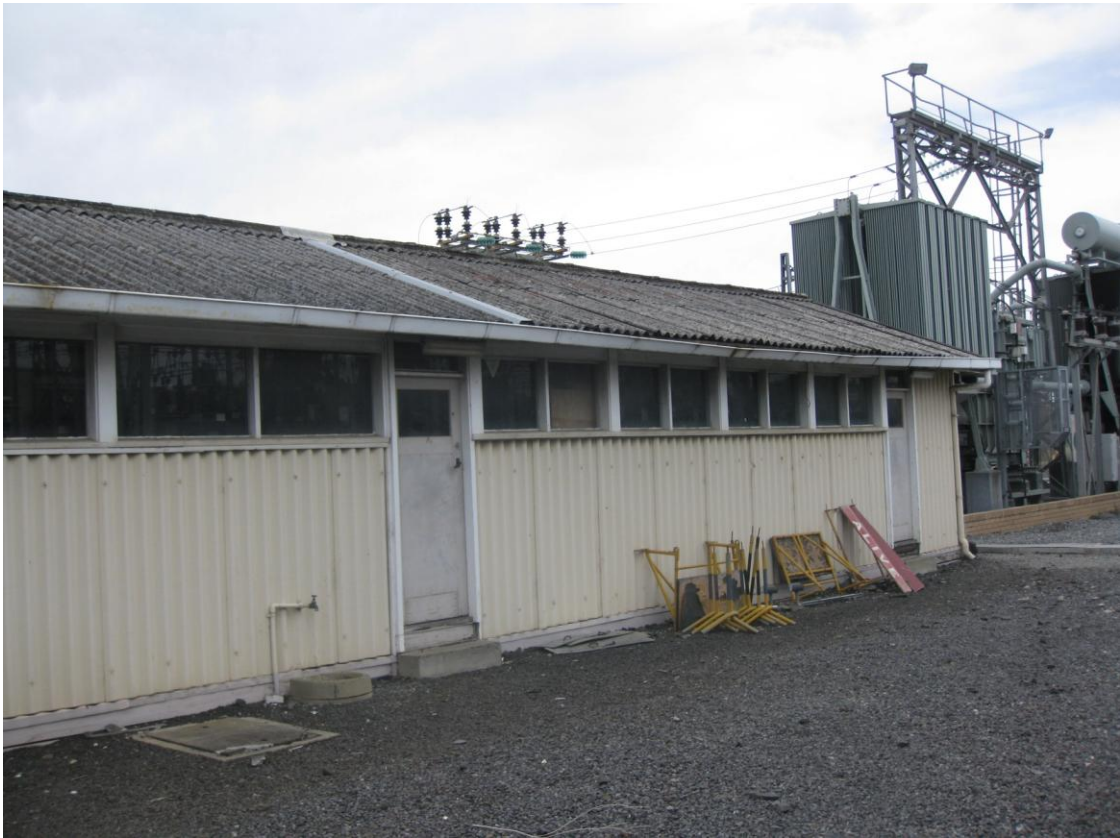
Photo No.1 – Control Room Building – Typical exterior (South side of building).

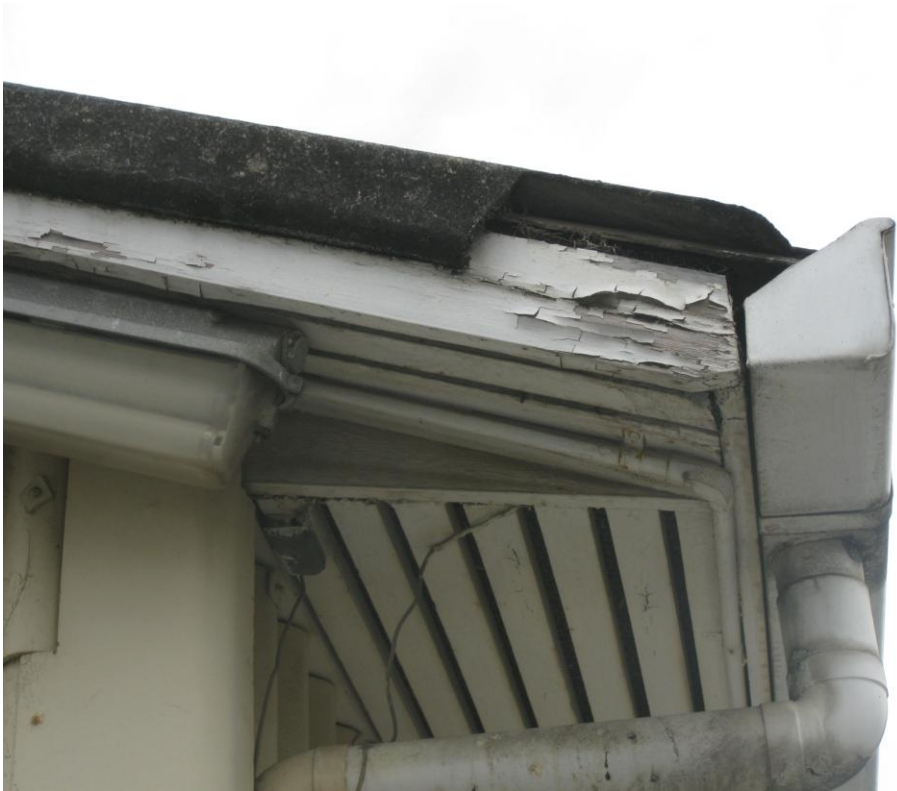
ITEM	DESCRIPTION	CONDITION	RECOMMENDATION
<u>Control Building</u>  Roof –	Corrugated asbestos cement roof sheeting with asbestos cement gable flashing over timber barge boards.          Metal gutters and Downpipes.          Eaves – bird mesh covered with spaced timber battens.	Top of corrugations on roof sheeting are weathered and possible asbestos residue could be deposited in roof gutters. <b>Refer to Photo No.1</b> – for typical exterior of building. Roof sheeting is probably brittle due to age and a small section of roof has been repaired with bent galvanised sheet. <b>Refer to Photo No.1</b>  Asbestos gable flashing has broken away at bottom ends of East gable. <b>Refer to Photo No.2</b>  Roof timber fascia severely rotted at N-W corner of Control Room. <b>Refer to Photo No.3</b>  Gutter has dropped on southern side of building. Water will collect in this section of gutter.  Some downpipe outlets are broken allowing water to flow onto yard surfacing and possibly under building. <b>Refer to Photo No.4</b>  Appears in satisfactory condition. Residue in eaves may indicate infiltration of birds or vermin.	Gutters should not be cleaned until inspected by an Contractor authorised in identifying and handling asbestos residue.  Clean, Seal or paint roof by an authorised Contractor to prevent further weathering, could also be considered. Precautions would need to be taken not to damage roof.  Install patch length of galvanised angle flashing to protect barge board ,eaves frame and battens from rotting. Sections of fascia boards which have rot should be cut out and replaced.  Difficult to fix, consider replacing gutter. (State of gutter internal surface unknown.) Repair outlets to ensure all run-off is directed to stormwater drain.

Photo No.2 - Control Room – Asbestos roof gable flashing broken.

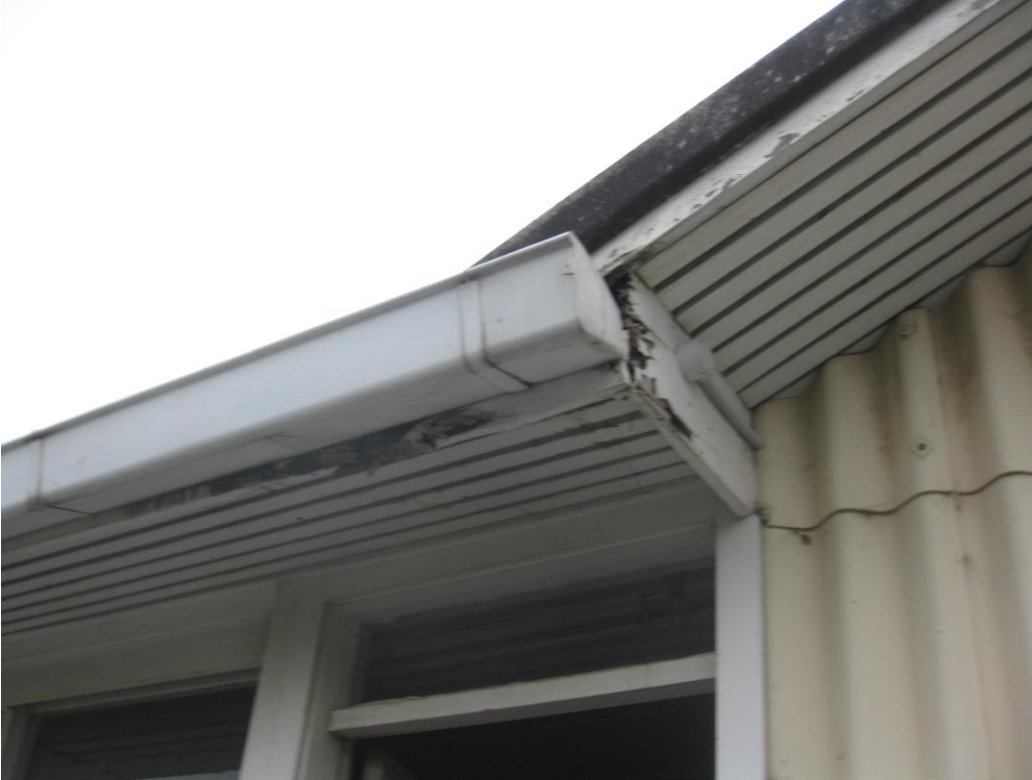
Photo No.3 – Control Room Building – Rotting timber fascia..

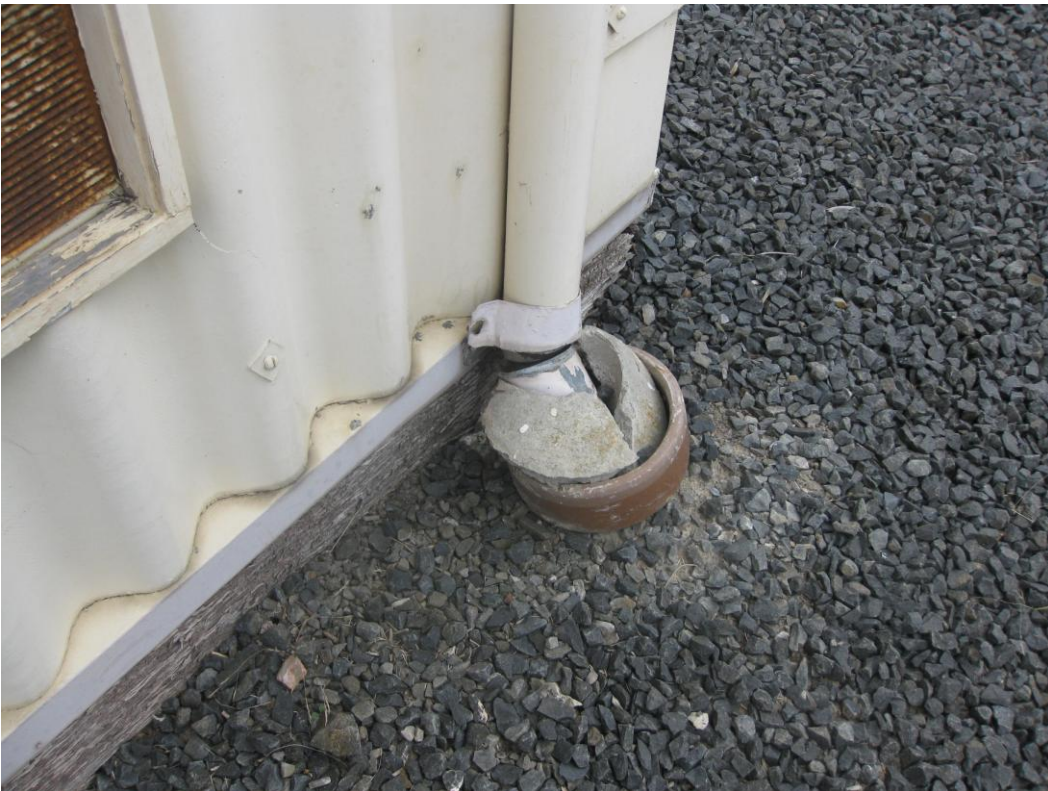
Photo No.4 – Control Room Building – Broken downpipe outlet.

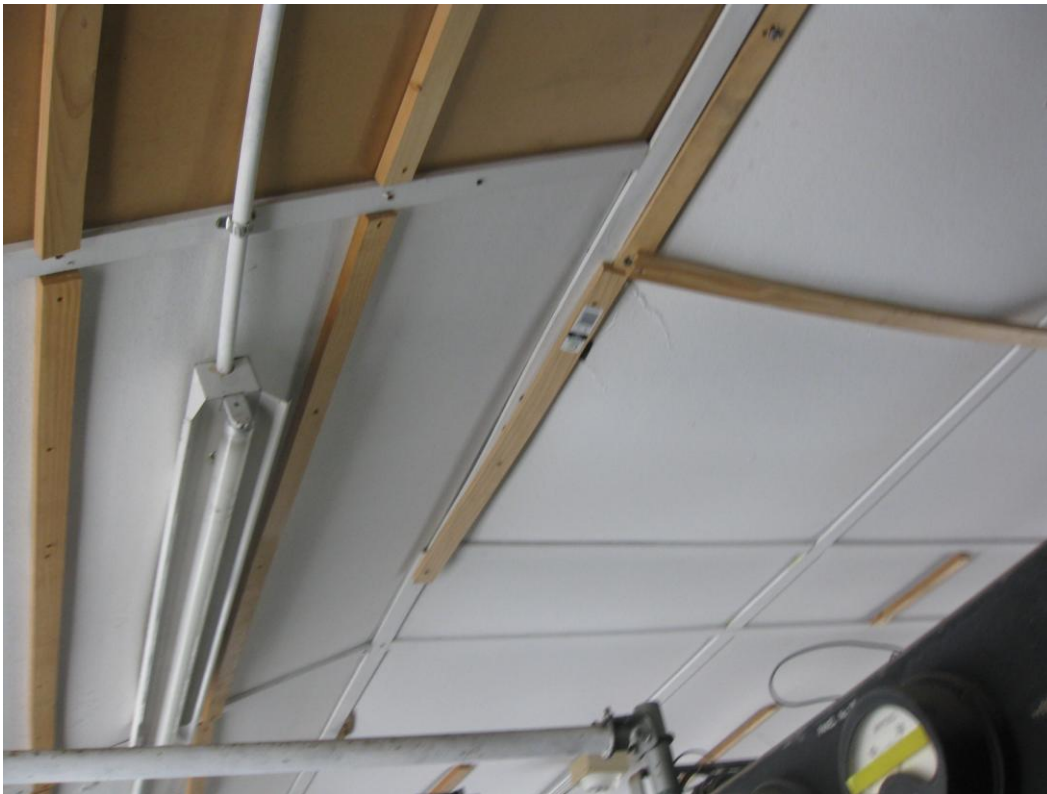
ITEM	DESCRIPTION	CONDITION	RECOMMENDATION
Roof – (continued)	<u>Ceiling</u> Control Room - 'Canite' sheeting. Battery Room – Asbestos Cement Sheeting	There is some distortion and cracking of ceiling panels, some panels have been replaced and it has been necessary to install extra battens in the Control room. <b>Refer to Photo No.5</b>	Ceiling will require attention on a needs basis. Currently the ceiling in the Control Room is serviceable but unsightly.
Walls –	Timber stud walls - <u>External Lining</u> – Profiled Asbestos Cement (AC) sheeting.  <u>Internal Lining</u> – Control Room - Masonite  Battery Room – Asbestos Cement Sheet  <u>Vents to Battery Room</u> – Lower metal vents to external wall.	External lining generally satisfactory. There are some broken sections under North wall doors. <b>Refer to Photo No.7</b>  Masonite generally satisfactory.  Lining satisfactory.  External face of vents have extensive corrosion. <b>Refer to Photo No.6</b>	Thoroughly clean external face of vents by wire brushing, apply anti- rust agent and 2 coats of zinc rich paint.

Photo No.5 – Control Room Building – Typical “Canite” ceiling.

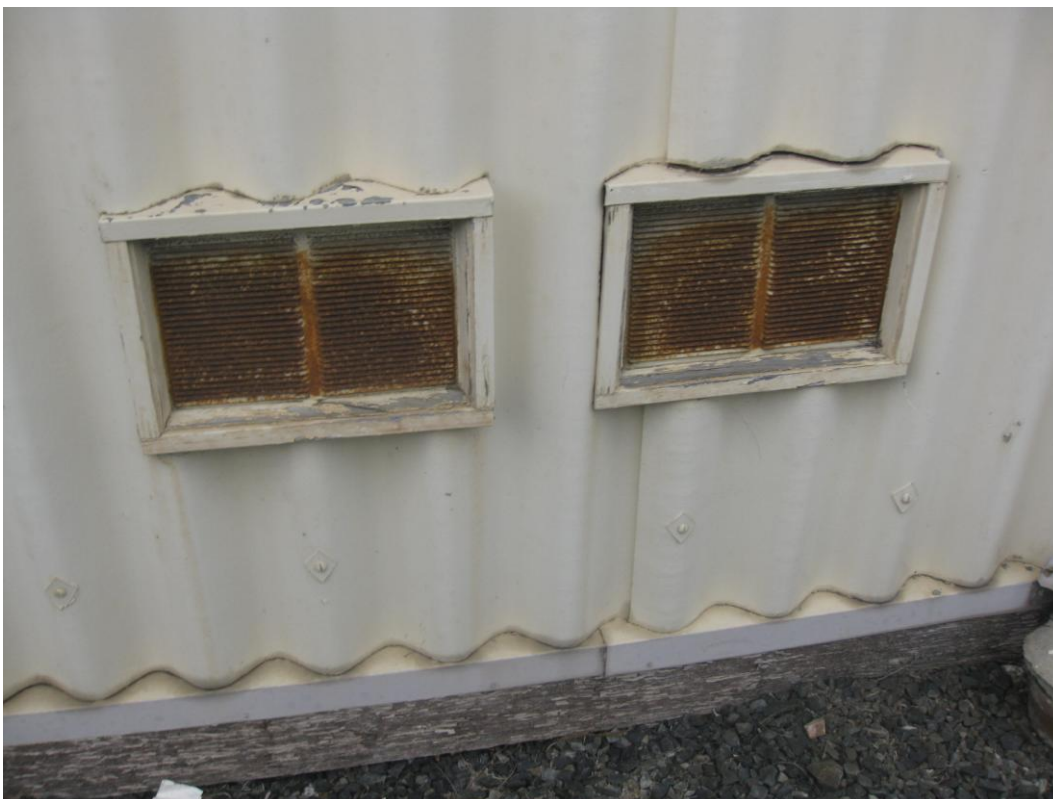
Photo No.6 - Battery Room Vents – Corrosion on external face of metal vents.

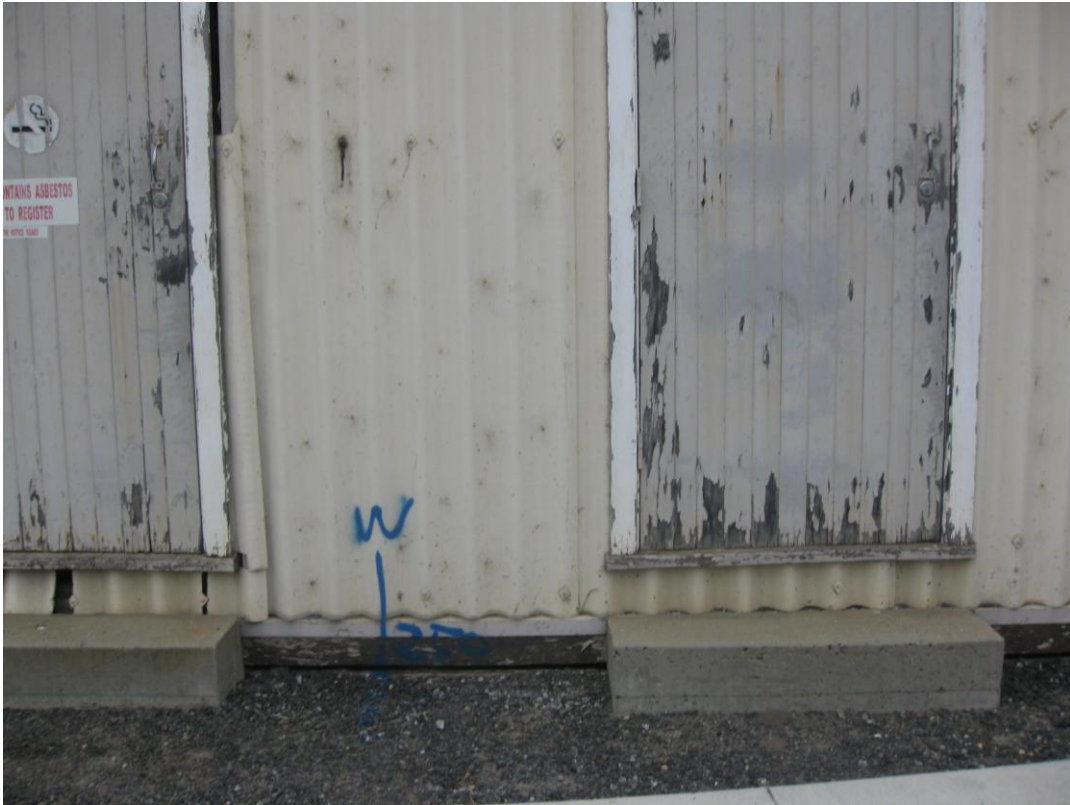
Photo No.7 – Control Room Building – T & G Timber doors (North wall)

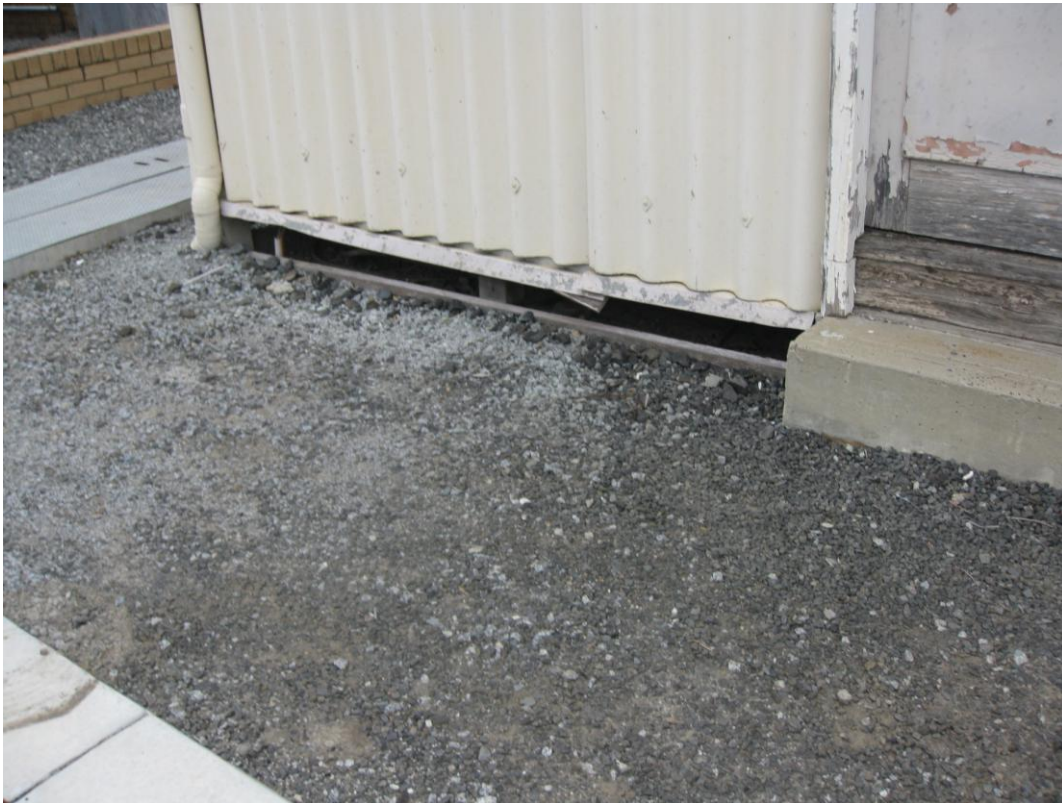
Windows –	Timber framed windows.	Window frames are considered to be satisfactory.	
Base Boards to sub-floor area -	Spaced Timber boards spanning between and fixed to exterior stumps.	Some rotting at corner joints and base board miss at N-E corner. <b>Refer to Photo No.8</b>	Install new board.

Photo No.8 – Control Room Building – Missing Base Board at N-E corner.
