Attachment 3: Use of polygons to identify affected areas and assets

Ergon Energy Network Cost Pass Through Application Tropical Cyclone Jasper - Cost Analysis Support Document

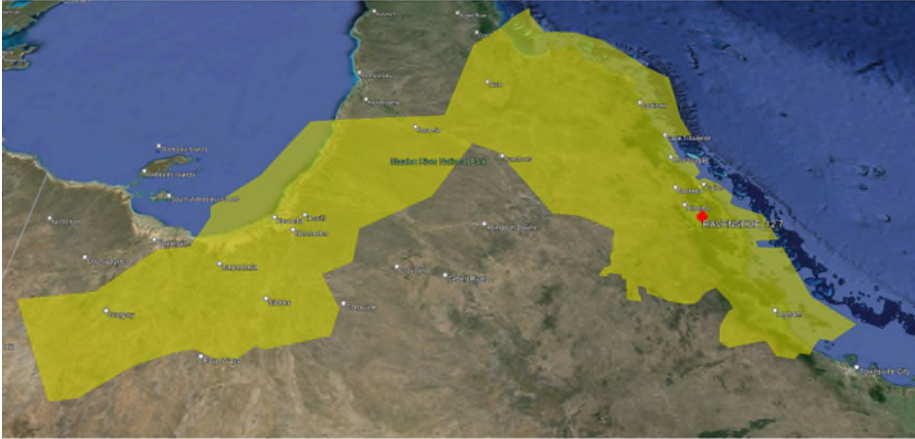
Item	Description
	<ul style="list-style-type: none">○ Test to make sure the created date of damage is greater than the Event start date;○ Test damage created date is from the start of the Event, to the end of the Event, plus 1 month (30-days).
Assumptions	The 30-Day post event period was determined to be a reasonable time period to include any recovery after the Event.
Images	<p data-bbox="488 607 1155 633">Google Earth Views of Polygons and Assessment Areas</p> <p data-bbox="488 651 1366 678">The areas impacted by the Event are coloured yellow in the picture below.</p>

The results of the spatial polygon analysis confirmed that there was no overlap of unplanned emergency works performed in areas where planned Repex works were scheduled. Similarly, the emergency vegetation clearance following the Event were not in Ergon Energy's forward maintenance plans. Therefore, all the restoration costs incurred were entirely incremental costs.

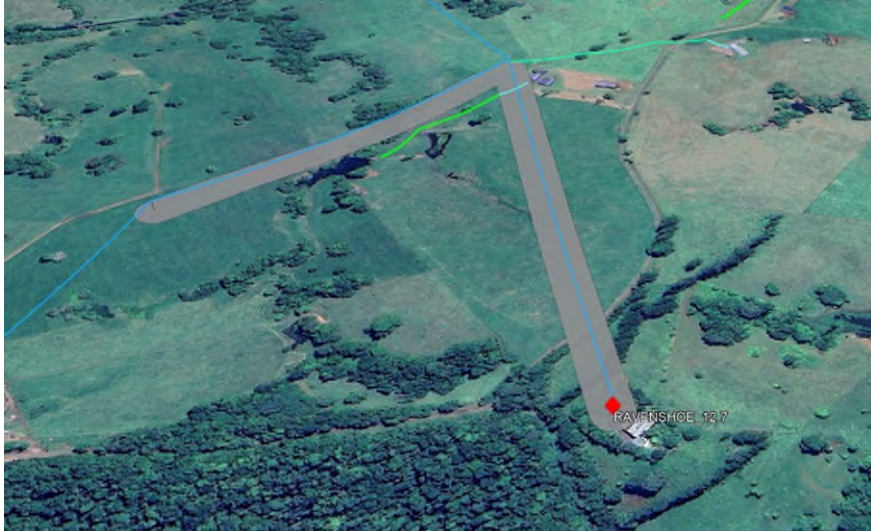
<p data-bbox="488 1211 1406 1272">◆ One location was identified as a potential area of spend overlap and this is shaded grey in the photo below.</p>

SOURCE	SITE_ID	PRIORITY	LOCATION	EVENT	EVENT_START	EVENT_END	RPX_RAISED	RPX_RBD	RPX_COMP	OVERLAP	RESULT
MET	5113864	P2	RAVENSHOE	TC Jasper	20231222	20231212	20230520	20231130		1	Priority works to minimise power disruption (Vege Clearance) – No reduction in future planned works.
