Vegetation Management ESV meeting materials

September 2023

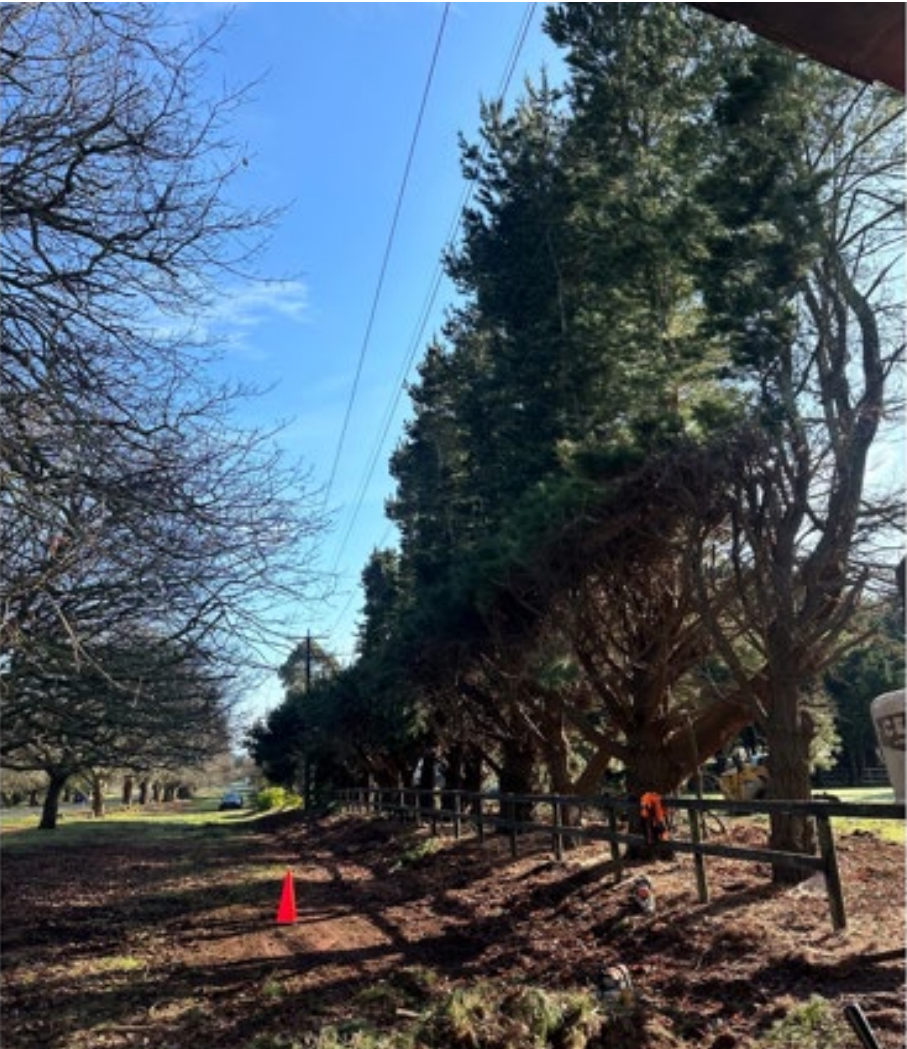
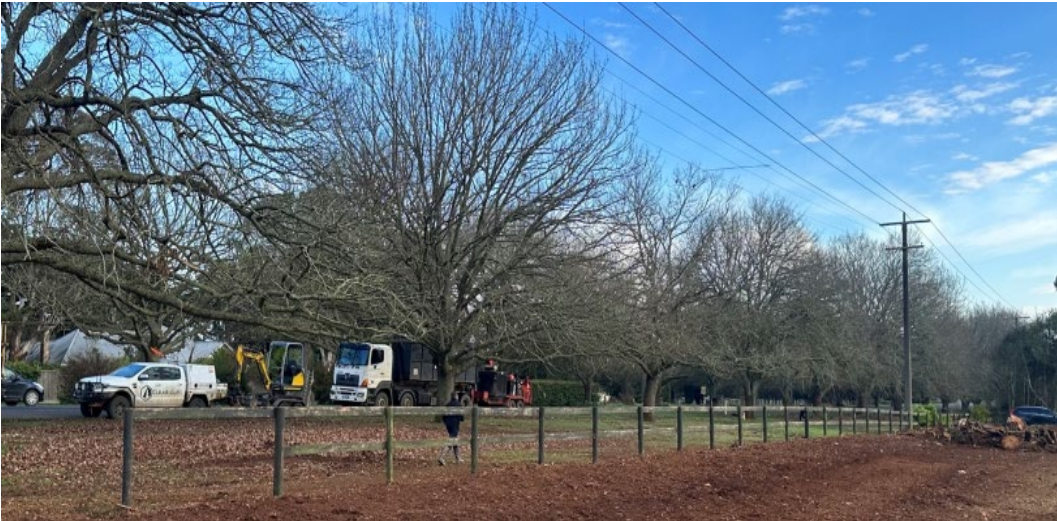
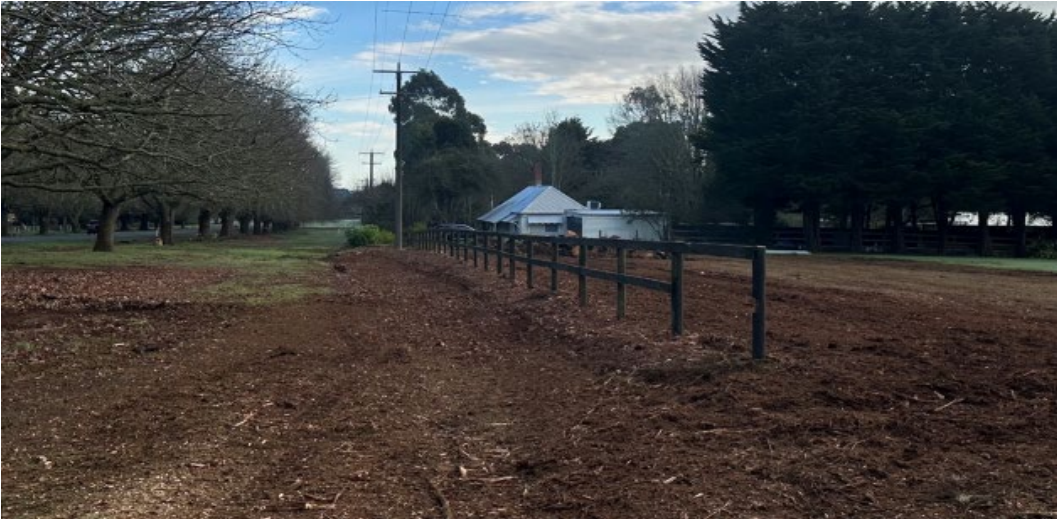
Recent cutting on Powercor network – Woodend

Full removal of row of pines to eliminate risk long term across two spans

Before

After

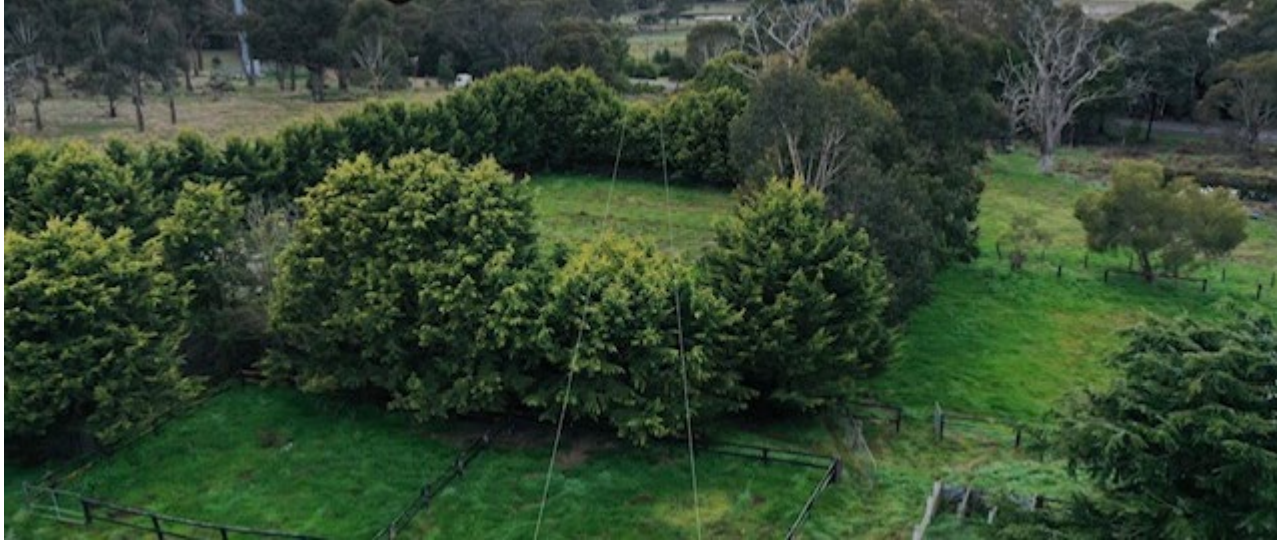
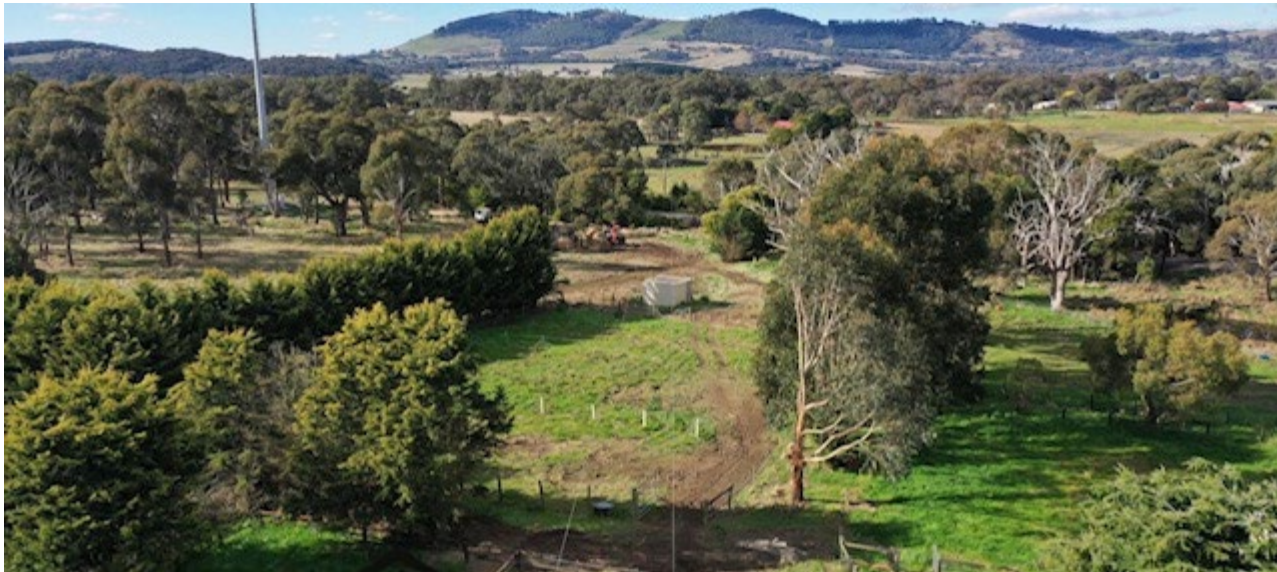
Recent cutting on Powercor network – Macedon

Post compliance and hazard tree cutting

Before

After

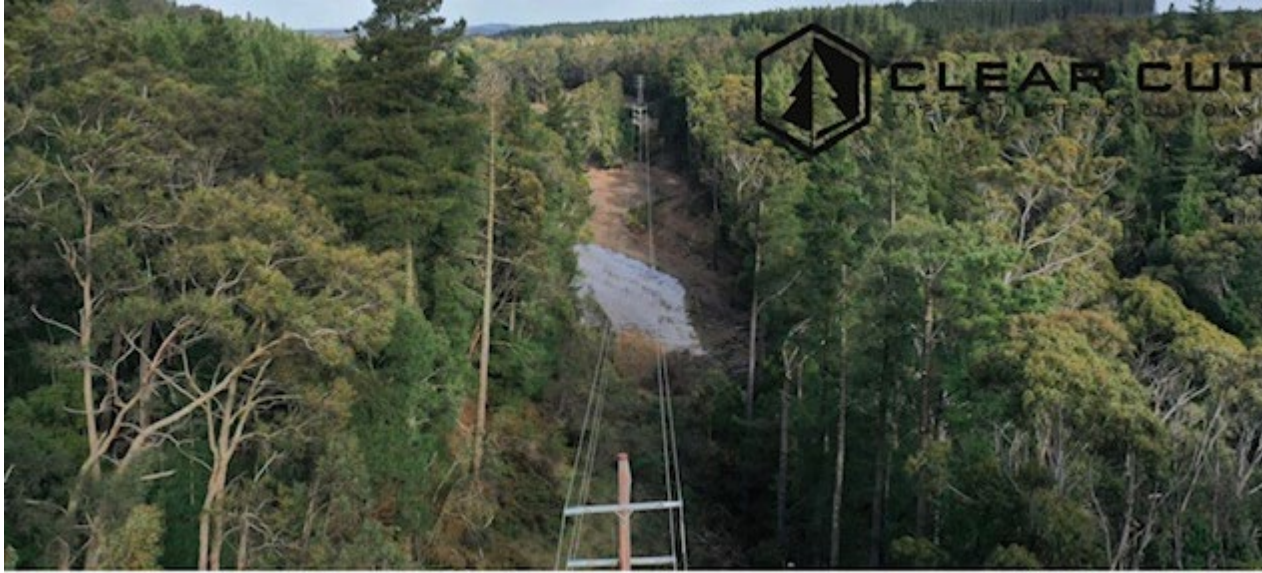
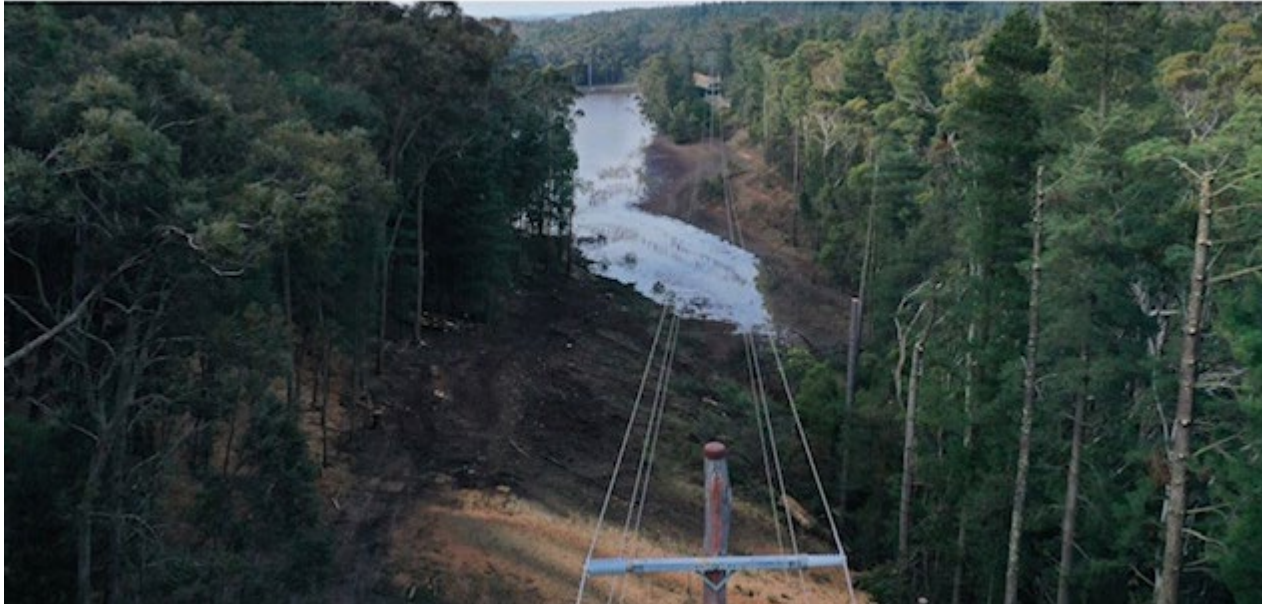
Recent cutting on Powercor network – Gisborne

Huge volume of vegetation removed across challenging terrain

Before

After
