Energy Queensland

Business Case: Townsville Training Facility

Network and Non-Network Document Hierarchy Reference Number	Regulatory Proposal Chapter Reference	Document	File Name
NON PRO - 009	7.142	Townsville Training Centre Business Case	EGX ERG 7.142 Business Case - Townsville Training Centre JAN19 PUBLIC

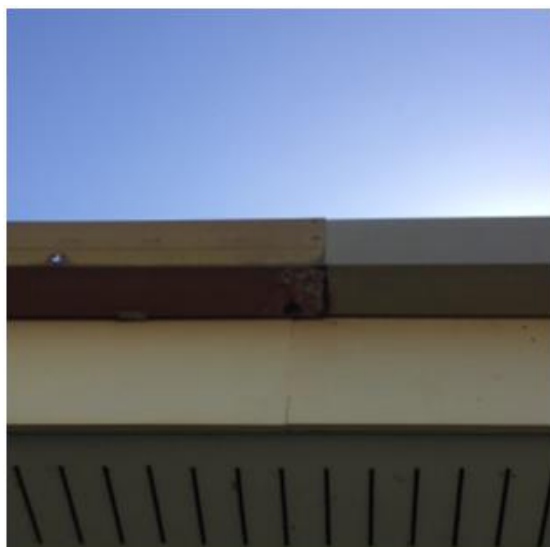
Image 2: Previous gutter repairs

- Full roof, gutter & soffit replacements, including downpipe reconfigurations to reduce damage to footings
- Full internal ceiling replacements to repair damages caused by roof issues
- Structural engineering assessment and reinforcements applied to damaged cyclone rated concrete bond beams including recertification following repair works.

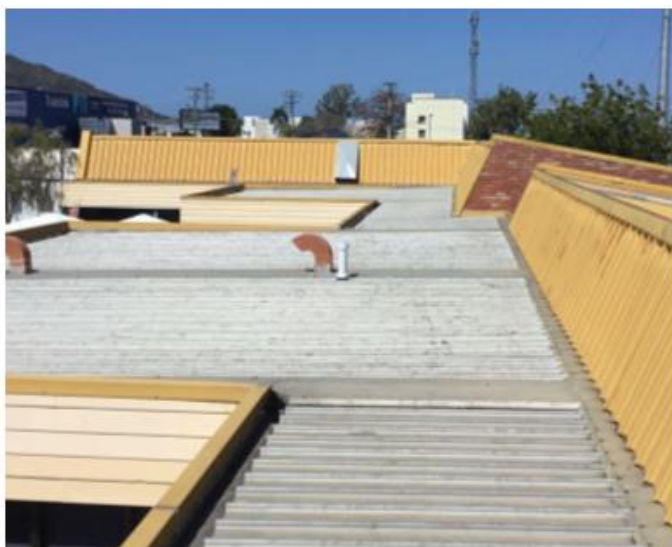
Image 3: Roof Condition & ACM Fascia

The site currently contains approximately 200m² of asbestos containing materials (ACM), refer Site Asbestos Register in List of References for further detail. Whilst all ACM is currently encapsulated in a safe manner significant site works are required to remove ACM where possible in order to achieve an asbestos free portfolio as per EQLs Non-Network Asbestos Removal Program. Any removal works would greatly impact current site operations due to the multitude of locations across the site containing ACM. Removal of ACM would best be conducted in conjunction with site redevelopments to minimise disruptions to site operations. The issues with drainage mean that the ACM will need to be removed as areas such as the soffits on the building are continuing to get water damage, impacting on the ACM.

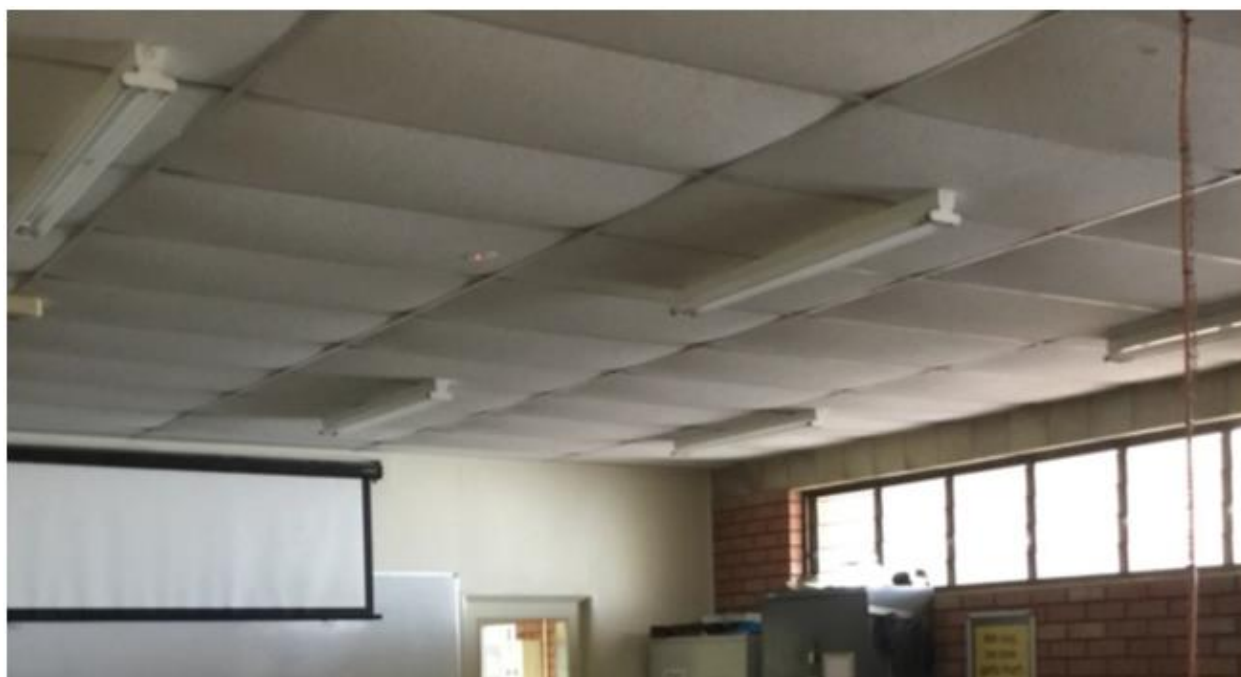
Image 6: Example of Ceiling Condition

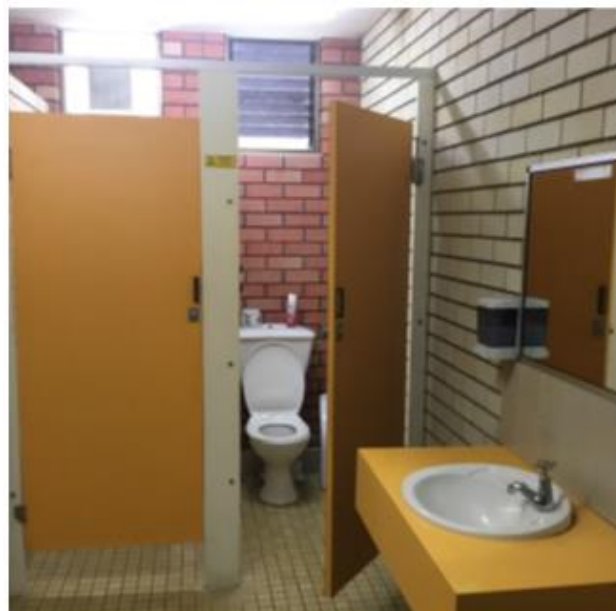
Image 7: Aged amenities with confirmed ACM

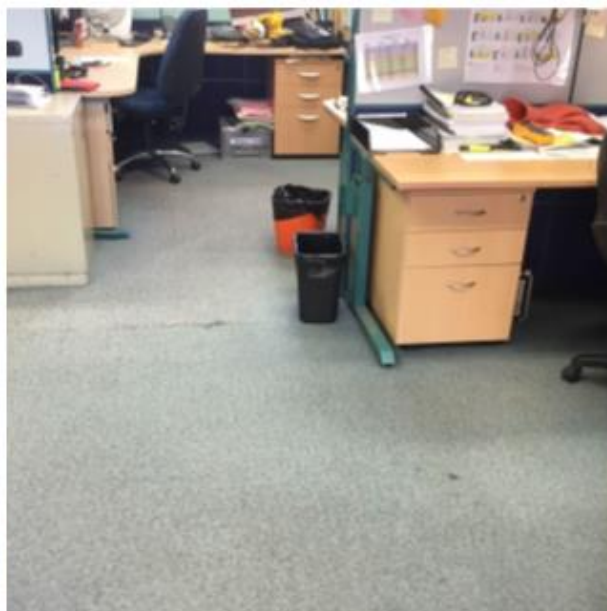
Image 8: Worn carpet in office area
