Cost pass through application – 500kV Transmission Line Tower Collapse (PUBLIC VERSION)

Cost pass through application – 500kV Transmission Line Tower Collapse

10 July 2020

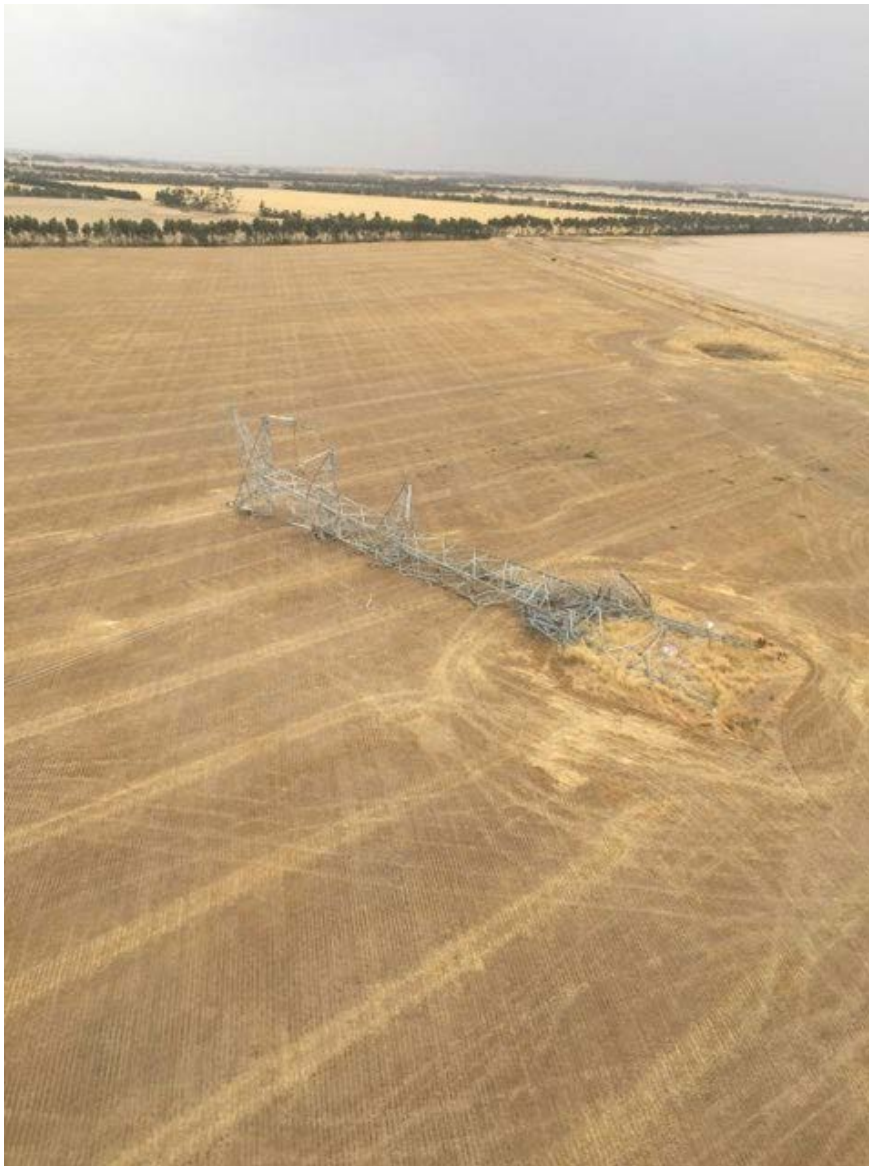
Figure 2: One of the collapsed 500kV double circuit towers

and each of the six towers failed in a similar manner, i.e. fell completely transversal/perpendicular to the wind direction.

The weather event near Cressy caused seven consecutive towers in the transmission line to fail. Six of the towers collapsed and the seventh was severely damaged. This occurred on Friday, 31 January 2020 at 13:24 hrs (AEST), the recorded time that the transmission lines tripped. Line crews immediately undertook an aerial patrol of the transmission lines and identified the failed towers. Employees of the regional distribution network service provider, Powercor, were present in the area and they also alerted AusNet Services to the location of the incident.

The towers had a condition assessment inspection in March 2019 with the overall tower condition classified as 'C2', which indicates that the towers are in a good condition and not affected by corrosion. The major work undertaken to date has been surface treatment of the tower legs at ground level as they enter the footings, to prevent weakening through corrosion.

AusNet Services notes that this treatment has been effective and this has been confirmed for the towers that collapsed.

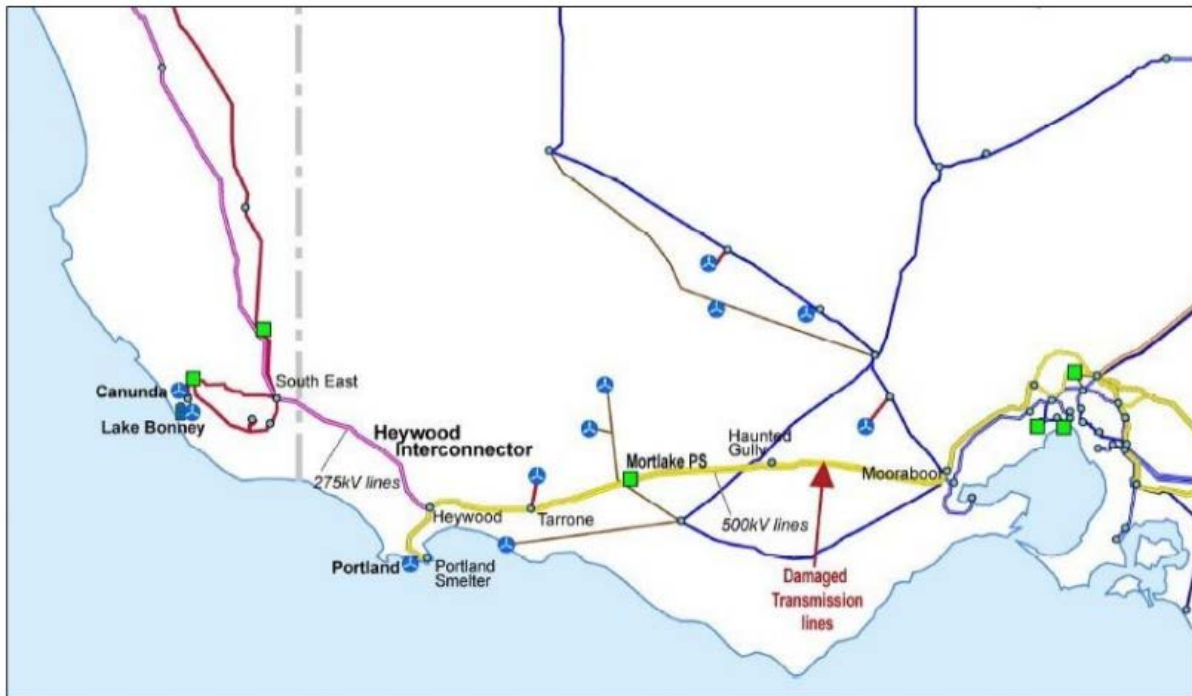
Figure 3: 500kV dual circuit transmission line route, south western Victoria

The route of the transmission line through south western Victoria is shown by the yellow line in Figure 3, which also locates the area where the towers collapsed (near Cressy) and the nearby terminal points (Moorabool, Mortlake and Haunted Gully) which give the transmission line(s) their identity.

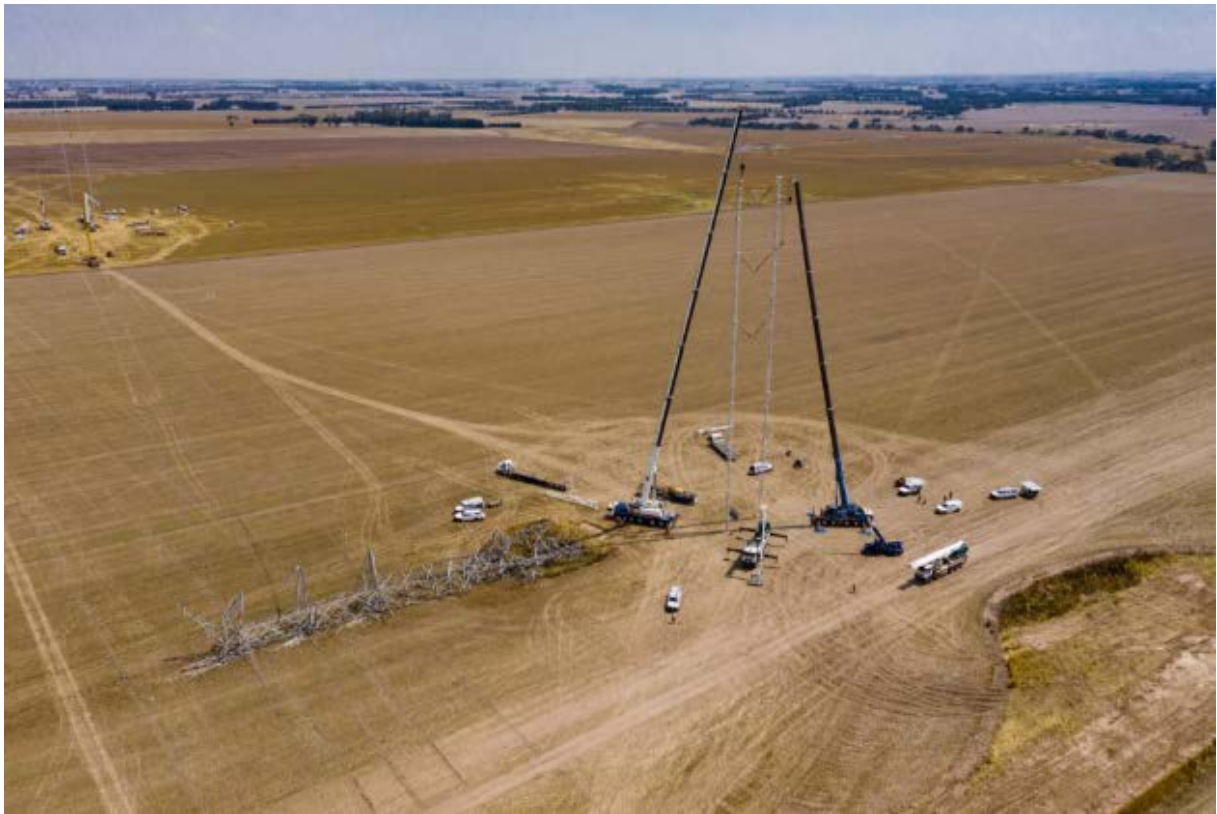
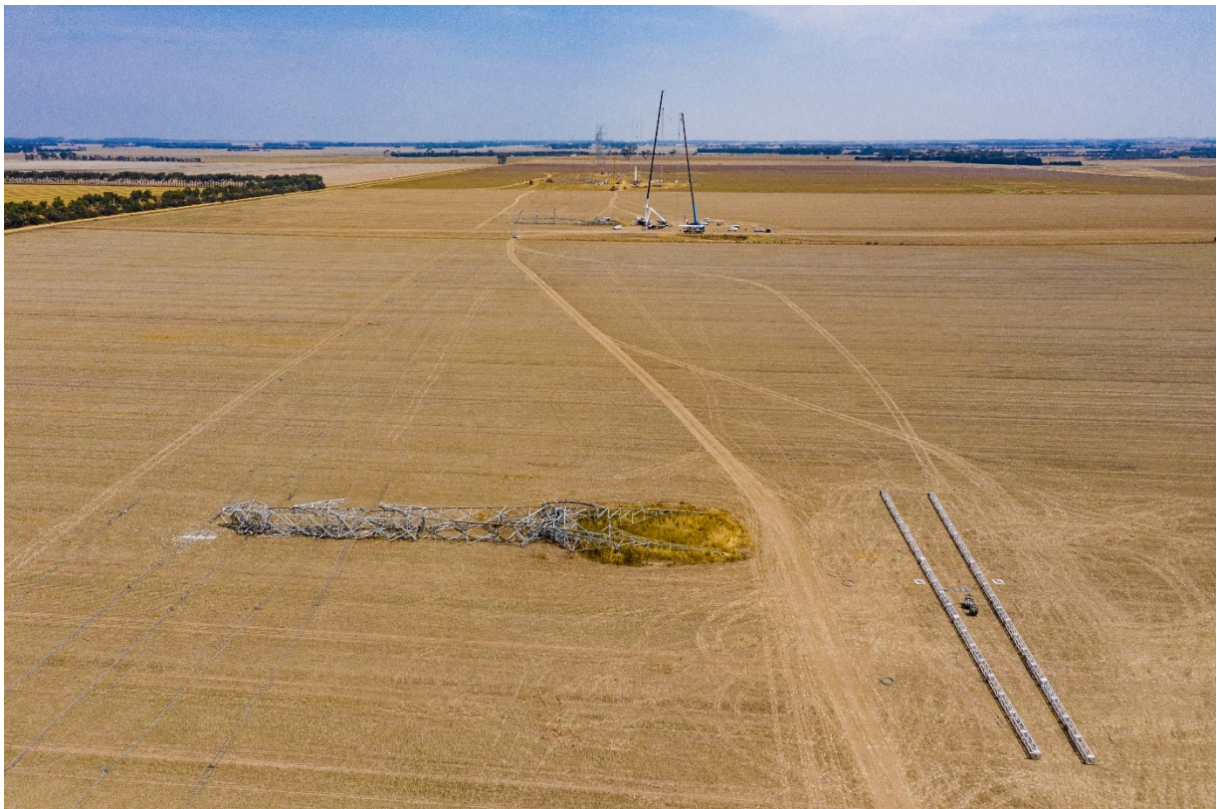
Figure 4: ERS mast structures being erected

The temporary transmission line sections were built consecutively to minimise the time to return the first line to service and mitigate risk for network users. The first line was returned

to service on 17 February, just two and a half weeks after the failure. The second line was returned to service within similar time period, on 3 March. The restoration demonstrated the immense value in having response plans in place and being prepared and skilled to respond to improbable contingencies such as experienced in this case.

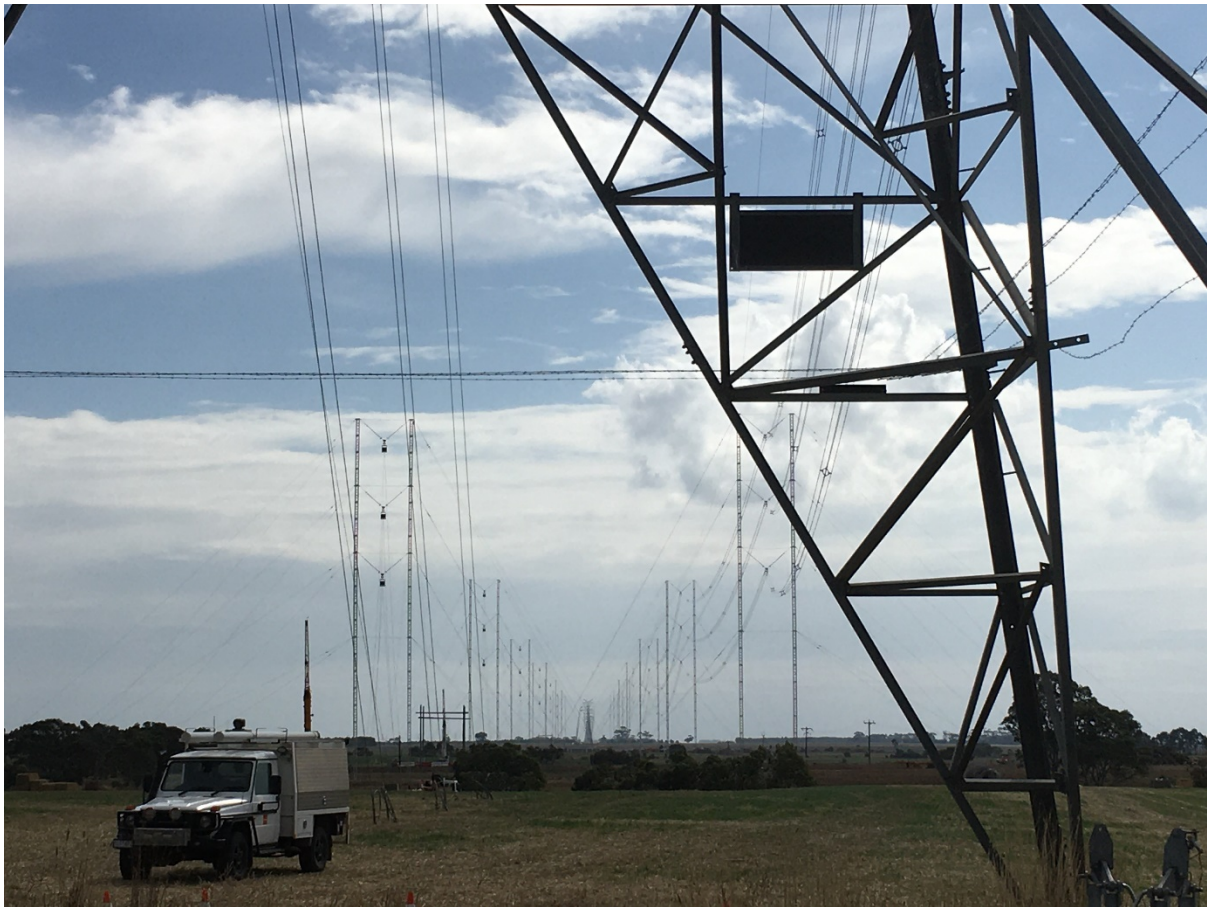
Figure 6: Completed temporary construction

The temporary ERS structures cannot be retained as a permanent solution for the following reasons, all of which are consistent with their purpose of facilitating prompt service restoration in emergency situations:

- The ERS structures are not designed to survive all environmental conditions that may be expected. The structures have a design working life of 6 months and a one in twenty chance of failure each year. There is a significant risk of subsequent failure and heightened transmission service risk if they are not replaced by permanent structures as soon as practicable. The risk is costed at around \$6M per annum whilst the temporary structures are in place;

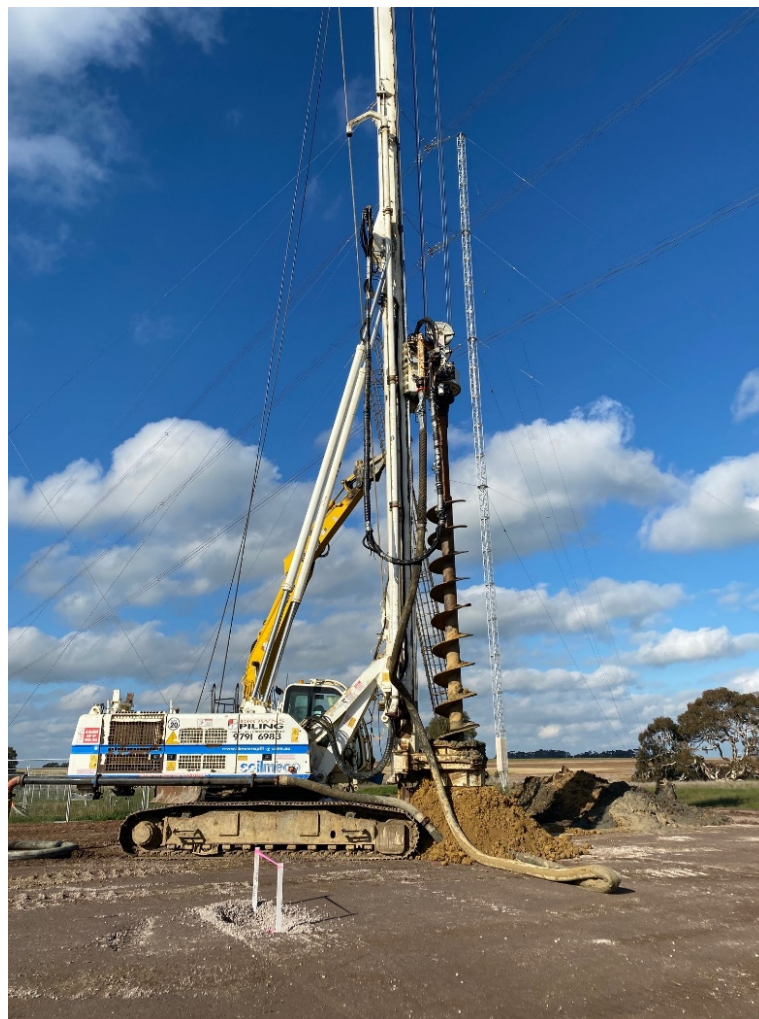
Figure 7: Foundation works for the permanent replacement towers

The tower replacement project will erect seven new double circuit towers at the locations of the failed towers. Recognising the continuing risk to transmission services, AusNet Services is seeking to ensure that permanent tower restoration is achieved as quickly as is practical. Mid-October 2020 is currently scheduled for service of the new towers. Figure 7 shows the foundation works underway for the new towers.

This component of the works involves procurement and erection of 7 new transmission towers, including foundations, and stringing new conductor to reform the circuits as a permanent transmission line section.

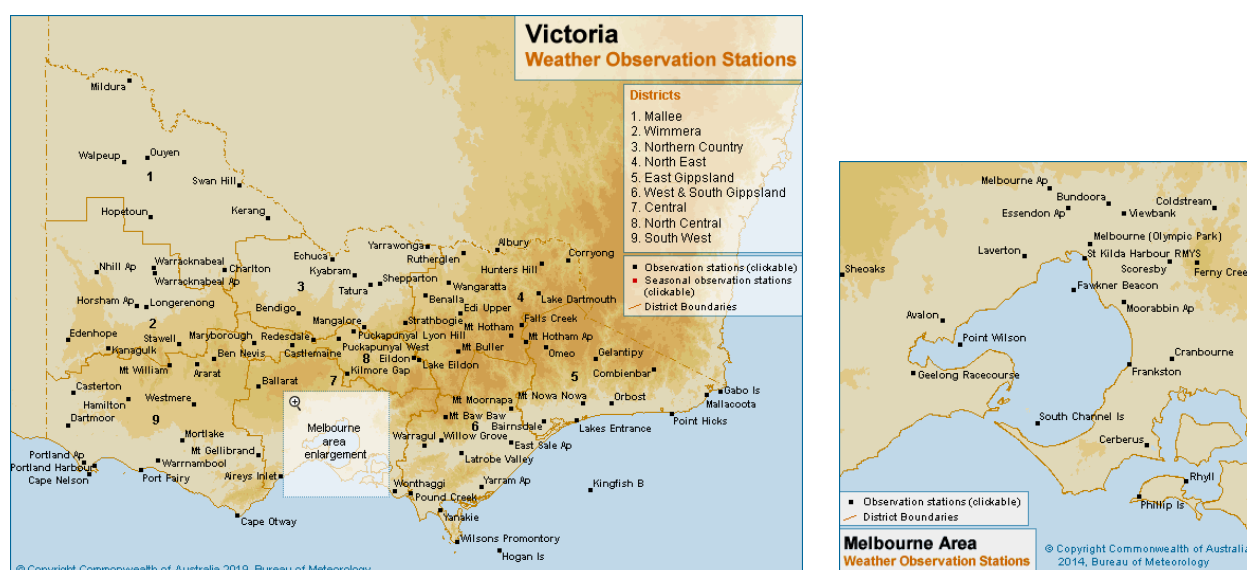
Figure 1: Location of Bureau Automatic Weather Stations across Victoria.

Except where noted, times are quoted as Australian Eastern Daylight Time (UTC + 11 hours). Wind speeds are 10-minute averages measured in kilometres per hour (km/h) and measured at a standard height of 10 metres above ground level. Wind gusts represent the maximum measured wind speed (3 second average) over the preceding 10-minutes. Wind directions refer to the direction from which the wind is coming and are given in 16 points, or degrees, of the compass as indicated. Temperatures and dew point temperatures are measured in degrees Celsius (°C). Precipitable water, measured in mm, is a measure of atmospheric moisture and represents the depth of water in a column of the atmosphere, were all the water in that column were precipitated as rain. Location maps showing Victorian observation sites mentioned in this report are shown in Figure 1.

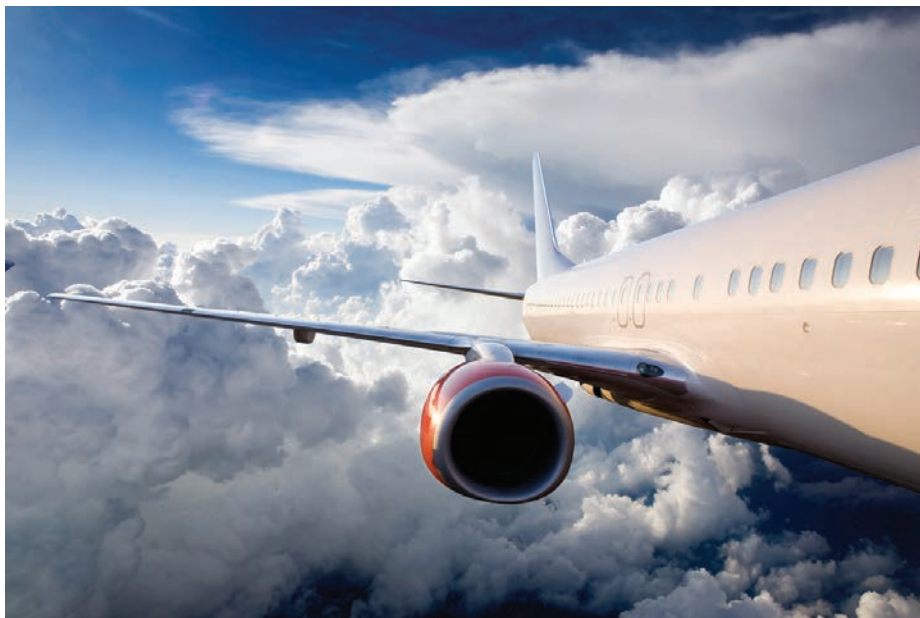
A thunderstorm is a cumulonimbus (CB) cloud in which electrical discharge can be seen as lightning and heard as thunder. A thunderstorm is potentially the most violent and destructive meteorological phenomenon confronting general aviation pilots.

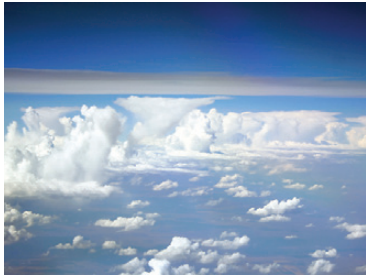
Squall line thunderstorms.

A **squall line** is a multicell thunderstorm where the cells are arranged in a long line. The adjacent cells are so close together that they form a continuous line of thunderstorms accompanied by a continuous, and often strong, surface gust front at the line's leading edge, hence the name squall line. They develop along a linear lifting mechanism such as a cold front or a pre-frontal trough and also within the inter-tropical convergence zone.

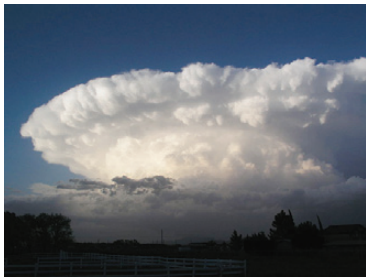
Supercell thunderstorm.

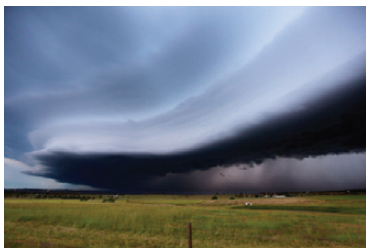
Shelf cloud.

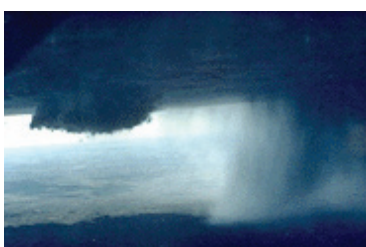
Wall cloud.

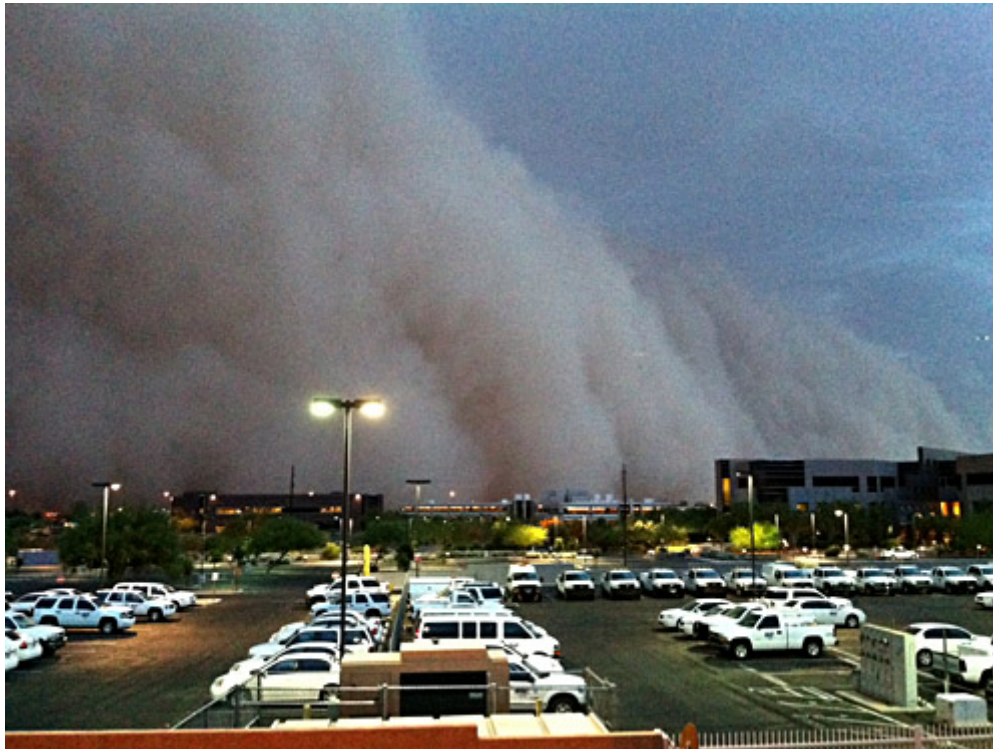
Wall of dust approaching the NWS Forecast Office in Phoenix July 5, 2011

On July 5, 2011, a massive dust storm resulted in widespread areas of zero or near zero visibility in Phoenix. The wind that produced this storm was generated by downbursts from thunderstorms with winds up to 70 mph (110 km/h).
