CP.02360

Nebo Transformers 3 and 4 Replacement

# T3 & T4 Transformer Condition Assessment H011 Nebo Substation

<b>Asset Category</b>	Power transformers	<b>Author</b>	[REDACTED]	<b>Authorisation</b>	[REDACTED]
<b>Activity</b>	Condition assessment - primary substation plant, power transformers.				
<b>Reviewed by:</b>	[REDACTED]	<b>Review Date:</b>			
<b>Document Type</b>	Report	<b>Team</b>	Substation Strategies		
<b>Issue date</b>	13/03/2020	<b>Date of site visit</b>	16/12/2019

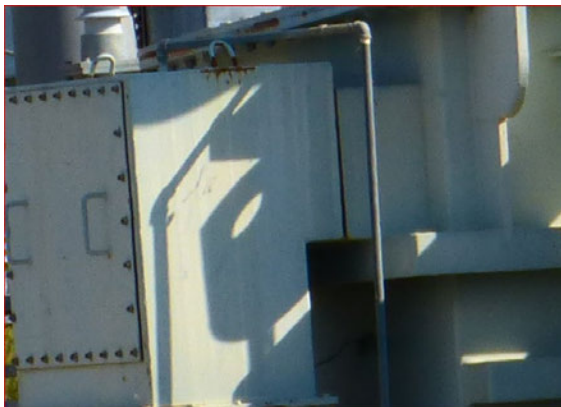
Figure 2- Transformer coating condition

Maintenance records do not provide any indication of corrosion issues, but visual inspection on site undertaken in 2015 and 2019 identified a number of corroded parts with corrosion levels varying from Grade 1 to Grade 4 (Figures 4, 5, 6, 7, 8, 9, 10 & 11). There are no records either indicating the transformer has been partially or fully painted (Figure 12). The original coating is oxidised in most locations (Figure 2) and the paint is falling from radiators especially (Figure 3).

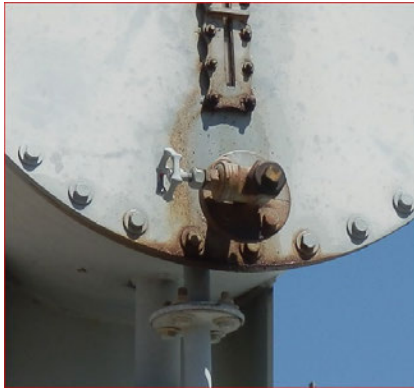
Figure 13 –Minor Oil Leak

According to the maintenance records, no oil leaks were detected. Visual inspection in 2015 and photos from 2019 indicate that there is at least one small oil leak (Figure 13) present around the sight glass on the conservator tank (most likely due to the sight glass gasket failure). It is expected that more oil leaks may eventuate based on the observed deteriorated condition of the gaskets (Figure 14).

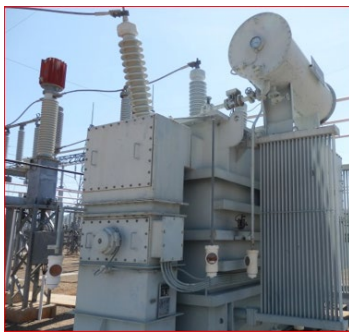
Figure 15 – Three desiccant breathers

The conservator is shared between OLTC and main tank and is equipped with a single homemade type breather, not allowing inspection of the oil bath on the bottom due to the design of the breather. This makes it very difficult to determine if the oil bath needs maintaining or is functioning correctly as a particulate filter.

In addition to this silica gel breather, the transformer is equipped with two more breathers, one for the earthing transformer and one for the earthing transformer disconnect chamber – all are homemade types with the same issues as mentioned above.

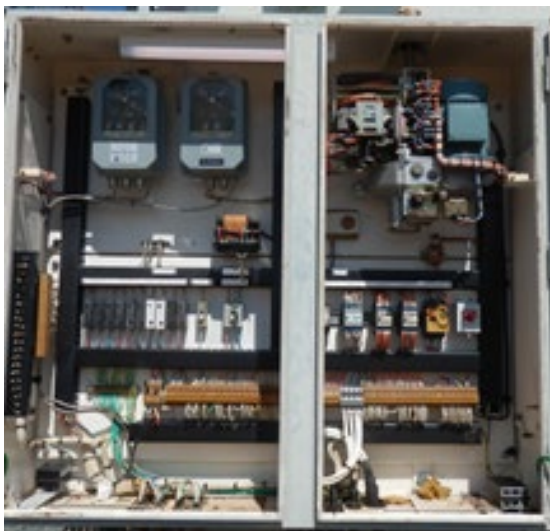
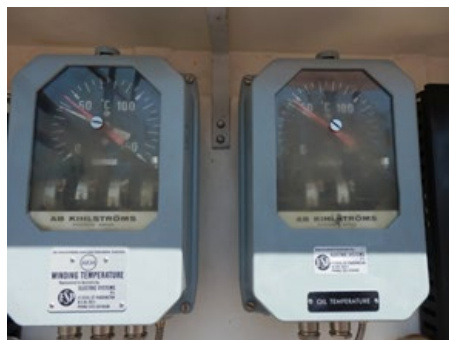
Figure 16 – WTI and OTI (Installed in Shared Control Cubicle)

Both the single winding hot spot and top oil temperature monitoring instruments have been replaced some years ago and were installed inside the Main Control Cubicle / tap changer control cubicle instead of on the side of the main tank where the full sun exposure accelerated their aging.

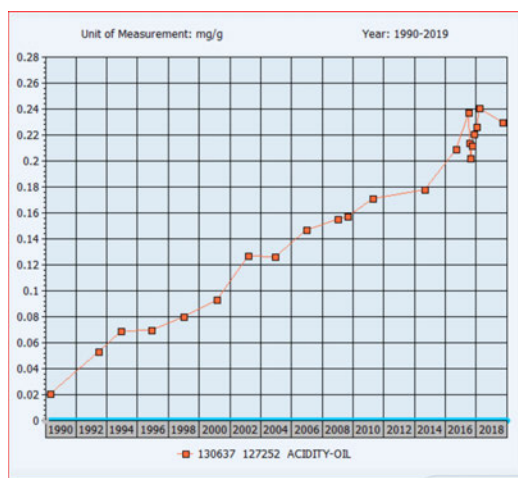
Figure 17– Oil DDF trend

Figure 18 – Oil Acidity Measurements

Figure 19 - Oil Resistivity Trend

Figure 20 – Oil Breakdown Voltage

As can be seen from the graphs above, the oil quality, although still within acceptable limits, is deteriorating, especially oil acidity and oil resistivity suggesting the end of service life for oil within 3 years (2023).

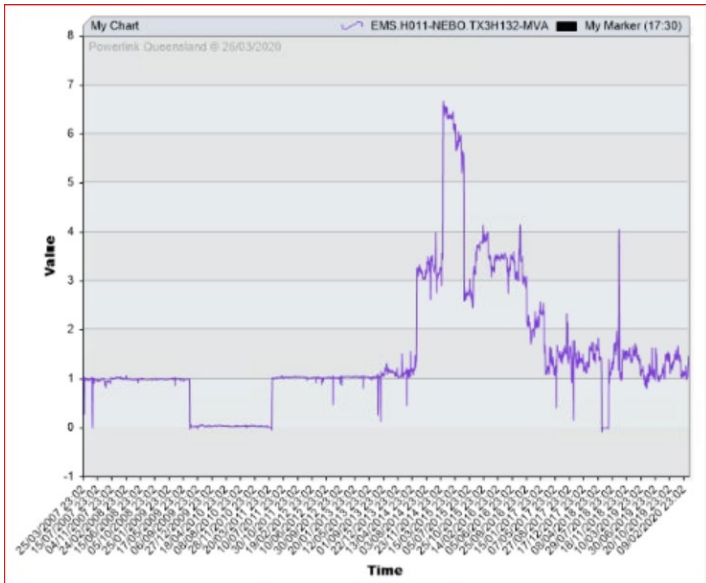
Figure 24 – Transformer 132 kV Loading History

The average loading between 2007 and 2020 was 1MVA, which is 20% of the nameplate rating, suggesting very light loading over service life. This explains the relatively high calculated DP value of insulating paper and other cellulose containing materials.

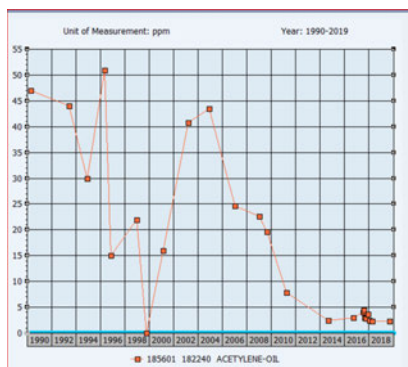
Figure 25- Acetylene in Oil

- There is obvious exchange of gasses between OLTC and main transformer tank in the common space of the conservator and possibly associated with leaks from the OLTC diverter switch cylinder (single column only) as acetylene is always present in the main tank oil samples.

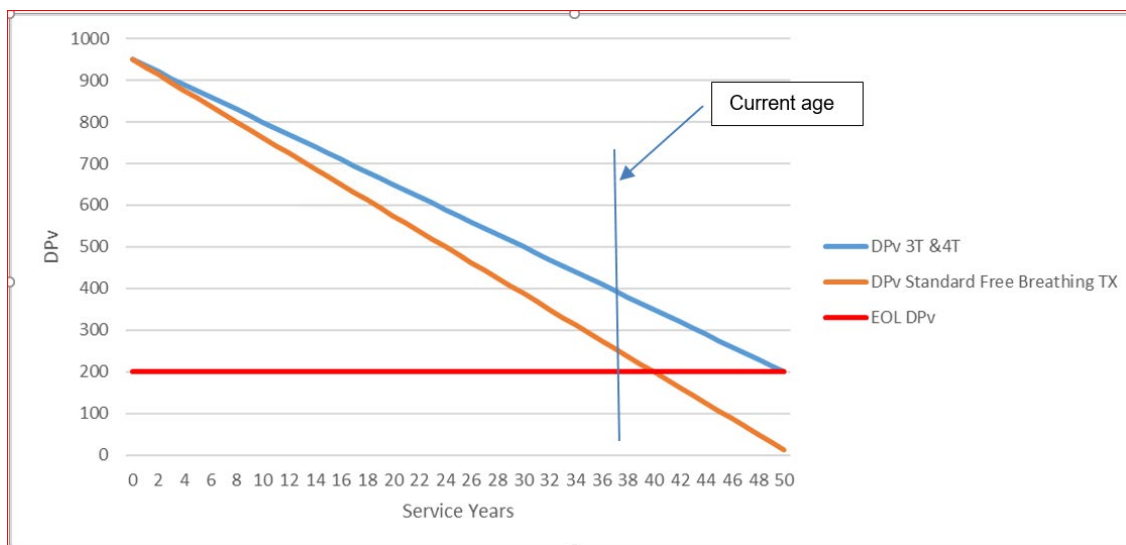
Figure 26- Calculation of cellulose insulation age using a number of indirect indicators

The insulation age of transformers T3 and T4 were calculated to be approximately 29-30 years as shown below in Figure 26. This indicates the localised winding hot spot insulation age whilst for insulation in other parts of the transformer it is just under 25 years. This is well below its nameplate age of 37 years.

estimated trend is shown in Figure 26, using an approximate value for the hot spot, considering that the furan data represents only an average of the total cellulose insulation mass. The DPV of the insulating paper is very dependent on the operating conditions (temperature, load and moisture).

Assuming that the transformer operating conditions remain the same, the trend shows that the transformer has 10-13 years (2030-33) of remaining service life (Refer Figure 26).

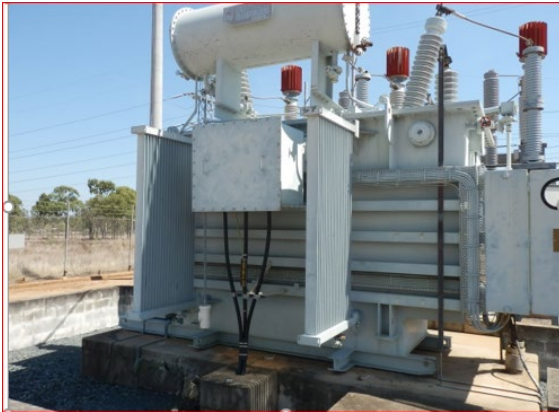
Figure 27 – 11 kV Cable Air Termination Box

Because there was no internal active part inspection performed, there is no way of knowing the state of the winding clamping or winding mechanical stability. Apart from two through faults associated with the 11 kV cable failure in 2009 and the cable air insulated terminal box fault in 2011, there are no other records available of exposure to through faults.

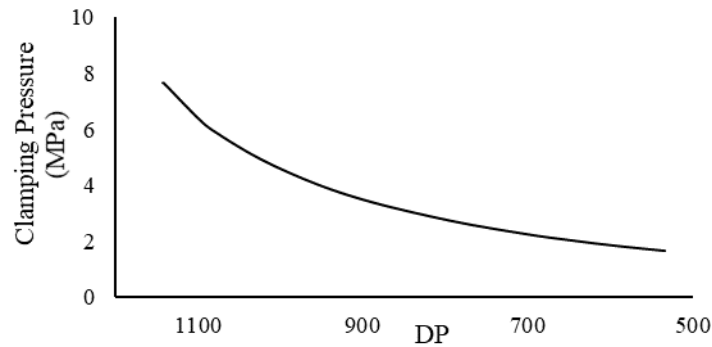
Figure 29 - Example of the effect of loss of DPv on Clamping Pressure

- (c) A drop in the internal cellulose insulation mass indicated by the change in DPv from 950 down to 390 will lower the winding residual clamping pressure but by how much is uncertain at this stage.

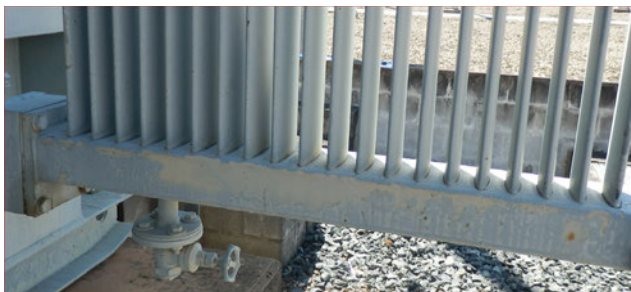
Figure 30 – Peeling paint

Due to a restricted access zone being in place at the time of site visit, this report relies on the information and photos provided in the condition assessment report from 2015. Maintenance records provide a single indication of a corrosion issue associated with tap changer drive shaft coupling (Figure 32 and 33), but visual inspection on site undertaken in 2015 and 2019 identified a number of other corroded parts with varying corrosion levels (Grade 1 to Grade 3). Below are photographs showing some of these. There are no records either indicating the transformer has been partially or fully painted, but there seems to be evidence of some painted parts. The original coating is oxidised in most locations and the paint is falling from radiators (Figure 30).

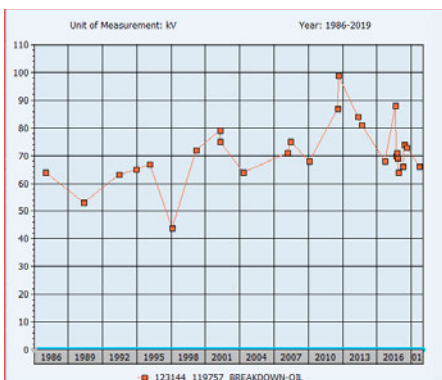
Figure 41 - Breakdown Voltage

The breakdown voltage of oil is also within acceptable limits.

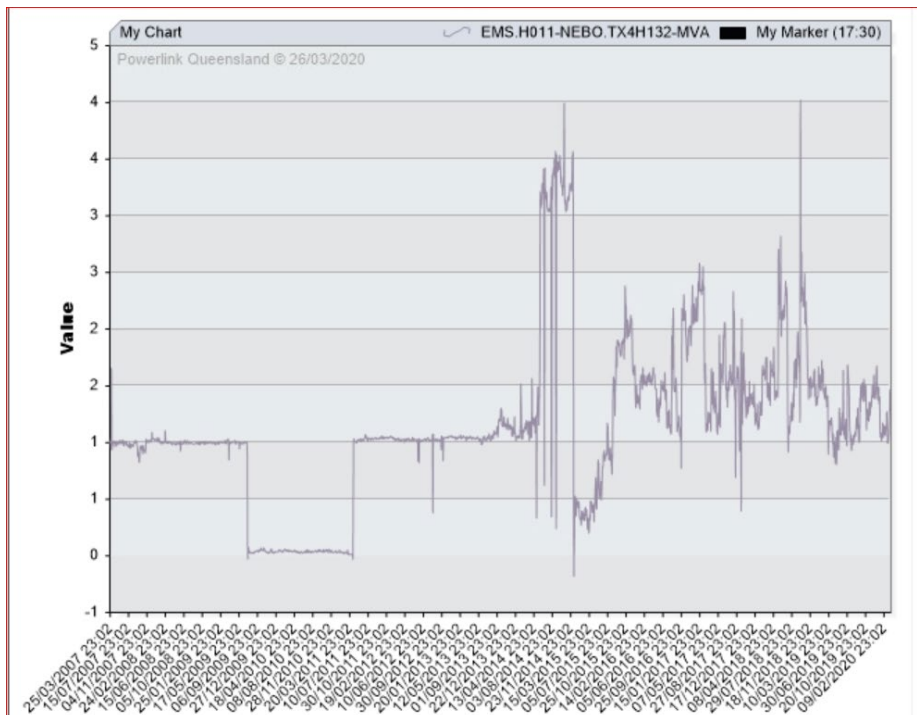
Figure 45 – Transformer No.4 Loading

The average loading between 2007 and 2020 was 1MVA, which is 20% of the nameplate rating, suggesting very light loading over its service life. This explains the relatively high calculated DP value of insulating paper and other cellulose containing materials.

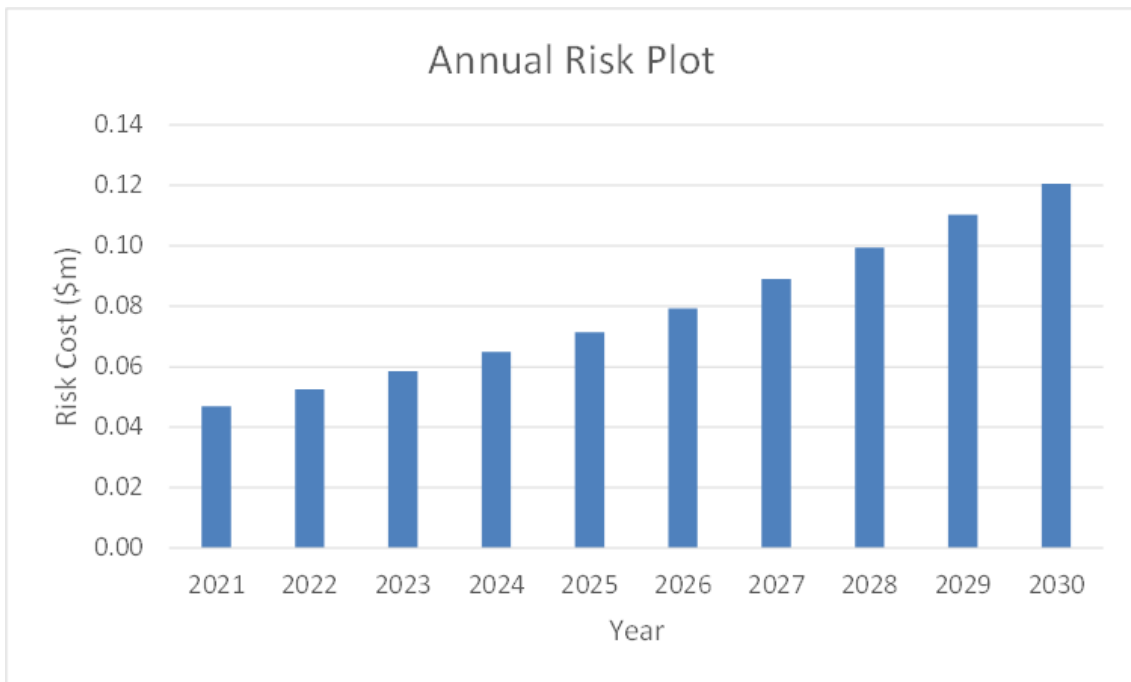
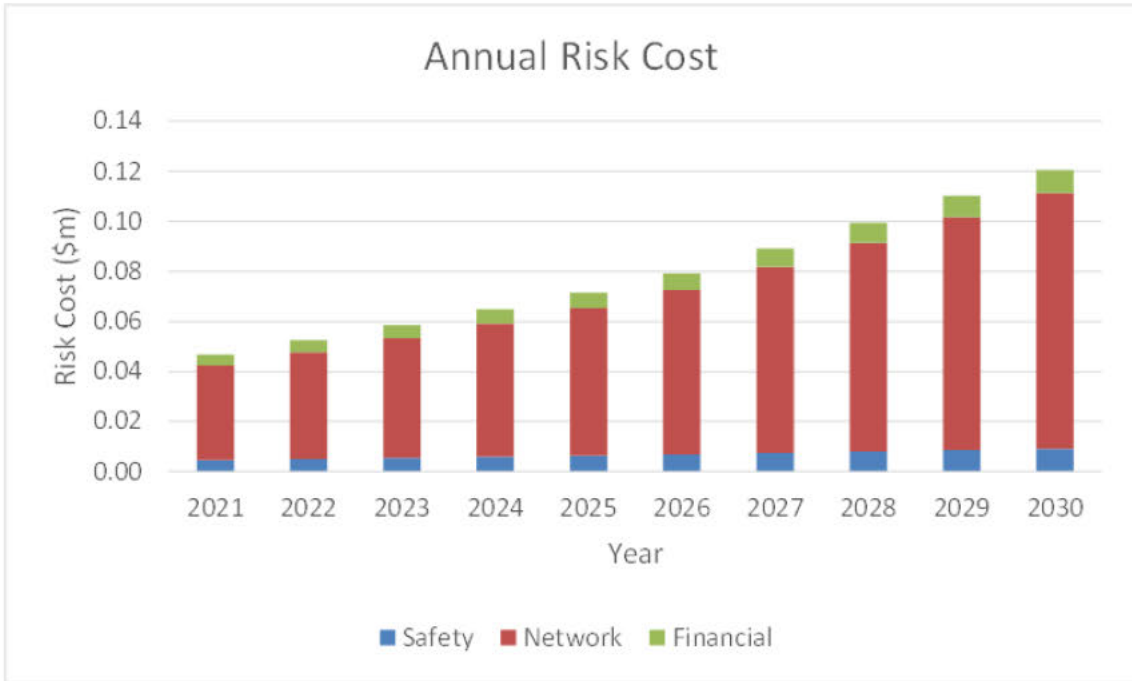
The modelled and extrapolated total base case risk costs are shown in Figures 1 to 4.

Figure 1 – Nebo T3 and T4 total risk cost (10 years)

Figure 2 – Nebo T3 and T4 risk cost (calculated 10 years and extrapolated 20 years)

Figure 3 – Nebo T3 and T4 risk cost (10 years) by risk category

Figure 4 – Nebo T3 and T4 risk cost by risk category (year 2022)
