Asset Management Plan

Power Transformers

Record Number: R32667

Date: October 2017

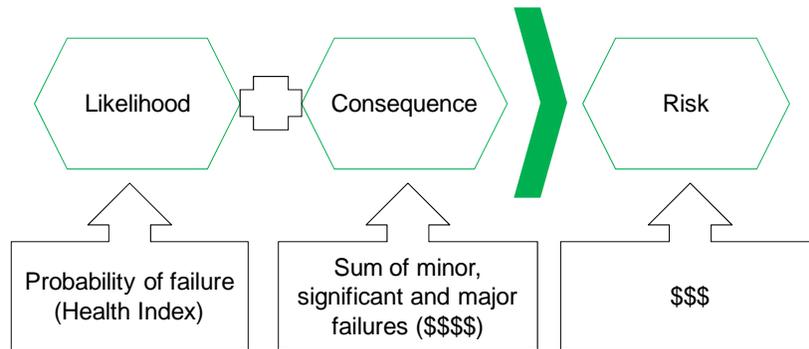
Figure 3: Risk derivation for CBRM

Figure 33 shows what CBRM considers as the two risk inputs.

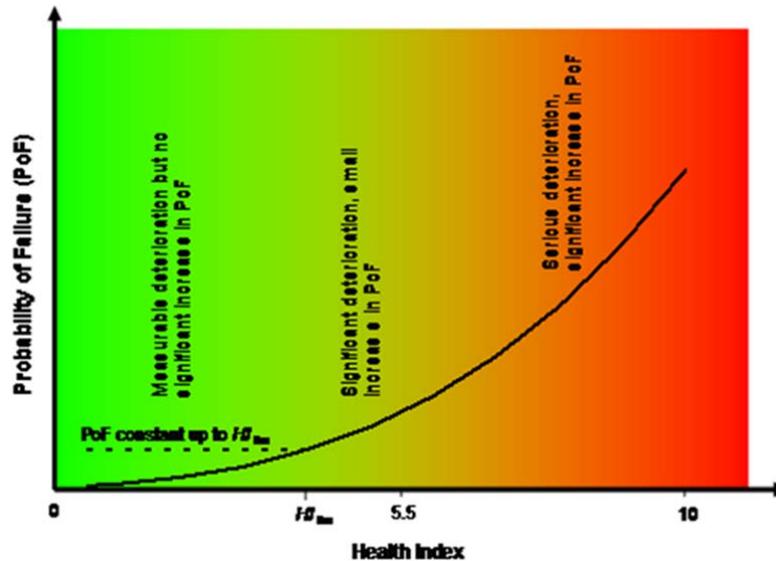
Figure 5: Deriving a probability of failure

Once a health index for an asset is derived, a probability of failure can be found. Notionally, the POF is an exponential function as shown in Figure 55.

It can be seen that assets with a low HI, even up to five, have quite a low probability of failure, but that increases dramatically at higher HIs. The equation and steepness of this curve is calculated independently for each asset based on input data.

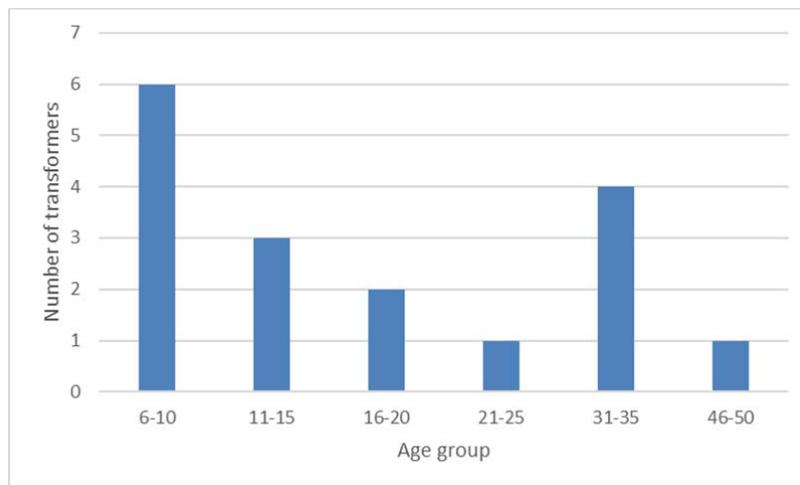
Figure 12: Network transformer age profile (as at October 2017)

The average age of TasNetworks' network transformer population is 18.4 years. There is currently one network transformer that exceeds the economic life of 45 years, and one unit will reach it within the next ten years, as shown in Figure 122.

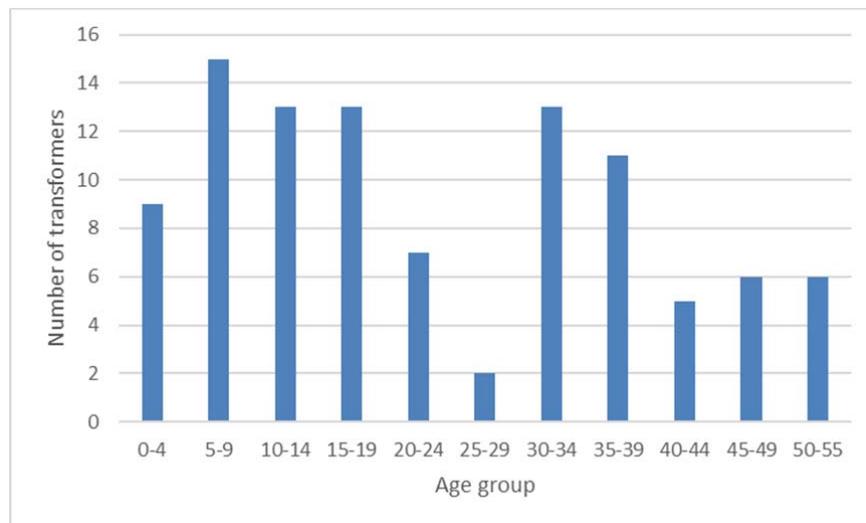
Figure 13: Supply transformer age profile (as at October 2017)

The average age profile of TasNetworks' supply transformer population is 23.2 years. As shown in Figure 133, there is currently 12 supply transformers that exceed the economic life of 45 years, and a further 16 units will exceed it within the next ten years.

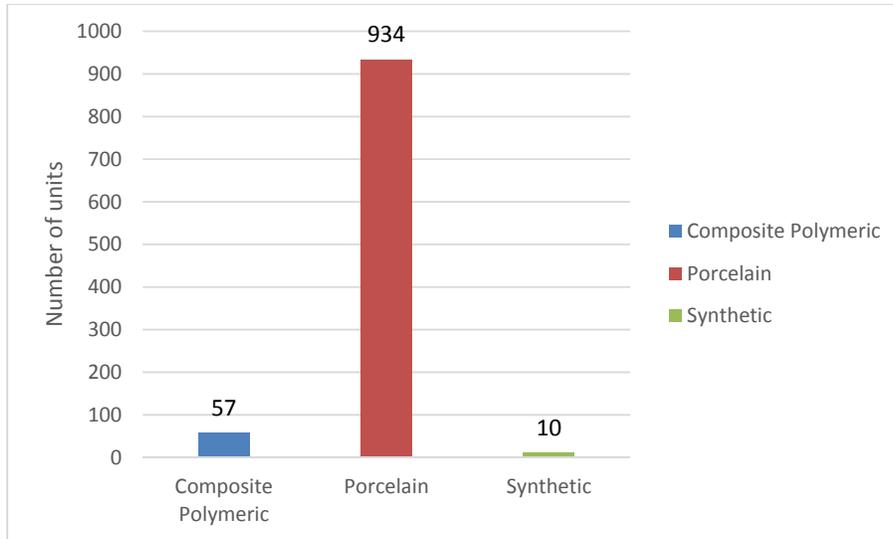
Figure 15: Power transformer bushing types

Figure 155 shows the types of bushings installed in power transformers. The present population is dominated by porcelain types; however this will slowly change as units are replaced with polymeric units as part of the natural transformer replacement regime.

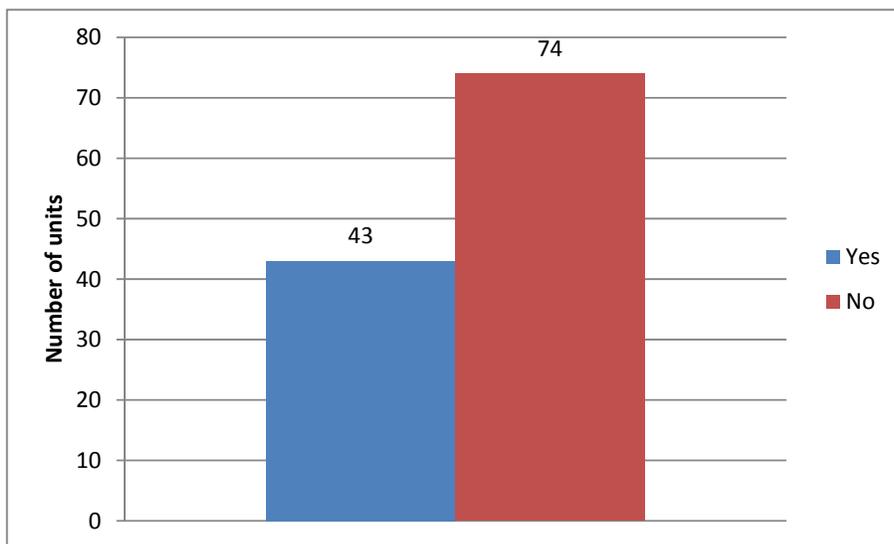
Figure 16: Power transformers with online monitoring system (DRMCC)

Figure 166 shows the number of power transformers that have an online monitoring system installed, typically a DRMMC unit. The program to install online monitoring systems has been in place since the early 2000s. The majority of online monitoring systems were factory installed as part of transformer replacement works. For future transformers online monitoring systems will be installed on an as-needed basis.

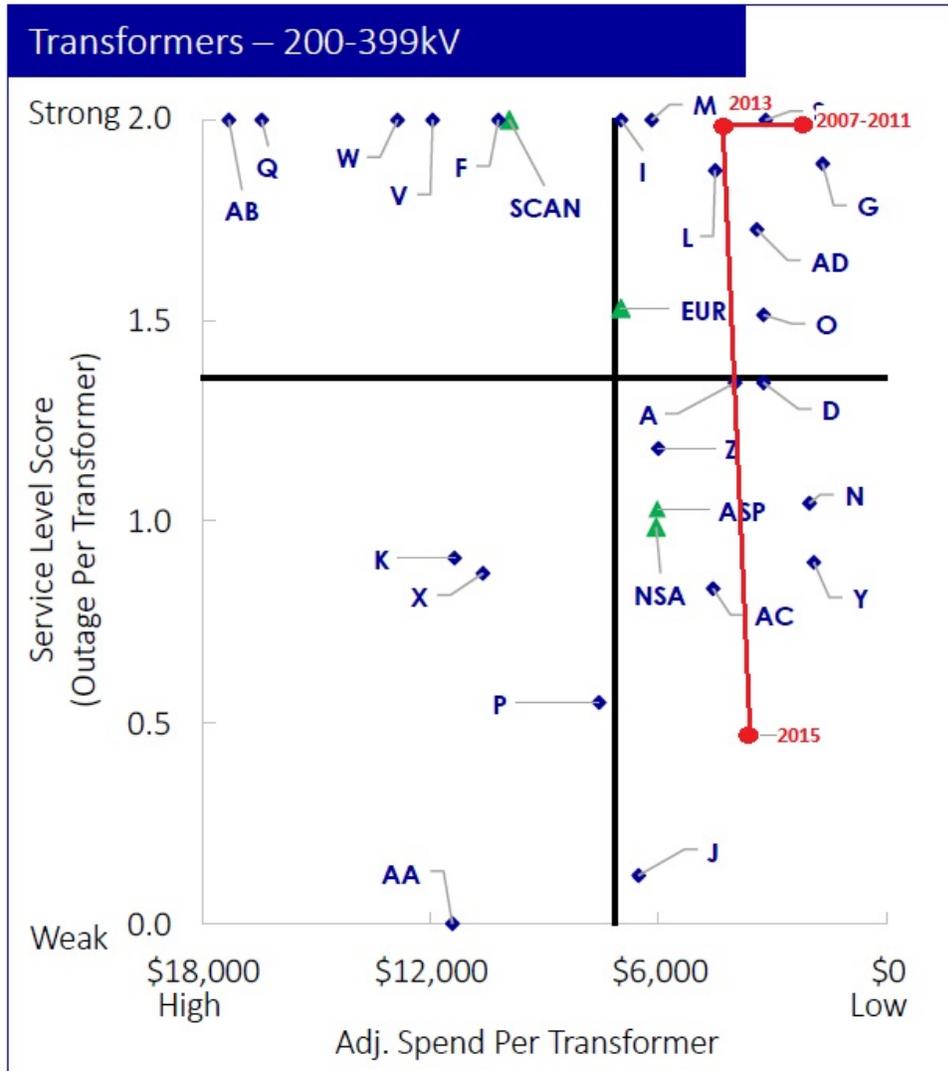
Figure 18: ITOMS network transformers benchmarked performance chart

Figure 18 illustrates TasNetworks' benchmarked performance, in terms of maintenance expenditure and fault outages of TasNetworks' 220 kV Network transformers against all other ITOMS participants for the last four reporting periods. It shows that TasNetworks had consistently maintained a strong service level with low service costs prior to the 2015 results when compared to other transmission companies in the study.

The trend of consistent strong service level scores from 2005 to 2011 was largely contributed to the ongoing review and continuous improvements to maintenance strategies. TasNetworks will continue this practice to ensure minimum operating expenditure whilst maintaining strong service levels.

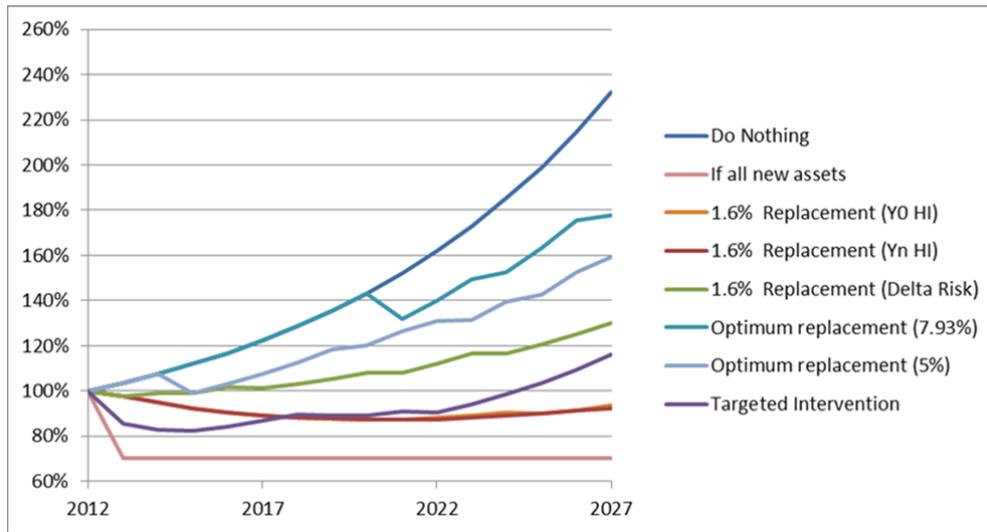
Figure 21: Normalised number of fleet faults

Figure 21 shows that any of the financial based regimes, being optimum replacement or delta risk see an increase in the number of faults across the fleet over time.

The replacement regimes based on health index show a definite improvement in terms of fault performance, which should be obvious, as replacing the units with high health index will reduce the associated probability of failure.

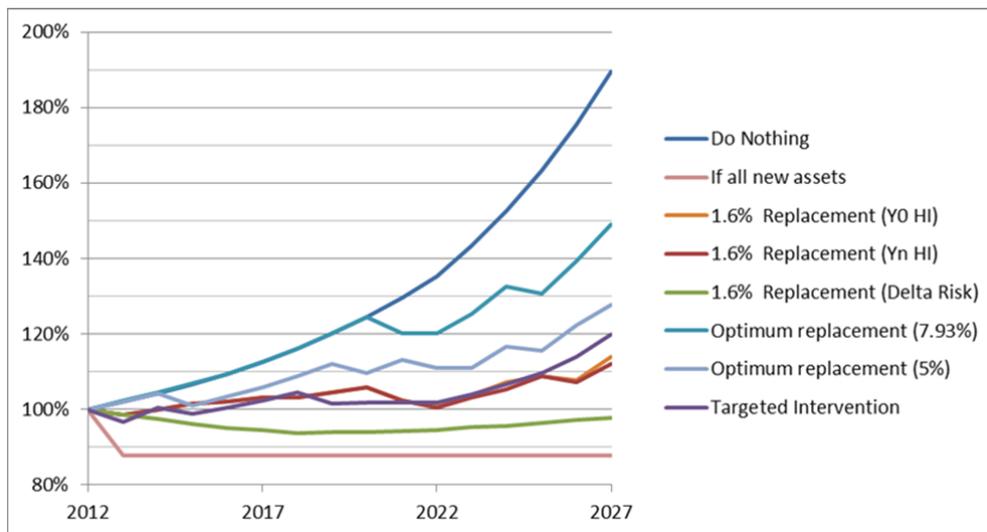
Figure 22: Normalised fleet risk

Figure 22 shows that the optimum replacement timing regimes see an increase in the risk across the fleet over time.

The replacement regimes based on health index show a slight increase in fleet risk over time. This indicates that the units that presently have a high health also coincidentally have high risk.

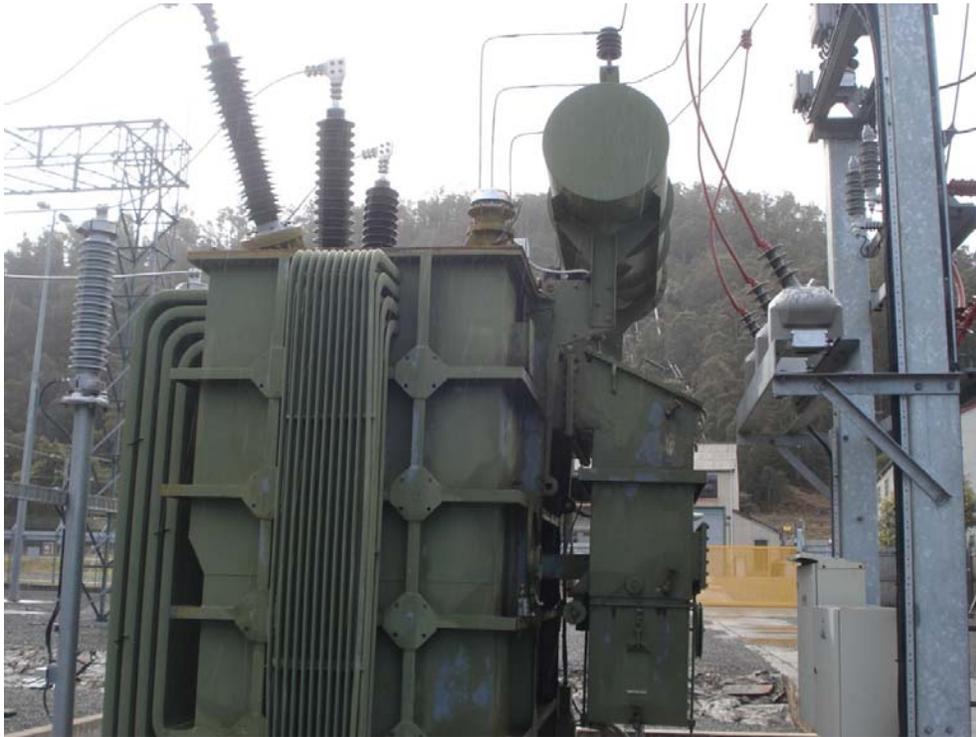
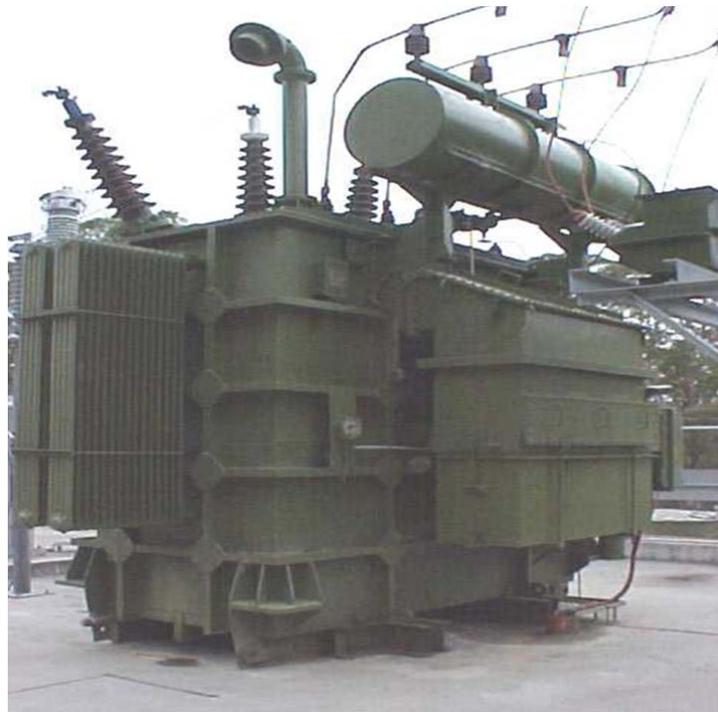
Figure 32: BGE/EPM 5 MVA (old photo having gooseneck and SRBP bushings which have been replaced)

The condition assessment report has identified that Waddamana T1:

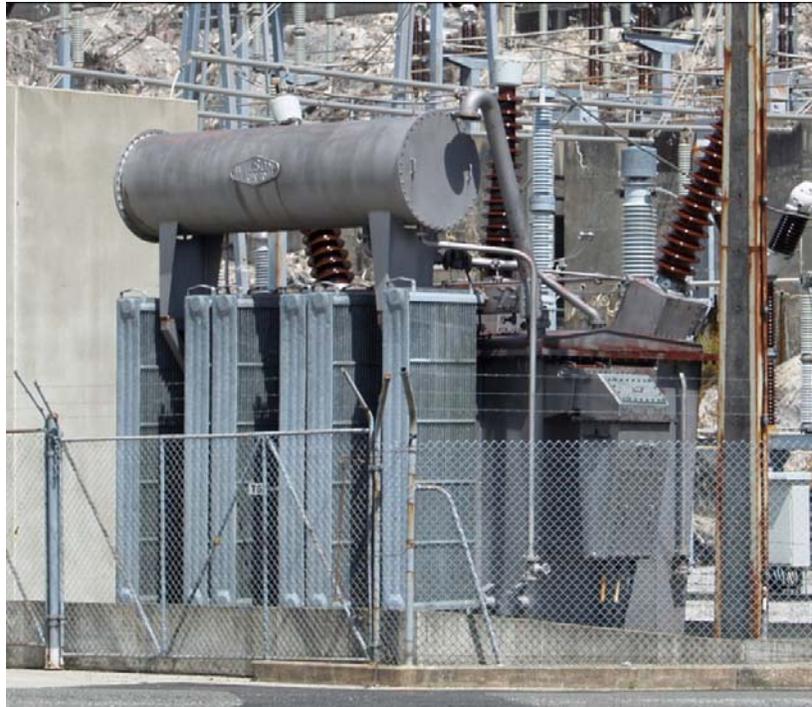
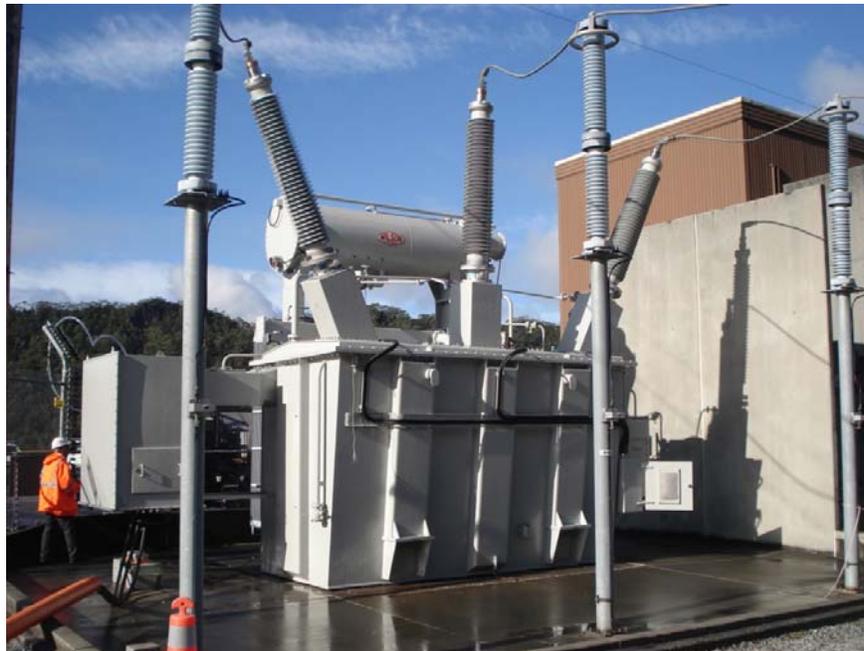
Figure 37: Wilson 10 MVA (before and after bushing replacement)

The condition assessment report has identified that the transformer:

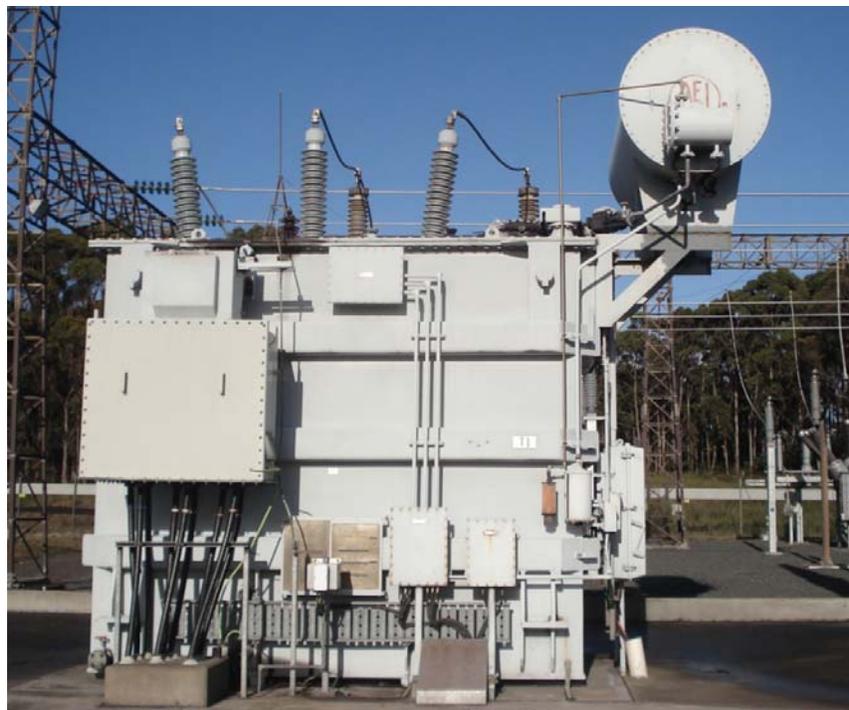
Figure 40: AEI 15/22.5 MVA

All four transformers are in deteriorating condition with oil leaks from cable boxes, main tank lid and also have deteriorating transformer marshalling boxes.

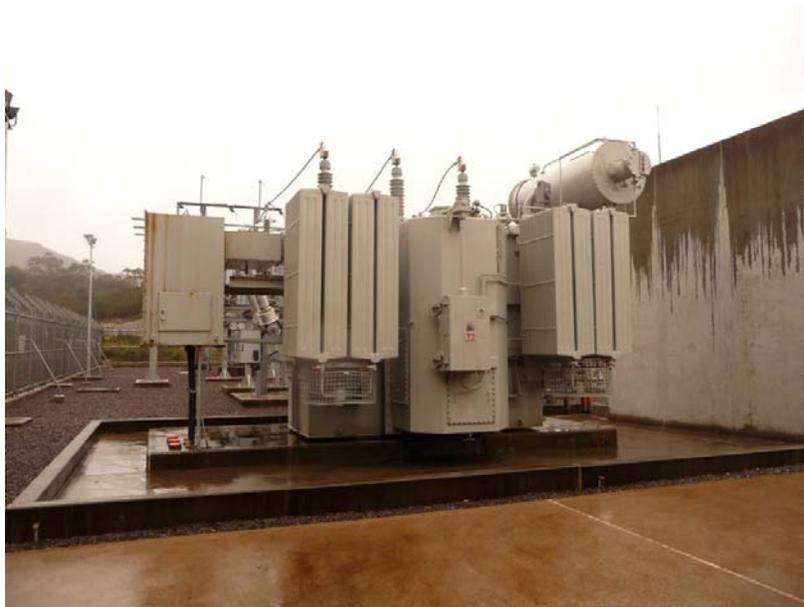
Figure 45: Wilson 22.5/15 MVA

These transformers were in service at Sorell Substation till 2011 and were removed and underwent minor refurbishment in 2012 that included new air insulated cable box, new WTI and OTI and painting of transformers.

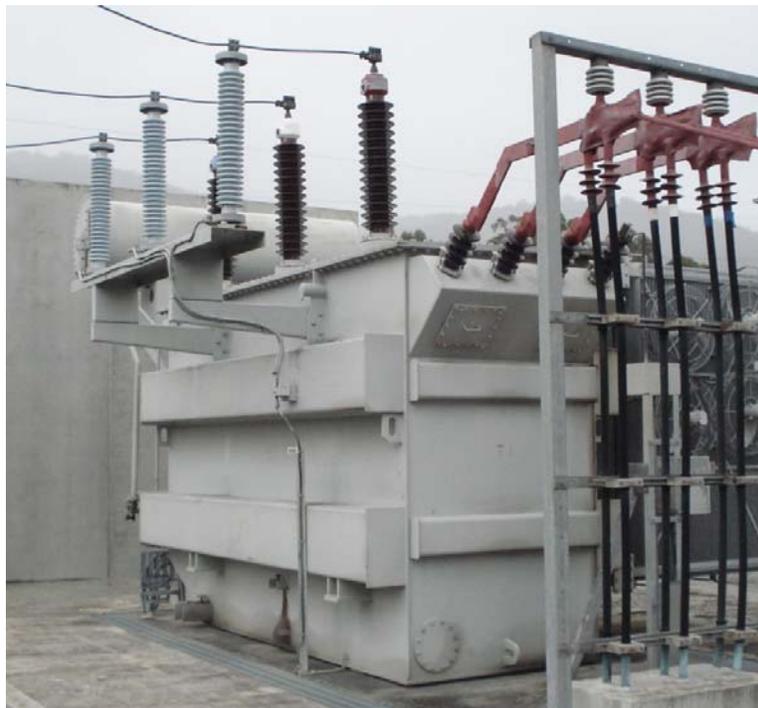
Figure 46: Wilson 12/20 MVA

The transformers are fitted with new WTIs and OTIs with 4-20 mA output for the remote monitoring of transformer temperatures. These units are in an acceptable condition.
