AER Information Request

2025-30

Reference	Root Cause Analysis	Date	September 2024
Attachments to response	N/A

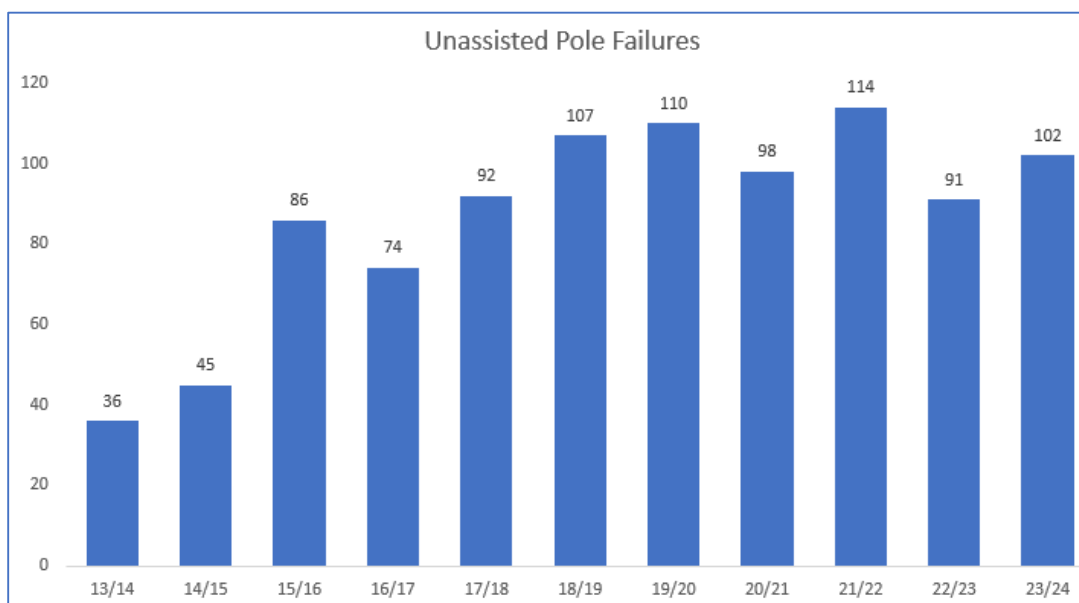
Figure 1 – Unassisted Pole Failures

One of the key indicators over time has been the Code of Practice Works requirement to achieve a 3 year moving average of 99.99% reliability for poles. That is, approximately 97 unassisted pole failures per year. The trend of unassisted pole failures is shown in Figure 1.

- Reported unassisted pole failures were very low through to 2017/18 and well below Code of Practice requirements.
- Volumes for 15/16, 16/17 and 17/18 have been backcast based on current criteria (i.e. inclusion of storm related failures where significant wind speeds or direct lightning strikes did not occur)
- Unassisted pole failure annual volumes went above the threshold in 2018/19 and has consistently been above the 3 year rolling average since then

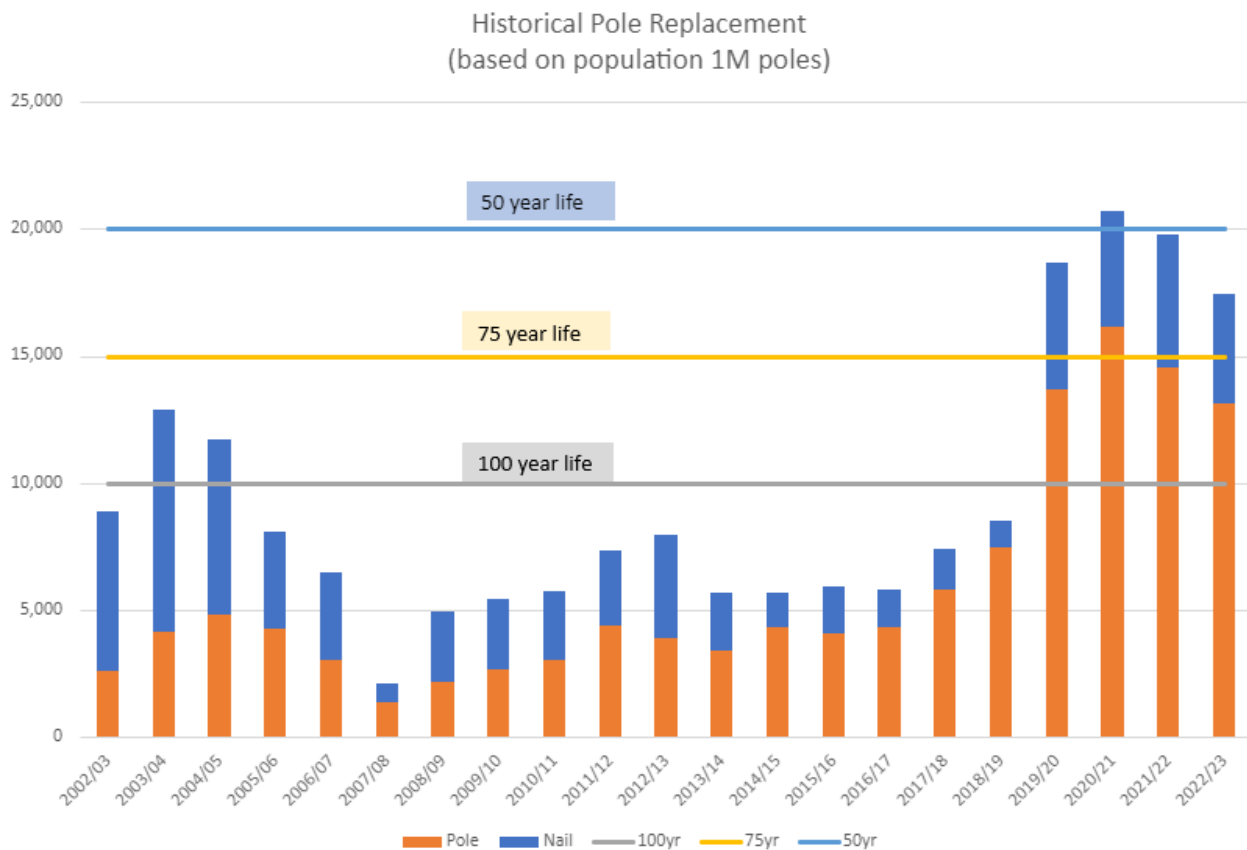
Figure 2 – Pole Replacement and Nailing

As shown in Figure 2, historical pole replacements were very low from the period from 2002/03 through to 2016/17, with an average of about 3,500 poles replaced over this period. When considering the accepted life of a pole of 50 years, let alone 75 year or 100 year lives, this average replacement rate is well below the notional replacement rate required to manage the asset effectively. It is thought that the under expenditure in pole replacements over this period is a likely contributor to the increase in unassisted pole failures and the worsening performance.

As a consequence of this decision, it also meant that defective poles and other defects could remain in service for an additional 2 or 4 years than they would have previously, which is somewhat evident in Figure 2. Modelling and risk assessments at the time assessed this to be a low risk given that the pole population was performing relatively well in terms of unassisted failures.

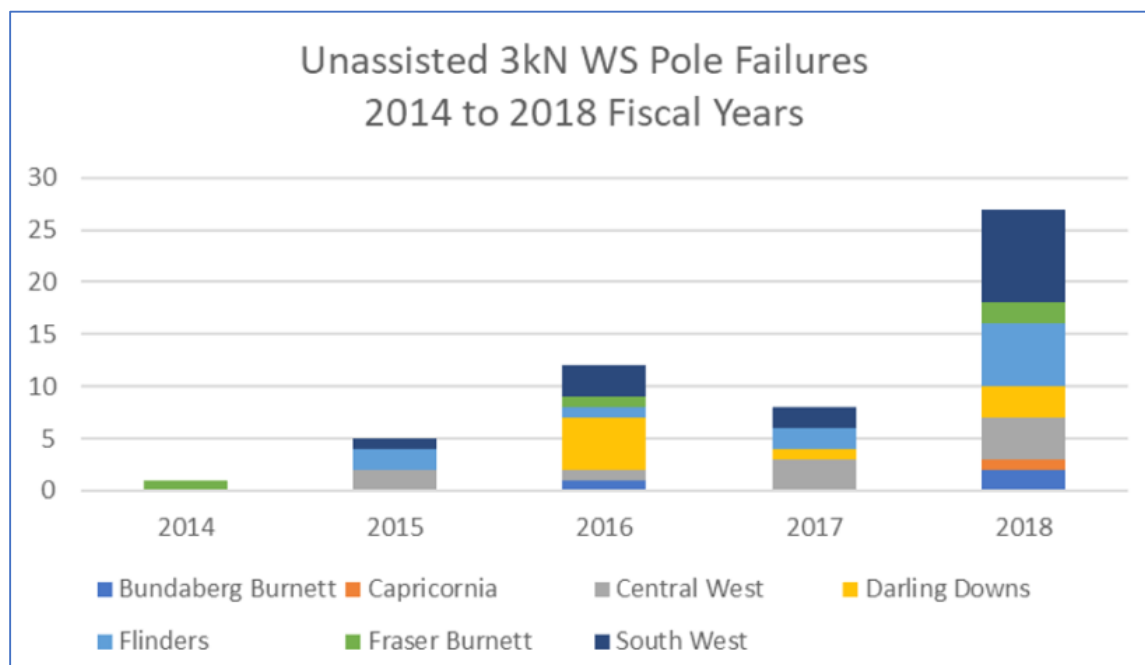
Figure 3 – Unassisted pole failure volumes of 3kN low strength poles 2014-2018

In late 2017, concerns were raised after regular unassisted failures of poles with a nominal strength of less than or equal to 5kN WS. The concerns were driven from two perspectives:

Figure 3 shows the 3kN pole failures that occurred in each operational area over a 5 year period. This information clearly shows the increase in 3kN pole failures that occurred in 2017/18 which triggered the review of the management of low strength poles.

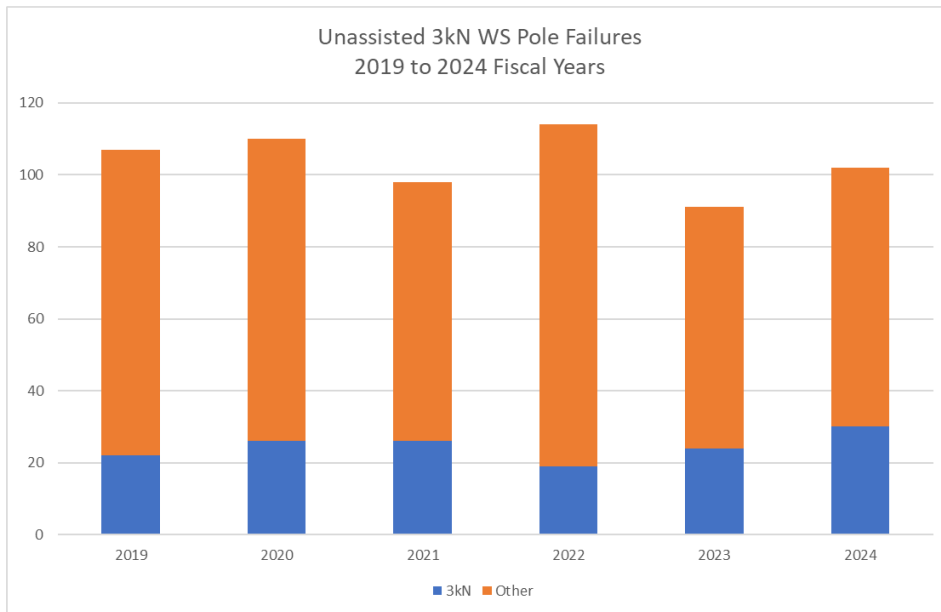
Figure 4 – Unassisted failures of 3kN poles 2019-2024

Unassisted 3kN pole failures have unfortunately remained high since this analysis was completed in 2018 as per Figure 4 below. 3kN poles account for approximately 24% of unassisted pole failures in this time which is very high for a population of 3kN poles that account for approximately 10% of the total pole population.

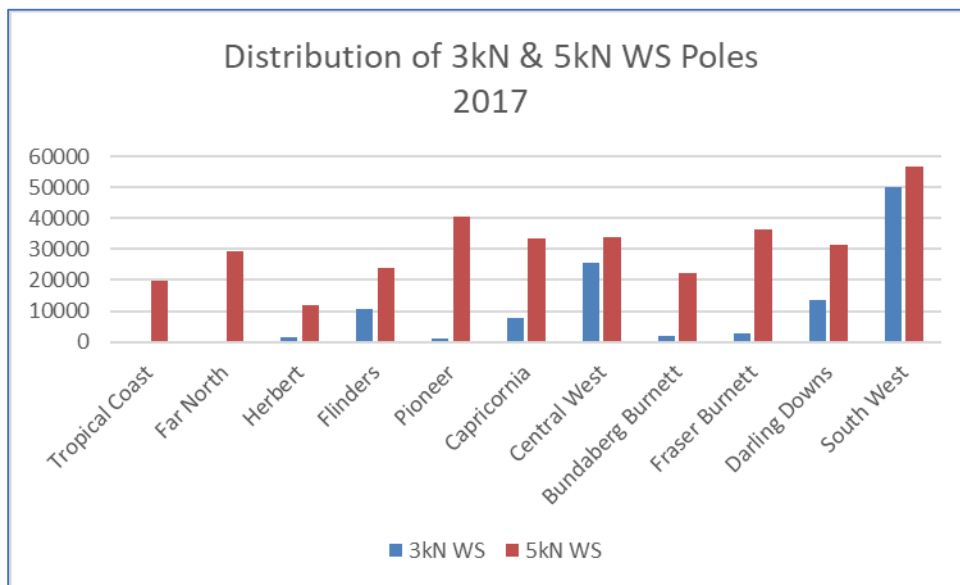
Figure 6 - geographical distribution of 3kN and 5kN poles

Figure 6 shows the distribution of poles with a nominal 3kN and 5kN Working Stress (WS) strength across the Ergon Energy network in 2017. The greatest population of lower strength poles were located in the western areas of the state in wind region A, particularly in the South West and Central West areas.

Based on analysis and investigation of pole failures, concerns were raised about the durability of these poles in dry areas, ability to withstand lightning strikes and identification of defects outside of the “normal” inspection zone where serviceability assessments are generally undertaken.

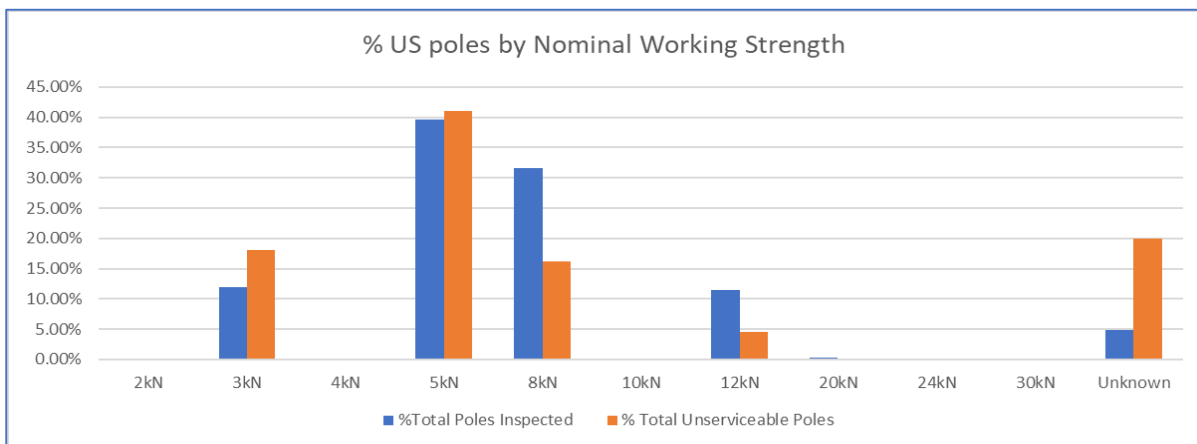
Figure 7 – Percent of US Poles by Strength

Figure 7 shows the percentage of the pole sizes inspected and the percentage of unserviceable poles per size. This shows that particularly for 3kN poles and unknown strength poles, the rate of unserviceability is high compared to the volume inspected.

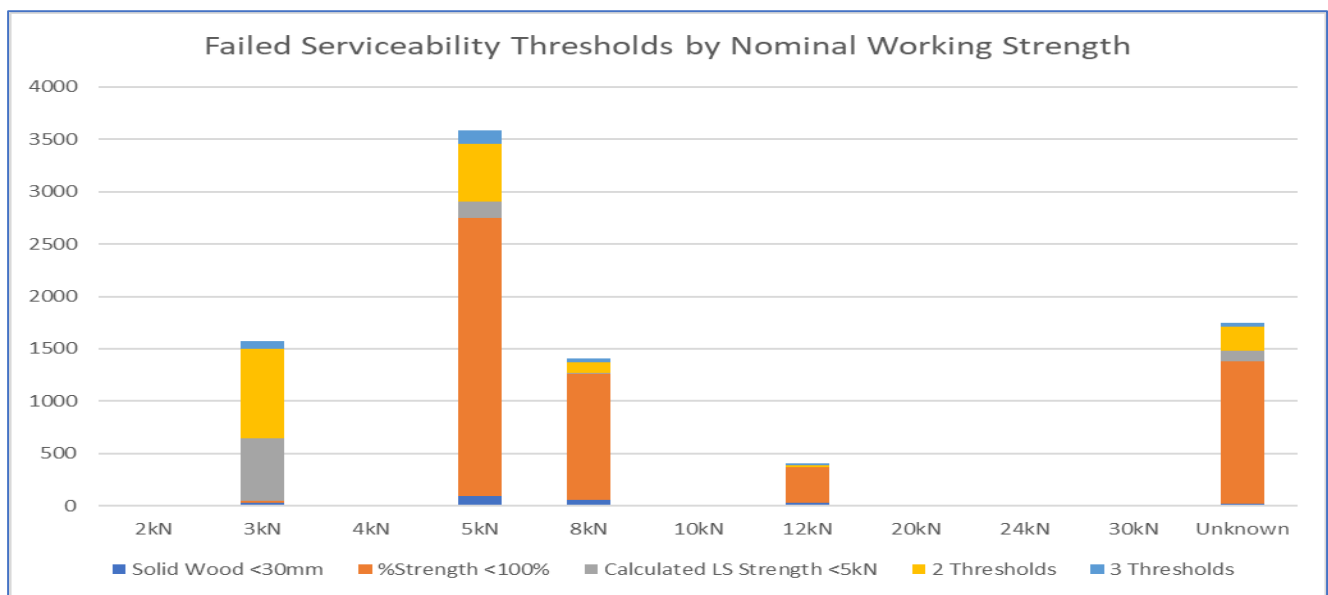
Figure 8 – Breakdown of reasons for failing serviceability

Figure 8 shows the numbers of poles which failed one or more of the three calculated serviceability thresholds, grouped by nominal working stress (WS) strength or pole structure:

- Minimum solid wood less than 30mm
- %Strength less than 100%
- Minimum calculated Limit State (LS) strength <5kN

- The scenarios for a small number of specific pole structures were revised and recalculated to ensure that the required tip loads were refined and reflected appropriately to ensure that the correct poles were deemed to be unserviceable.
- Three additional structures with lower required loads were created to provide greater granularity:
 - Urban HV intermediate (span 60m)
 - Rural intermediate, span <100m
 - Light service pole (span 30m)
- Changes to the nailing criteria to allow the nailing of poles that failed the minimum strength criteria and had a calculated LS strength between 4.5 to 5.0kN (approximately 35% of unserviceable 3kN poles as shown in Figure 9) to enable increased nailing of 3kN poles.

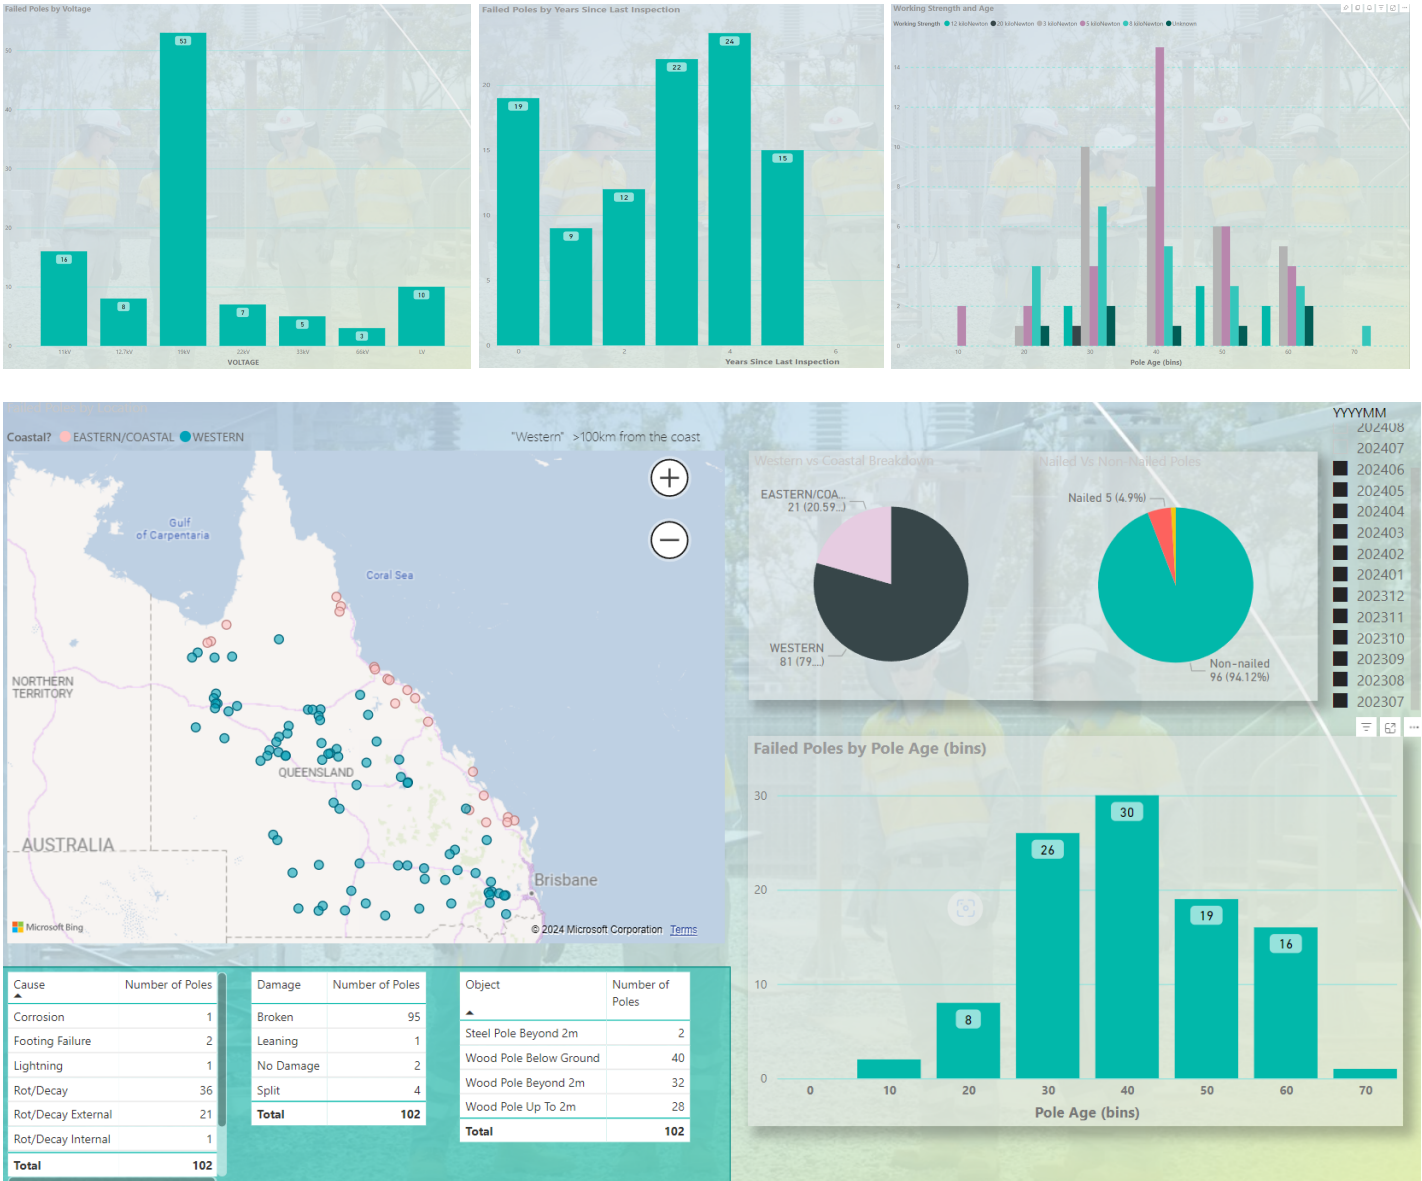
Figure 12 – Unassisted pole failure attribute trends 2023/24

Figure 12 and Figure 13 show the 2023/24 financial year failures and the typical failure information that is trended and reviewed including working strength, age, location, voltage and last inspection outcomes.

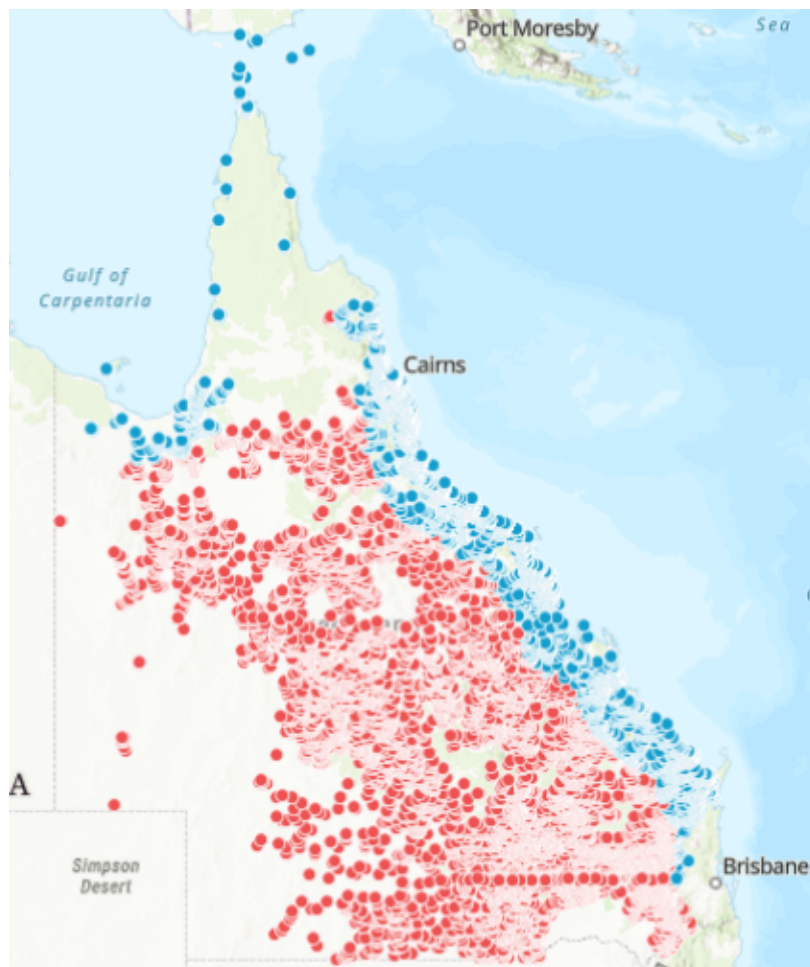
Figure 14 – Map of unserviceable poles

The unserviceable poles are scattered across Queensland as indicate in Figure 14.

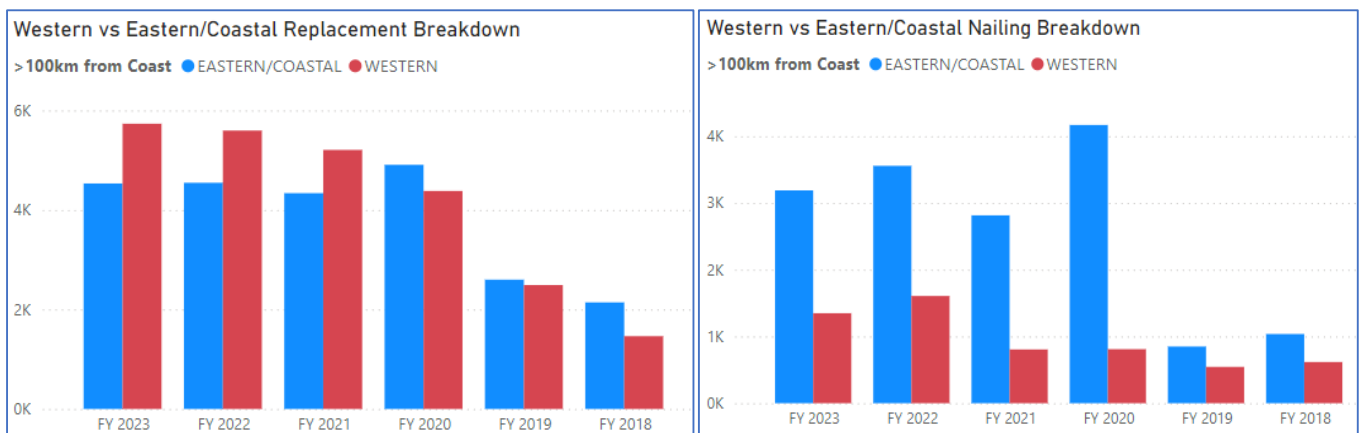
Figure 15 – Pole Replacements (left graph) vs Pole Nailing (right graph)

Figure 15 shows the overall trend in pole replacements. As shown, in FY 2018, FY 2019 and FY 2020, a higher volume of replacements were occurring in the Eastern areas but from FY 2021 onwards and as a result of the pole serviceability calculation improvements implemented in April 2019 and changes to pole nailing suitability criteria, the Western areas account for a higher volume of replacements while the Eastern areas an increase in nailing has occurred.

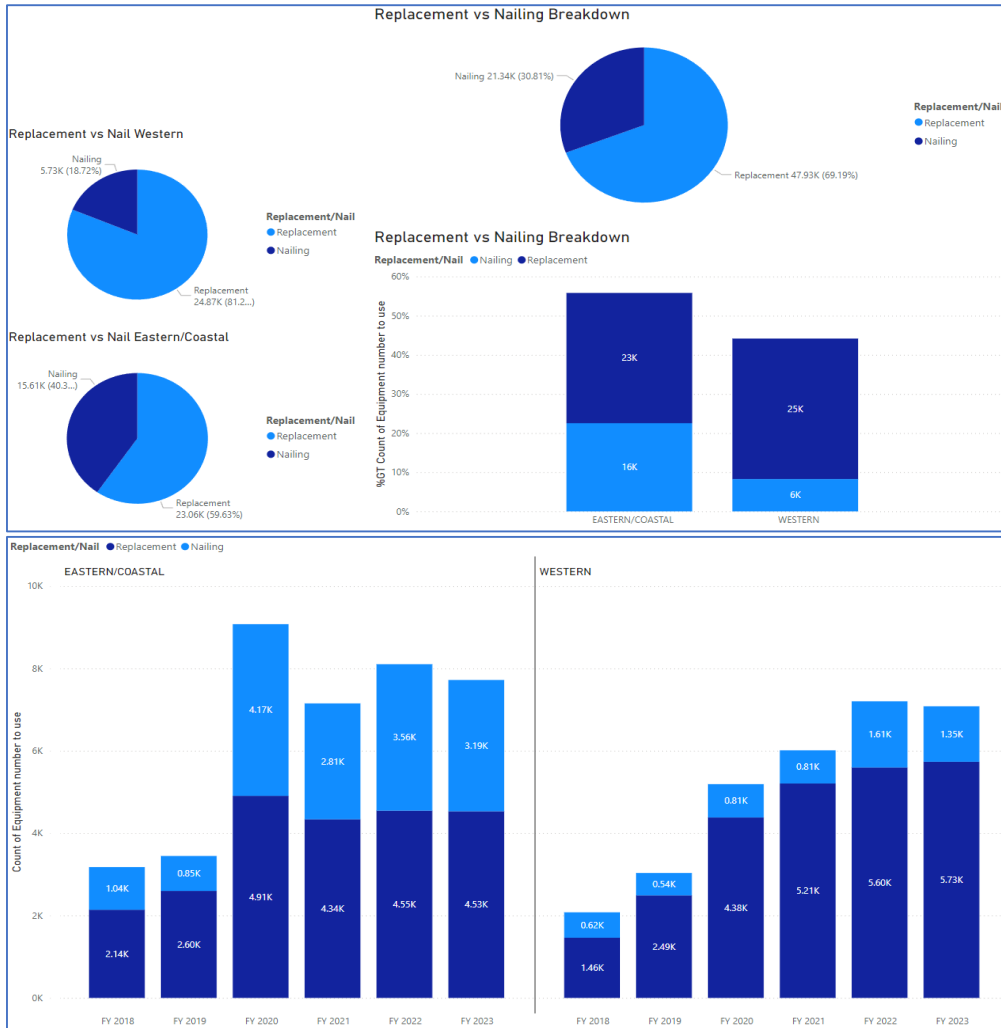
Figure 16 – Pole Replacement versus Nailing

Figure 16 shows the replacement vs nailing rates over the past 6 years.

Overall, a ratio of about 70:30 is maintained between replacement and nailing.

The graph of the Western region replacement versus nailing volumes shows that in 2021/22, an increase is seen in the nailing rates. This is due to a change that was implemented in August 2020 to enable the nailing of poles that had a calculated Limit State Strength between 4.5kN and 5kN.

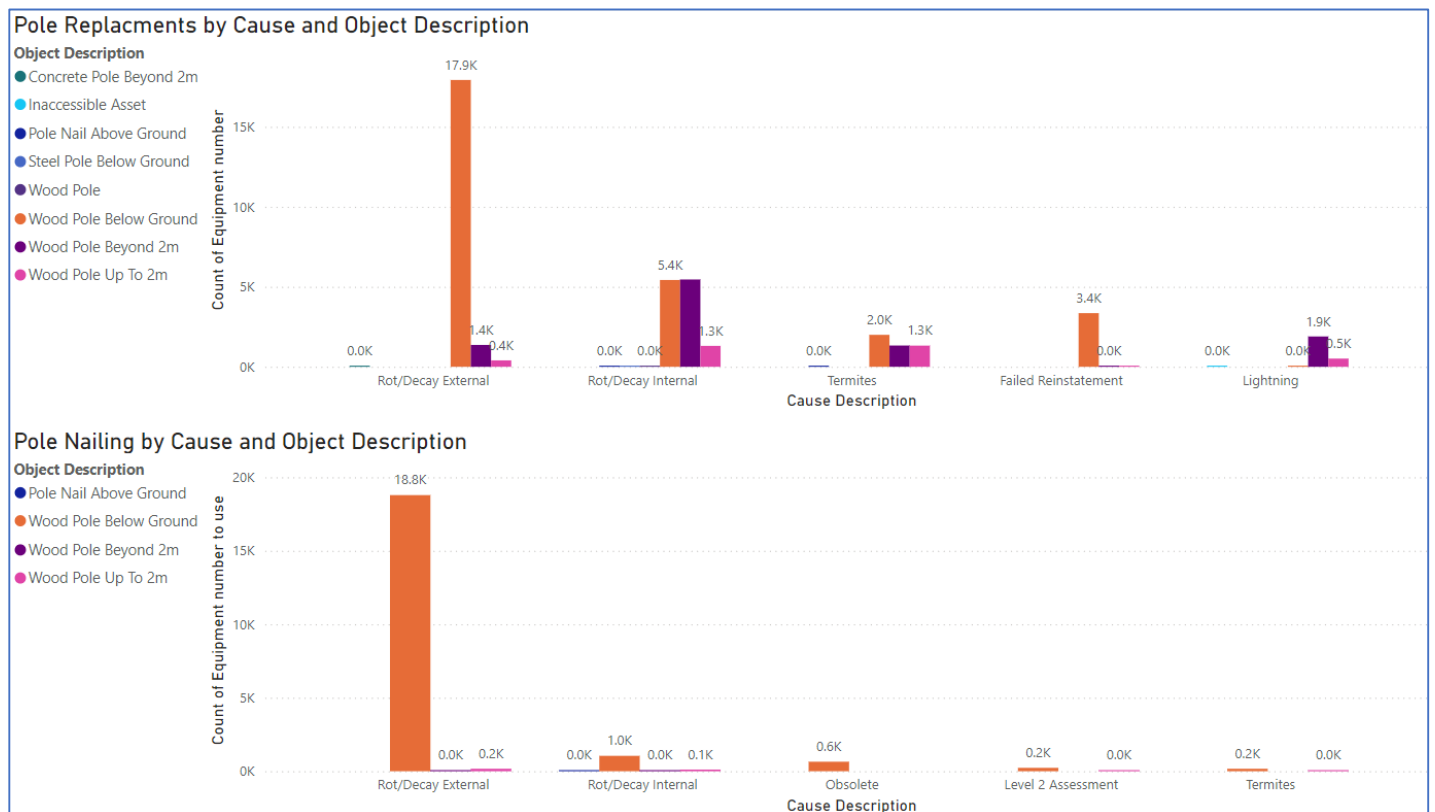
Figure 17 – Unserviceable poles by Object and Cause

Figure 17 shows a split of the top 5 causes of poles becoming unserviceable (x axis) and the location and material of the pole where it is unserviceable. This data clearly shows that the predominant reason for unserviceable poles is rot/decay (primarily external) and termite damage.

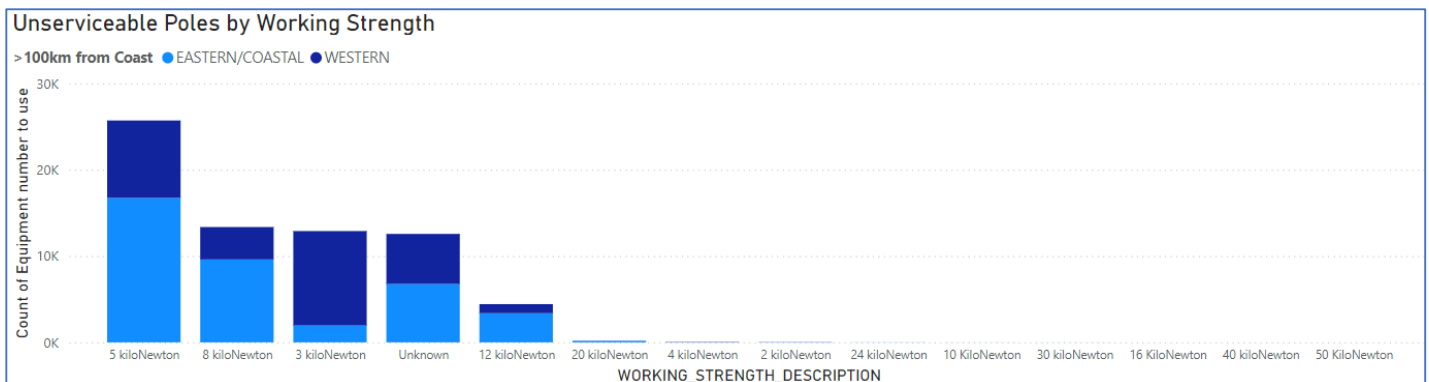
Figure 18 – Unserviceable poles by working strength

Figure 18 shows the pole strengths that are most prone to becoming unserviceable.

The predominant working strength that fails the serviceability assessment are 5kN and 8kN poles however this is due to the high population of these poles in the network. Of interest is the volumes of 3kN and unknown strength poles that are unserviceable.

There is a population of approximately 94,000 3kN poles remaining in the network. For 3kN poles this translates to an unserviceable rate of approximately 16% (of the 3kN poles inspected). By comparison, for 5kN poles, with a population of approximately 322,000, the unserviceable rate is approximately 6.5%.

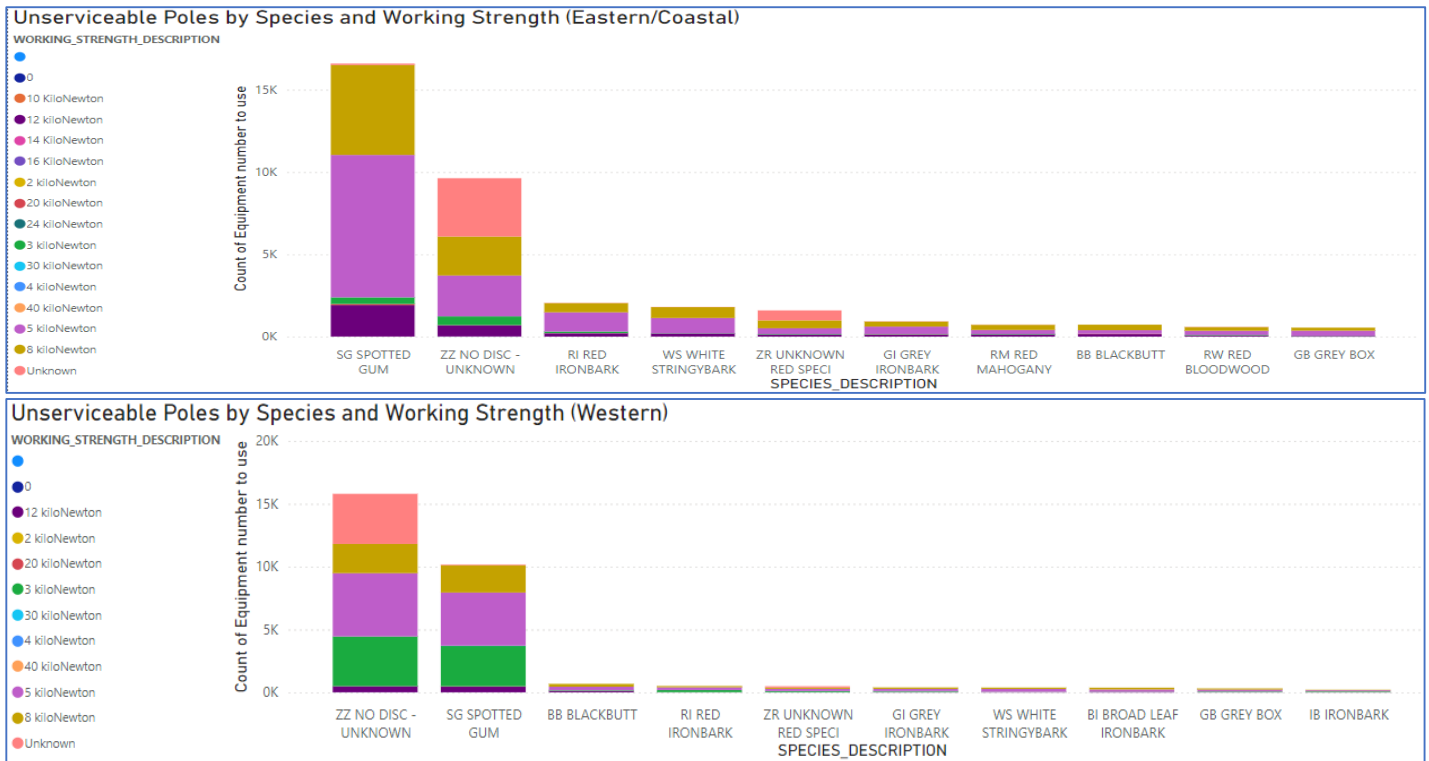
Figure 19 – Unserviceable poles by species

As shown in Figure 19, the predominant timber species of Ergon’s wood poles is Spotted Gum at around 46% of the total population and therefore it is also the predominant species of pole that is replaced. Poles with an Unknown species make up approximately 15% of the population and have the highest replacement rate based on the population. The majority of Ergon Energy wood poles are Strength Group S2 and Durability Class 2.

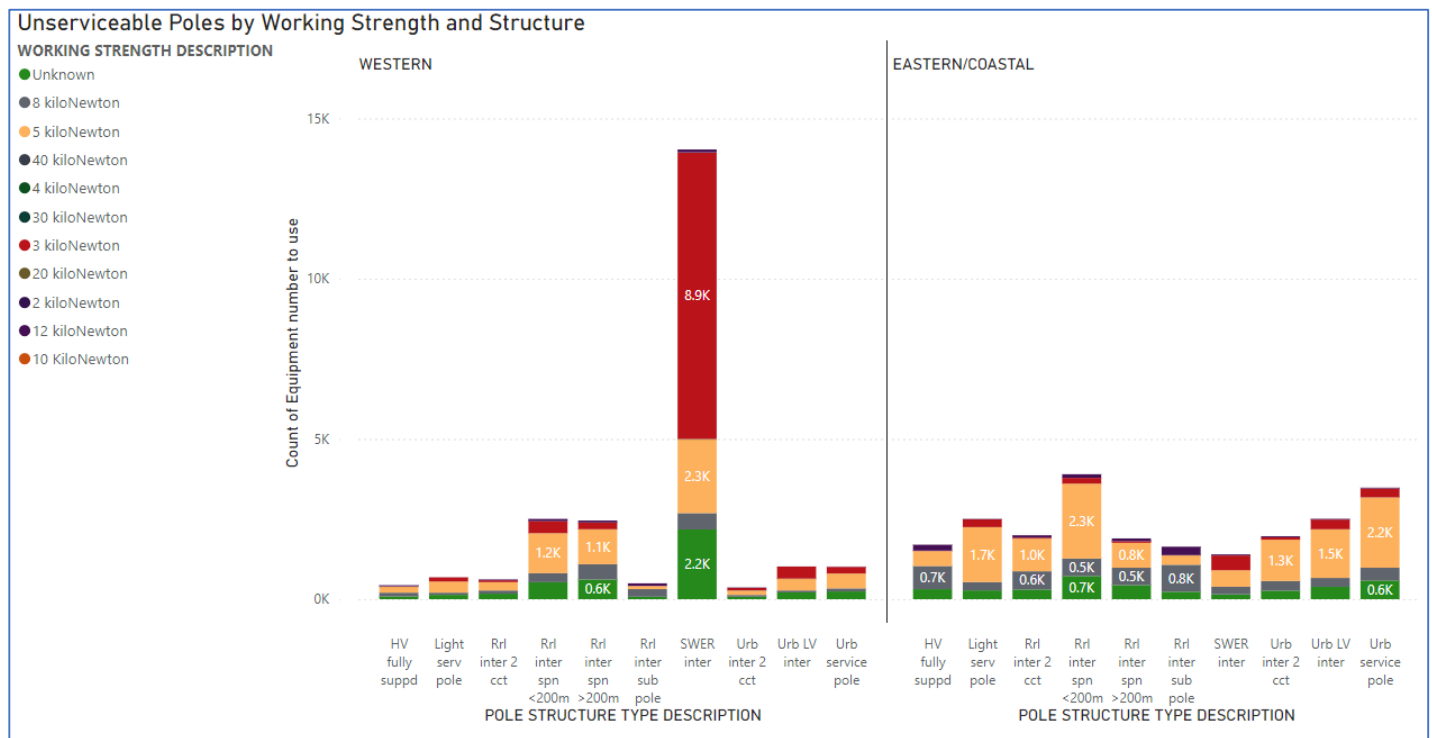
Figure 21 – Unserviceable poles by working strength and pole structure

Ergon Energy uses Pole Structures as part of the serviceability assessment process to define the pole tip load supported by that pole. The most common structure is SWER intermediate which is a lightly loaded structure with a single, small SWER conductor attached at a higher tension than in urban areas and with an average span length of 200m. As shown in Figure 21, 3kN poles were installed commonly for the SWER intermediate construction and are the most common combination of strength and structure to become unserviceable. Note that this data only shows the top 10 pole structures per volume – there are 81 Pole Structures to select from when completing the serviceability assessment.

This graph clearly shows majority of unserviceable 3kN SWER poles in the Western region.

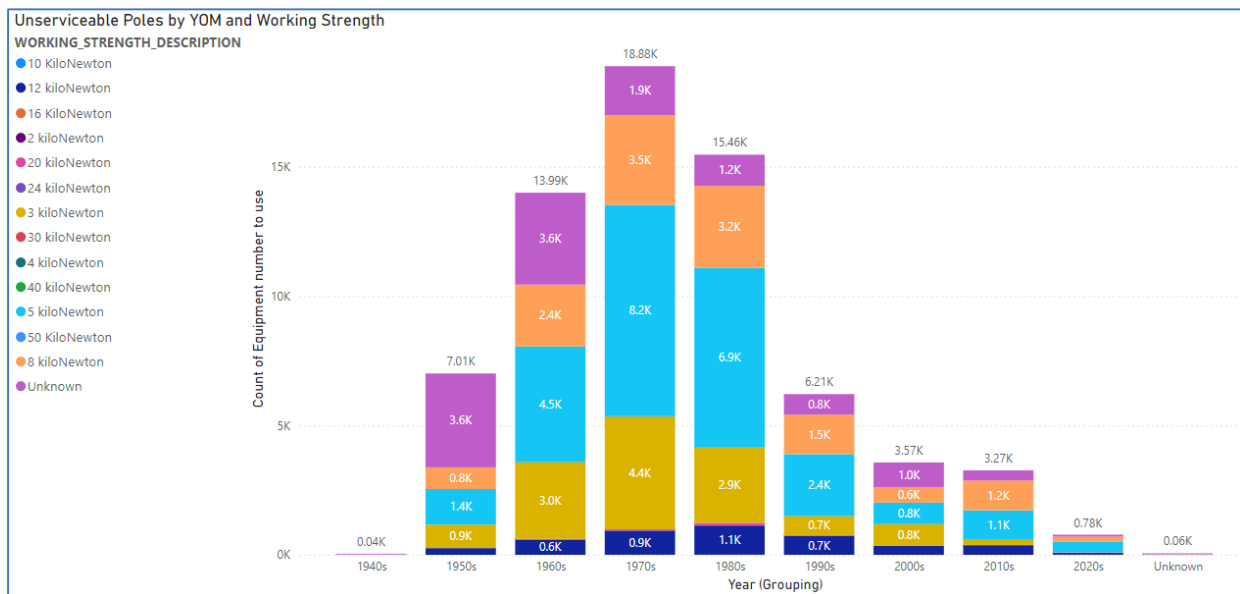
Figure 22 – Unserviceable poles by year of manufacture

Figure 22 shows information about the year of manufacture of the poles that are made unserviceable and the working strength of these poles. The data shows that the majority of the poles that are unserviceable are aged >40 years old with a high volume of 5kN and 3kN strength ratings. 73% of 3kN poles were installed in Western areas prior to 1990. The volume of 3kN poles failing serviceability assessment significantly reduces as the year of manufacture is greater than 1990, which aligns with the smaller population of 3kN poles of that more recent vintage in service in the network.

Of poles over 40 years old, failed reinstatement is a significant volume which captures nailed poles where the nail is no longer effective in supporting the pole.

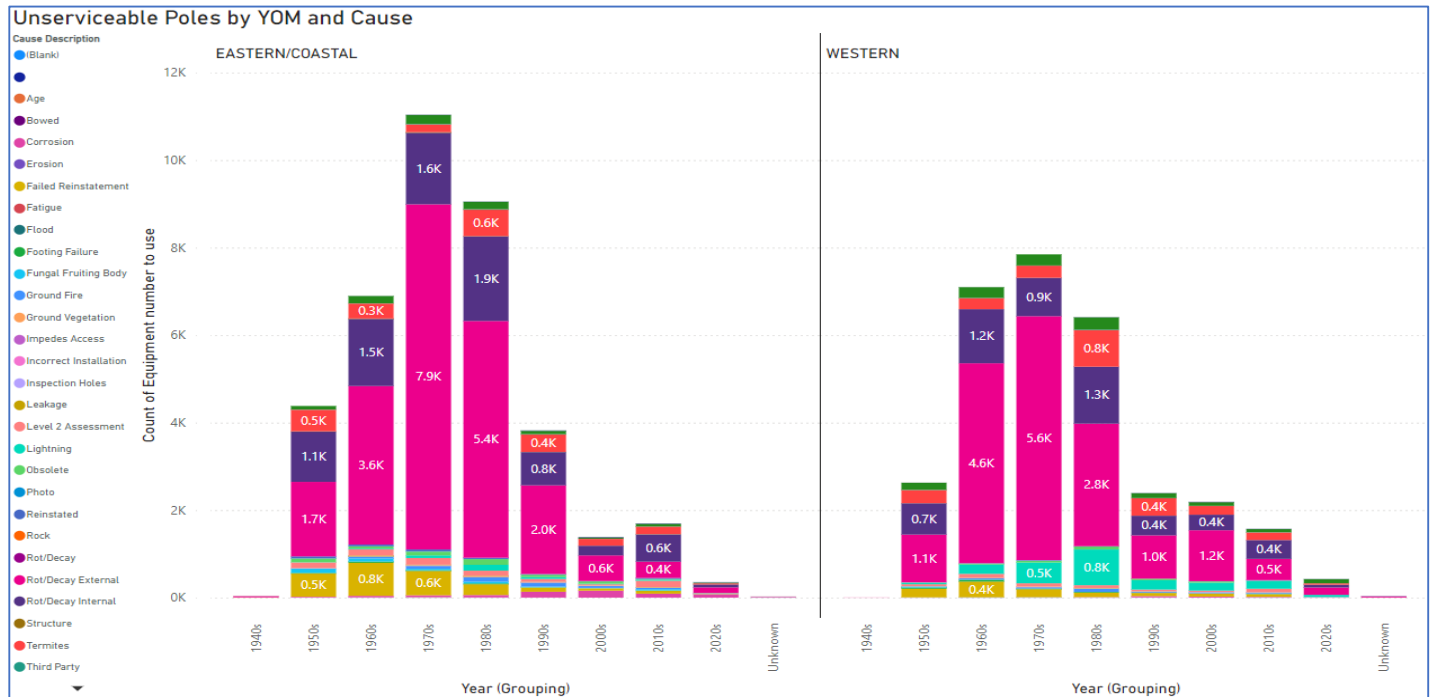
Figure 23 – Unserviceable poles by year of manufacture and cause

Figure 23 shows the age of the unserviceable pole against the cause of the pole being unserviceable. The dominant cause of unserviceable poles is rot/decay which may be internal and/or external as indicated by the larger pink and purple sections of the columns.

In Western areas, lightning is the cause of a number of unserviceable poles across all age ranges as severe storms are prevalent during summer months. Some of these may be lightning strikes that occurred some time ago but the pole has remained in service until the visual inspection of the degradation has deemed it unserviceable.

Termite damage is a significant cause of unserviceable poles in all areas but particularly in Western areas. The 2 most damaging termite species in Australia are prevalent in Western areas, namely Mastotermes, the most destructive species in Australia, and Coptotermes, the species with the most economical impact (refer to *Pests of Timber in Queensland*, B.C. Peters, J. King, F.R. Wylie, Queensland Department of Primary Industries, 1996).

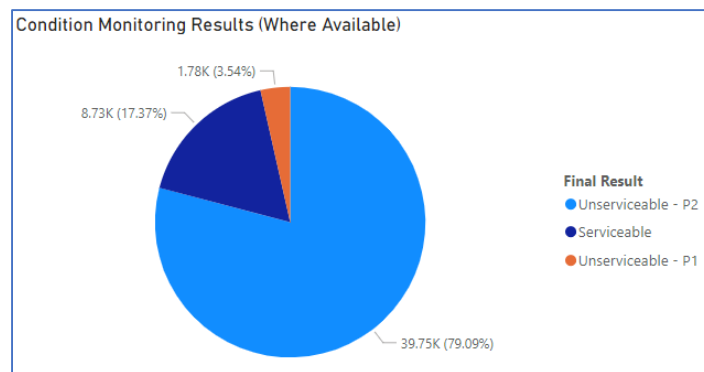
Figure 24 – Determination of pole serviceability

Figure 24 highlights that 82.63% of unserviceable poles are purely determined based on the results of the pole serviceability calculations. 17.37% of unserviceable poles are identified based on visual assessment of the condition of the pole.

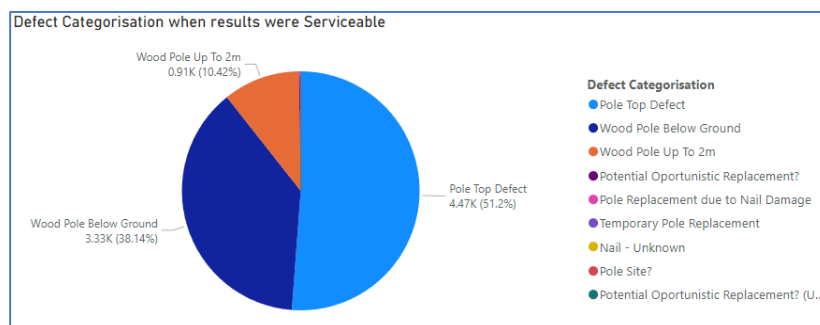
Figure 25 – Location on pole related to unserviceable determination

As per Figure 25 below, of those unserviceable poles identified through visual assessment, over 50% are due to deterioration at the top of the pole which isn't subject to the serviceability assessment calculations and measurements. These are generally related to lightning strikes and stays or other fittings that are wrapped around or embedded in the timber causing deterioration and rot/decay to form.

Visual assessment of below ground condition contributes 38%. A small number of visual assessments are due to identified fungal fruiting bodies, or splits or cracks through the pole where substantial loss of cross-sectional area has not yet occurred. The majority are based on the inspector's observation of the deterioration and level of rot/decay or termite damage of nailed poles below ground. Condition monitoring measurements for nailed poles are taken at the top of the nail and below ground degradation is not reflected in the calculated results.

Visual assessment of the pole up to 2 metres from the ground is the other main component and this will generally be caused by deterioration or damage caused by bushfire, third party impacts, rot/decay and termite damage.

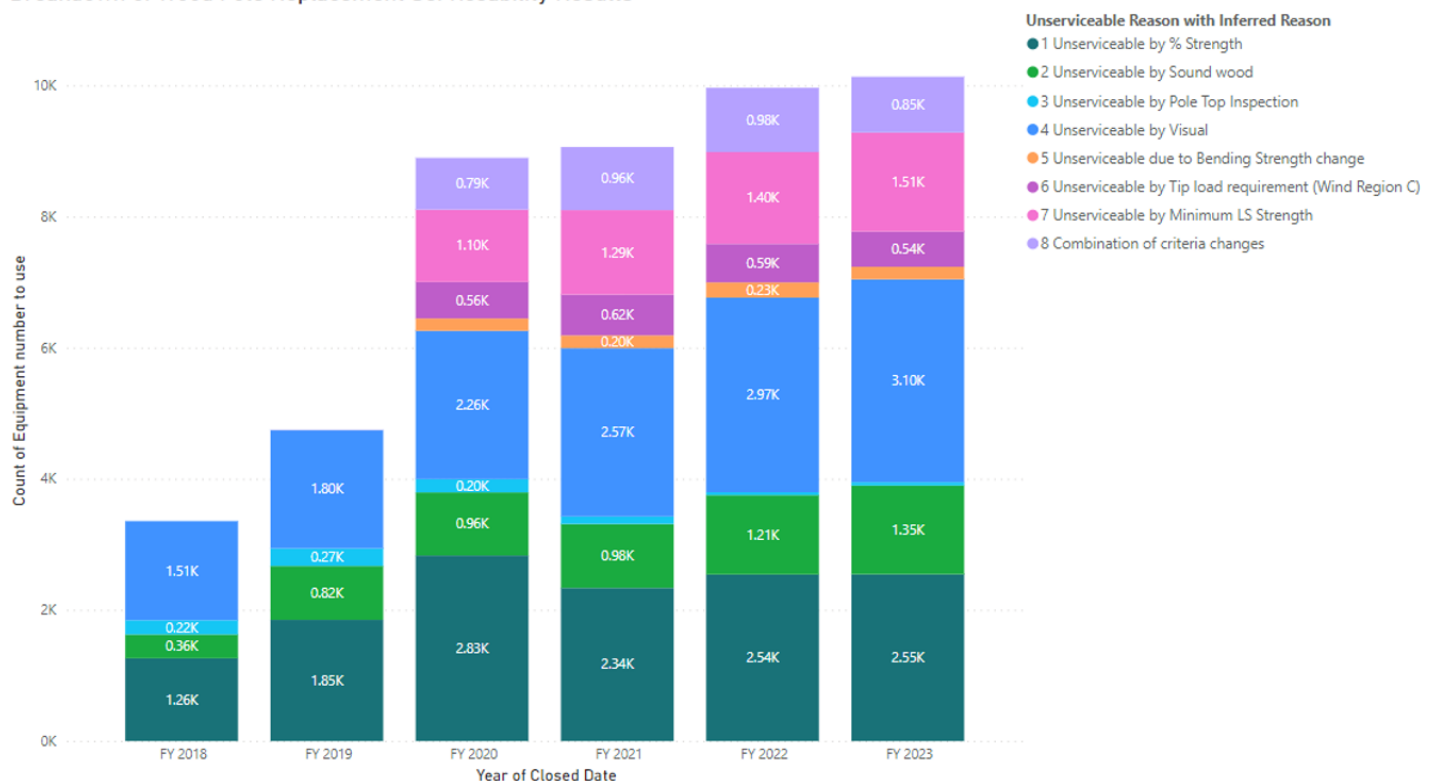
Figure 26 – Impact of changes to pole serviceability calculations on wood pole replacement volumes (all poles)

Figure 26 shows an increase in the number of pole replacements driven from serviceability assessment from FY2020 to FY2023, when compared to those in FY2018 and FY2019. The work order and condition monitoring results have been analysed for all unserviceable poles to identify the numbers which can be attributed to each of the following categories that reflect the modification made to the pole serviceability calculations in April 2019 in addition to categories of unserviceability that were in place prior to these changes:

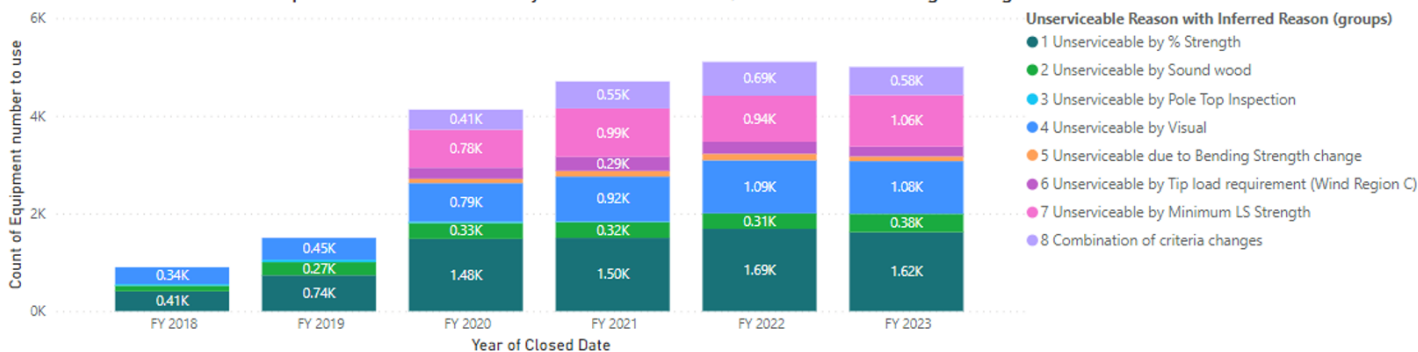
Figure 27 - Impact of changes to pole serviceability calculations on unserviceable pole volumes (low strength poles)

The implementation of the minimum calculated strength threshold has the greatest impact on unserviceable pole replacement volumes and is particularly evident for lower strength poles (2kN and 3kN) as demonstrated in Figure 27. The majority of low strength poles are located in western Queensland, therefore there are low numbers of unserviceable low strength poles impacted by the tip load change in wind region C.

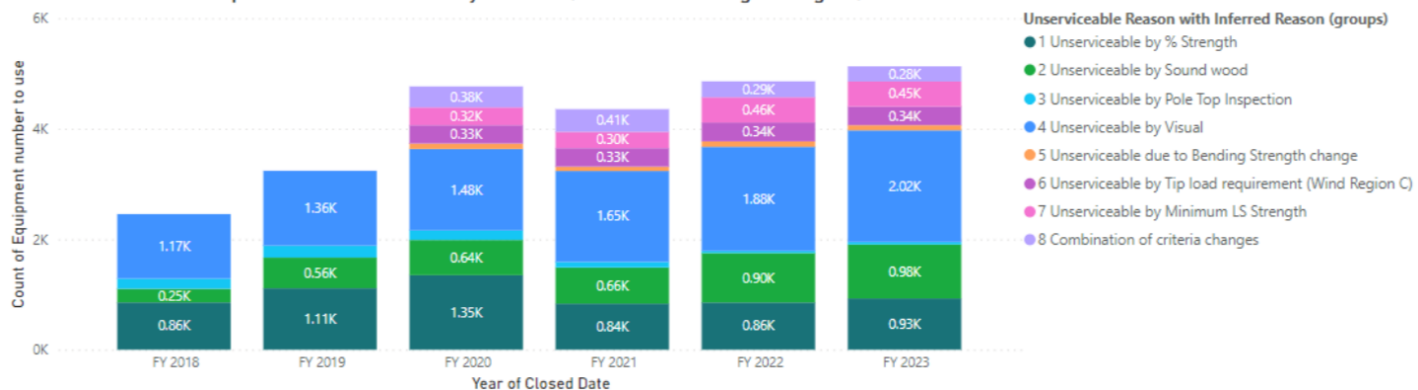
Figure 28 - Impact of changes to pole serviceability calculations on unserviceable pole volumes (higher strength poles)

Figure 28 shows the lower impact of the minimum calculated strength threshold for poles with larger nominal working strengths. However, it has had a larger impact on Eastern Wind region C poles.

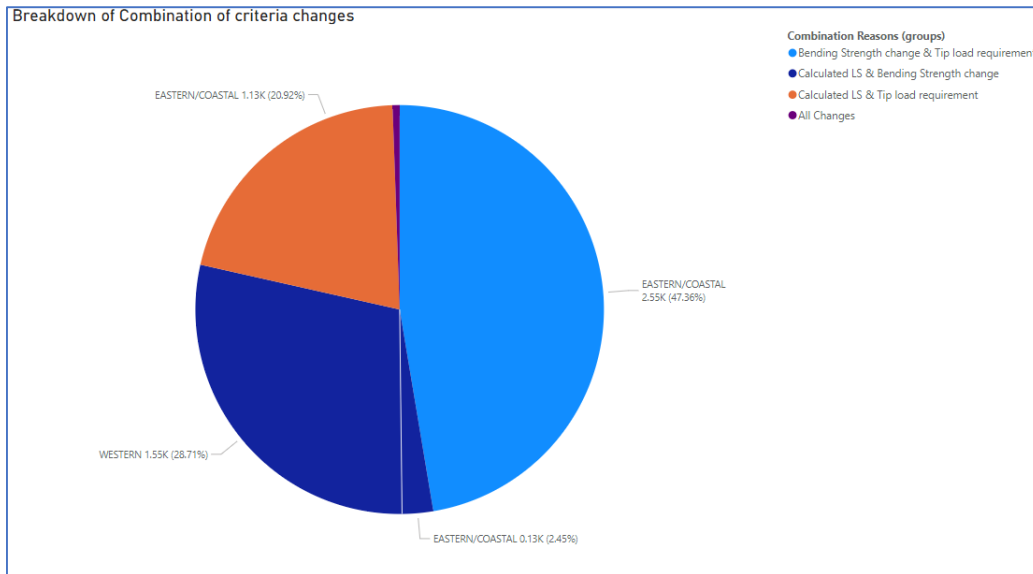
Figure 29 – Breakdown of unserviceable poles that failed due to combination of changes

Note that 87% of unserviceable poles that failed due to a combination of the changes were in part due to the reduction in Characteristic Bending Strength (refer Figure 29).

Note that 65% of unserviceable poles that failed due to a combination of the changes were in part due to the Tip Load changes in wind region C (refer Figure 29).

Note that 47% of unserviceable poles that failed due to a combination of the changes were in part due to the Minimum Calculated Limit State strength (refer Figure 29).

This category represents those poles that failed serviceability due to a combination of the changes made. As per Figure 29, over 87% of these failed the serviceability assessment due to the bending strength change (as well as either tip load requirements or calculated minimum LS strength).

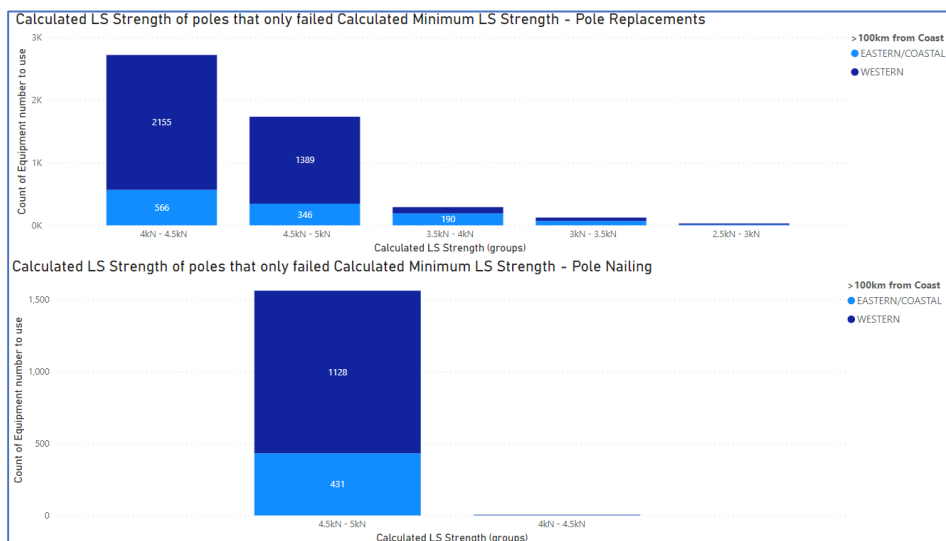
Figure 30 – Location breakdown of unserviceable poles due to the calculated limit state strength

Figure 30 shows that the poles that have failed only the calculated minimum strength criterion are predominantly from the western area of the network. The majority of these low strength poles are replaced. These poles are typically low strength SWER with long spans over 200m. From August 2020, poles with a calculated strength between 4.5kN and 5kN are nailed provided other nailing assessment criteria are met.
