AER Information Request

2025-30

Reference	Root Cause Analysis	Date	September 2024
Attachments to response	N/A

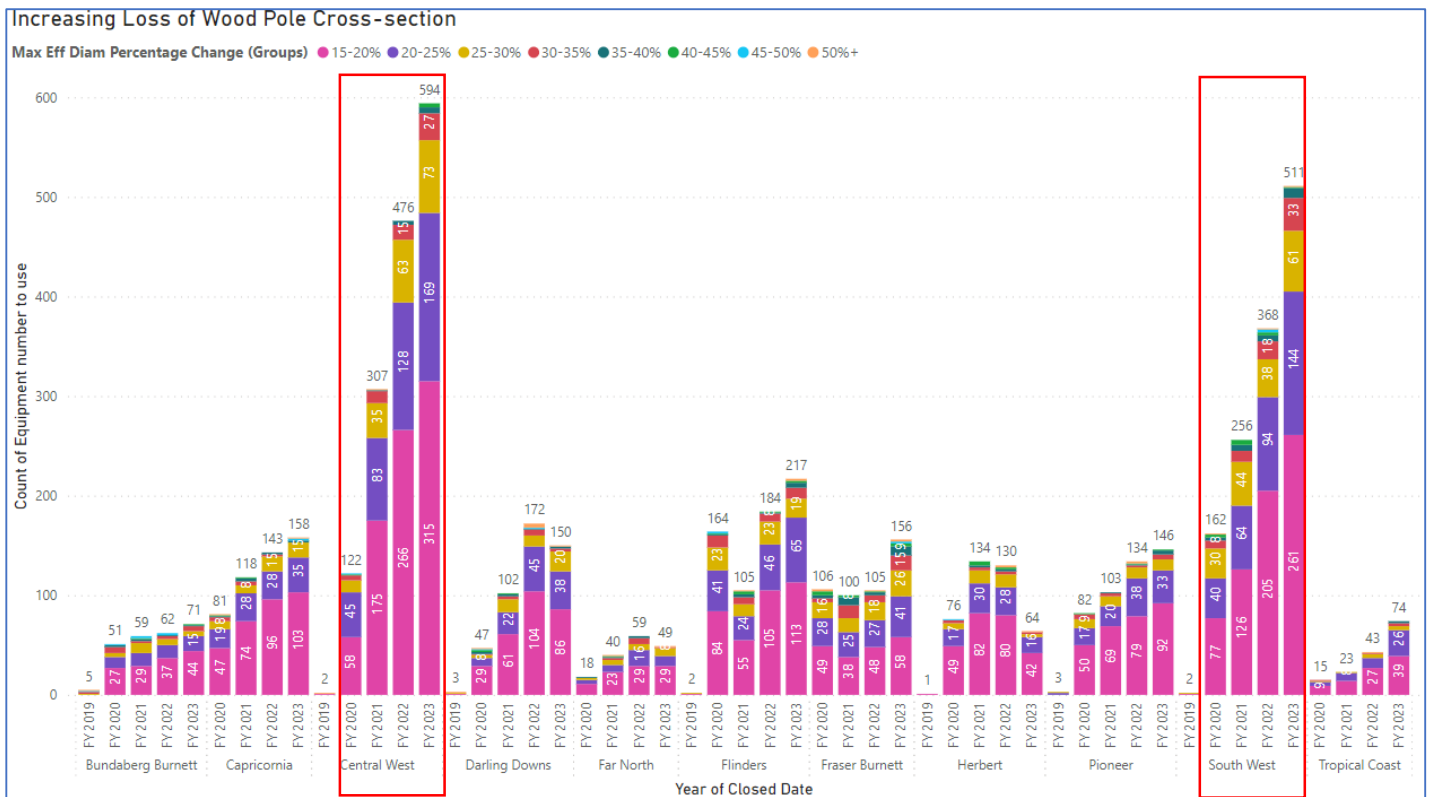
Figure 31 – Increasing loss of cross-section for unserviceable poles from FY2019 onwards

The degradation is evident when comparing the percentage loss of cross-sectional area for all unserviceable poles from FY2019, to that of the previous cyclic inspection. Central West and South West distribution areas were most affected by the flooding and unseasonal rain. They are also the areas with the majority of low strength poles (refer to Figure 31).
