Building Condition Review and CAPEX Plan

BGIS - TransGrid – Orange Regional Depot Centre

04 December 2020

Project No. EB1110

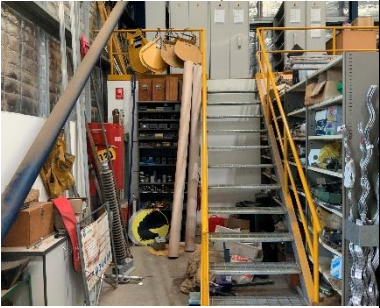
Item	DTS Clause	Description of Non-compliance	Requirement to Satisfy BCA
1.	D1.6	<p>The width of the stairway to the small mezzanine in the Workshop is less than 1000mm (approximately 900mm).</p>

<p>Corridors within the Pavilion building are less than 1000mm (approximately 850mm).</p>	<p>The widths are required to be not less than 1000mm clear of any obstructions. Alternatively, a performance solution from a fire safety engineer satisfying Performance Requirements DP4 and EP2.2.</p>

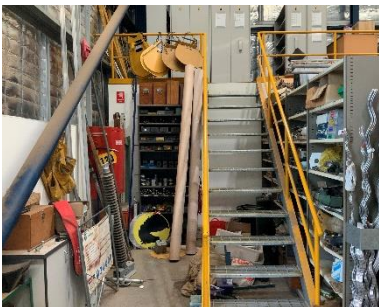
2.	D2.13	<p>The stairway to the small mezzanine within the Workshop has non-compliant risers which are 250mm high. The treads are not provided with contrasting nosing.</p>

<p>To provide safe passage, stairways must comply with the following:</p> <ul style="list-style-type: none"> • minimum 2 risers / maximum 18 in each flight • risers 115mm min 190 mm max - going 250mm min 355mm max - 2R+G 550mm min 700mm max. • Adjacent risers, or between adjacent goings a variation no greater than 5mm is permitted and the largest and smallest riser within the flight or the largest and smallest going within a flight is not to exceed a variation of 10mm. • Under the requirements of AS1428.1-2009 open riser are not permitted. • All treads to be fitted with non-slip finish or non-skid strips. • Treads are required to have a surface or nosing strip with a slip-resistance classification not less than listed in Table D2.14 when tested in accordance with AS 4586

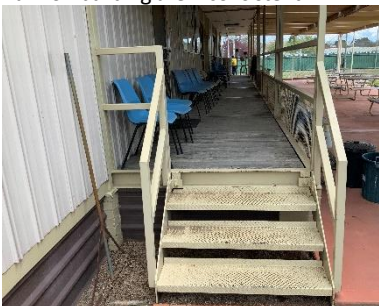
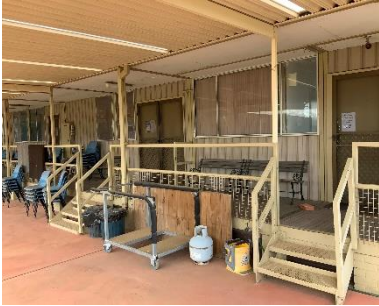
<p>The stairs to the verandah of the Pavilion building are inconsistent.</p>

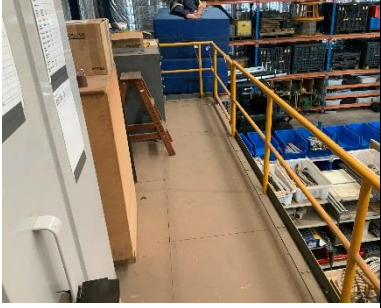
Riser (R)		Going (G) ⁽²⁾		Quantity (2R+G)		Max	Min	Max	Min	Max	Min	Public stairways	190	115	355	250	700	550	Private stairways ⁽¹⁾	190	115	355	240	700	550
	Riser (R)		Going (G) ⁽²⁾		Quantity (2R+G)																									
	Max	Min	Max	Min	Max	Min																								
Public stairways	190	115	355	250	700	550																								
Private stairways ⁽¹⁾	190	115	355	240	700	550																								
3.	D2.16	<p>The balustrade to the small mezzanine within the Workshop is less than 1000mm high. (approximately 900mm)</p>	<p>A balustrade not less than 1000mm in height is required to be provided. Where horizontal rails are provided a bottom rail not more than 150mm above the floor is required and the space</p>

<p>between rails must not exceed 460mm.</p>
4.	D2.17	<p>Handrails are generally provided to stairways, however compliance with AS1428.1 is not achieved.</p>

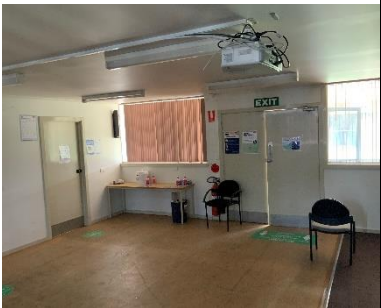
5.	D2.21	<p>Doors to the Pavilion building are not provided with compliant door hardware.</p>

<p>Exit doors should be provided with “free handle” egress via a downward or pushing action and, if serving an area accessible to people with disabilities, must have non-slip “D” pull handles with 35-45mm hand clearances.</p>

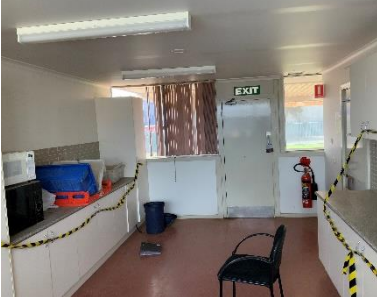
<p>Exit doors in the office are electronically locked. Confirmation that the doors unlock on fire trip to be provided.</p>

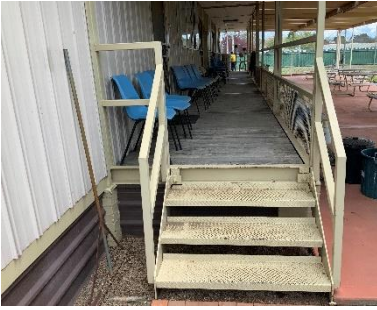
6.	D3.2	<p>Access to the Pavilion is not provided.</p>

<p>Ramps are required to provide access to the Pavilion.</p>
7.	D3.3	<p>The majority of the doors within the office are less than the minimum 850mm wide and not provided with the required door circulation in accordance with AS1428.1. Access to the accessible toilet does not comply with the required door circulation.</p> <p>There are no ambulant facilities</p>

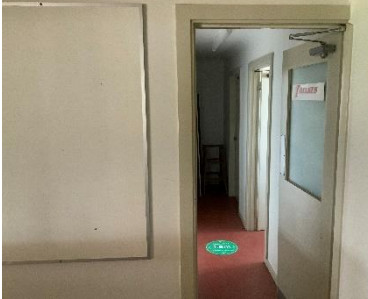
<p>Doors and corridors within the Pavilion do not comply with AS1428.1</p>	<p>A full audit by an access consultant should be undertaken to determine details of non-compliances with AS1428.1. Major modifications would be required to achieve compliance throughout.</p>

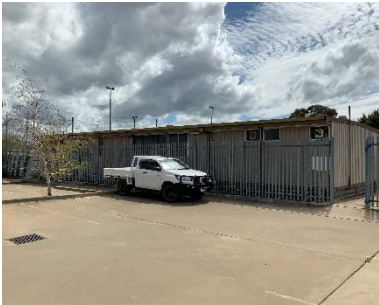
8.	D3.5	<p>No accessible parking space is provided</p>

<p>At least 1 accessible parking space in accordance with AS/NZS 2890.6 – 2009 is required to be provided.</p>

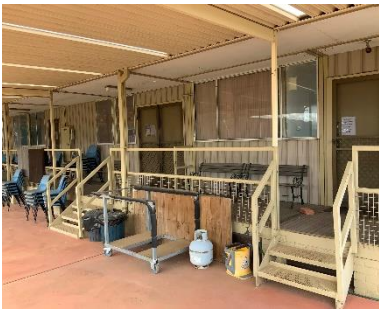
10.	D3.8	<p>TGSI's are not provided to stairs.</p>

<p>Tactile indicators are to be provided to all stairways and ramps in accordance with sections 1 and 2 of AS/NZS 1428.4.1</p>

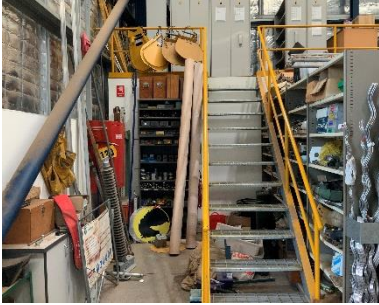
Item	DTS Clause	Description of Non-compliance	Requirement to Satisfy BCA
1.	D1.6	<p>The width of the stairway to the small mezzanine in the workshop is less than 1000mm (approximately 900mm).</p>

<p>The widths are required to be not less than 1000mm clear of any obstructions. Alternatively, a performance solution from a fire safety engineer satisfying Performance Requirements DP4 and EP2.2.</p>

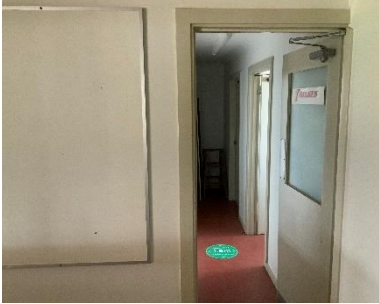
<p>Corridors within the pavilion building are less than 1000mm (approximately 850mm).</p>

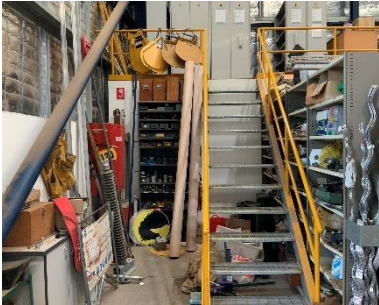
2.	D2.13	<p>The stairway to the small mezzanine within the workshop has non-compliant risers which are 250mm high. The treads are not provided with contrasting nosing.</p>

<p>The stairs to the verandah of the</p>	<p>To provide safe passage, stairways must comply with the following:</p> <ul style="list-style-type: none"> • minimum 2 risers / maximum 18 in each flight • risers 115mm min 190 mm max - going 250mm min 355mm max - 2R+G 550mm min 700mm max. • Adjacent risers, or between adjacent goings a variation no greater than 5mm is permitted and the largest and smallest riser within the flight or the largest and smallest going within a flight is not to exceed a variation of 10mm. • Under the requirements of AS1428.1-2009 open riser are not permitted. • All treads to be fitted with non-slip finish or non-skid strips. • Treads are required to have a surface or nosing strip

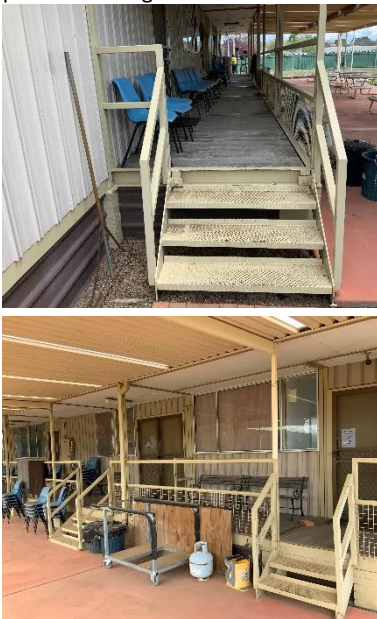
Item	DTS Clause	Description of Non-compliance	Requirement to Satisfy BCA																											
		<p>pavilion building are inconsistent.</p>

<p>with a slip-resistance classification not less than listed in Table D2.14 when tested in accordance with AS 4586</p>

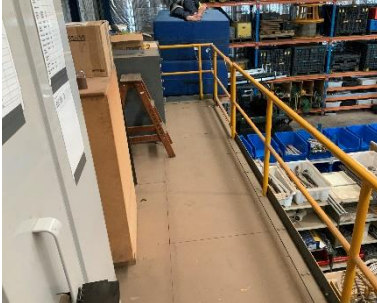
Riser (R)		Going (G) ⁽²⁾		Quantity (2R+G)		Max	Min	Max	Min	Max	Min	Public stairways	190	115	355	250	700	550	Private stairways ⁽¹⁾	190	115	355	240	700	550
	Riser (R)		Going (G) ⁽²⁾		Quantity (2R+G)																									
	Max	Min	Max	Min	Max	Min																								
Public stairways	190	115	355	250	700	550																								
Private stairways ⁽¹⁾	190	115	355	240	700	550																								
3.	D2.16	<p>The balustrade to the small mezzanine within the workshop is less than 1000mm high. (approximately 900mm)</p>

<p>A balustrade not less than 1000mm in height is required to be provided. Where horizontal rails are provided a bottom rail not more than 150mm above the floor is required and the space between rails must not exceed 460mm.</p>																											
4.	D2.17	<p>Handrails are generally provided to stairways however compliance with AS1428.1 is not achieved.</p>

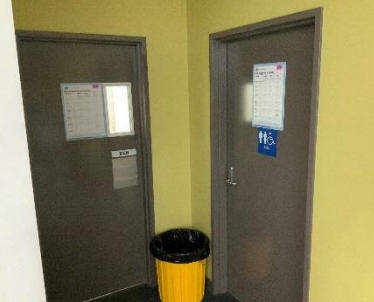
Item	DTS Clause	Description of Non-compliance	Requirement to Satisfy BCA
		<p>There are no ambulant facilities</p>

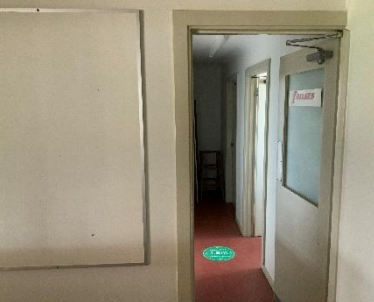
<p>Doors and corridors within the pavilion do not comply with AS1428.1</p>

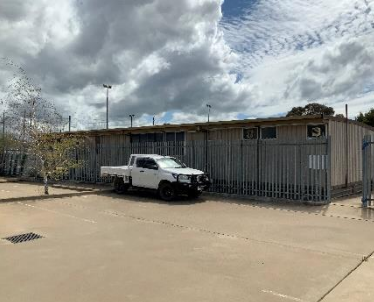
8.	D3.5	<p>No accessible parking space is provided</p>

<p>At least 1 accessible parking space in accordance with AS/NZS 2890.6 – 2009 is required to be provided.</p>

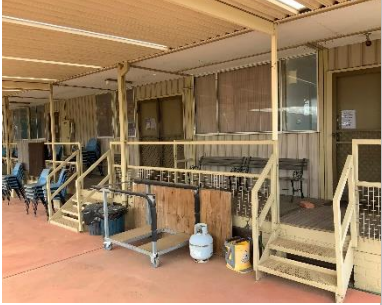
10.	D3.8	<p>TGSI’s are not provided to stairs.</p>	<p>Tactile indicators are to be provided to all stairways and ramps in accordance with sections 1 and 2 of AS/NZS 1428.4.1</p>

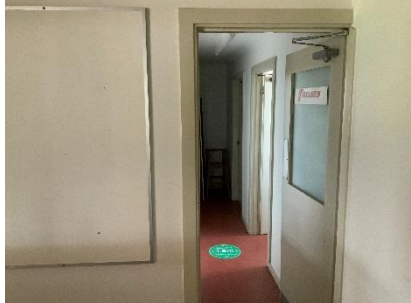
<p>Corridors within the pavilion building are less than 1000mm (approximately 850mm).</p>

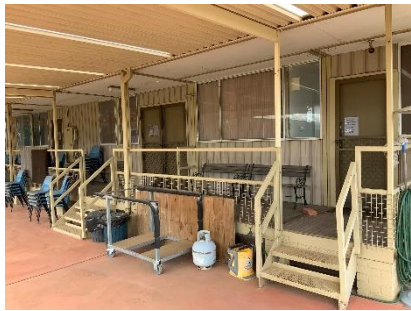
Does not comply															
D2.17	<p>Handrails</p> <p>Handrails to exits including parts of fire isolated exit serving an area required to be accessible to people with disabilities must comply with Clause 12 of AS1428.1, viz:</p> <ul style="list-style-type: none"> • Handrails not to obstruct circulation space • 30-50mm diameter • 865-1000mm above nosing line of stairs • 865-1000mm above ramps and landings • Consistent height throughout • 50mm grip clearance and no obstructions to handhold • Continuous at internal (return) landings • Provided with handrail extensions and 180 degree curled ends 	<p>Handrails are generally provided to stairways however compliance with AS1428.1 is not achieved.</p>

Does not comply

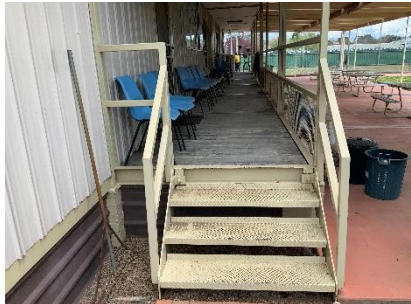
Clause	Description	Comment	Status
	Access is generally required for persons with a disability throughout all areas unless specifically exempted.	D3.4. Access is required to be provided to the office building and pavilion	
D3.2	<p>Access to buildings</p> <p>External access to the building for people with a disability must be provided:</p> <ul style="list-style-type: none"> From main pedestrian entry points at the allotment boundary. Through the principle pedestrian entrance. Through at least 50% of all pedestrian entries. From accessible car parking spaces. For buildings over 500m², so that an accessible entry occurs within 50m of any non-accessible entry. From any another accessible building on the site. 	<p>Generally, access is provided to the main office building.</p> <p>Access to the pavilion is not provided.</p> <p>Access to the wash bay would be exempt under Clause D3.4 due</p>

Does not comply

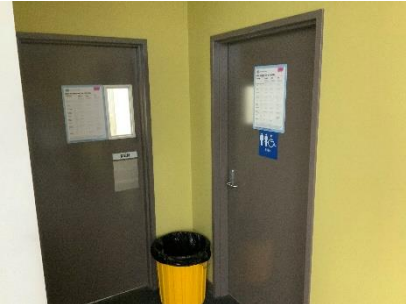
D3.3	<p>Parts of the building to be accessible</p> <p>All parts of the building must be accessible to people with a disability except for areas where access would be inappropriate due to the particular use or areas that would pose a health or safety risk to people with a disability.</p> <p>Every ramp, except a fire isolated ramp, must comply with Clause 10 of AS 1428.1.</p> <p>Every stairway, except a fire isolated stairway, must comply with Clause 11 of AS 1428.1.</p> <p>Access ways must have passing spaces and turning spaces complying with AS 1428.1.</p> <p>A ramp or passenger lift need not be provided to serve a storey or level other than the entrance storey of a class 5, 6, 7b or 8 building containing not more than 3 storeys and with a floor area of each storey, excluding the entrance floor, of not more than 200m².</p> <p>Pile height or pile thickness of carpets shall comply with the requirements of this Clause and AS 1428.1.</p>	<p>The majority of the doors within the office are less than the minimum 850mm wide and not provided with the required door circulation in accordance with AS1428.1. Access to the accessible toilet does not comply with the required door circulation.</p> <p>There are no ambulant facilities</p>

<p>Doors and corridors within the pavilion do not comply with AS1428.1</p>

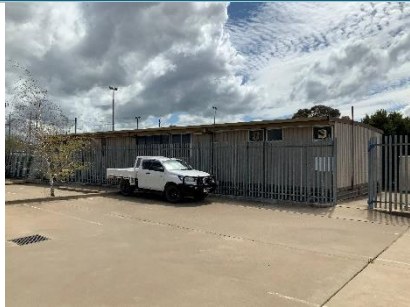
D3.4	<p>Exemptions</p> <p>Certain areas may not need to be accessible if the area is deemed inappropriate because of the particular use or the area would pose a health or safety risk for people with disabilities.</p>		Noted
D3.5	<p>Accessible carparking</p> <p>The accessible parking spaces must comply with AS/NZS 2890.6 – 2009.</p>	No accessible parking space is provided	Does not comply

Clause	Description	Comment	Status
	<p>General requirements are:</p> <ul style="list-style-type: none"> • 2.4m x 5.4m. • 2.2m head clearance for access and egress routes to and from accessible car spaces. • 2.5m head clearances over accessible car spaces. • Flat even surfaces. • Designated and sign posted for disabled users.

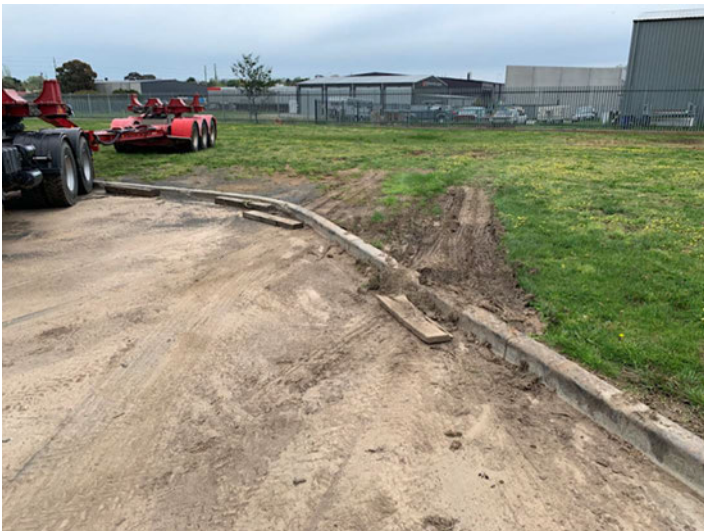
Orange_Bld_027.jpg

1.007	Orange Depot	Orange Depot	External	EXTERNAL	Concrete Hardstand	Concrete Kerbing - All around hardstand poured in situ. Some Kerb damage evident.	Repair works to approx. 20m kerb damage	General	CAP	3	Fair	Orange_Bld_27 and 30	\$ -	\$ -	\$ 1,500.00	\$ -	\$ -	\$ -	\$ -	\$ -	\$ -	\$ -	\$ -	\$ -	\$ -	\$ 1,500.00

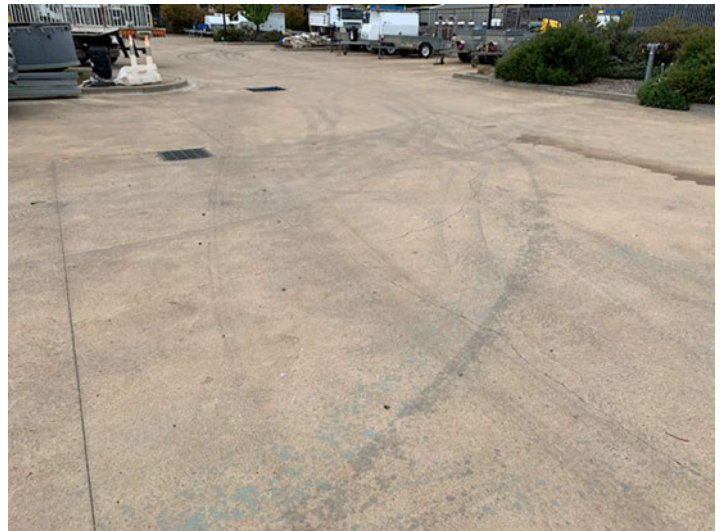
Orange_Bld_028.jpg

1.018	Orange Depot	Orange Depot	External	EXTERNAL	Concrete Hardstand	Surface Cracks - Various surface settlement cracks	Epoxy fill and crack repair	General	CAP	3	Fair	Orange_Bld_28 and 35	\$ -	\$ -	\$ 2,500.00	\$ -	\$ -	\$ -	\$ -	\$ -	\$ -	\$ -	\$ -	\$ -	\$ -	\$ 2,500.00

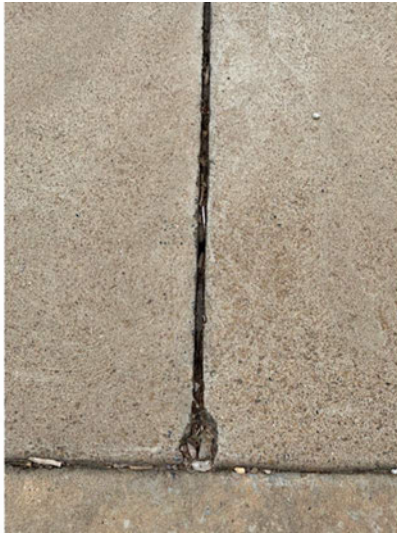
Orange_Bld_029.jpg

1.004	Orange Depot	Orange Depot	External	EXTERNAL	Concrete Hardstand	Saw Cut Joint Damage and Joint Caulking - Average Grid pattern 7m x 5m	Require clean and caulk	General	CAP	3	Fair	Orange_Bld_29	\$ -	\$ -	\$ 1,500.00	\$ -	\$ -	\$ -	\$ -	\$ -	\$ -	\$ -	\$ -	\$ -	\$ 1,500.00

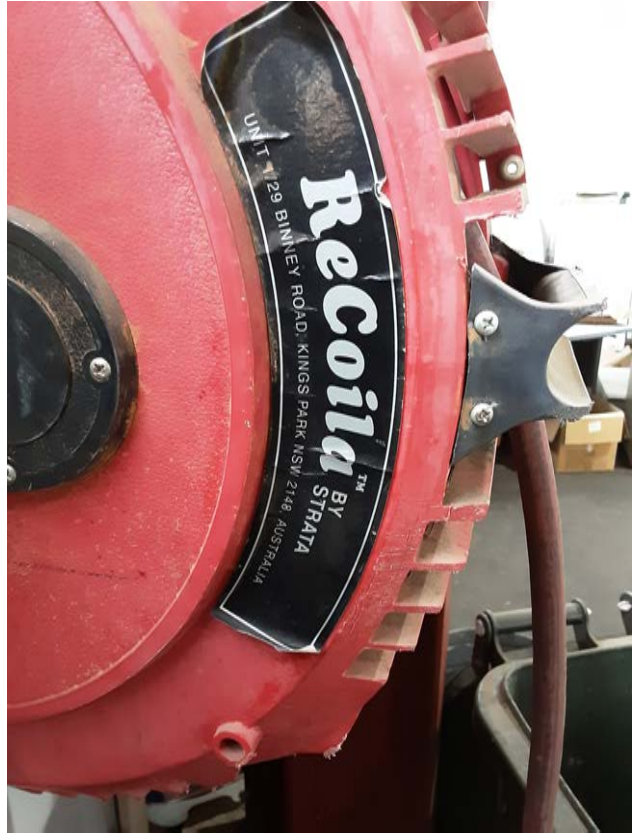
Orange_Hyd_015.jpg

5.022	Orange Depot	Workshop	Wash Bay	HYDRAULIC	Hose Tap	Worn out hose reels	Allow for replacement	General	CAP	3	Fair	Orange_Hyd_15	\$ -	\$ -	\$ 1,000.00	\$ -	\$ -	\$ -	\$ -	\$ -	\$ -	\$ -	\$ -	\$ 1,000.00
