Building Condition Review and CAPEX Plan

BGIS - TransGrid – Tamworth Regional Depot Centre

07 December 2020

Project No. EB1110

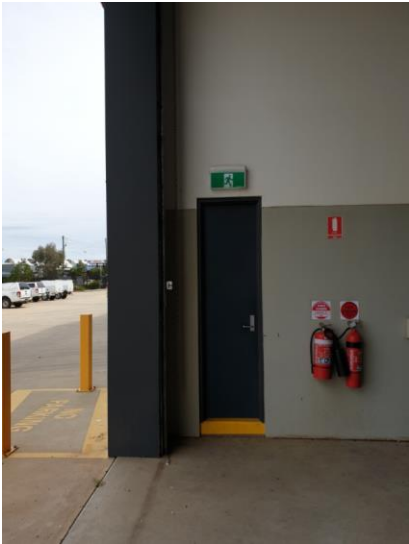
Item	DTS Clause	Description of Non-compliance	Requirement to Satisfy BCA
1.	D1.6	<p>The doorway between the wash bay and trailer store of Building 2 was measured to be less than the required 750mm (approx. 568mm)</p>

<p>The doorway is required to be not less than 750mm clear of any obstructions.</p> <p>Note, Clause D2.19 permits roller shutters to be used as exit doors serving a part of the workshop / wash bay with a floor area of not more than 200m². Exit sign to be adjusted should the roller shutter form the required exit from the wash bay.</p> <p>Alternatively, a performance solution from a fire safety engineer satisfying Performance Requirements DP4 and EP2.2 would be required.</p>

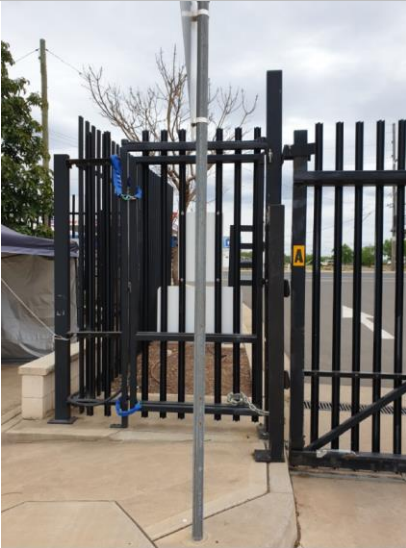
2.	D1.10	<p>The gate providing access to the road was locked with a chain and padlock.</p>	<p>The gates are required to be openable without a key.</p> <p>Site personnel advised the gates unlock on fire trip. Confirmation that the gates are not locked and are openable without a key should be obtained.</p>

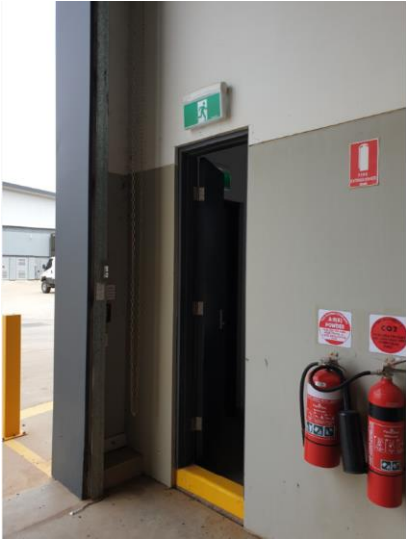
3.	D2.15	<p>A step at the threshold of the doorway between the wash bay and trailer store of Building 2 was identified.</p>

A step should not occur at doorways without a threshold landing.
4.	D3.2	The door control to the main entry door to building was located within 500mm of the corner.	Power operated door controls are required to be located on the continuous accessible path of travel no closer than 500mm from an internal corner.

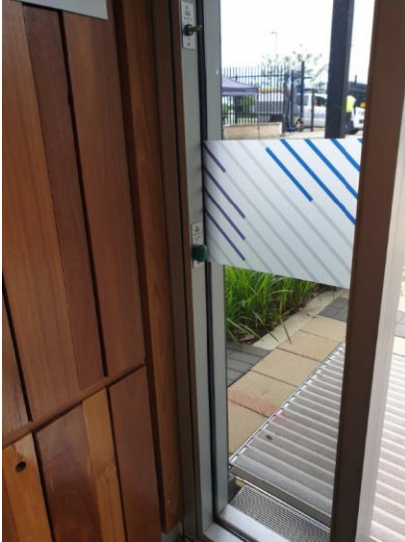
5.	D3.6	<p>There is no braille exit signage provided to the exit doors.</p> <p>Signage to the ambulant toilets is to be provided in accordance with AS1428.1 - 2009 and Specification D3.6 of the BCA.</p>	<p>Every doorway required to be provided with an exit sign under Clause E4.5 is to be provided with braille and tactile signage that states "EXIT" and identifies the floor level "LEVEL #".</p> <div data-bbox="980 1010 1338 1150" style="text-align: center;">

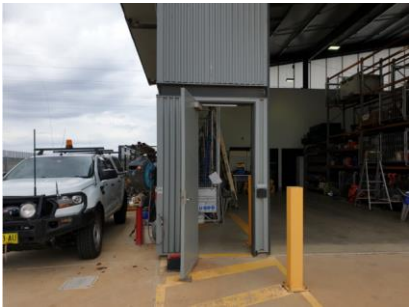
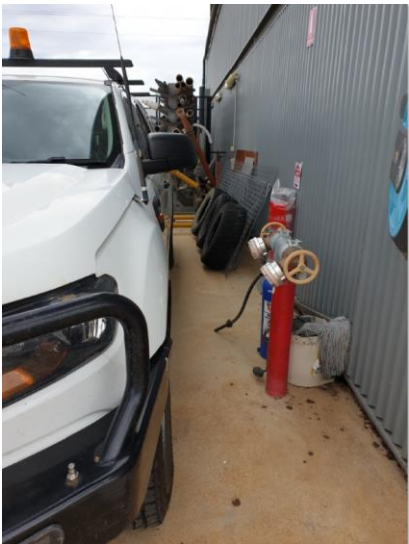
6.	E1.3	<p>The external fire hydrant located within 10m of Building 1 is to be safeguarded by construction-</p> <p>(i) having a FRL of not less than 90/90/90;</p> <p>(ii) extending 2 m each side of the fire hydrant outlet; and</p> <p>(iii) extending not less than 3 m above the ground adjacent to the fire hydrant or the height of the building, whichever</p>	<p>The hydrant system is required to comply with AS2419.1-2005. A detailed assessment from the fire services engineer should be undertaken to identify any shortfalls with the system.</p>

<p>The external fire hydrant located adjacent to Building 1 was obstructed by a parked car.</p>

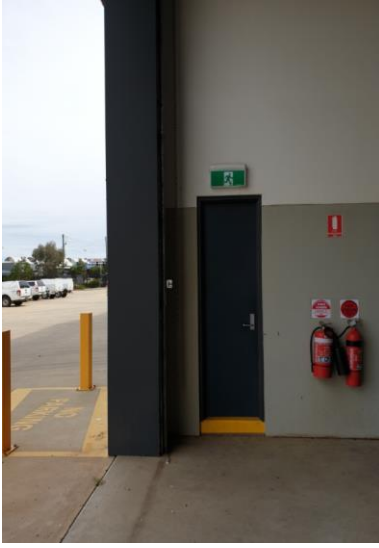
Item	DTS Clause	Description of Non-compliance	Requirement to Satisfy BCA
1.	D1.6	<p>The doorway between the wash bay and trailer store of Building 2 was measured to be less than the required 750mm (approx. 568mm)</p>

<p>The doorway is required to be not less than 750mm clear of any obstructions.</p> <p>Note, Clause D2.19 permits roller shutters to be used as exit doors serving a part of the workshop / wash bay with a floor area of not more than 200m². Exit sign to be adjusted should the roller shutter form the required exit from the wash bay.</p> <p>Alternatively, a performance solution from a fire safety engineer satisfying Performance Requirements DP4 and EP2.2.</p>

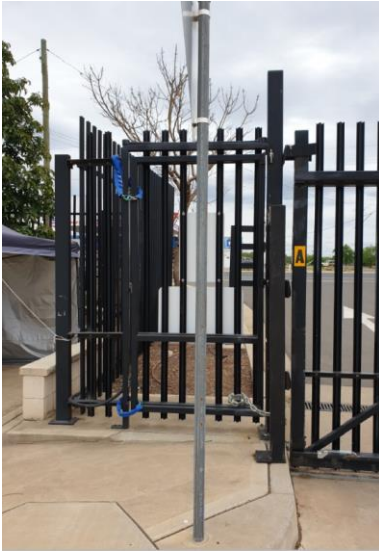
2.	D1.10	<p>The gate providing access to the road was locked with a chain and padlock.</p>

<p>The gates are required to be openable without a key should be obtained.</p> <p>Site personnel advised the gates unlock on fire trip. Confirmation that the gates are not locked and are openable without a key should be obtained.</p>

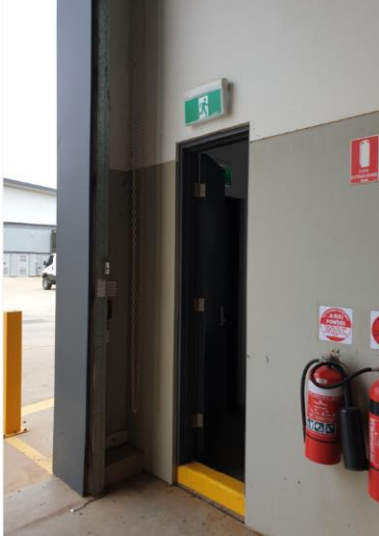
3.	D2.15	<p>A step at the threshold of the doorway between the wash bay and trailer store of Building 2 was identified.</p>	<p>A step should not occur at doorways without a threshold landing.</p>

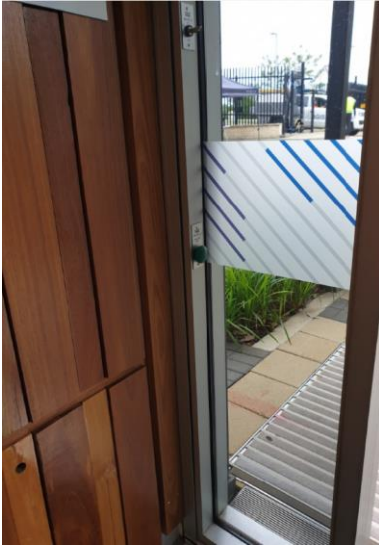
4.	D3.2	<p>The door control to the main entry door to building was located within 500mm of the corner.</p>

<p>Power operated door controls are required to be located on the continuous accessible path of travel no closer than 500mm from an internal corner.</p>
5.	D3.6	<p>There is no braille exit signage provided to the exit doors.</p> <p>Signage to the ambulant toilets is to be provided in accordance with AS1428.1 - 2009 and Specification D3.6 of the BCA.</p>	<p>Every doorway required to be provided with an exit sign under Clause E4.5 is to be provided with braille and tactile signage that states “EXIT” and identify the floor level “LEVEL #”.</p>

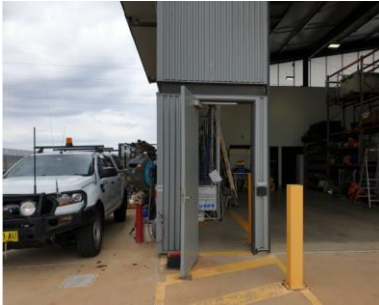
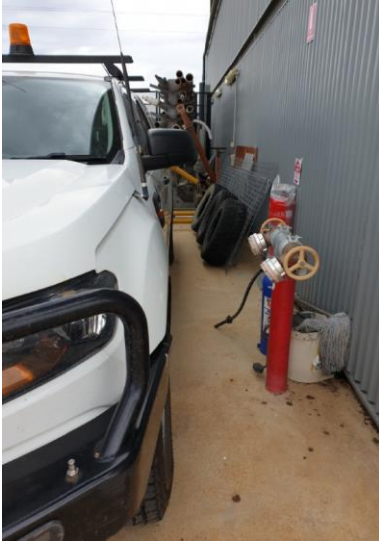
6.	E1.3	<p>The external fire hydrant located within 10m of Building 1 is to be safeguarded by construction-</p> <ul style="list-style-type: none"> (i) having a FRL of not less than 90/90/90; (ii) extending 2 m each side of the fire hydrant outlet; and (iii) extending not less than 3 m above the ground adjacent to the fire hydrant or the height of the building, whichever is the lesser.

<p>The external fire hydrant located adjacent to Building 1 was obstructed by a parked car.</p>

<p>The hydrant system is required to comply with AS2419.1-2005. A detailed assessment from the fire services engineer should be undertaken to identify any shortfalls with the system.</p>

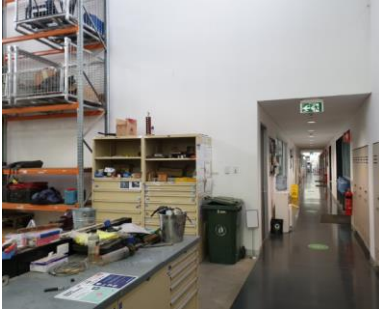
Item	DTS Clause	Description of Non-compliance	Requirement to Satisfy BCA
		<p>Exit signs were not provided to Building 1 – workshop 2.</p> <p>Exit signs were not provided to the Building 1 – tech service workshop and mains workspace.</p> <p>The doorway separating the corridor and workshop 1 within Building 1 should be provided with an exit sign. It was unclear where the direction sign was directing occupancy.</p>

7.	E4.2 & E4.5	<p>Emergency lighting was provided within the office portion of Building 1. Emergency lighting was not evident within the workshop and wash bay of both buildings.</p>	<p>A detailed assessment by the fire services consultant should be undertaken to determine required emergency lighting and exit signage.</p>

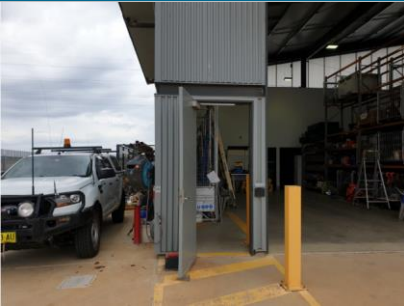
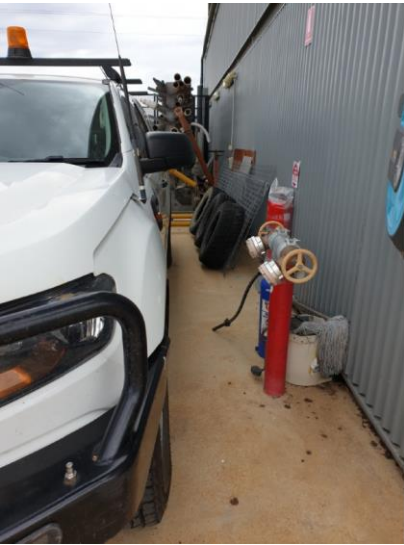
<p>The external fire hydrant located adjacent to Building 1 was obstructed by a parked car.</p>

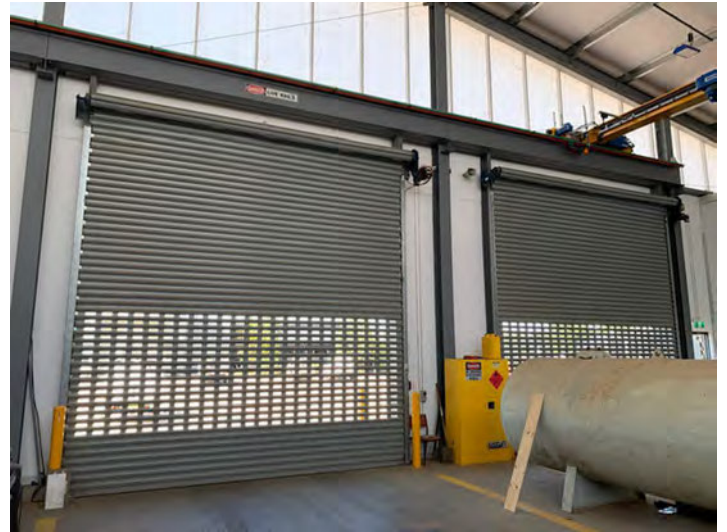
Tamworth_Bld_34.jpg

1.059	Tamworth Depot	Building 2	Workshop - Undercover vehicle parking & trailer store	INTERNAL	Floors	Damaged floor repair - condition cracked	Crack and bollard floor damage to be repaired	General	CAP	3	Poor	Tamworth_Bld_34	\$ -	\$ -	\$ 2,000.00	\$ -	\$ -	\$ -	\$ -	\$ -	\$ -	\$ -	\$ -	\$ -	\$ 2,000.00

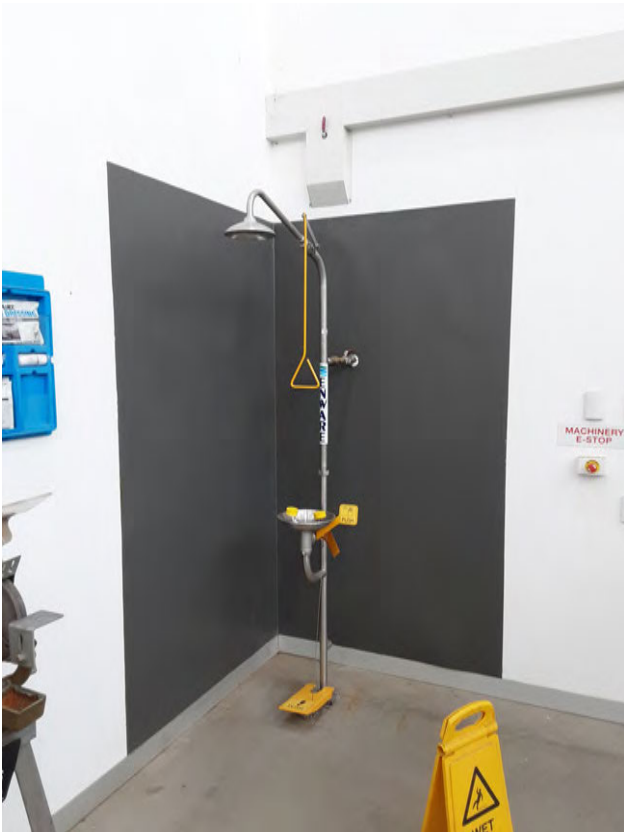
Tamworth_Hyd_007.jpg

5.018	Tamworth Depot	Building 1	Internal	HYDRAULIC	Deluge Shower with eye wash	Deluge Shower station within work shop 2.	Deluge Shower system provide testing under R&M	WH&S Risk	MC/R&M	2	Failed	Tamworth_Hyd_07	\$ 250.00	\$ 250.00	\$ 250.00	\$ 250.00	\$ 250.00	\$ 250.00	\$ 250.00	\$ 250.00	\$ 250.00	\$ 250.00	\$ 250.00	\$ 250.00	\$ 250.00	\$ 2,500.00

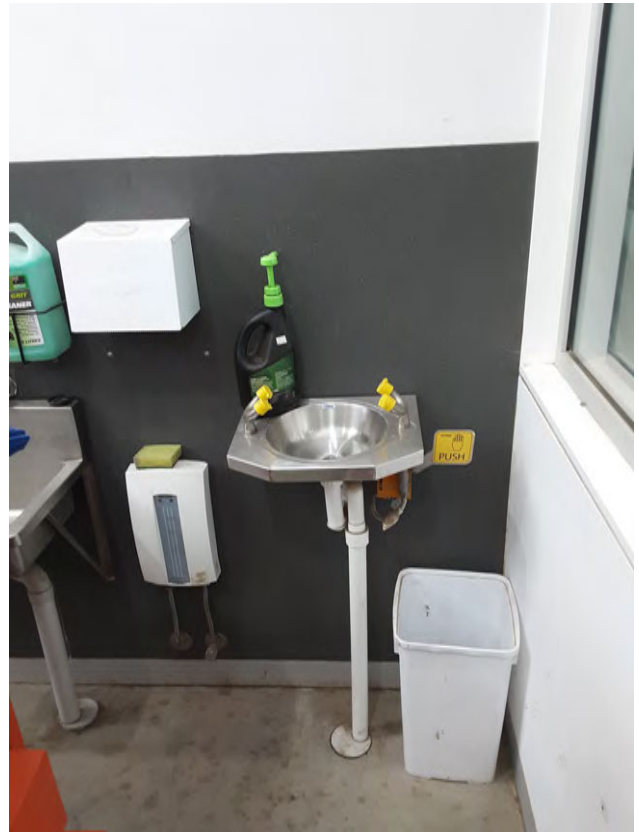
Tamworth_Hyd_008.jpg

5.019	Tamworth Depot	Building 1	Internal	HYDRAULIC	Eyewash Station	Eye wash station within Workshop-2 Left wall, testing tag not stamped	Allow for testing under R&M	WH&S Risk	MC/R&M	2	Failed	Tamworth_Hyd_08	\$ 250.00	\$ 250.00	\$ 250.00	\$ 250.00	\$ 250.00	\$ 250.00	\$ 250.00	\$ 250.00	\$ 250.00	\$ 250.00	\$ 250.00	\$ 250.00	\$ 250.00	\$ 2,500.00

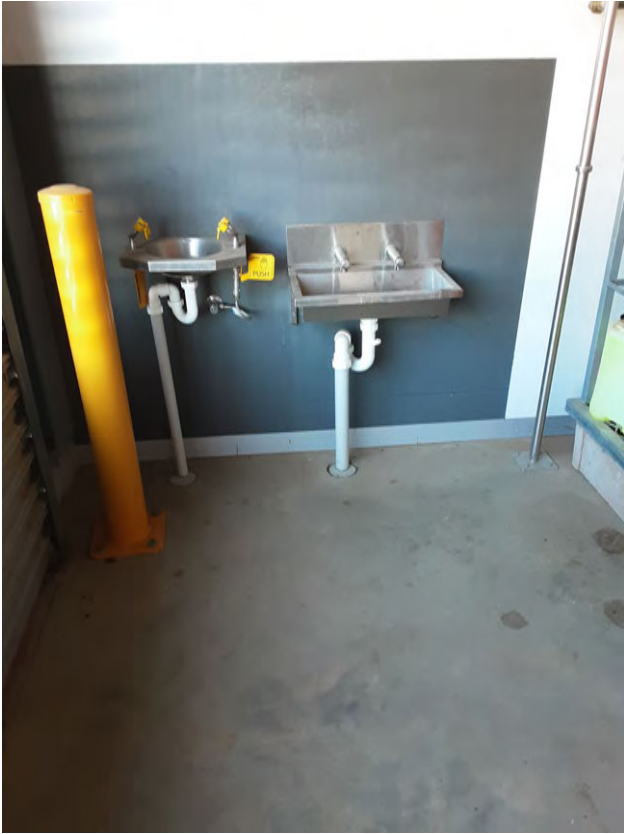
Tamworth_Hyd_009.jpg

5.021	Tamworth Depot	Building 1	Internal	HYDRAULIC	Eyewash Station	Eye wash station within Workshop-2 right wall, testing tag not stamped	Allow for testing under R&M	WH&S Risk	MC/R&M	2	Failed	Tamworth_Hyd_09	\$ 250.00	\$ 250.00	\$ 250.00	\$ 250.00	\$ 250.00	\$ 250.00	\$ 250.00	\$ 250.00	\$ 250.00	\$ 250.00	\$ 250.00	\$ 250.00	\$ 250.00	\$ 2,500.00

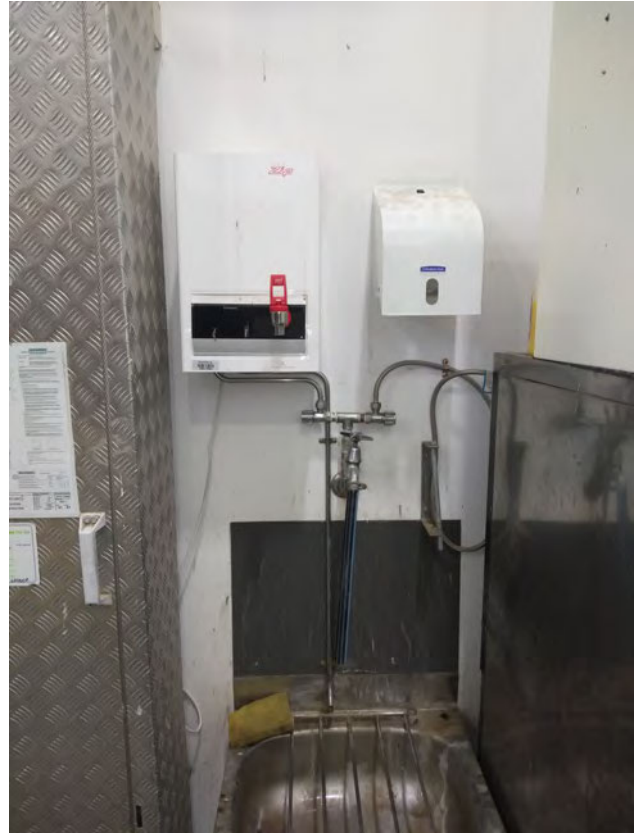
Tamworth_Hyd_010.jpg

5.023	Tamworth Depot	Building 1	Internal	HYDRAULIC	Hot Water System	Over head hot water Zip system in fair condition in the mains lines store	Allow to replace	General	CAP	4	Fair	Tamworth_Hyd_10	\$ -	\$ -	\$ -	\$ -	\$ -	\$ -	\$ -	\$ -	\$ 5,000.00	\$ -	\$ -	\$ -	\$ -	\$ 5,000.00

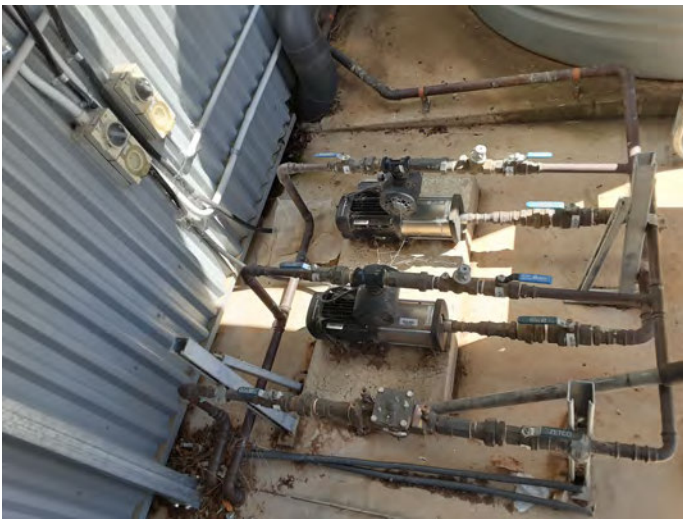
Tamworth_Hyd_011.jpg

5.027	Tamworth Depot	Building 1	External	HYDRAULIC	Pumps	Dual pumps system for rain water system and filtration system	Allow to replace in the long term	General	CAP	4	Fair	Tamworth_Hyd_11	\$ -	\$ -	\$ -	\$ -	\$ -	\$ -	\$ -	\$ -	\$ -	\$ -	\$ -	\$ -	\$ 12,000.00	\$ 12,000.00

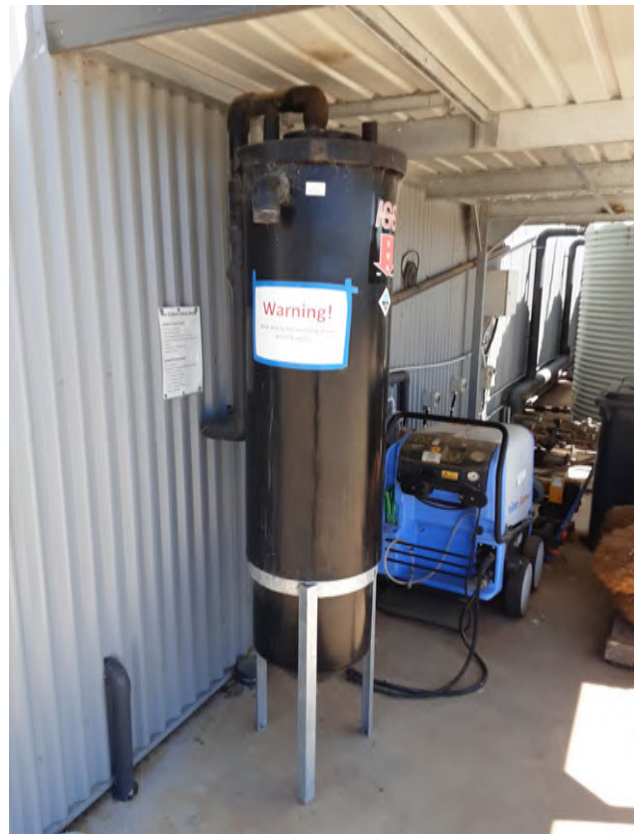
Tamworth_Hyd_012.jpg

5.028	Tamworth Depot	Building 1	External	HYDRAULIC	Filter	Rain water filter system for rain water system	Allow to replace in the long term	General	CAP	4	Fair	Tamworth_Hyd_12	\$ -	\$ -	\$ -	\$ -	\$ -	\$ -	\$ -	\$ -	\$ -	\$ -	\$ -	\$ -	\$ 8,000.00	\$ 8,000.00
