Building Condition Review and CAPEX Plan

BGIS - TransGrid – Wagga Wagga Regional Depot Centre

11 December 2020

Project No. EB1110

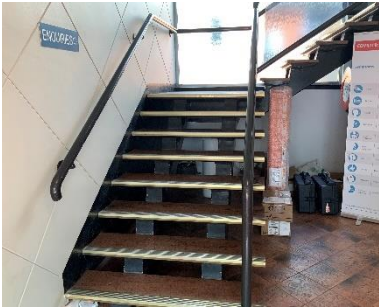
Item	DTS Clause	Description of Non-compliance	Requirement to Satisfy BCA																											
1.	D2.13	<p>The central stairway in the Administration building has inconsistent risers with some risers exceeding 190mm.</p>

<p>The external stairs have risers exceeding 190mm, gaps exceeding 135mm in the risers and do not have a contrasting nosing.</p> <p>Under AS1428.1 open risers are not permitted</p>	<p>To provide safe passage, stairways must comply with the following:</p> <ul style="list-style-type: none"> • minimum 2 risers / maximum 18 in each flight • risers 115mm min 190 mm max - going 250mm min 355mm max - 2R+G 550mm min 700mm max. • Adjacent risers, or between adjacent goings a variation no greater than 5mm is permitted and the largest and smallest riser within the flight or the largest and smallest going within a flight is not to exceed a variation of 10mm. • Under the requirements of AS1428.1-2009 open riser are not permitted. • All treads to be fitted with non-slip finish or non-skid strips. • Treads are required to have a surface or nosing strip with a slip-resistance classification not less than listed in Table D2.14 when tested in accordance with AS 4586

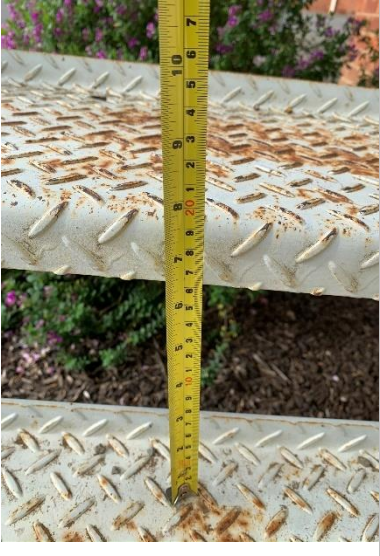
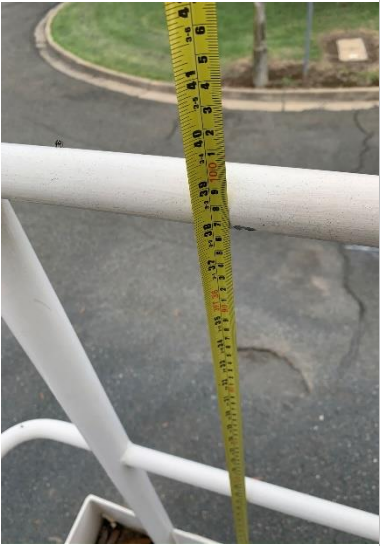
2.	D2.16	<p>The balustrade to the external stairs serving level 1 of the administration building has horizontal rails with gaps greater than 125mm.</p>

<p>Generally, 125mm maximum gap size limits apply between balusters or rails and a 1m minimum height applies, with alternate dimensions permitted in fire isolated stairs and industrial areas.</p>

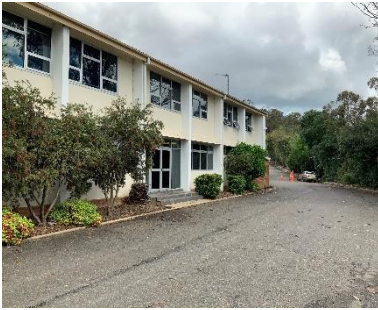
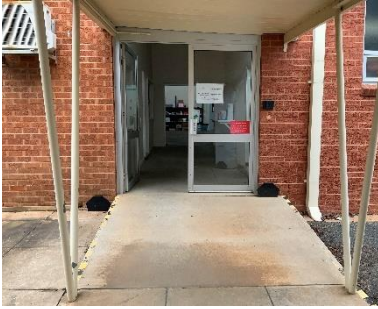
3.	D2.17	<p>Handrails are not provided to the external stairway just outside the mess room.</p>	<p>Handrails in accordance with AS1428.1 are required.</p>

<p>Handrails to stairways are not compliant with AS1428.1.</p> <p>No handrails are provided to the ramp leading to the workshop building.</p>

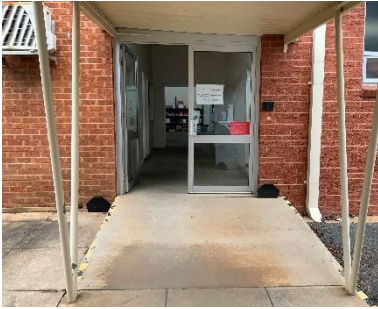
4.	D3.2	<p>Access between the Admin Building and Workshop Building is via a non-compliant ramp which doesn't comply with AS 1428.1. There is no landing provided between the ramp and doorway.</p>

<p>Ramps complying with AS1428.1-2009 are required with landings provided at the doorway.</p>

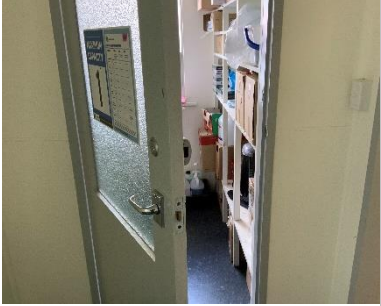
5.	D3.3	<p>Access to Level 1 of the Admin building is not provided.</p> <p>The majority of the doors within the Admin Building are less than the minimum 850mm wide.</p> <p>There are no ambulant facilities provided.</p>	<p>A full audit by an access consultant should be undertaken to determine details of non-compliances with AS1428.1. Major modifications would be required to achieve compliance throughout.</p> <p>Level 1 of the Admin Building would require access via a passenger lift.</p>

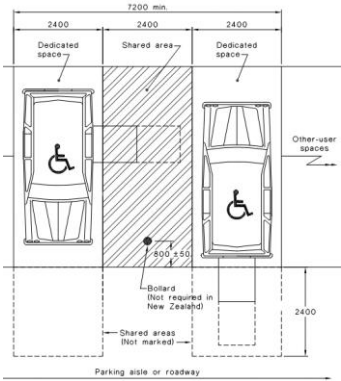
6.	D3.5	No accessible parking space is provided.	<p>At least 1 accessible parking space in accordance with AS/NZS 2890.6 – 2009 is required to be provided.</p>

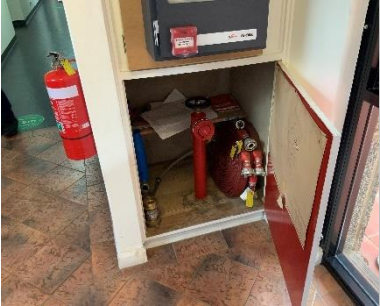
9.	E1.3	<p>The hydrant at the main entrance lobby of the Admin Building is lower than 750mm as required under AS2419.1. The signage on the door to the hydrant cupboard doesn't state "FIRE HYDRANT".</p>

<p>External hydrants are located within 10m of the building and are not protected by a fire rated wall 3m high and 2m either side of the hydrant outlet.</p>	<p>The hydrant system is required to comply with AS2419.1-2005. A detailed assessment from the fire services engineer should be undertaken to identify any shortfalls with the system.</p> <p>Hydrant system is to be modified to ensure compliance and fire rated walls constructed to protect the external hydrants from the building they serve.</p>

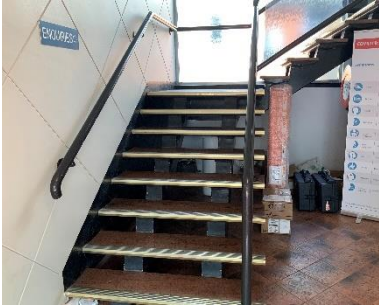
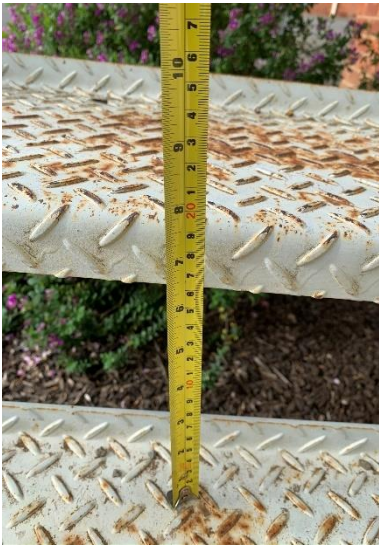
Item	DTS Clause	Description of Non-compliance	Requirement to Satisfy BCA																											
1.	D2.13	<p>The central stairway in the administration building has inconsistent risers with some risers exceeding 190mm.</p>

<p>The external stairs have risers exceeding 190mm, gaps exceeding 135mm in the risers and do not have a contrasting nosing.</p> <p>Under AS1428.1 open risers are not permitted</p>

<p>To provide safe passage, stairways must comply with the following:</p> <ul style="list-style-type: none"> • minimum 2 risers / maximum 18 in each flight • risers 115mm min 190 mm max - going 250mm min 355mm max - 2R+G 550mm min 700mm max. • Adjacent risers, or between adjacent goings a variation no greater than 5mm is permitted and the largest and smallest riser within the flight or the largest and smallest going within a flight is not to exceed a variation of 10mm. • Under the requirements of AS1428.1-2009 open riser are not permitted. • All treads to be fitted with non-slip finish or non-skid strips. • Treads are required to have a surface or nosing strip with a slip-resistance classification not less than listed in Table D2.14 when tested in accordance with AS 4586

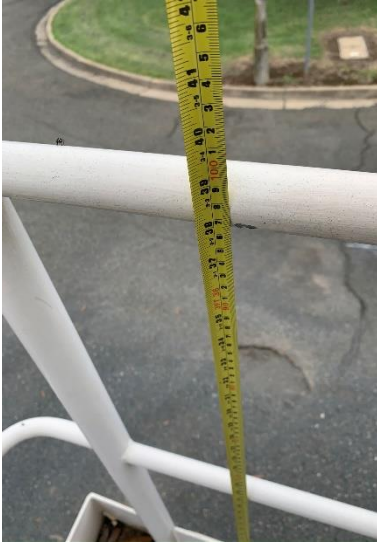
Item	DTS Clause	Description of Non-compliance	Requirement to Satisfy BCA
2.	D2.16	<p>The balustrade to the external stairs serving level 1 of the administration building has horizontal rails with gaps greater than 125mm.</p>

<p>Generally, 125mm maximum gap size limits apply between balusters or rails and a 1m minimum height applies, with alternate dimensions permitted in fire isolated stairs and industrial areas.</p>

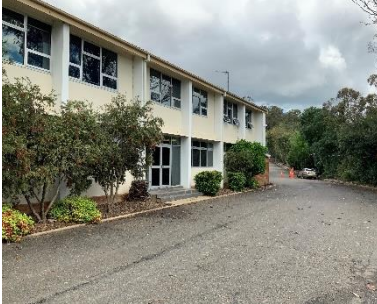
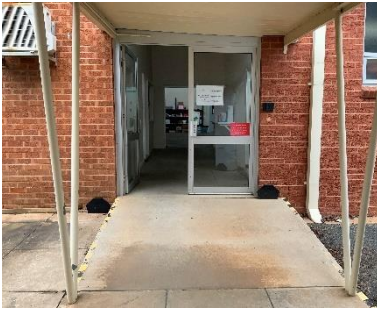
3.	D2.17	<p>Handrails are not provided to the external stairway just outside the mess room.</p>

<p>Handrails to stairways are not compliant with AS1428.1, No handrails are provided to the ramp leading to the workshop building.</p>

<p>Handrails in accordance with AS1428.1 are required</p>

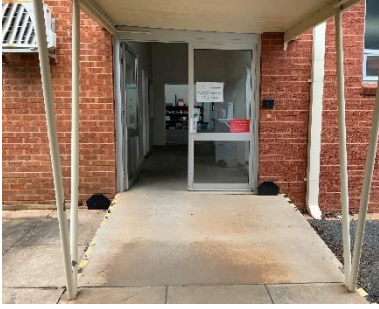
4.	D3.2	<p>Access between administration building and workshop building is via a non-compliant ramp which doesn't comply with AS 1428.1. There is no landing provided between the ramp and</p>	<p>Ramps complying with AS1428.1-2009 are required with landings provided at the doorway.</p>

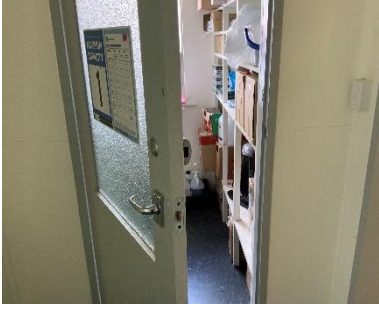
5.	D3.3	<p>Access to level 1 of the administration building is not provided.</p> <p>The majority of the doors within the administration building are less than the minimum 850mm wide.</p> <p>There are no ambulant facilities provided.</p>

<p>A full audit by an access consultant should be undertaken to determine details of non-compliances with AS1428.1. Major modifications would be required to achieve compliance throughout.</p> <p>Level 1 of the administration building would require access via a passenger lift.</p>

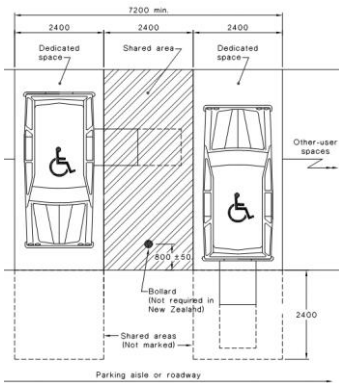
6.	D3.5	<p>No accessible parking space is provided</p>	<p>At least 1 accessible parking space in accordance with AS/NZS 2890.6 – 2009 is required to be provided.</p>

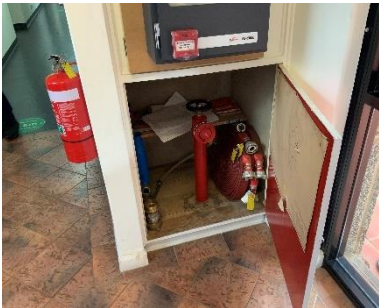
9.	E1.3	<p>The hydrant at the main entrance lobby of the administration building is lower than 750mm as required under AS2419.1. The signage on the door to the hydrant cupboard doesn't state "FIRE HYDRANT"</p>

<p>External hydrants are located within 10m of the building and are not protected by a fire rated wall 3m high and 2m either side of the hydrant outlet.</p>	<p>The hydrant system is required to comply with AS2419.1-2005. A detailed assessment from the fire services engineer should be undertaken to identify any shortfalls with the system.</p> <p>Hydrant system is to be modified to ensure compliance and fire rated walls constructed to protect the external hydrants from the building they serve.</p>

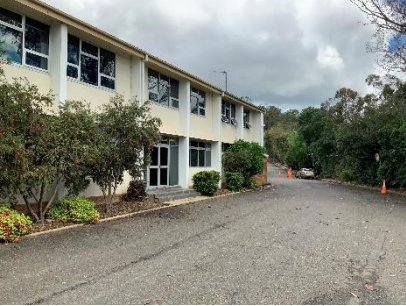
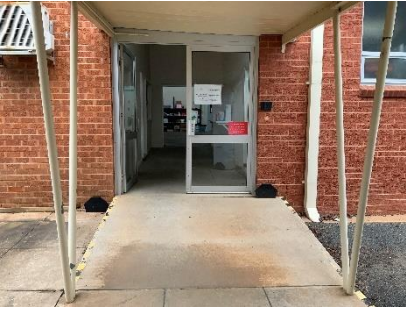
Does not comply
D2.17	Handrails Handrails to exits including parts of fire isolated exit serving an area required to be accessible to people with disabilities must comply with Clause 12 of AS1428.1, viz: <ul style="list-style-type: none"> • Handrails not to obstruct circulation space • 30-50mm diameter • 865-1000mm above nosing line of stairs • 865-1000mm above ramps and landings • Consistent height throughout • 50mm grip clearance and no obstructions to handhold • Continuous at internal (return) landings • Provided with handrail extensions and 180 degree curled ends 	Handrails are not provided to the external stairway just outside the mess room.

<p>Handrails to stairways are not compliant with AS1428.1,</p> <p>No handrails are provided to the ramp leading to the workshop building.</p>

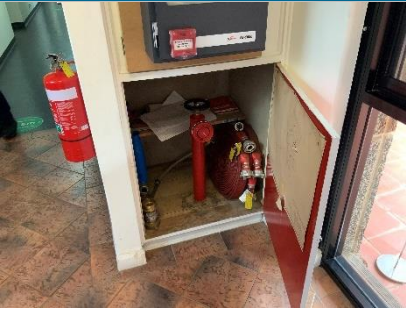
<p data-bbox="831 595 1238 707">External hydrants are located within 10m of the building and are not protected by a fire rated wall 3m high and 2m either side of the hydrant outlet.</p>

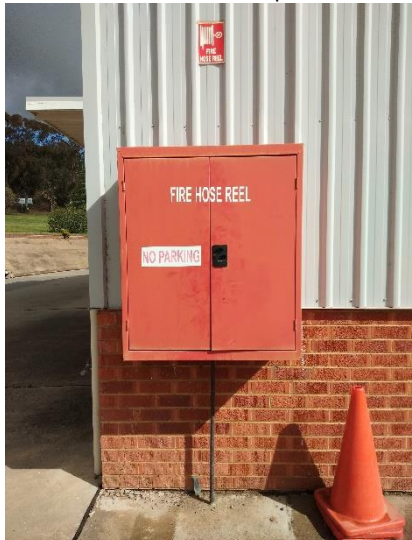
E1.4	<p>Fire hose reels</p> <p>Under the current BCA the building requires a Fire hose reel coverage to AS2441-2005. The fire schedule identifies that the hose reel system is installed to AS2441 – 1998.</p> <p>Note: Fire hose reels not required to: -</p> <ul style="list-style-type: none"> ▪ Class 2, 3, 4, 5 and 9c buildings; ▪ Class 8 electricity network substations; 	<p>Hose reels are not required to Class 5 buildings.</p> <p>There are a couple of external hose reels provided to the workshop. The cupboard to one hose reel was not able to be opened. Full coverage to the building would not be achieved from the hose reels provided.</p>

<p>Does not comply</p>

<p data-bbox="826 792 1241 907">A detailed assessment of the hose reels by the fire services engineer should be undertaken to confirm compliance with AS2441-2005.</p>	
E1.5	Sprinklers	A sprinkler system is not required nor installed to the premises	N/A
E1.6	Portable fire extinguishers Portable Fire Extinguishers are required be installed to Table E1.6 and AS 2444 requirements, at: <ul style="list-style-type: none"> • Throughout Class 5 buildings • emergency services switchboards • kitchens • flammable liquid stores • at nurses' stations • special risk areas where fire hose reels are not installed	A service consultant should be consulted if a detailed assessment is required	No issues identified
E1.7	-	This Clause has deliberately been left blank	
E1.8	Fire control centre		N/A
E1.9	Fire precautions during construction		N/A
E1.10	Provisions for special hazards		N/A

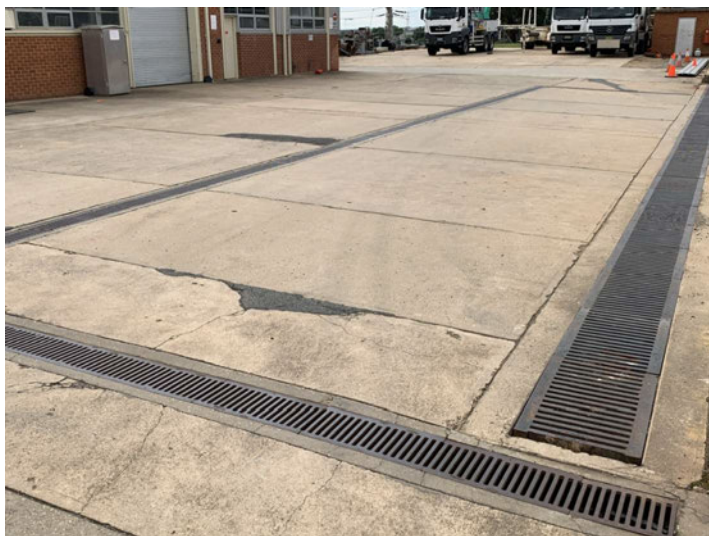
Wagga_Blg_001.jpg

1.001	Wagga Wagga Depot	Wagga Wagga Depot	External	EXTERNAL	Concrete Hardstands	Surface Cracks	Implement a Epoxy Repair Program	General	CAP	2	Poor	Wagga_Blg_001	\$ -	\$ -	\$ 25,000.00	\$ -	\$ -	\$ -	\$ -	\$ -	\$ -	\$ -	\$ -	\$ 25,000.00

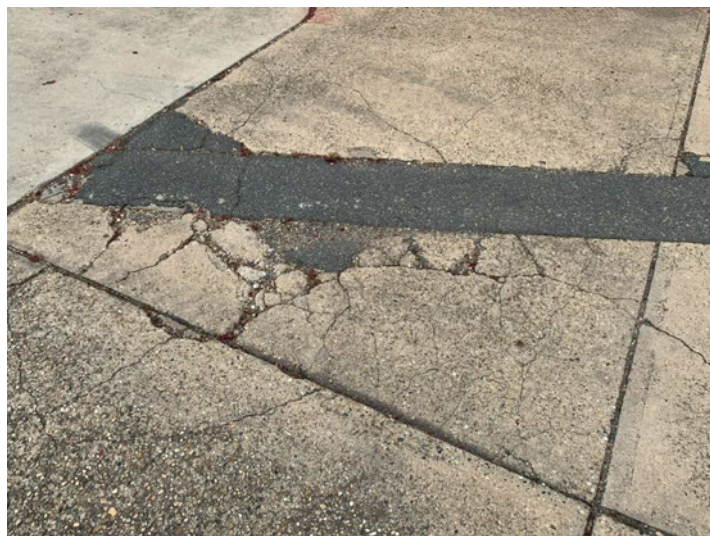
Wagga_Blg_002.jpg

1.005	Wagga Wagga Depot	Wagga Wagga Depot	External	EXTERNAL	Concrete Hardstands	Saw Cut Joints	Implement a Saw Cut Joint Repair Program	General	CAP	2	Poor	Wagga_Blg_002	\$ -	\$ -	\$ 2,500.00	\$ -	\$ -	\$ -	\$ -	\$ -	\$ -	\$ -	\$ -	\$ -	\$ 2,500.00

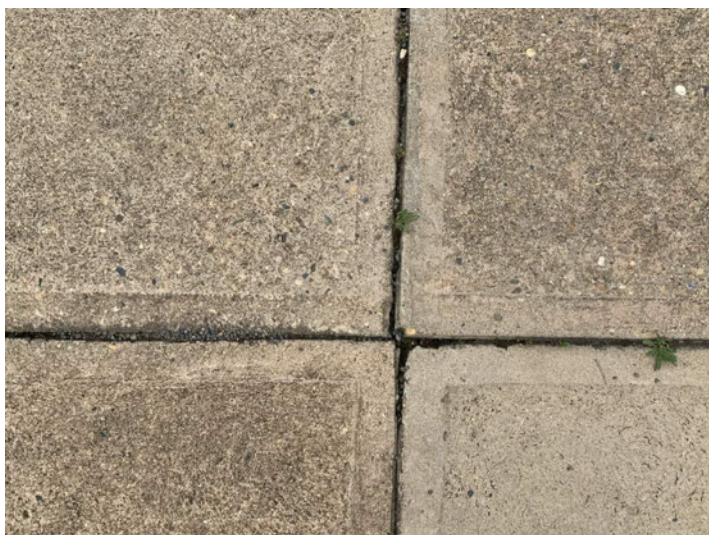
Wagga_Blg_003.jpg

1.004	Wagga Wagga Depot	Wagga Wagga Depot	External	EXTERNAL	Concrete Hardstands	Corner Joints	Minor Corner Joint Damage - 5 Corner Joints	General	CAP	2	Poor	Wagga_Blg_003	\$ -	\$ -	\$ 2,500.00	\$ -	\$ -	\$ -	\$ -	\$ -	\$ -	\$ -	\$ -	\$ -	\$ 2,500.00

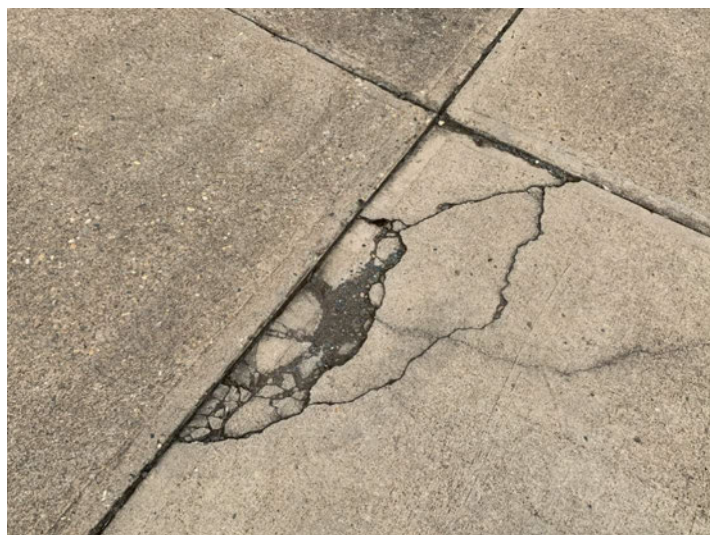
Wagga_Blg_004.jpg

1.003	Wagga Wagga Depot	Wagga Wagga Depot	External	EXTERNAL	Concrete Hardstands	Joint Spalling	Implement a Joint Spalling Repair Program	General	CAP	2	Poor	Wagga_Blg_004	\$ -	\$ -	\$ 5,000.00	\$ -	\$ -	\$ -	\$ -	\$ -	\$ -	\$ -	\$ -	\$ -	\$ 5,000.00

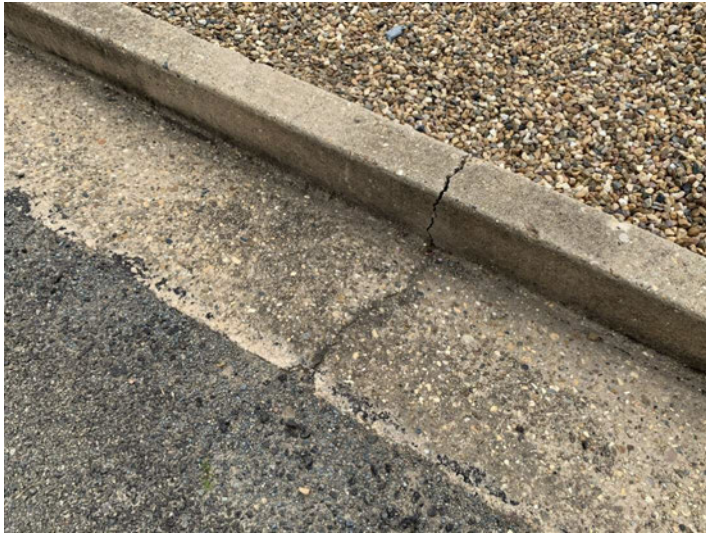
Wagga_Blg_005.jpg

1.009	Wagga Wagga Depot	Wagga Wagga Depot	External	EXTERNAL	Concrete Hardstands	Concrete Kerbing	Repair Isolated Cracking	General	CAP	2	Poor	Wagga_Blg_005	\$ -	\$ -	\$ 2,500.00	\$ -	\$ -	\$ -	\$ -	\$ -	\$ -	\$ -	\$ -	\$ -	\$ 2,500.00

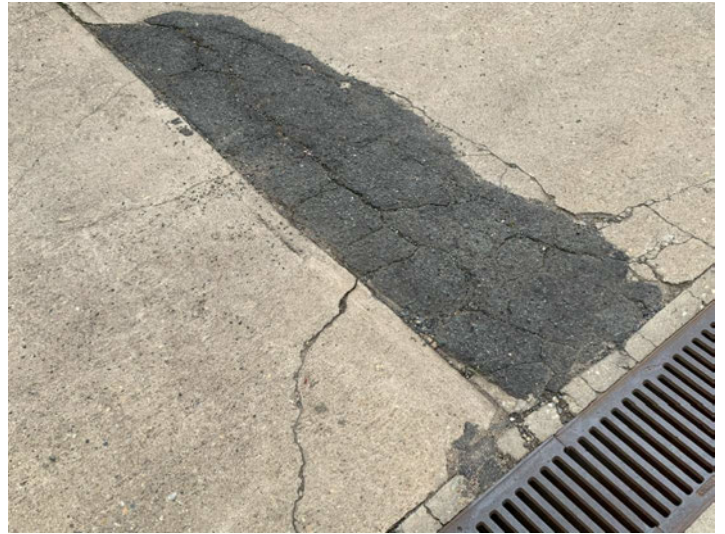
Wagga_Blg_006.jpg

1.002	Wagga Wagga Depot	Wagga Wagga Depot	External	EXTERNAL	Concrete Hardstands	Slab Deflection	Minor Slab Deflection to be Investigated & Repaired	General	CAP	2	Fair	Wagga_Blg_006	\$ -	\$ -	\$ 1,500.00	\$ -	\$ -	\$ -	\$ -	\$ -	\$ -	\$ -	\$ -	\$ -	\$ 1,500.00

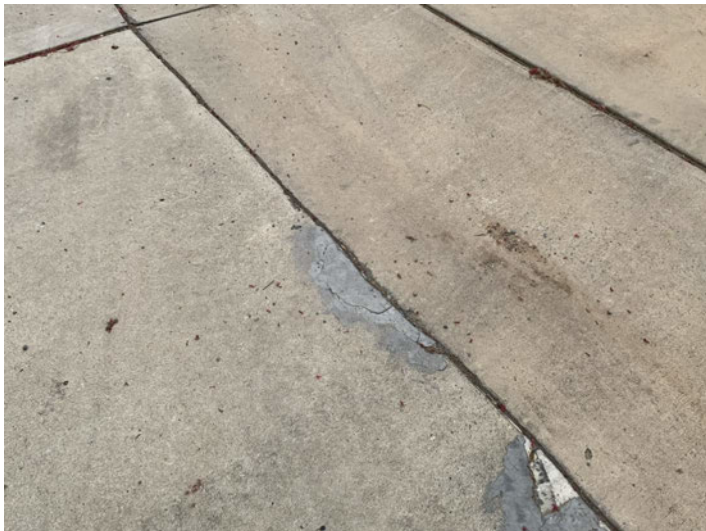
Wagga_Blg_007.jpg

1.006	Wagga Wagga Depot	Wagga Wagga Depot	External	EXTERNAL	Concrete Hardstands	Construction Joints	Implement a Construction Joint Repair Program	General	CAP	2	Poor	Wagga_Blg_007	\$ -	\$ -	\$ 2,500.00	\$ -	\$ -	\$ -	\$ -	\$ -	\$ -	\$ -	\$ -	\$ -	\$ 2,500.00

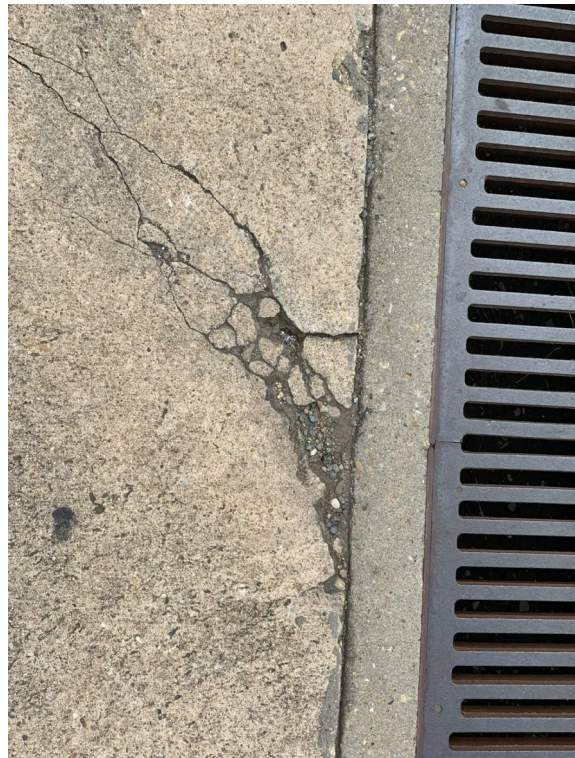
Wagga_Blg_008.jpg

1.010	Wagga Wagga Depot	Wagga Wagga Depot	External	EXTERNAL	Concrete Hardstands	Gutters & Culverts	Repair Isolated Cracking	General	CAP	2	Poor	Wagga_Blg_008	\$ -	\$ -	\$ 2,500.00	\$ -	\$ -	\$ -	\$ -	\$ -	\$ -	\$ -	\$ -	\$ -	\$ 2,500.00

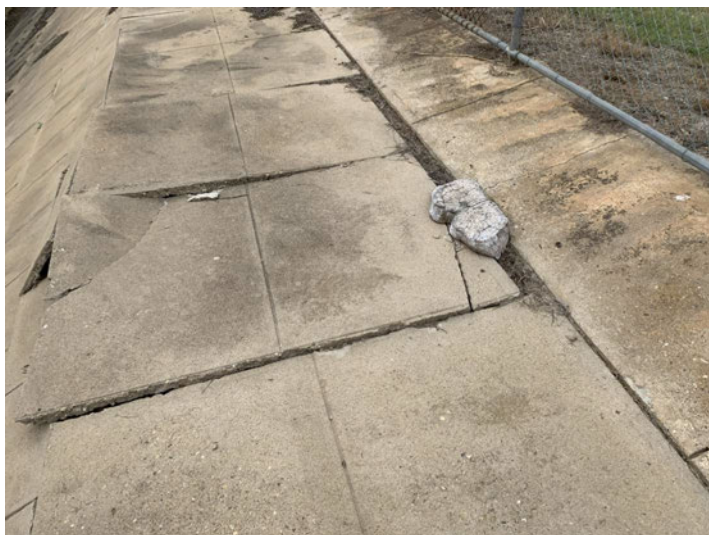
Wagga_Blg_009.jpg

1.012	Wagga Wagga Depot	Wagga Wagga Depot	External	EXTERNAL	Concrete Hardstands	Concrete Paved Areas	Replace Crack Entry Pavers	General	CAP	2	Poor	Wagga_Blg_009	\$ -	\$ -	\$ 15,000.00	\$ -	\$ -	\$ -	\$ -	\$ -	\$ -	\$ -	\$ -	\$ -	\$ 15,000.00

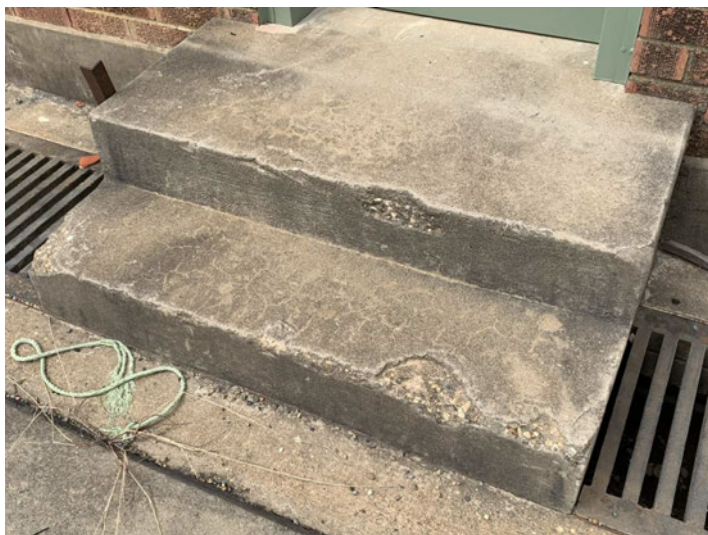
Wagga_Blg_010.jpg

1.013	Wagga Wagga Depot	Wagga Wagga Depot	External	EXTERNAL	Concrete Hardstands	Concrete Stairs	Repair Damage Stair Treads	General	CAP	2	Poor	Wagga_Blg_010	\$ -	\$ -	\$ 2,500.00	\$ -	\$ -	\$ -	\$ -	\$ -	\$ -	\$ -	\$ -	\$ -	\$ 2,500.00

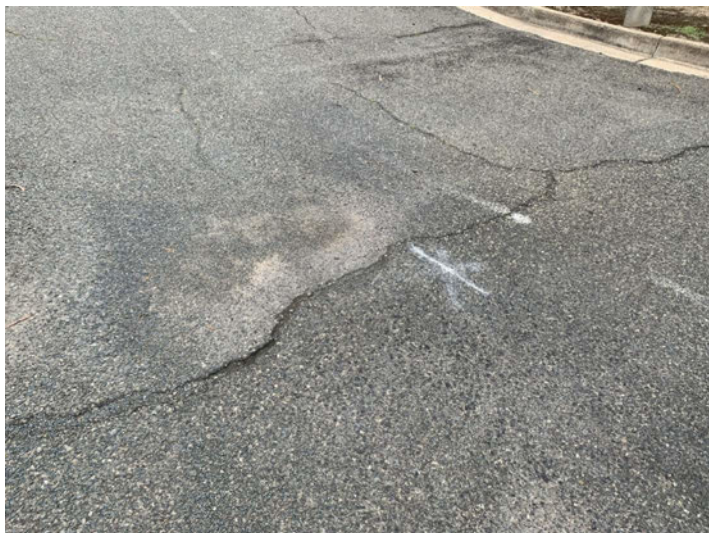
Wagga_Blg_011.jpg

1.014	Wagga Wagga Depot	Wagga Wagga Depot	External	EXTERNAL	Tarmac - Roads	Surface Cracks	Repair & Resurface Tarmac	General	CAP	2	Poor	Wagga_Blg_011	\$ -	\$ -	\$ 150,000.00	\$ -	\$ -	\$ -	\$ -	\$ -	\$ -	\$ -	\$ -	\$ -	\$ 150,000.00

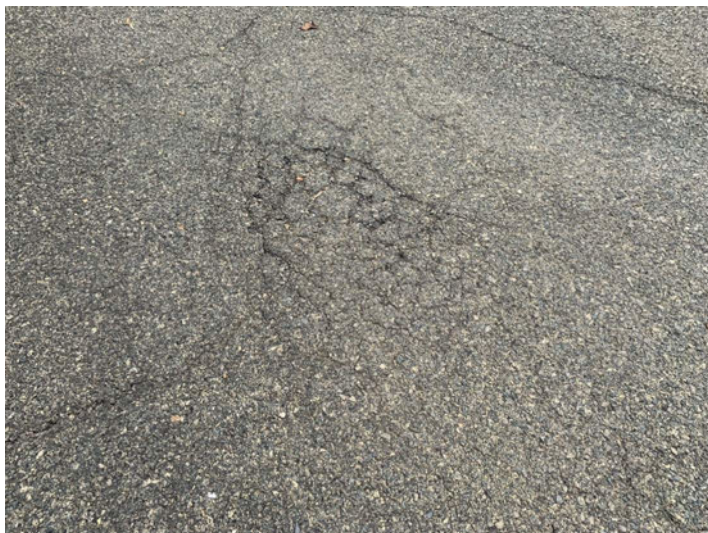
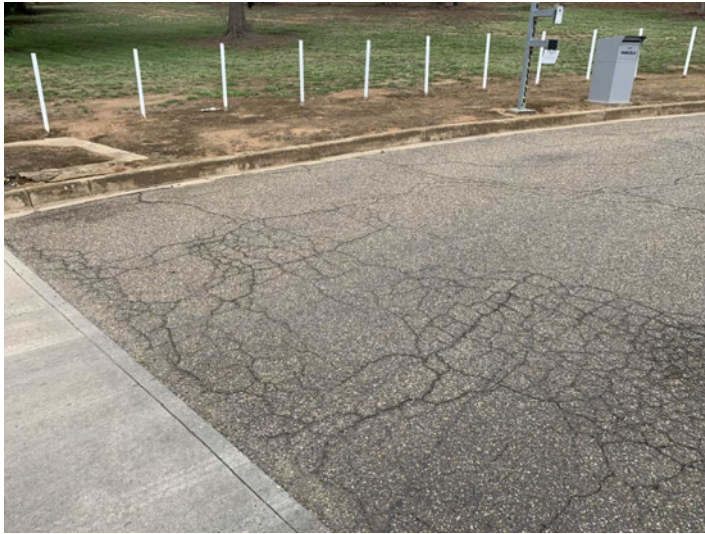
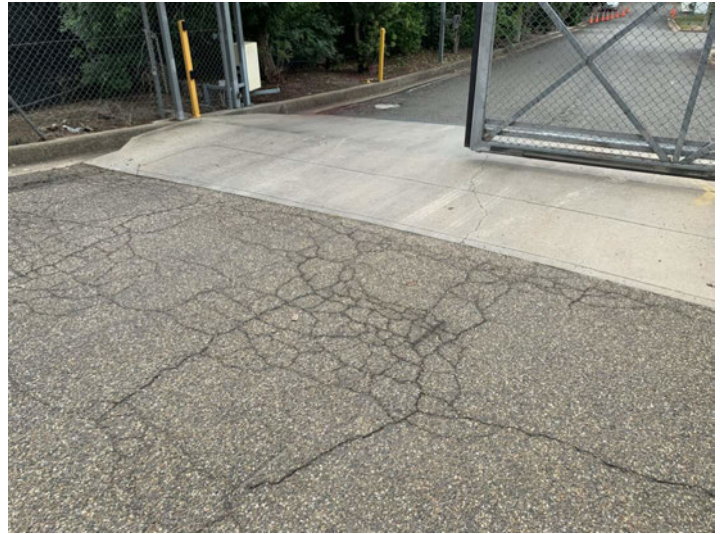
1.015	Wagga Wagga Depot	Wagga Wagga Depot	External	EXTERNAL	Tarmac - Roads	Crocodile Cracking	Repair & Resurface Tarmac - as part of surface cracks	General	CAP	2	Poor	Wagga_Blg_012, 013, 014	\$ -	\$ -	\$ -	\$ -	\$ -	\$ -	\$ -	\$ -	\$ -	\$ -	\$ -	\$ -	\$ -

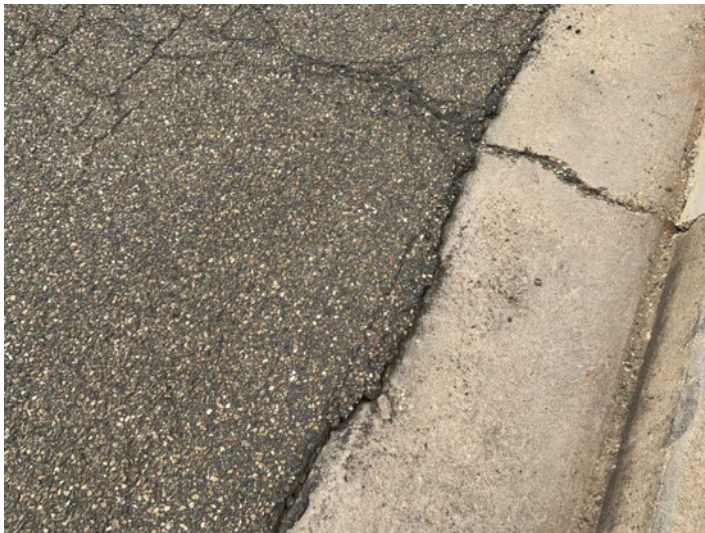
Wagga_Blg_015.jpg

1.016	Wagga Wagga Depot	Wagga Wagga Depot	External	EXTERNAL	Tarmac - Roads	Edge Cracking	Short Term Repair & Resurface Tarmac - as part of surface cracks	General	CAP	2	Poor	Wagga_Blg_015	\$ -	\$ 5,000.00	\$ -	\$ -	\$ -	\$ -	\$ -	\$ -	\$ -	\$ -	\$ -	\$ -	\$ 5,000.00

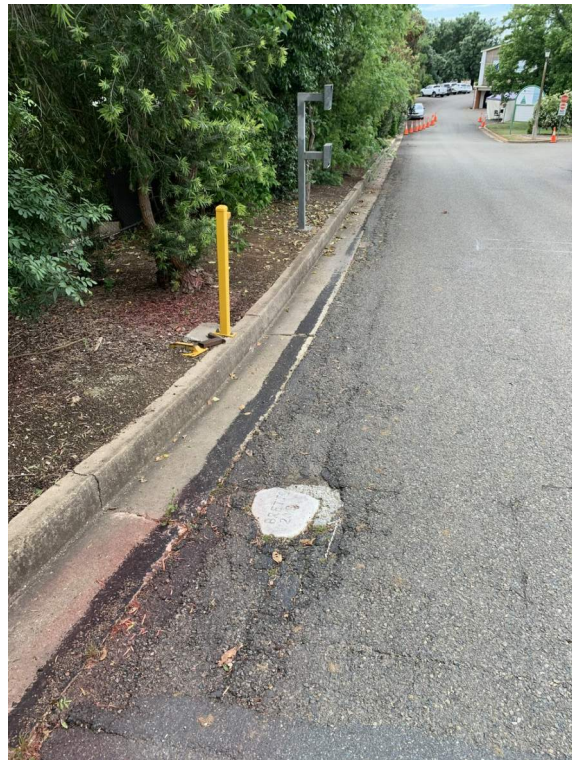
Wagga_Blg_016.jpg

1.017	Wagga Wagga Depot	Wagga Wagga Depot	External	EXTERNAL	Tarmac - Roads	Pot Holes	Short term Repair & Resurface Tarmac - as part of surface cracks	General	CAP	2	Poor	Wagga_Blg_016	\$ -	\$ 5,000.00	\$ -	\$ -	\$ -	\$ -	\$ -	\$ -	\$ -	\$ -	\$ -	\$ -	\$ 5,000.00

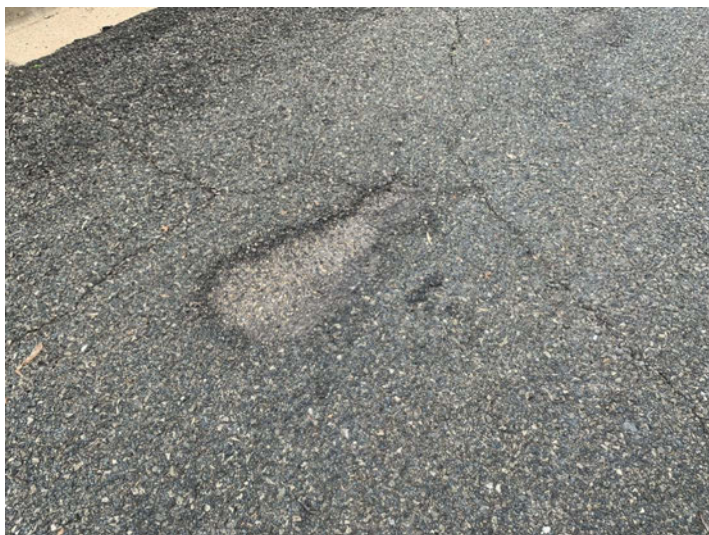
Wagga_Blg_017.jpg

1.018	Wagga Wagga Depot	Wagga Wagga Depot	External	EXTERNAL	Tarmac - Roads	Depressions & Ravelling	Repair & Resurface Tarmac	General	CAP	2	Poor	Wagga_Blg_017	\$ -	\$ -	\$ -	\$ -	\$ -	\$ -	\$ -	\$ -	\$ -	\$ -	\$ -	\$ -	\$ -

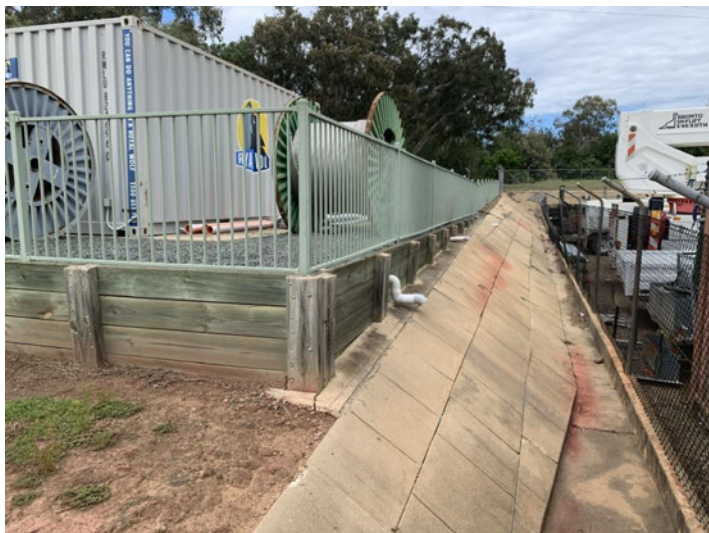
Wagga_Blg_019.jpg

1.023	Wagga Wagga Depot	Wagga Wagga Depot	External	EXTERNAL	Retaining Walls	Retaining Walls	Replace - Timber Retaining Walls	General	CAP	2	Poor	Wagga_Blg_019	\$ -	\$ -	\$ 15,000.00	\$ -	\$ -	\$ -	\$ -	\$ -	\$ -	\$ -	\$ -	\$ -	\$ 15,000.00

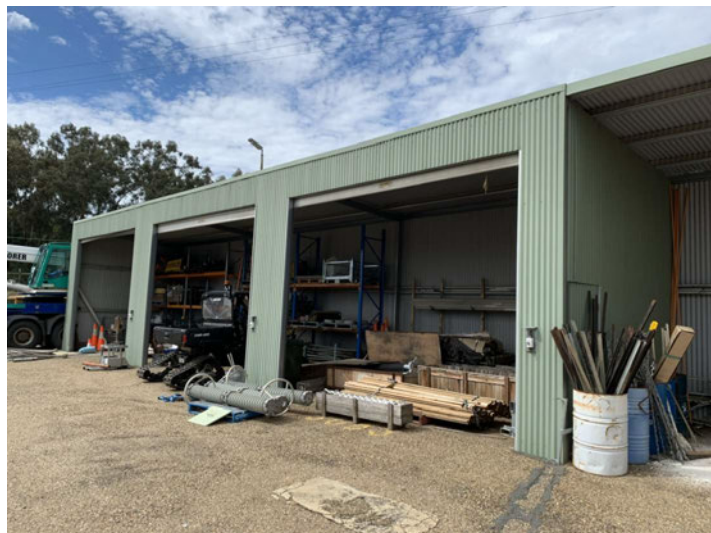
Wagga_Blg_139.jpg

1.273	Wagga Wagga Depot	Garage Compound	General	FAÇADE	Roller Shutters	Metal	Shed A - Repair to Roller Shutter Door	General	CAP	2	Poor	Wagga_Blg_139	\$ -	\$ -	\$ 2,500.00	\$ -	\$ -	\$ -	\$ -	\$ -	\$ -	\$ -	\$ -	\$ 2,500.00

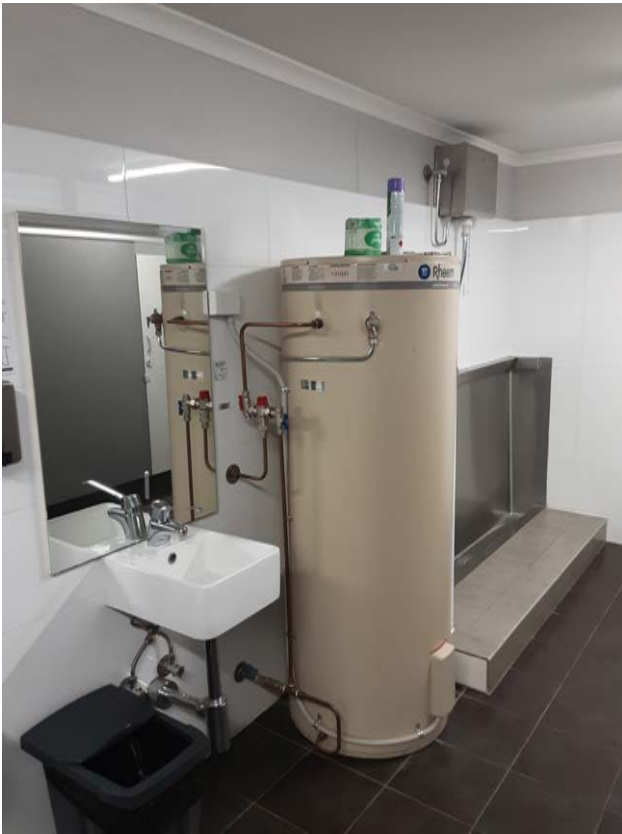
Wagga_Hyd_001.jpg

5.006	Wagga Wagga Depot	Admin Building	Ground Floor - Internal	HYDRAULIC	Male toilets and change room	Hot water system 315 litres	Allow for replacement for 'end of life'	Operational Risk	CAP	4	Good	Wagga_Hyd_01	\$ -	\$ -	\$ -	\$ -	\$ -	\$ -	\$ -	\$ -	\$ -	\$ -	\$ -	\$ 3,000.00

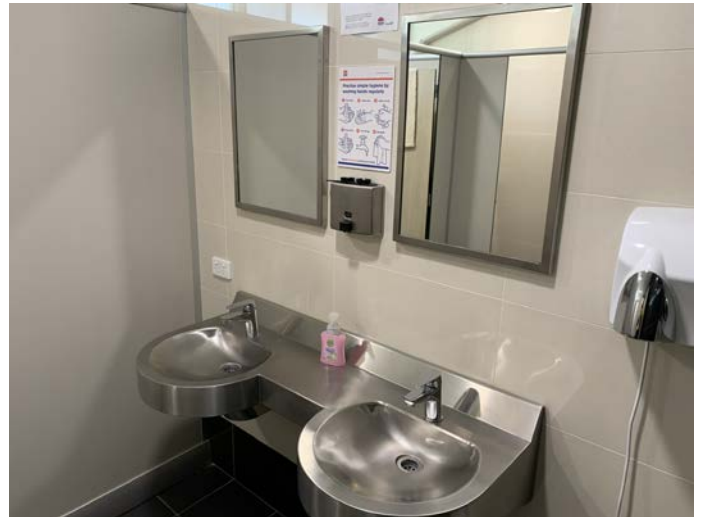
Wagga_Hyd_006.jpg

5.007	Wagga Wagga Depot	Admin Building	Level 1 - Internal	HYDRAULIC	Female toilets	Single stainless steel Wash basin (2 basin) with single mixing tap and Zip hot water unit	No major capital works envisaged in the reporting period.	General	R&M	4	Good	Wagga_Hyd_06	\$ -	\$ -	\$ -	\$ -	\$ -	\$ -	\$ -	\$ -	\$ -	\$ -	\$ -	\$ -

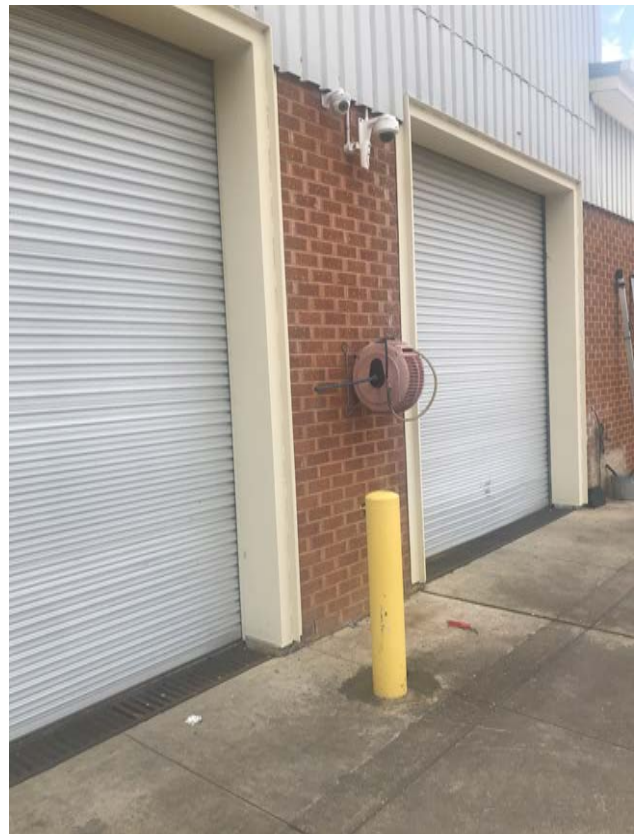
Wagga_Hyd_012.jpg

5.012	Wagga Wagga Depot	Wagga Wagga Depot	External	HYDRAULIC	Retractable Hose Tap	Fair condition	Allow to replace in the medium term	General	CAP	3	Fair	Wagga_Hyd_12	\$ -	\$ -	\$ 800.00	\$ -	\$ -	\$ -	\$ -	\$ -	\$ -	\$ -	\$ -	\$ -	\$ 800.00

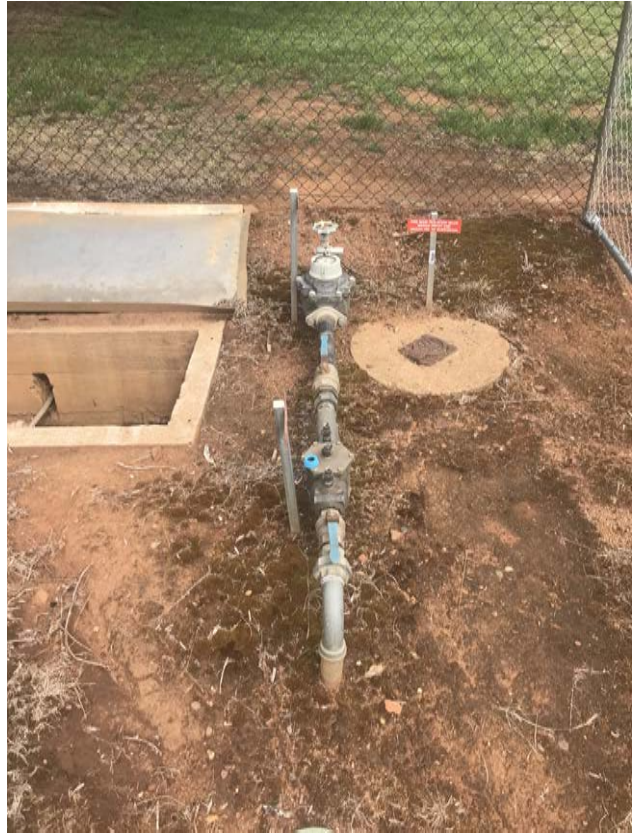
Wagga_Hyd_014.jpg

5.015	Wagga Wagga Depot	Wagga Wagga Depot	External	HYDRAULIC	Main domestic inlet valve	Fair condition RPZ installation does not seem compliant	Allow for hydraulic contractor inspection, confirm installation to prevent back flow and is covered under maintenance.	General	MC/R&M	2	Fair	Wagga_Hyd_14	\$ -	\$ -	\$ 800.00	\$ -	\$ -	\$ -	\$ -	\$ -	\$ -	\$ -	\$ -	\$ -	\$ 800.00

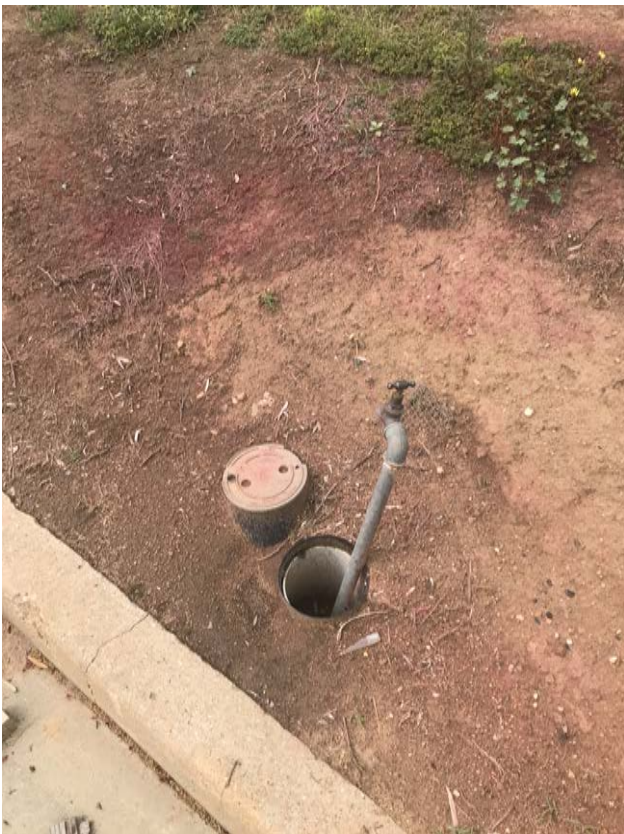
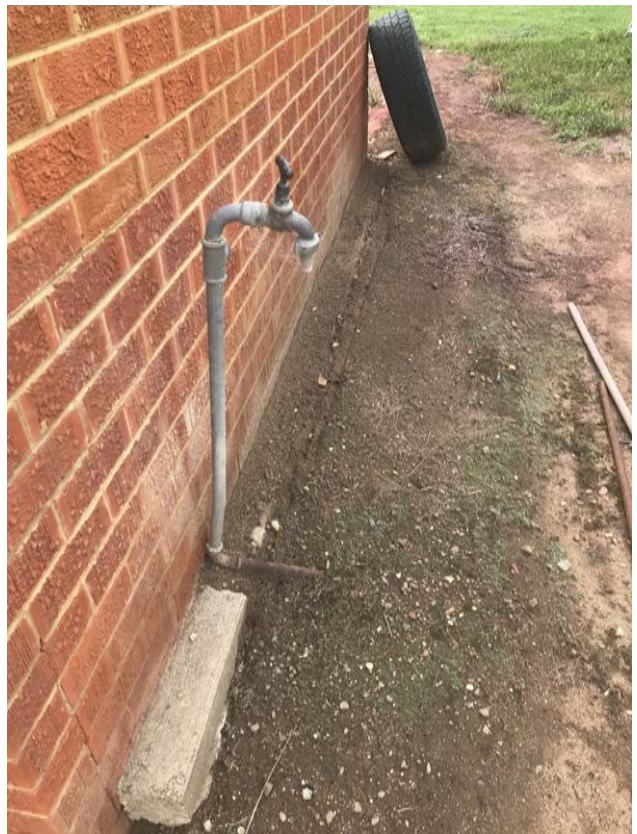
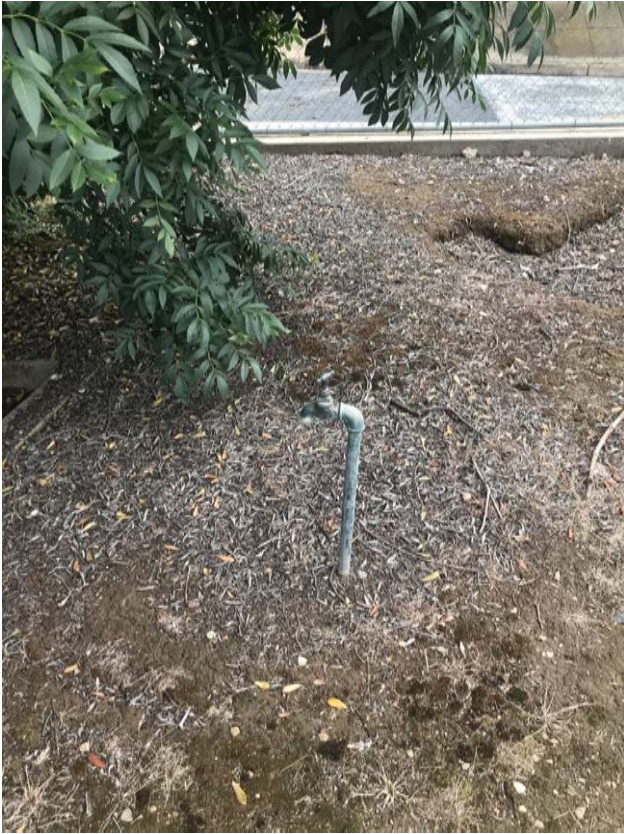
5.013	Wagga Wagga Depot	Wagga Wagga Depot	External	HYDRAULIC	Hose Tap	Multiple external hose taps in Fair	Allow to replace	General	CAP	2	Fair	Wagga_Hyd_15 to 17	\$ -	\$ -	\$ -	\$ -	\$ -	\$ -	\$ -	\$ -	\$ -	\$ -	\$ -	\$ 4,000.00

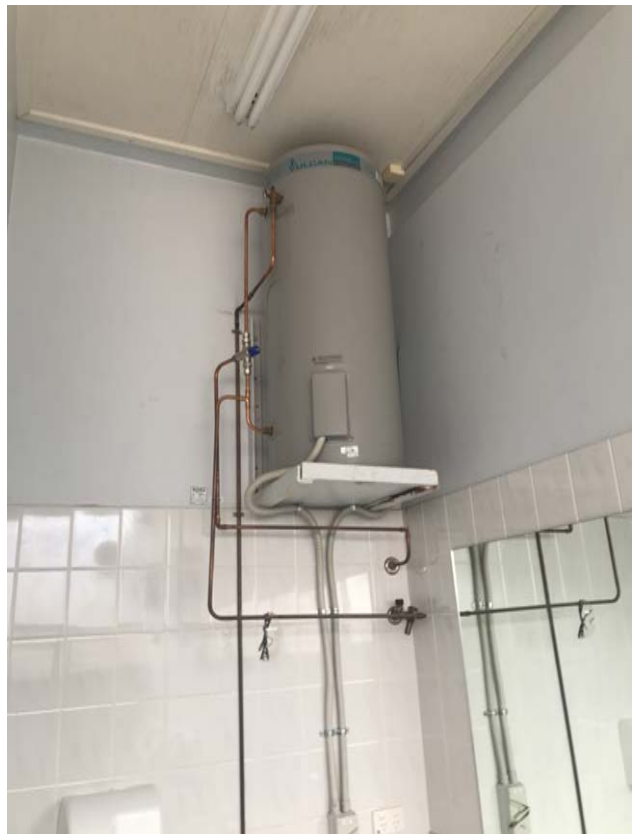
Wagga_Hyd_020.jpg

5.018	Wagga Wagga Depot	Workshop Building	Internal	HYDRAULIC	Male toilets	Hot Water system in Fair condition	Allow to replace in the medium term	Operational Risk	CAP	3	Fair	Wagga_Hyd_20	\$ -	\$ -	\$ -	\$ -	\$ -	\$ -	\$ 2,000.00	\$ -	\$ -	\$ -	\$ -	\$ -	\$ 2,000.00
