Building Condition Review and CAPEX Plan

BGIS - TransGrid – Yass Regional Depot Centre

10 December 2020

Project No. EB1110

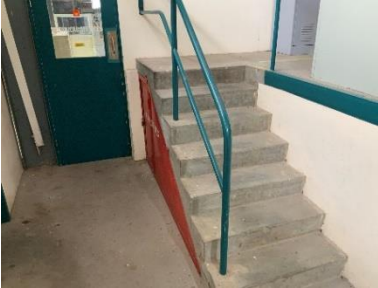
Item	DTS Clause	Description of Non-compliance	Requirement to Satisfy BCA
1.	D1.6	<p>The stair to the raised floor within the workshop is less than 1000mm wide. The landing to the stair is only 900mm wide.</p>

<p>The widths are required to be not less than 1000mm clear of any obstructions. Alternatively, a performance solution from a fire safety engineer satisfying Performance Requirements DP4 and EP2.2 is required.</p>

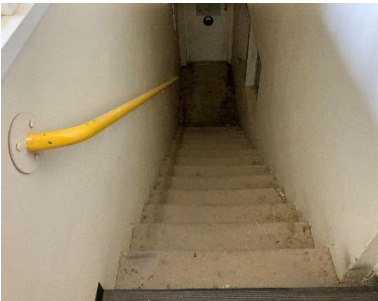
<p>The internal stair within the southern control centre is less than 1000mm wide.</p>

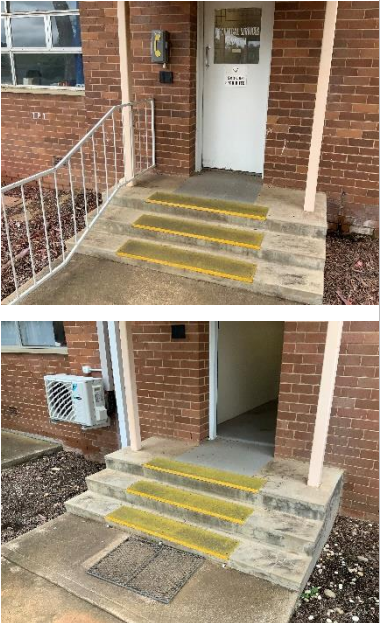
Item	DTS Clause	Description of Non-compliance	Requirement to Satisfy BCA																											
2.	D2.13	<p>The 2 entry stairs to the Workshop are inconsistent and do not have complaint nosing strips in accordance with AS1428.1.</p>

<p>To provide safe passage, stairways must comply with the following:</p> <ul style="list-style-type: none"> • Minimum 2 risers / maximum 18 in each flight • Risers 115mm min 190 mm max - going 250mm min 355mm max - 2R+G 550mm min 700mm max. • Adjacent risers, or between adjacent goings a variation no greater than 5mm is permitted and the largest and smallest riser within the flight or the largest and smallest going within a flight is not to exceed a variation of 10mm. • Under the requirements of AS1428.1-2009 open riser are not permitted. • All treads to be fitted with non-slip finish or non-skid strips. • Treads are required to have a surface or nosing strip with a slip-resistance classification not less than listed in Table D2.14 when tested in accordance with AS 4586

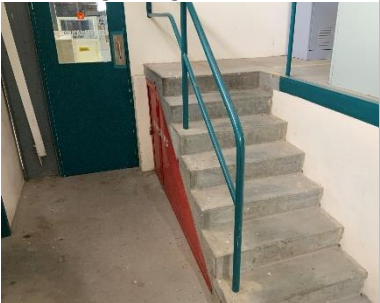
<p>The stair to the raised floor within the Workshop does not have contrasting nosing.</p>

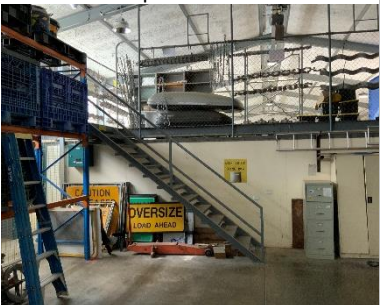
<p>The stairs leading to the mezzanine within the Workshop have risers between 205-210mm which exceed the maximum permitted of 190mm.</p>

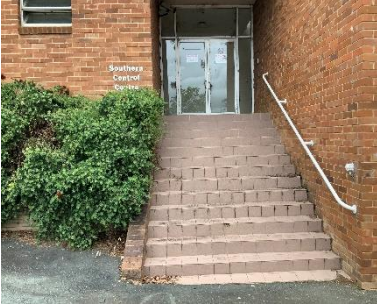
Item	DTS Clause	Description of Non-compliance	Requirement to Satisfy BCA
		<p>The stairs to the Southern Control Centre have some minor inconsistencies</p>

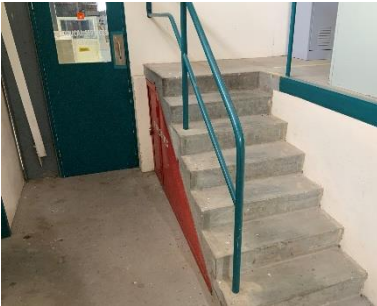
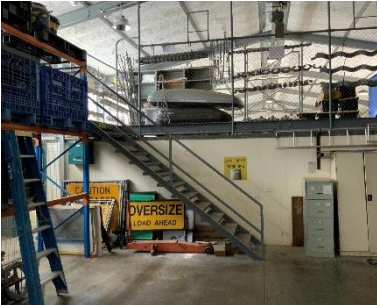
3.	D2.16	<p>The balustrade to the landing of the stair to the raised floor and small mezzanine within the Workshop is less than 1000mm high. (approximately 900mm)</p>

<p>The balustrade to the rear external stair of the Southern Control Centre</p>	<p>A balustrade not less than 1000mm in height is required to be provided. Where horizontal rails are provided a bottom rail not more than 150mm above the floor is required and the space between rails must not exceed 460mm.</p>

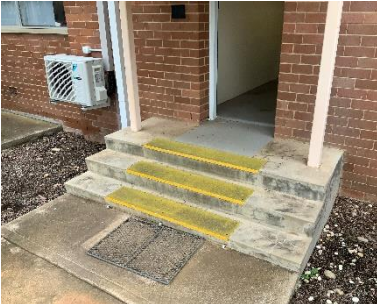
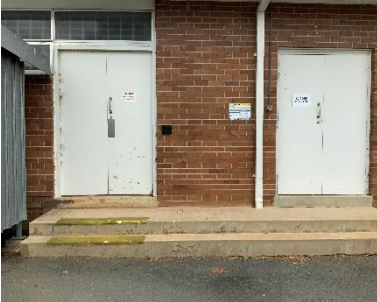
4.	D2.17	<p>Handrails to stairways are not compliant with AS1428.1,</p> <p>No handrails are provided to the stair or ramp leading to the Workshop Building.</p>

<p>No handrails are provided to the stair to the side of the Southern Control Centre</p>	<p>Handrails in accordance with AS1428.1 are required.</p>

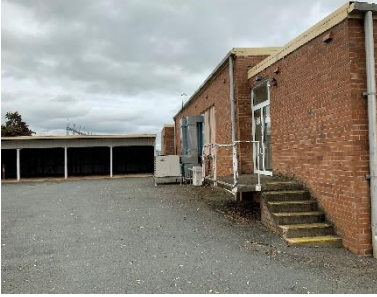
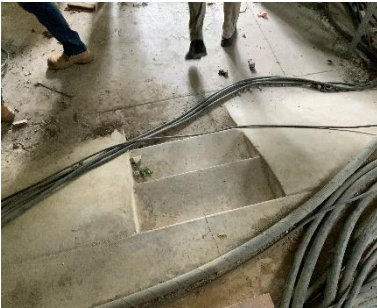
<p data-bbox="428 625 756 709">No handrail provided to the stairs within the lower floor level of the Southern Control Centre</p>

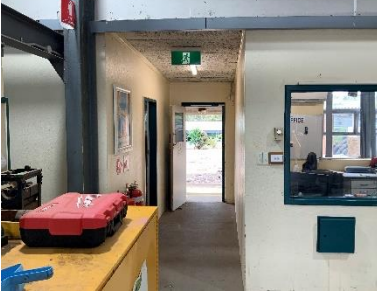
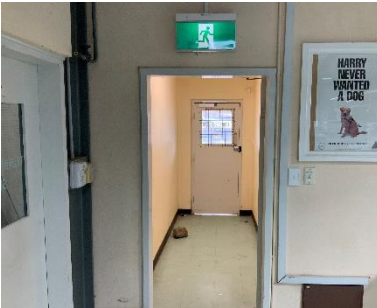
5.	D2.20	<p data-bbox="428 1056 784 1108">Exit doors within the Workshop swing against the direction of travel.</p>

The doors are required to be reswung to swing in the direction of egress.

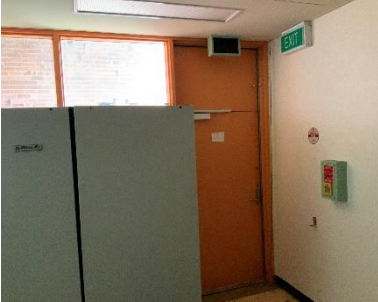
Item	DTS Clause	Description of Non-compliance	Requirement to Satisfy BCA
6.	D2.21	<p>The Southern Control Centre rear exit door was not able to be opened.</p>

<p>Exit doors should be provided with “free handle” egress via a downward or pushing action and, if serving an area accessible to people with disabilities, must have non-slip “D” pull handles with 35-45mm hand clearances.</p>

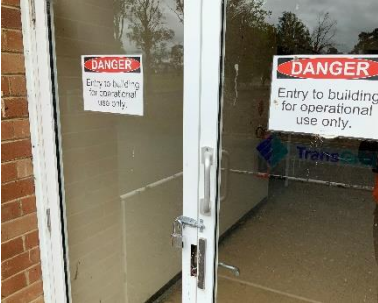
<p>The Southern Control Centre had door hardware where it was not possible to open the door from the inside of the building</p>

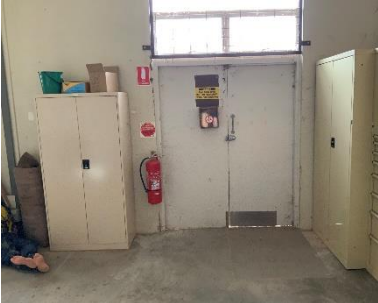
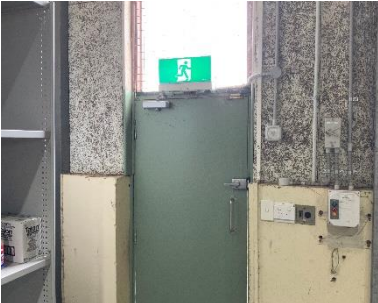
<p>The Workshop had some doors with non-compliant door hardware or hardware at the incorrect height.</p>

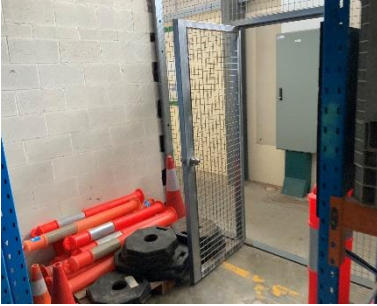
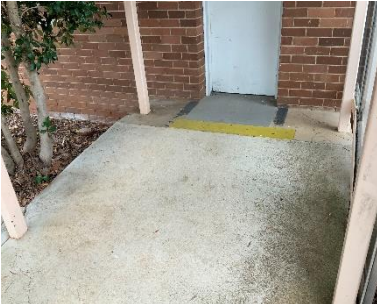
7.	D3.2	<p>Access between Admin Building and Workshop Building is via a non-compliant ramp which doesn't comply with AS 1428.1.</p>

Compliant ramps or lifts are required to be provided to provide access for people with disabilities. A detailed assessment by an Access Consultant should be undertaken.
8.	D3.3	There are no ambulant or accessible facilities provided in the Workshop or Southern Control Centre.	A full audit by an Access Consultant should be undertaken to determine details of non-compliances with AS1428.1. Major modifications would be required to achieve compliance throughout.

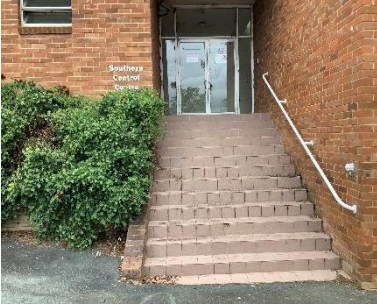
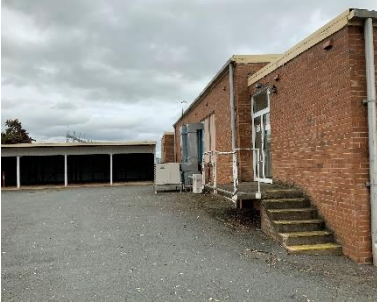
<p>Access is not provided to the southern control Centre.</p>

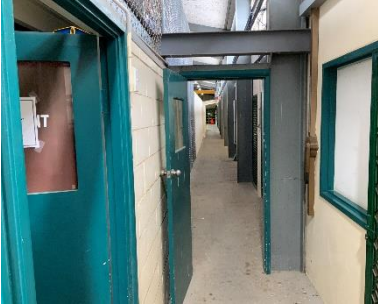
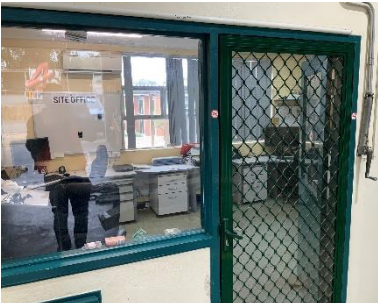
Item	DTS Clause	Description of Non-compliance	Requirement to Satisfy BCA
		<p>Most doors within the Workshop are less than 850mm clear in width and have a solid door and screen door.</p>

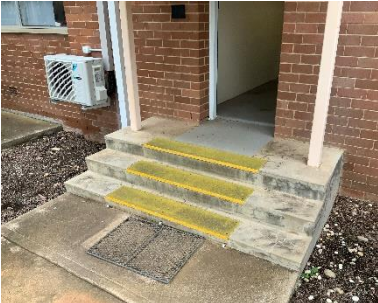
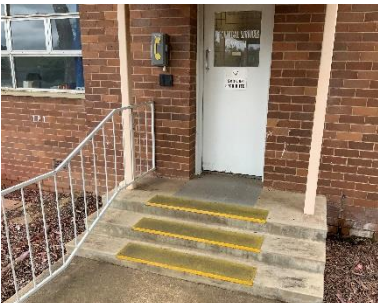
<p>Handrails compliant with AS1428.1 are not provided to the stairs serving the Workshop or Southern Control Centre.</p>

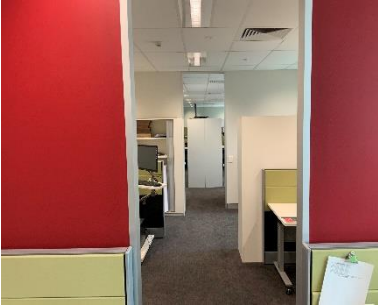
<p data-bbox="428 1379 803 1495">The door leading from the corridor in the Admin Building to the office area has a clear width of 840mm and not 850mm.</p>	
9.	D3.5	No accessible parking space is provided.	At least 1 accessible parking space in accordance with AS/NZS 2890.6 – 2009 is required to be provided.

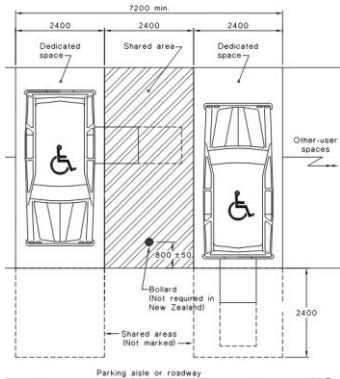
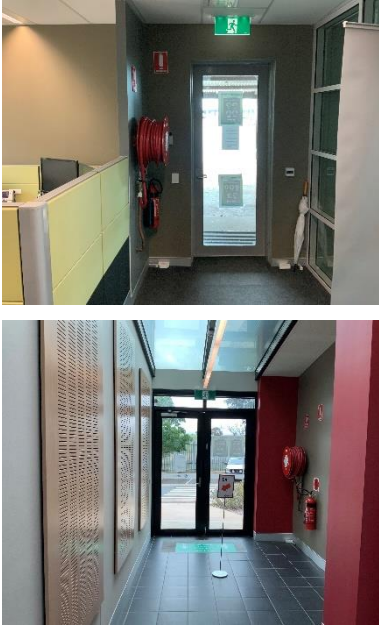
10.	D3.6	<p>There is no braille exit signage provided to the exit doors.</p>

<p>Every doorway required to be provided with an exit sign under Clause E4.5 is to be provided with braille and tactile signage that states “EXIT” and identify the floor level “LEVEL #”.</p>

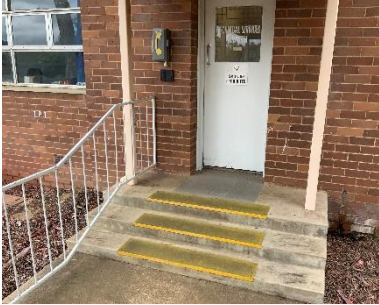
11.	D3.8	<p>TGSI's are not provided to stairs serving the Workshop or Southern Control Centre in accordance with AS1428.4.1.</p>

<p>Tactile indicators are to be provided to all stairways and ramps in accordance with sections 1 and 2 of AS/NZS 1428.4.1.</p>

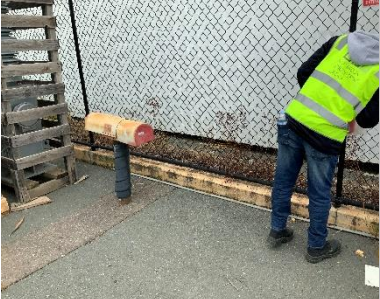
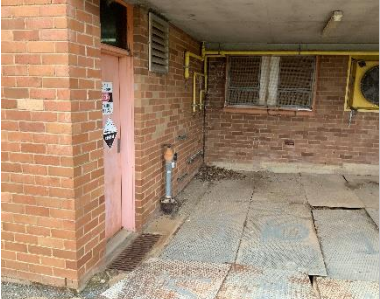
<p data-bbox="428 926 789 982">Hydrants are not provided with storz couplings.</p>

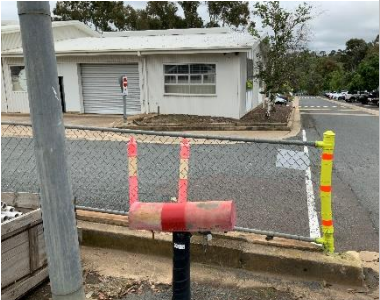
<p data-bbox="428 1304 727 1388">The hydrant booster does not comply with the current requirements of the AS2419.1.</p>

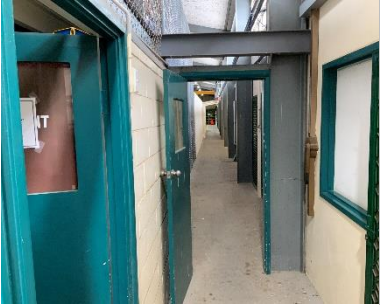
<p data-bbox="428 1220 786 1360">The signage within the Southern Control Centre is not the correct pictorial exit signs and they were not illuminated. There was insufficient exit signage within the building too.</p>

<p data-bbox="821 846 1435 926">A detailed assessment by the fire services consultant should be undertaken to determine required emergency lighting and exit signage.</p>

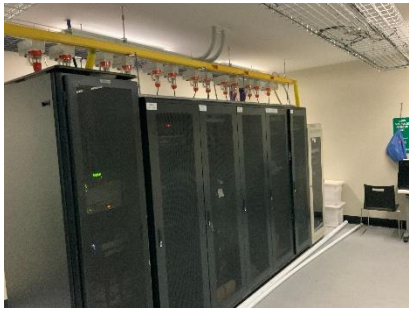
3.	C2.12	<p>A room containing a battery system that has a total voltage of 12 volts or more and a storage capacity of 200 kWh or more must be separated by 2-hour fire rated construction.</p> <p>The comms room within the administration building contain are number of UPS.</p>

Confirmation of the total voltage and storage capacity are to be provided to confirm if fire separation is required.

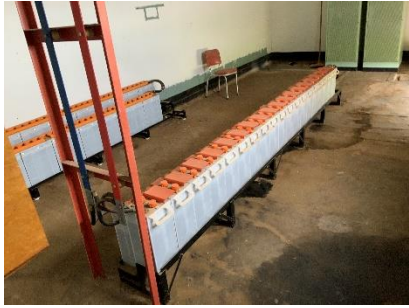
Item	DTS Clause	Description	Note
		<p>A room within the Southern Control Centre contained numerous batteries which was not fire separated.</p>

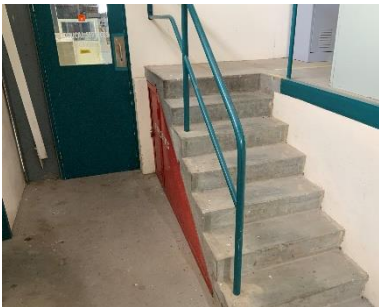
Item	DTS Clause	Description of Non-compliance	Requirement to Satisfy BCA
1.	D1.6	<p>The stair to the raised floor within the workshop is less than 1000mm wide. The landing to the stair is only 900mm wide.</p>

<p>The widths are required to be not less than 1000mm clear of any obstructions. Alternatively, a performance solution from a fire safety engineer satisfying Performance Requirements DP4 and EP2.2.</p>

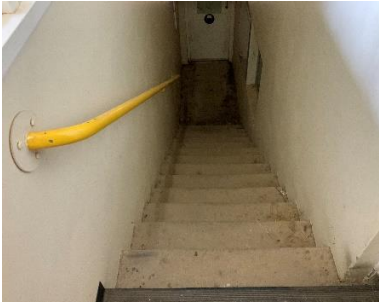
<p>The internal stair within the southern control centre is less than 1000mm wide.</p>

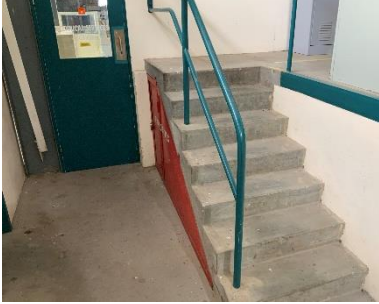
<p data-bbox="472 1252 823 1368">The stairs leading to the mezzanine within the workshop have risers between 205-210mm which exceeds the maximum permitted of 190mm.</p>

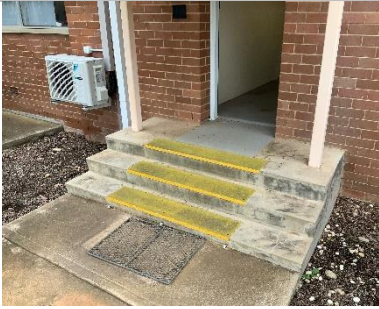
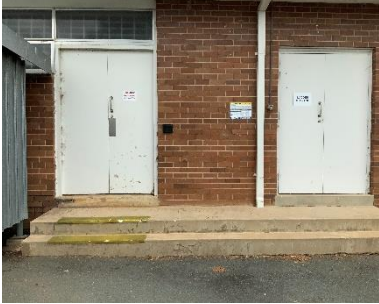
<p>No handrails are provided to the stair to the side of the Southern Control Centre</p>

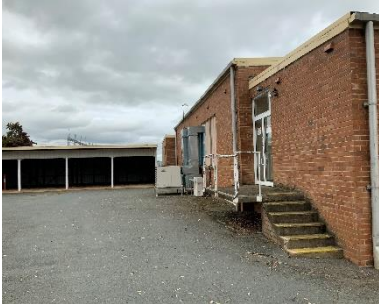
<p>No handrail provided to the stairs within the lower floor level of the southern control centre</p>

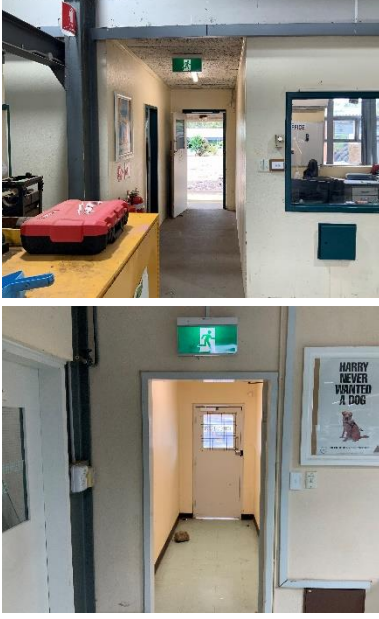
6.	D2.21	<p>The southern control centre rear exit door was not able to be opened.</p>

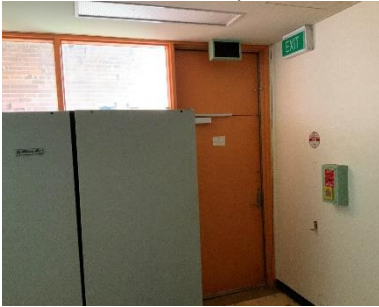
<p>The southern control centre had door hardware where it was not possible to open the door from the inside of the building</p>

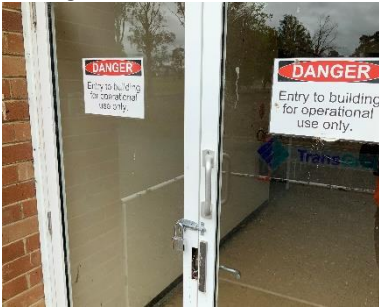
<p>The workshop had some doors with non-compliant door hardware or hardware at the incorrect height.</p>	<p>Exit doors should be provided with “free handle” egress via a downward or pushing action and, if serving an area accessible to people with disabilities, must have non-slip “D” pull handles with 35-45mm hand clearances.</p>

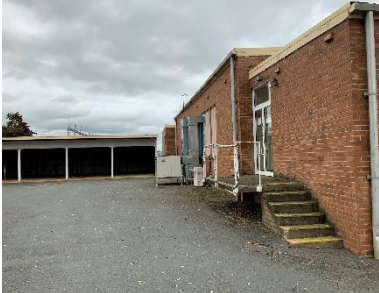
8.	D3.3	<p>There are no ambulant or accessible facilities provided in the workshop or southern control centre.</p> <p>Most doors within the workshop are less than 850mm clear in width and have a solid door and screen door.</p>

<p>A full audit by an access consultant should be undertaken to determine details of non-compliances with AS1428.1. Major modifications would be required to achieve compliance throughout.</p>

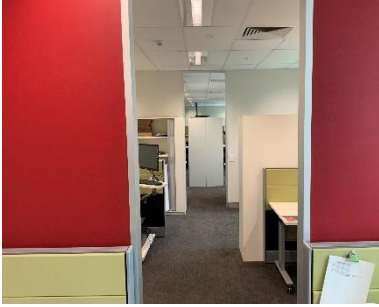
<p data-bbox="472 1630 839 1749">The door leading from the corridor in the administration building to the office area has a clear width of 840mm and not 850mm.</p>	
9.	D3.5	No accessible parking space is provided	At least 1 accessible parking space in accordance with AS/NZS 2890.6 – 2009 is required to be provided.

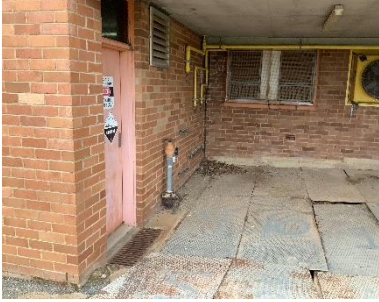
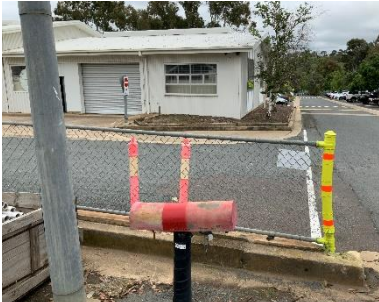
<p>Hydrants are not provided with storz couplings.</p>

<p>The hydrant system is required to comply with AS2419.1-2005. A detailed assessment from the fire services engineer should be undertaken to identify any shortfalls with the system.</p> <p>Where triggered under an upgrade the hydrant system would need to be upgraded to comply with AS2419.1 or via a Performance Solution from a fire safety engineer.</p>

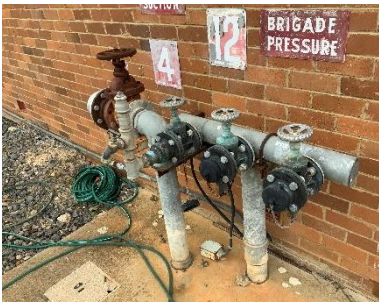
<p>The hydrant booster does not comply with the current requirements of the AS2419.1</p>

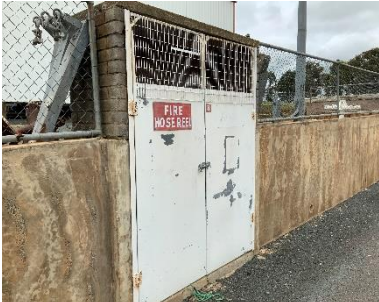
13.	E1.4	<p>A cupboard between the workshop building and vehicle compound has a fire hose reel sign but not hose reel is provided in it.</p>

<p>The sign should be removed and provided with portable extinguisher signage.</p>

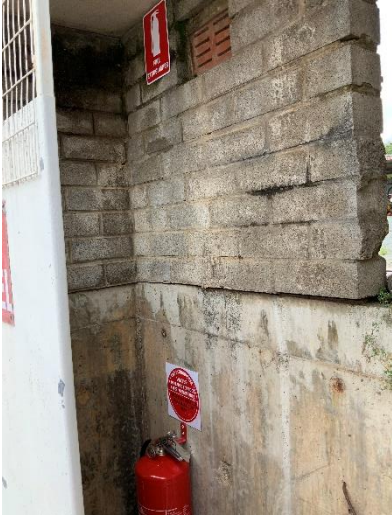
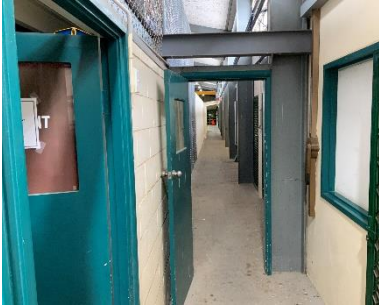
Item	DTS Clause	Description of Non-compliance	Requirement to Satisfy BCA
14.	E4.5	<p>Additional exit signage is required in the workshop building.</p>

<p>A detailed assessment by the fire services consultant should be undertaken to determine required emergency lighting and exit signage.</p>

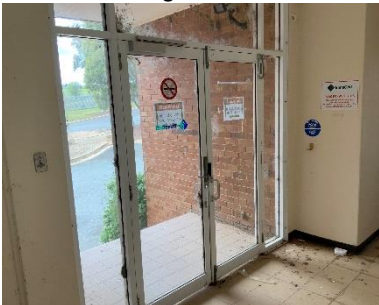
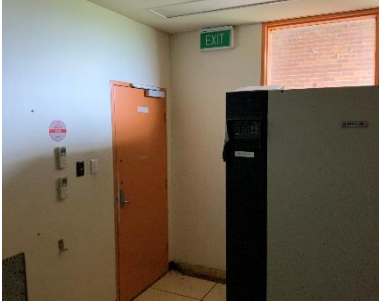
<p>The signage within the southern control centre is not the correct pictorial exit signs and they were not illuminated. There was insufficient exit signage within the building too.</p>

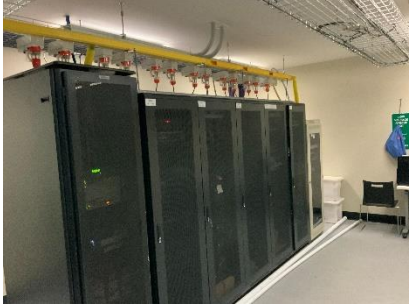
3.	C2.12	<p>A room containing a battery system that has a total voltage of 12 volts or more and a storage capacity of 200 kWh or more must be separated by 2 hour fire rated construction.</p> <p>The comms room within the administration building contain are number of UPS.</p>

<p>Confirmation of the total voltage and storage capacity are to be provided to confirm if fire separation is required.</p>

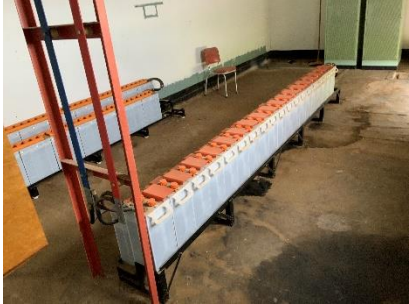
<p>A room within the southern control centre contained numerous batteries which was not fire separated.</p>

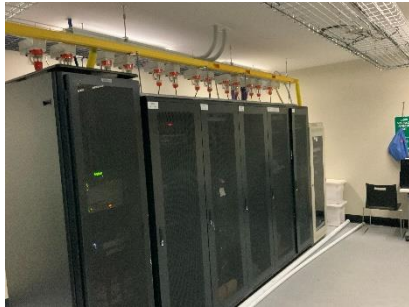
Clause	Description	Comment	Status
C2.10	Separation of lift shafts		N/A
C2.11	Stairways and lifts in one shaft		N/A
C2.12	<p>Separation of equipment</p> <p>Two-hour fire enclosure is required for:</p> <ul style="list-style-type: none"> ▪ lift motor rooms ▪ emergency generators sustaining emergency equipment operating in emergency mode ▪ central mechanical smoke control plant ▪ boilers ▪ a battery system installed in the building that has a total voltage of 12 volts or more and a storage capacity of 200 kWh or more. 	<p>The comms room within the administration building contain are number of UPS. Confirmation of the total voltage and storage capacity are to be provided to confirm if fire separation is required.</p>

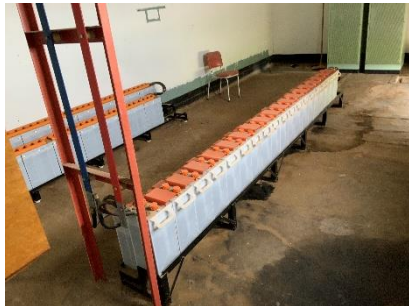
<p>A room within the southern control centre contained numerous batteries which was not fire separated. Confirmation of the total voltage and storage capacity are to be provided to confirm if fire separation is required.</p>

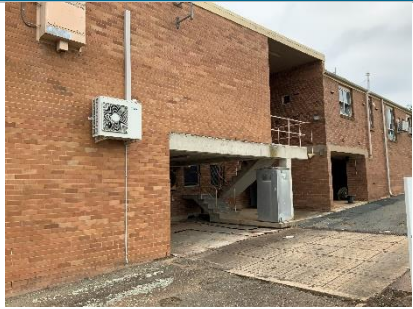
<p>The balustrade to the rear external stair of the southern control centre is less than 1000mm.</p>	Does not comply

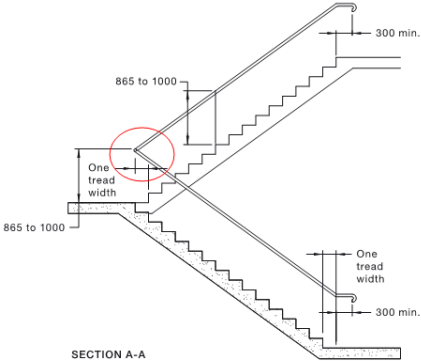
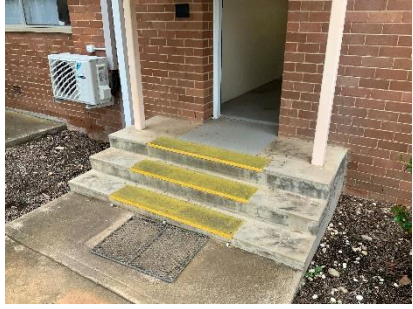
<p style="text-align: center;">SECTION A-A</p>	<p>Handrails to stairways are not compliant with AS1428.1,</p> <p>No handrails are provided to the stair or ramp leading to the workshop building.</p>

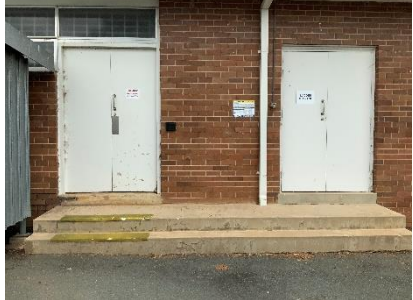
<p>No handrails are provided to the stair to the side of the Southern Control Centre</p>

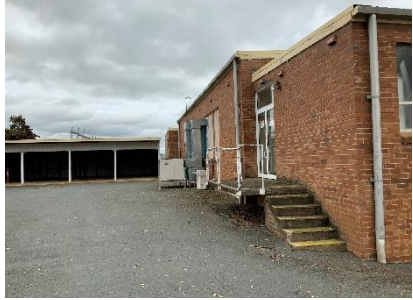
<p>No handrail provided to the stairs within the lower floor level of the southern control centre</p>	<p>Does not comply</p>

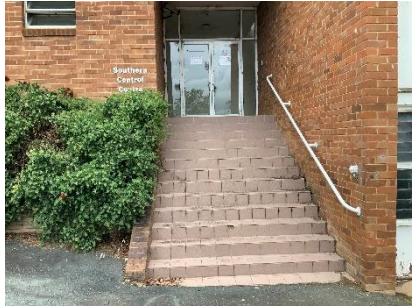
Access is not provided to the southern control centre

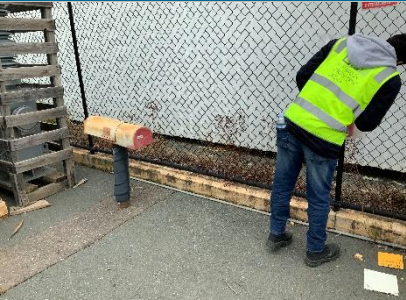
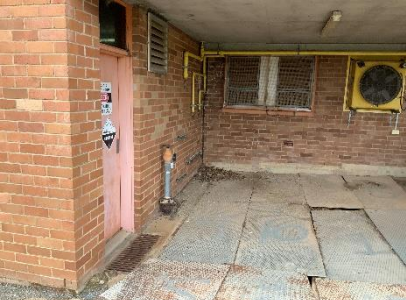
<p data-bbox="831 857 1169 913">Hydrants are not provided with storz couplings.</p>

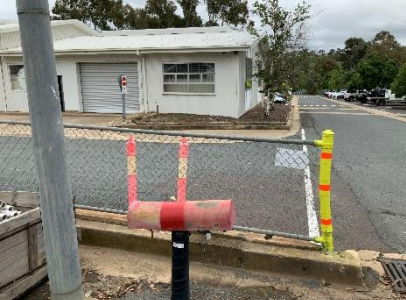
<p data-bbox="831 1227 1222 1283">The hydrant booster does not comply with the current requirements of the AS2419.1</p>

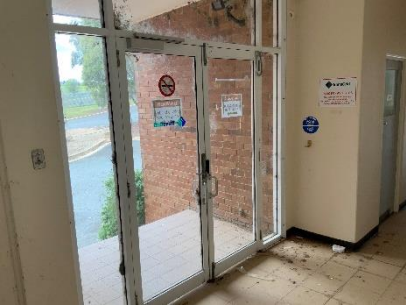
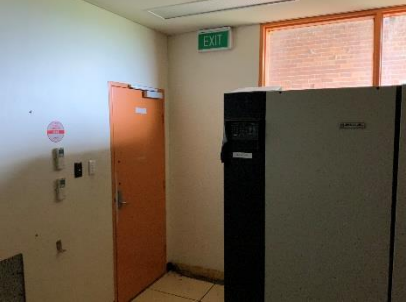
<p>The signage within the southern control centre is not the correct pictorial exit signs and they were not illuminated. There was insufficient exit signage within the building too.</p>
