POWERLINK QUEENSLAND  
REVENUE PROPOSAL

**CP.01656**

**Calliope River to Larcom Creek 275kV  
Transmission Line Refit**

**Transmission Line Condition Assessment – Report**  
**BS1515 – Mt Miller to Larcom Ck**

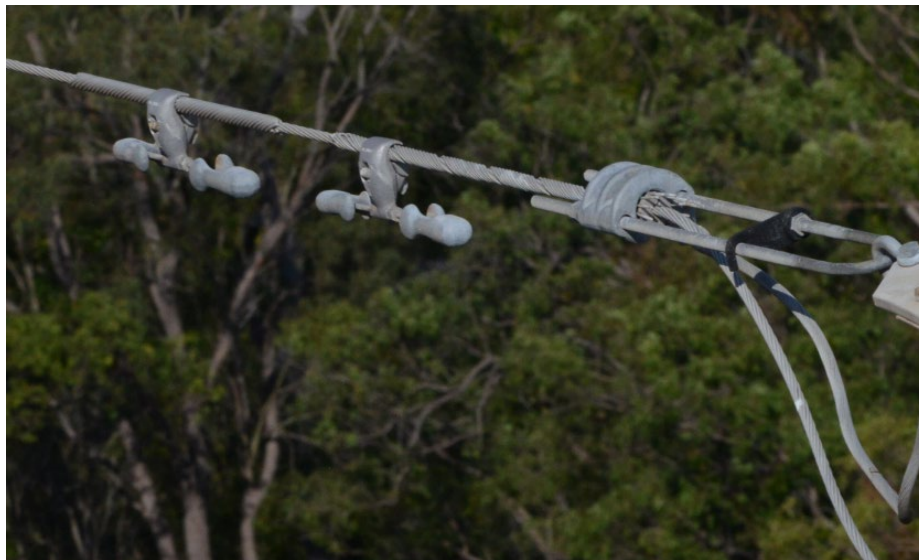
Figure 20: 1515-STR-0021 OHEW & OHEW Hardware

The OHEW was replaced in 2008 when the OPGW was installed.

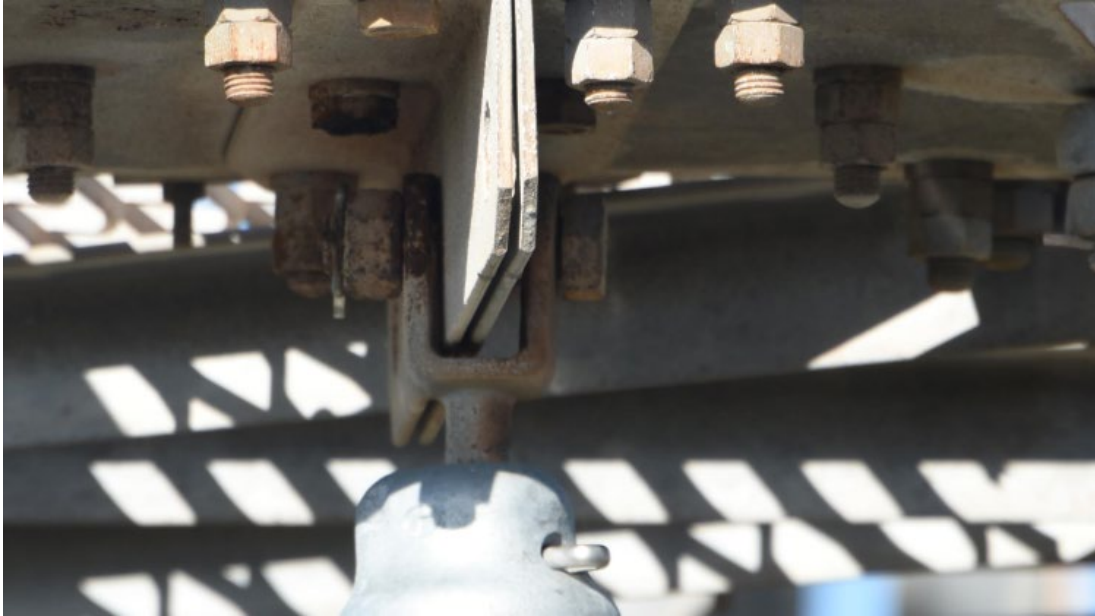
Figure 29: 1515-STR-0017 Bridging Insulator Hardware - Cold End

The bridging insulators were changed in 2015, however no hardware was changed.

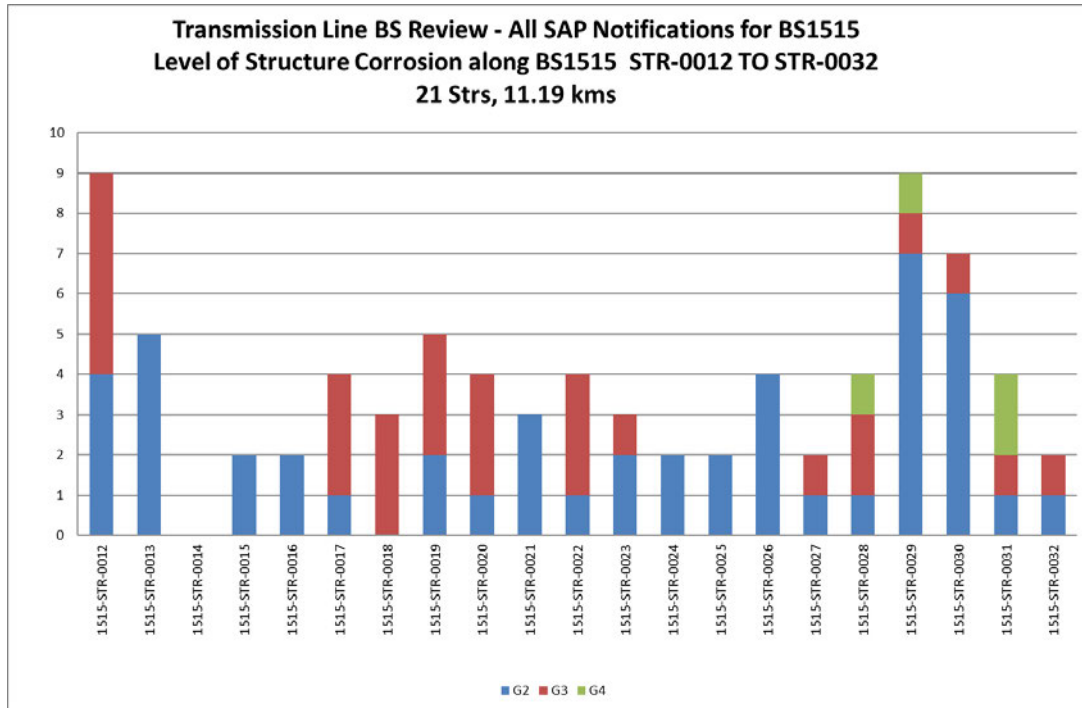
Figure 33: Graph of SAP all Notifications for Corrosion on Structures

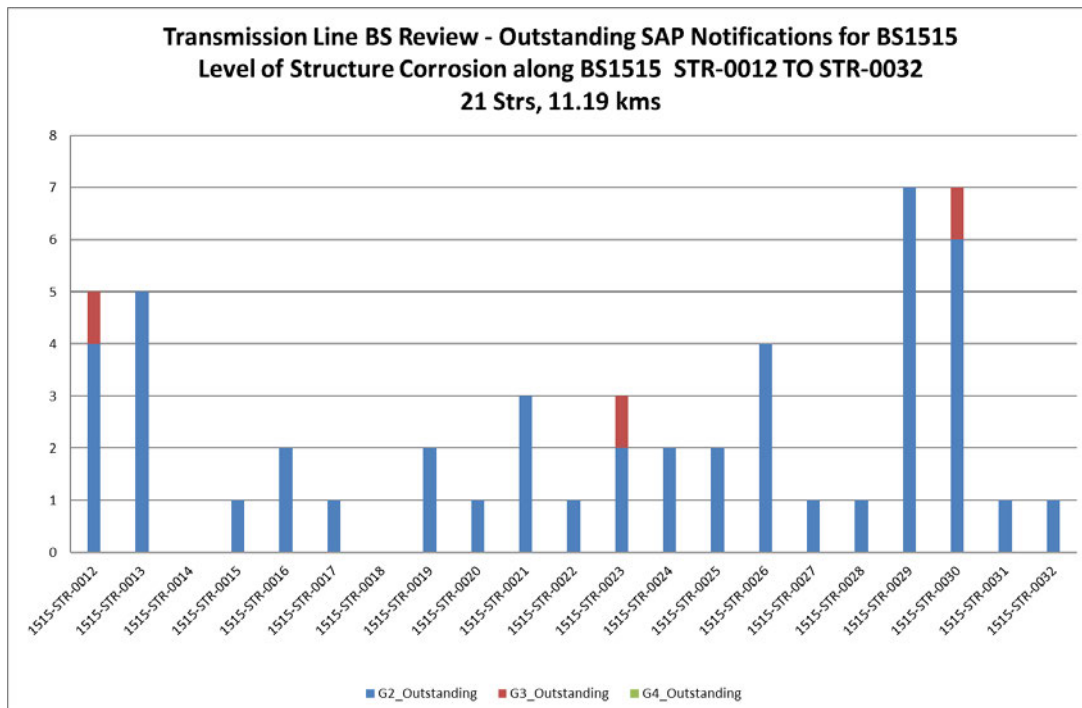
Figure 34: Graph of SAP Outstanding Notifications for Corrosion on Structures

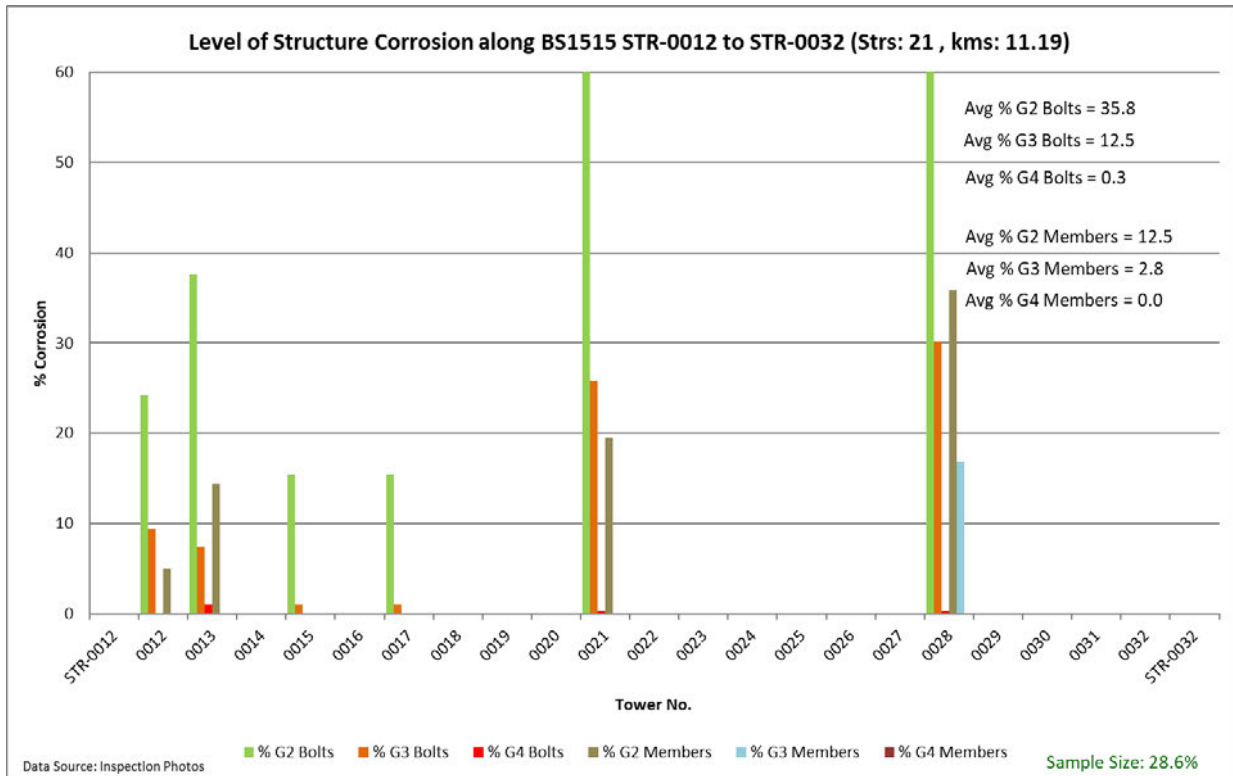
An estimated 36% of tower nuts and bolts are exhibiting grade 2 corrosions with 12% grade 3 and some grade 4 corrosions present. An estimated 13% of steel members are also showing grade 2 corrosions with 3% members having progressed to grade 3.

Figure 36 in the appendix shows the spread of G2, G3 and G4 corrosion observed from the sampled structures.

**Figure 36: Percentage of Structure Corrosion**

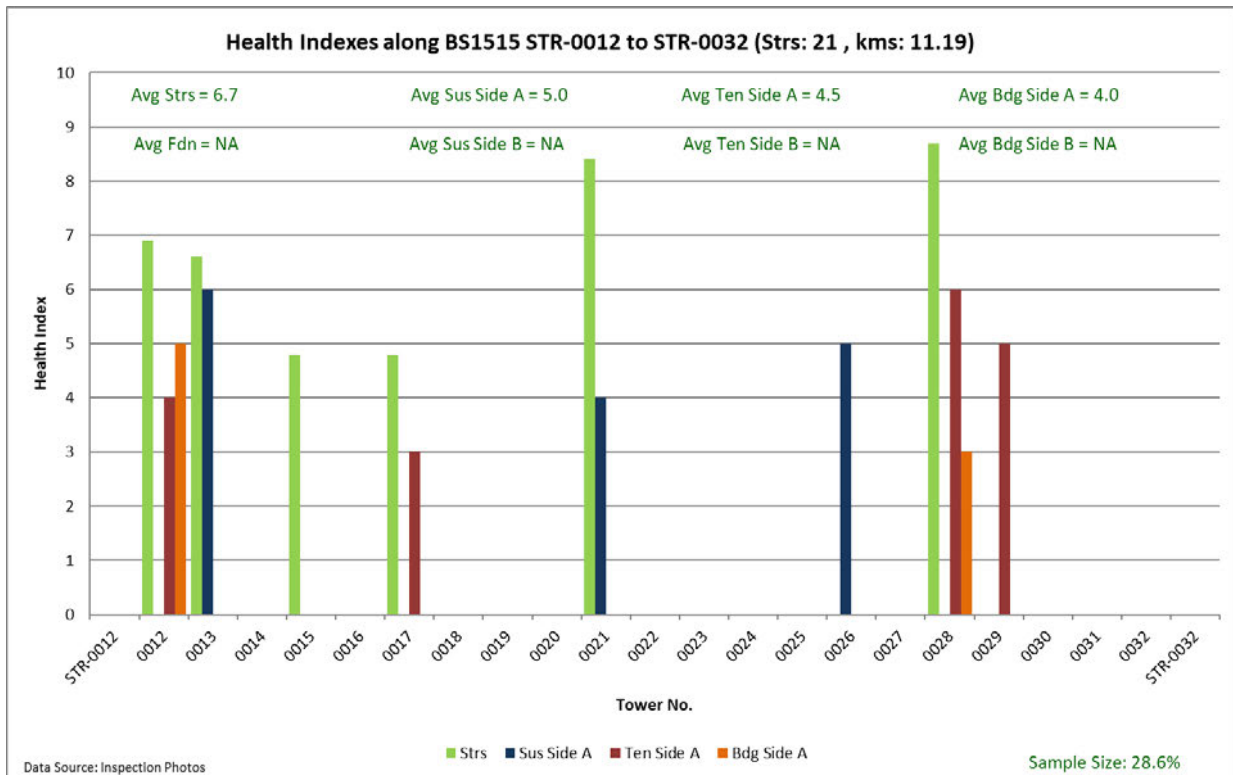
Based upon the data presented in this report and measurement documents for 28% of structures, this line will require additional maintenance to keep it in a serviceable condition. A maximum health index of 8.7 was calculated for 15% of towers which equates to about 3 towers. As the maintenance resources required to keep the line in service are low it is recommended to perform additional maintenance to delay a refurbishment or rebuild in the short term. In 2022 it is estimated that on average across the built section 20% of bolts would have reached grade 3 and 6% of members would have reached grade 3 if no maintenance is performed.

**Figure 37: Health Index of Components along Line**
