**POWERLINK QUEENSLAND  
REVENUE PROPOSAL**

**CP.02356**

**Lilyvale Transformers 3 and 4 Replacement**

# Transformers Condition Assessment H015 Lilyvale Substation

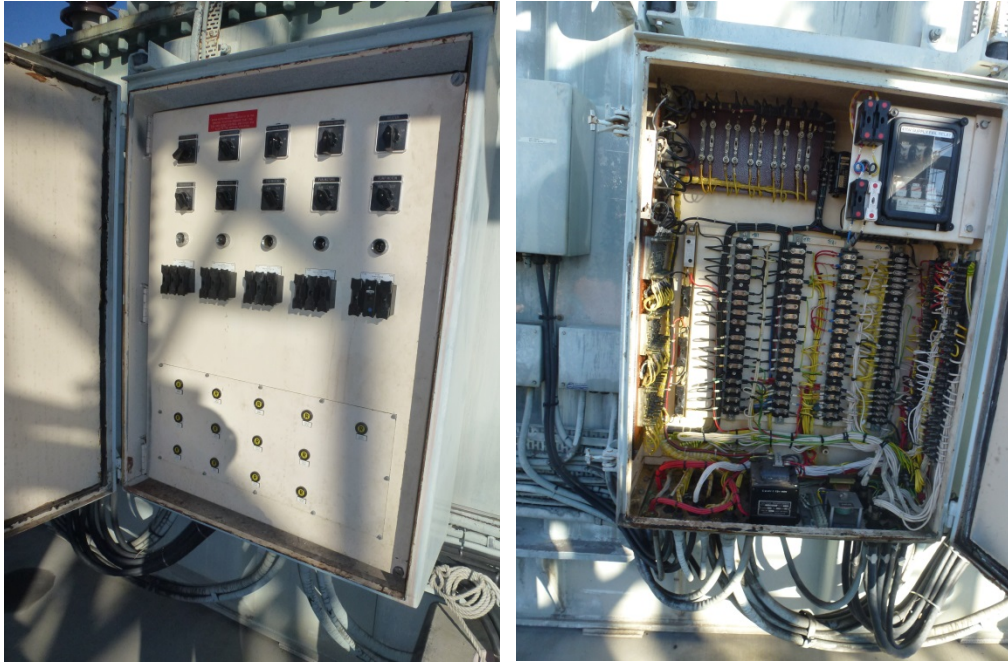
**Figure 39:** Main Control Cubicle control panel and wiring.

The main control cubicle was inspected for signs of potential issues but all appeared as expected, with only some minor corrosion around the door sealing lip on the lower edge of the cubicle. There were signs of some recent wiring additions to an otherwise old but clean installation. The replacement of any secondary system components if ever they fail should be fairly straight forward with more modern equivalent items (e.g. old mechanical phase failure relay visible in Figure 39, RH side photo) .

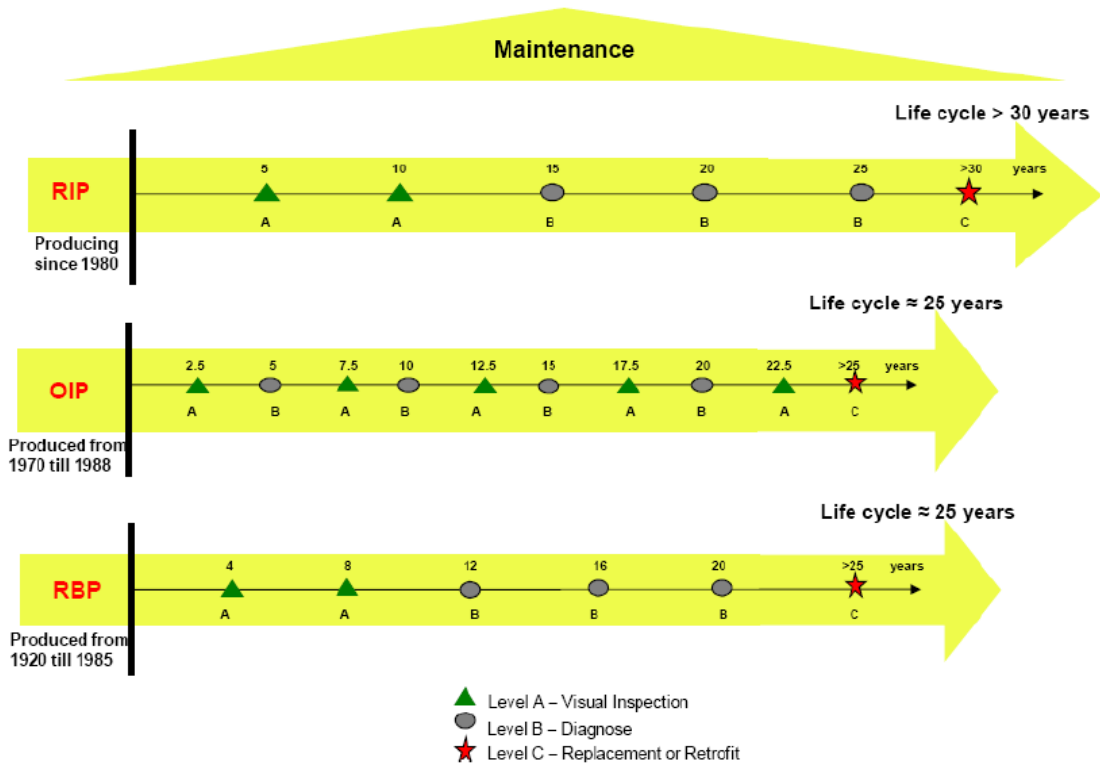
**Figure 41:** Relative high voltage bushing design life.

For reference, manufacturers indicate that such bushings have an expected design life of 25 to 30 years as shown in Figure 41. The relative ages of all three transformers are shown below and all exceed the design life by 4 - 10 years.

- Transformer T3 = 34 years old.
- Transformer T4 = 34 years old.
- Transformer T7 = 40 years old.

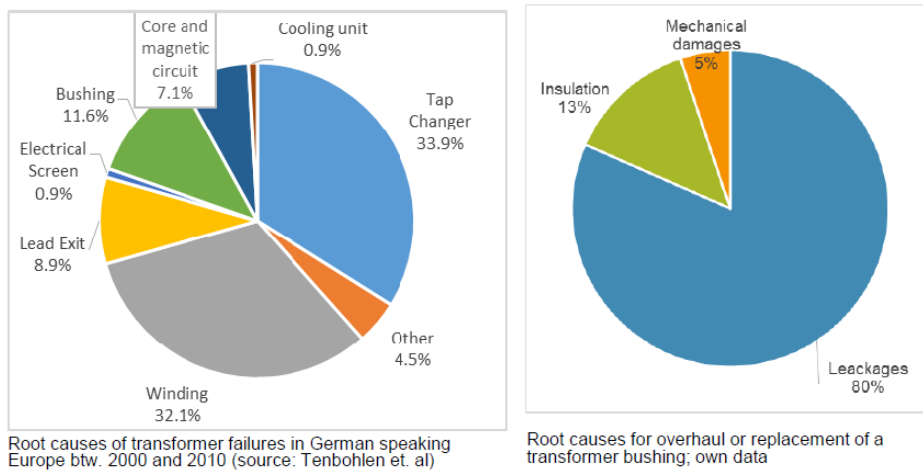
Figure 42: Transformer failure causes.

Bushing failures can represent approximately 12% of transformer failures but out of this 12%, only 13% is from insulation failure and 80% is from breathing to atmosphere. Refer to Figure 42. The remainder is due to mechanical damage. This means that only about 1.6% of transformer failures are due to the failure of HV bushing insulation. The oil leaks noted around bushing turrets appeared to be coming from gaskets on the main tank side and not from actual HV or LV bushing gaskets so it would appear that the bushings have a low probability of insulation failure and with scheduled periodic field testing for DLA and capacitance, pending bushing insulation failure should be detectable prior to complete insulation failure.
