POWERLINK QUEENSLAND
REVENUE PROPOSAL

CP.02369

**Blackwater Transformers 1 and 2
Replacement**

Transformer T1 & T2 Condition Assessment T032 Blackwater Substation

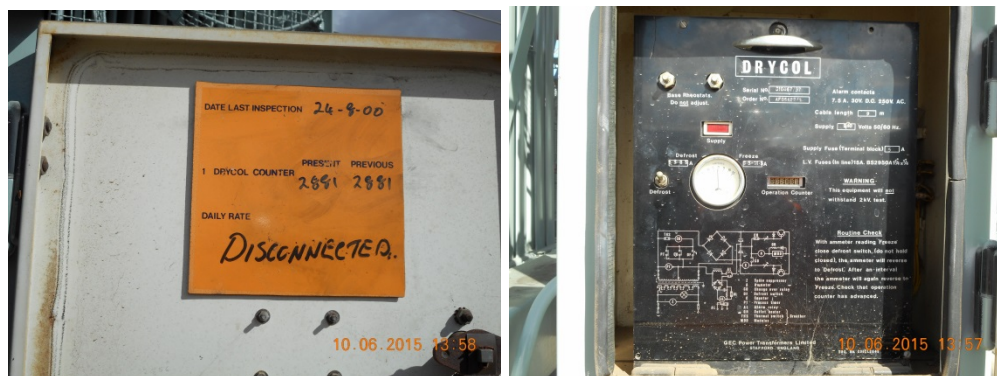
Figure 14 The original Drycol refrigerant breather (now removed) control cubicle still mounted on the cooler bank support frame.

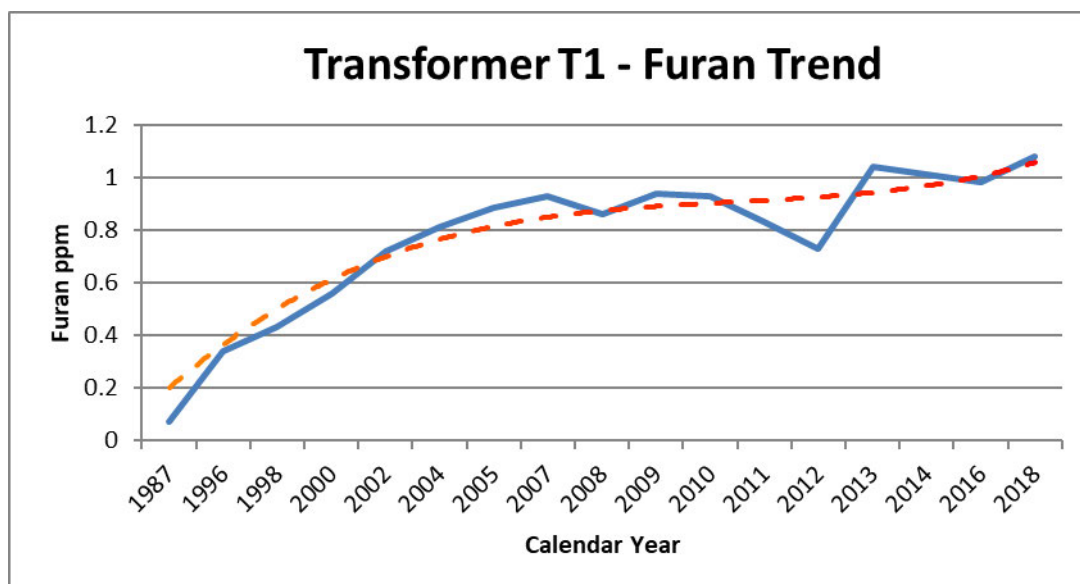
As expected, the dissolved furan level in oil will fluctuate depending on the transformer insulation operating environment and if the transformer internals and the oil have been subjected to vacuum treatment(s). As stated earlier, some allowances have been made in the calculations for the “real” dissolved furan level and the result is shown in figure 18. The average trend in the bulk cellulose insulation aging is shown by the red dotted line in this figure. Because of the more localised nature of the winding hot spots, when the dissolved furan generation from these higher temperature locations is averaged out in the total transformer oil volume, the hot spot contribution of furans is not easily distinguishable from that generated by the bulk insulation mass.

The dip in measured dissolved furan level in oil around the year 2012 was due to the transformer being refurbished and off line for a period of time.

Figure 18 The dissolved furan in oil (ppm) has been plotted against sample date for T1.

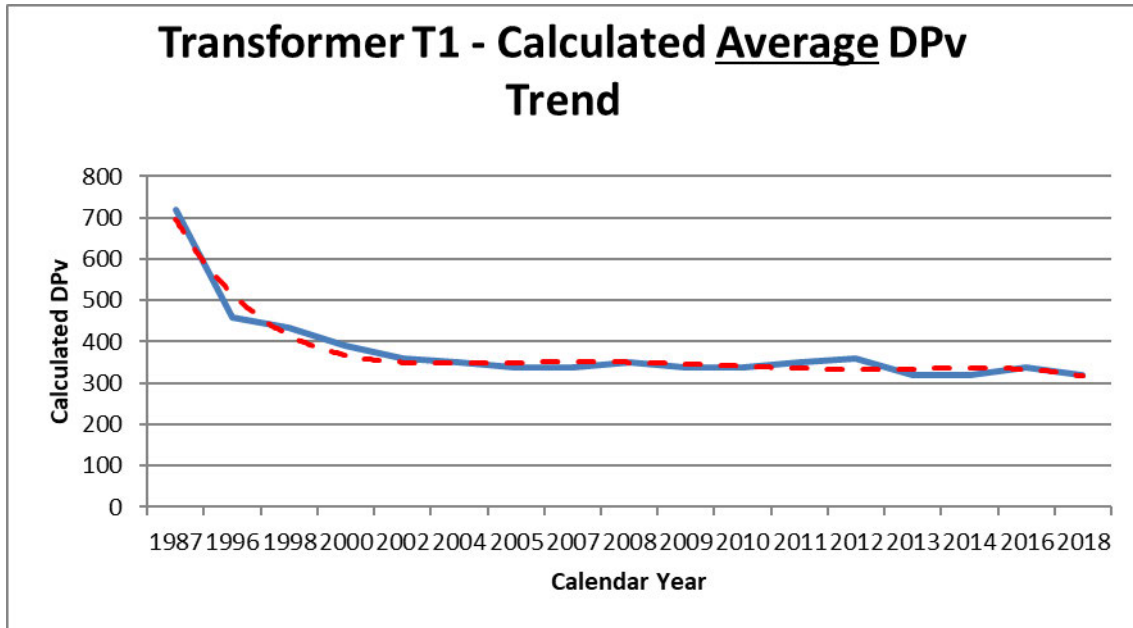
Figure 19 The bulk insulation average DP_v has been plotted against transformer age.

Figure 19 does show a greater insulation aging rate early in the transformer's life which tends to support this concept. This is also evidenced in the levels of dissolved carbon-oxide gases in the DGA test data and probably accounts for the rapid generation in dissolved furan levels early in the transformer's life. This was not as per QEGB policy (or Powerlink's policy at present) but in those days, CREB was responsible for specifying, purchasing, maintaining and operating this transformer as well as applying the temperature set points for fan and oil pump start.

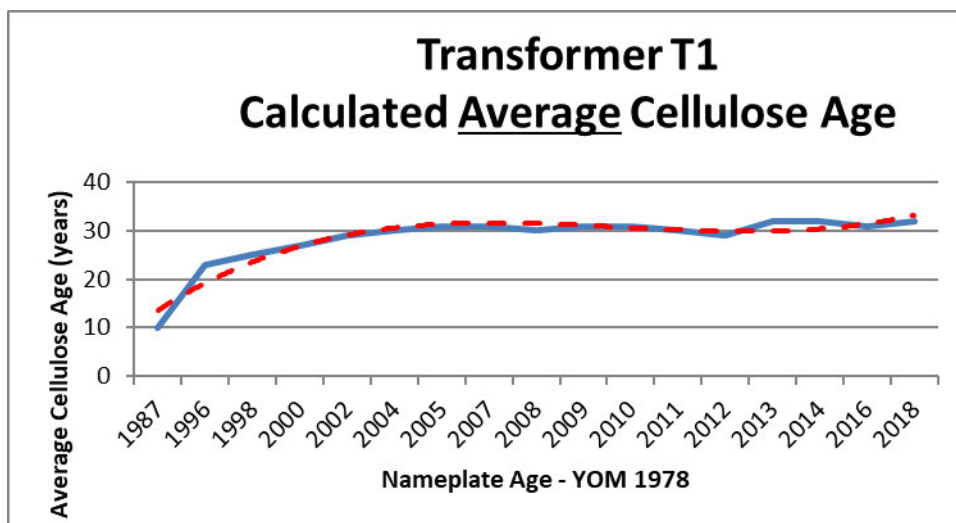
Figure 20 The calculated bulk insulation aging over the life of the transformer.

The average age of the bulk cellulose insulation system within the transformer is calculated to be approximately 32 years ($DP_v = 319$) but with a more localised age of approximately

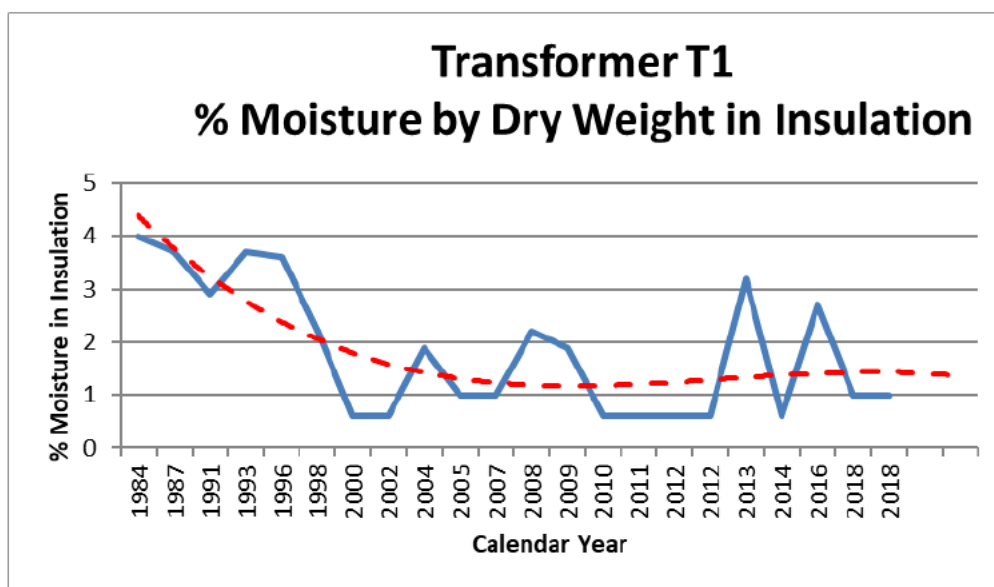
After this point in time, the moisture in oil measured level appeared to stabilise, apart from what appears like some erroneous data. This is reflected in figure 22 which shows a plot of the calculated percent by dry weight moisture in insulation over most of the transformer's life. The red dotted line in figure 22 is an attempt to compensate for any erroneous data errors.

Figure 22 Calculated average of % moisture in insulation by dry weight.

So overall, the insulation system by today’s standards is considered relatively dry. It is well below the 4% level beyond which can introduce risks of insulation failure under the right combination of specific operating / environmental conditions.

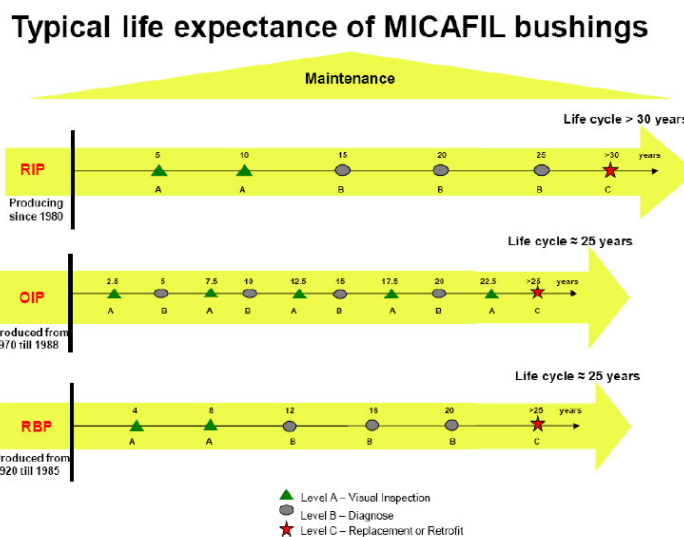
All bushings are original and Micafil SRBP design and the last test results are satisfactory. All bushings (high voltage, low voltage and neutral) have porcelain casings and can fail catastrophically resulting in significant safety consequence if personnel are present on site during failure. As they passed their service life with very limited data available re failures of bushings of this type and age, it is recommended to reduce safety risk exposure by replacing HV and LV bushings with dry type in polymer casing. Based on manufacturer data (Refer Figure 45) the service life of these type of bushings is 25 years.

Figure 23 Bushing life expectancy provided by the bushing manufacturer.

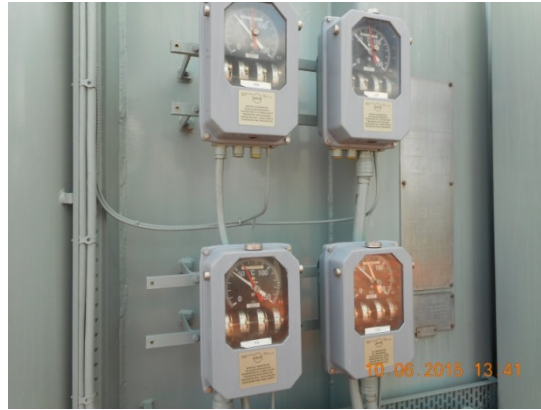
The top oil and winding hot spot temperature monitoring instruments were all readable and the indicated temperatures across all instruments appeared reasonable for the load at the time.

Figure 36 The three winding hot spot and one top oil temperature indicators are still readable through the viewing window.

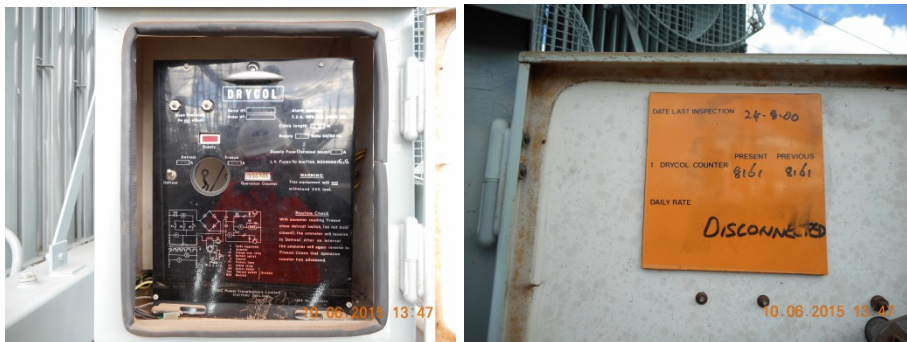
Figure 37 The original Drycol refrigerant breather (now removed) control cubicle still mounted on the cooler bank support frame.

Similar to Transformer T1 When the original Drycol refrigerant breather was removed from the main conservator around the year 2000, a small diameter air pipe was installed between the main conservator and the replacement conventional desiccant breather. Refer to figure 37 for a visual arrangement.

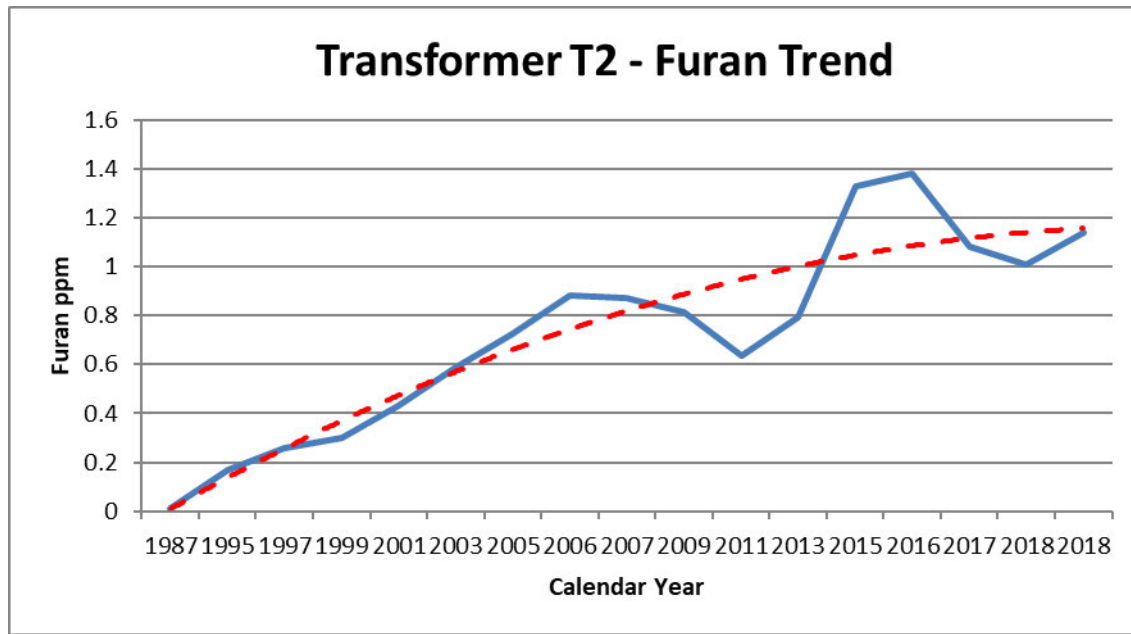
As expected, the dissolved furan level in oil will fluctuate depending on the transformer insulation operating environment and if the transformer internals and the oil have been subjected to vacuum treatment(s). As stated earlier, some allowances have been made in the calculations for the “real” dissolved furan level (figure 40).

The average trend in the bulk cellulose insulation aging is shown by the red dotted line in this figure. Because of the more localised nature of the winding hot spots, when the dissolved furan generation from these higher temperature locations is averaged out in the total transformer oil volume, the hot spot contribution of furans is not easily distinguishable from that generated by the bulk insulation mass.

The dip in measured dissolved furan level in oil around the year 2012 was due to the transformer being refurbished and off line for a period of time.

Figure 40 The dissolved furan in oil (ppm) has been plotted against sample date.

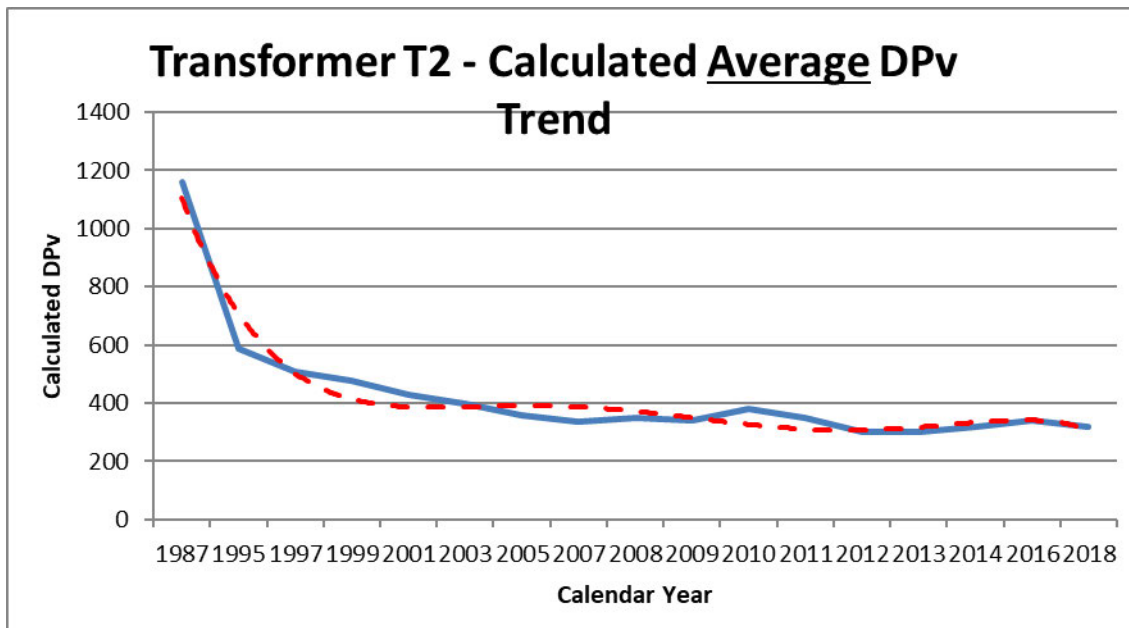
Figure 41 The bulk insulation average DP_v has been plotted against transformer age.

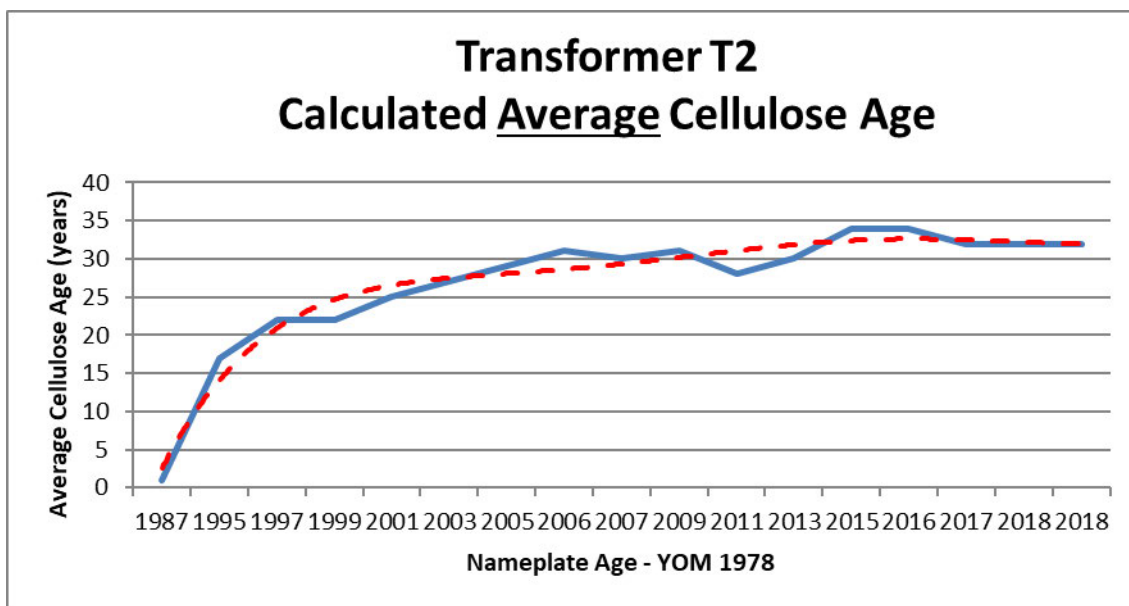
Figure 42 The calculated bulk insulation aging over the life of both transformer T1 and T2 at Blackwater.

The average age of the bulk cellulose insulation system within the transformer is calculated to be approximately 34 years (DP_v = 290) but with a more localised age of approximately 40 years (DP_v = approx. 230). This suggests that the cellulose insulation in critical areas of the windings has probably reached end of reliable life for a transformer built in 1979 (36 years of age). The insulation in this transformer appears to be more aged than for its sister unit, Blackwater T1, by only a couple of years.

Figure 42 does show a greater insulation aging rate early in the transformer’s life which tends to support this concept. This is also evidenced in the levels of dissolved carbon-oxide gases in the DGA test data and probably accounts for the rapid generation in dissolved furan levels early in the transformer’s life.

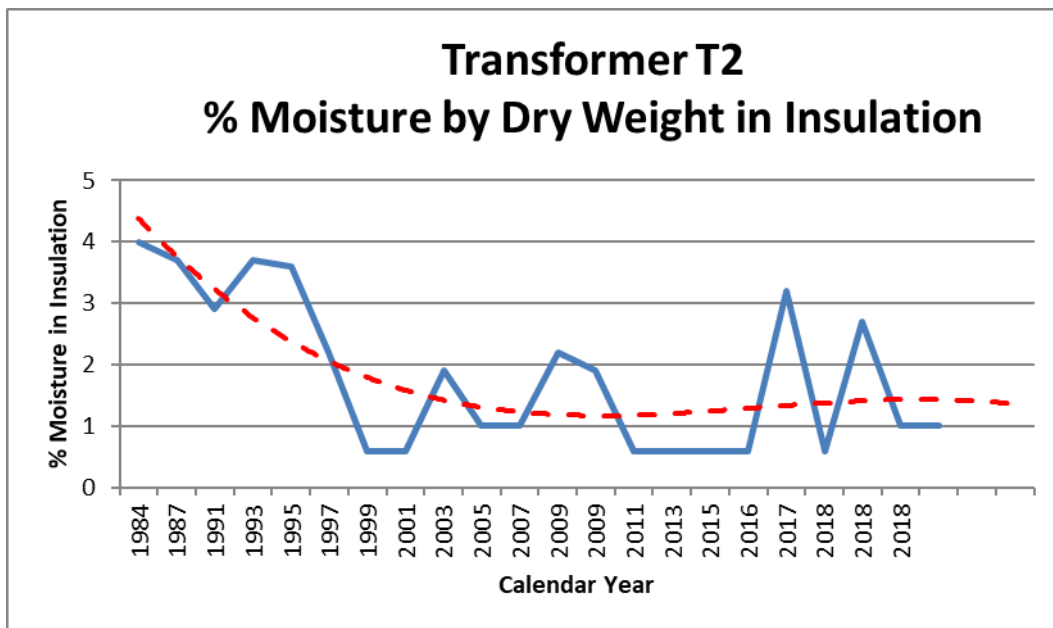
From the date of the first oil sample in 1981, the measured dissolved moisture in oil level appeared to progressively drop, perhaps due to the presence of the Drycol breather system fitted to this transformer up until the year 2000. This is reflected in figure 44 which shows a plot of the calculated percent by dry weight moisture in insulation over most of the transformer’s life. The red dotted line in figure 44 is an attempt to compensate for any erroneous data errors.

Figure 44 Calculated average of 1.5% moisture in insulation by dry weight.

So overall, the insulation system by today’s standards is considered relatively dry. It is well below the 4% level beyond which can introduce risks of insulation failure under the right combination of specific operating / environmental conditions.

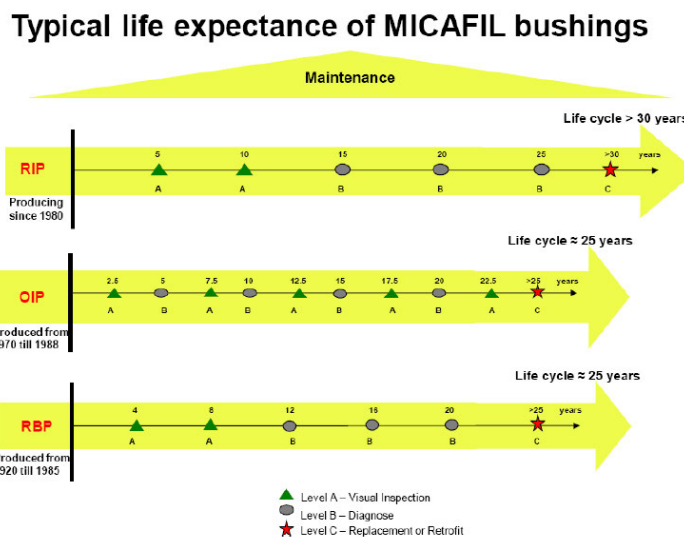
The reliability of the HV and LV bushings has to be considered low since they have exceeded the predicted design life and there is no established end of life criteria to date based on Utility operational experience.

All bushings are original and Micafil SRBP design and the last test results are satisfactory. All bushings (high voltage, low voltage and neutral) have porcelain casings and can fail catastrophically resulting in significant safety consequence if personnel are present on site during failure. As they passed their service life with very limited data available re failures of bushings of this type and age, it is recommended to reduce safety risk exposure by replacing HV and LV bushings with dry type in polymer casing. Based on manufacturer data (Refer Figure 45) the service life of these type of bushings is 25 years.

Figure 45 Bushing life expectancy provided by the bushing manufacturer.
