POWERLINK QUEENSLAND
REVENUE PROPOSAL

CP.02370

Tully Transformer 2 Replacement

T2 Transformer Condition Assessment T048 Tully Substation

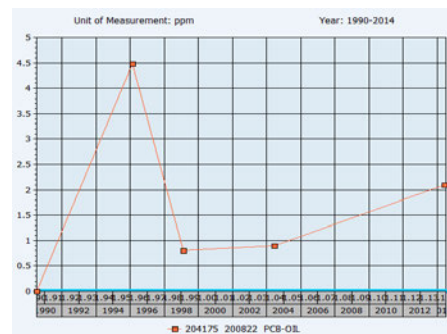
Figure 9: PCB in oil

Currently the overall oil quality for this transformer looks satisfactory apart from the presence of PCB but it does appear that around 1998/99, the oil was either processed to remove dissolved PCB or replaced. This resulted in the significant improvement of the oil resistivity, dielectric loss angle and acidity and significant reduction of PCB level.

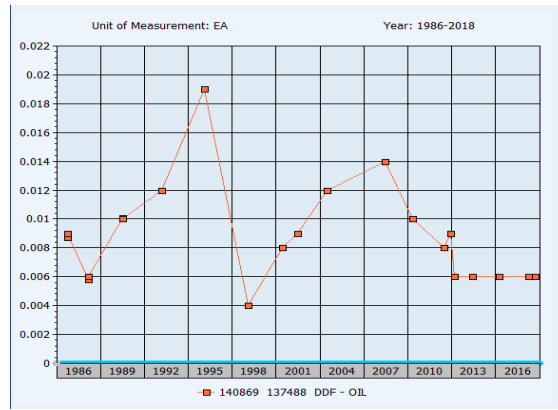
Figure 10: Oil DDF trend

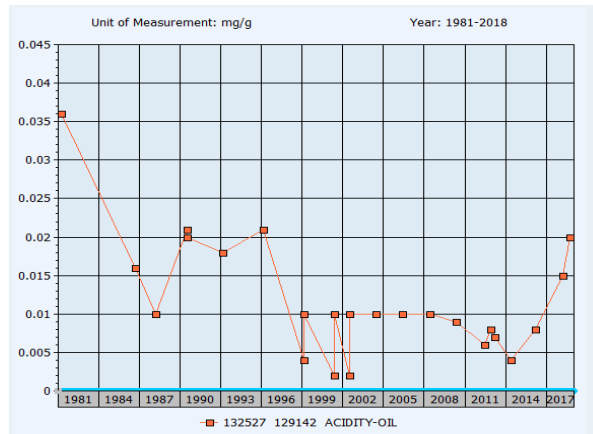
Figure 14: Oil Acidity

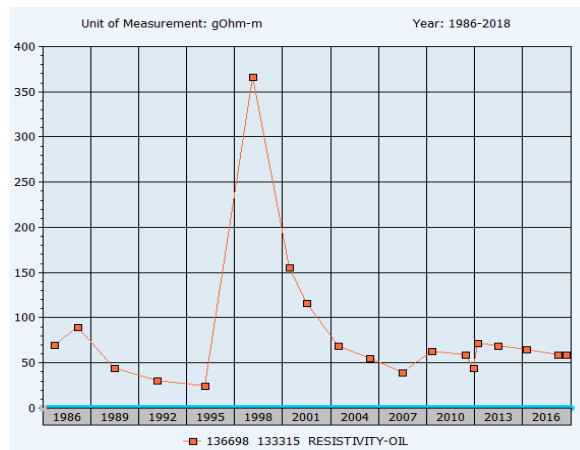
Figure 11: Oil resistivity trend

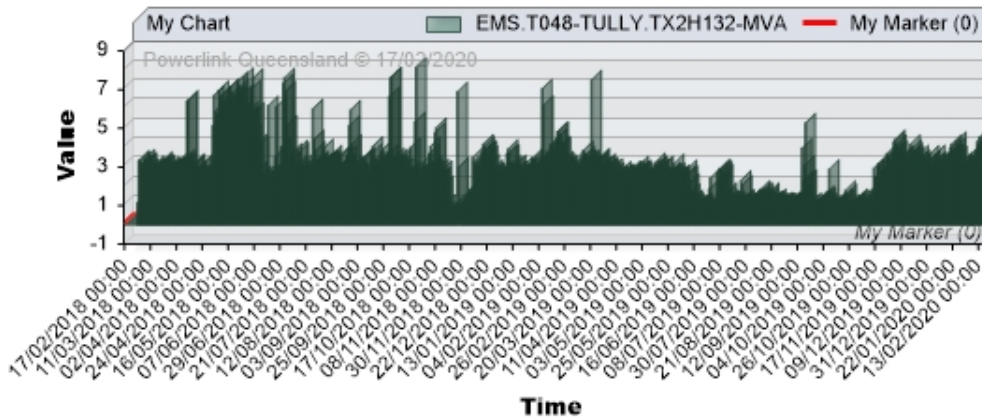
The peak loading in MVA on the 132kV side of this transformer over period 17/02/2018 to 13/02/2020 did not exceed 45% of the nameplate rating. The average loading over this period was 3MVA, which is 15% of the nameplate rating.

Figure 16–T2 transformer loading in MVA in period 17/02/2018 -13/02/2020 (the peak load is 9 MVA)

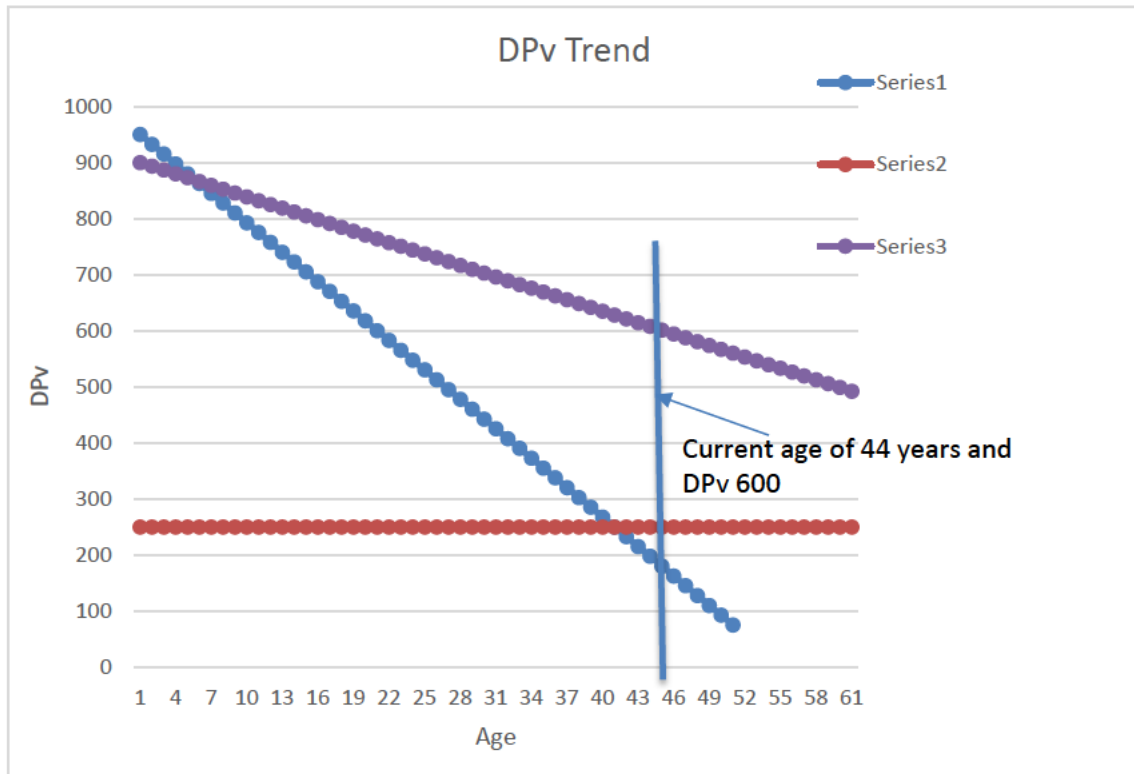
Insulation age of this transformer was calculated to be approximately 15-21 years as shown below in Figure 20. This is well below its nameplate age of 44 years. This takes into account the approximate DPv at the hot spot.

Since no actual paper samples were taken from the transformer for this assessment, using the Chendong formula a paper DP value was calculated based on the dissolved furans in oil and its estimated trend is shown in Figure 20, using approximate value for hot spot considering that the furan data represents only an average of the total cellulose insulation mass. DPv of the insulating paper is very dependent on the operating conditions (temperature i.e. load and moisture).

Assuming that the current transformer operating conditions remain the same, the trend shows that the transformer has several years of remaining service life (Refer Figure 20).
