POWERLINK QUEENSLAND REVENUE PROPOSAL

CP.02371

Bouldercombe Transformers 1 and 2 Replacement

H010 Bouldercombe Transformer T1 & T2 Condition Assessment

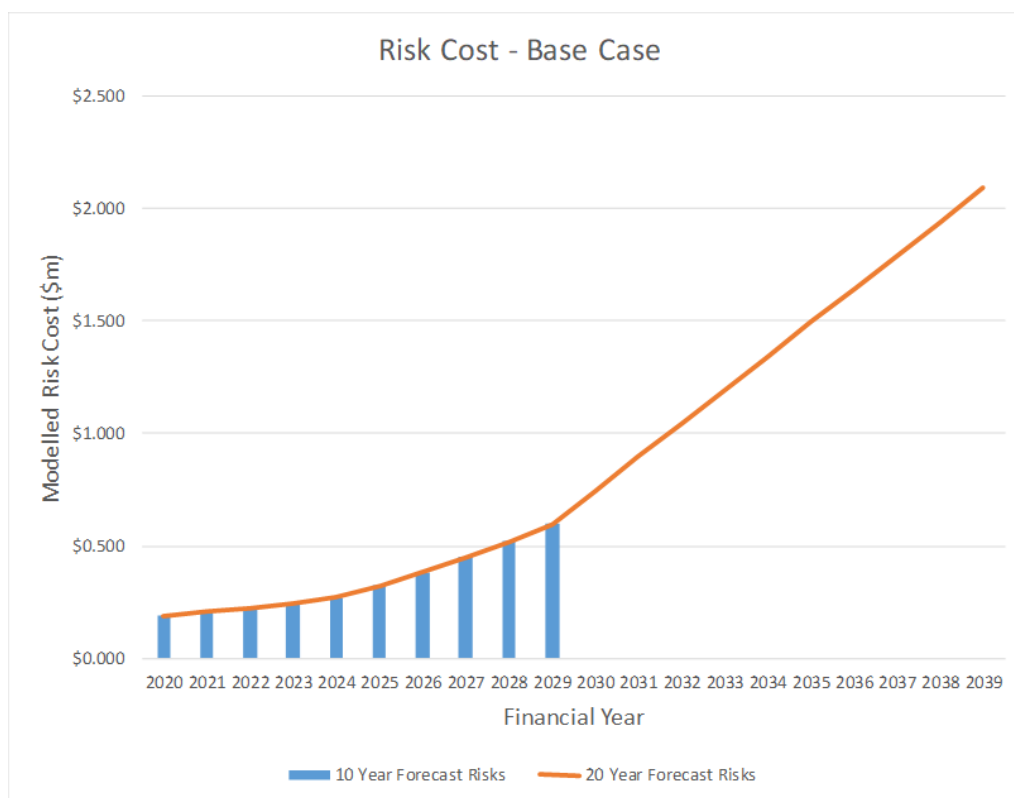
Figure 2-1 Annual Risk Monetisation Profile (Nominal)

Where a 'Do Nothing' scenario is adopted (see Figure 2-1), the forecast level of risk associated with the asset escalates to over \$500k per annum in 2030.

This is predominantly due to network risks (unserved energy) associated with potential outages of T1 and T2³. This annual risk profile is expected to escalate rapidly to over \$2m from 2039.

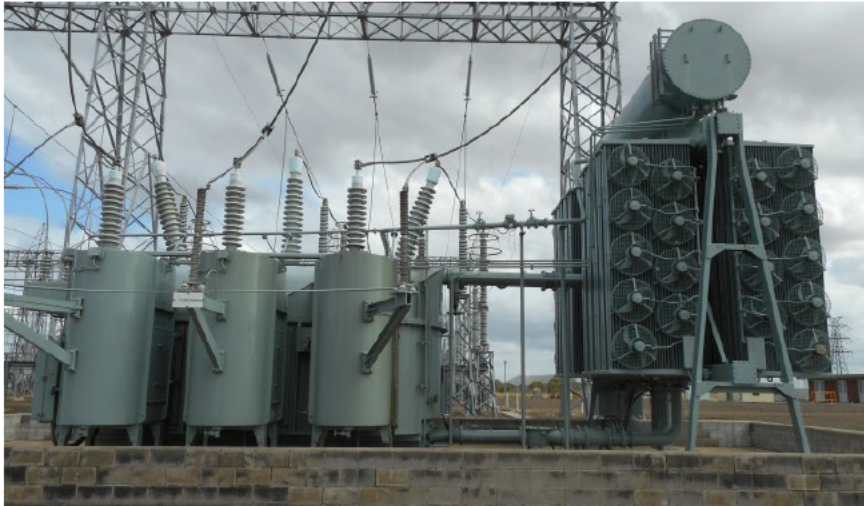
Figure 1: 200MVA 288/138/19.1kV transformer T1 at H010 Bouldercombe.

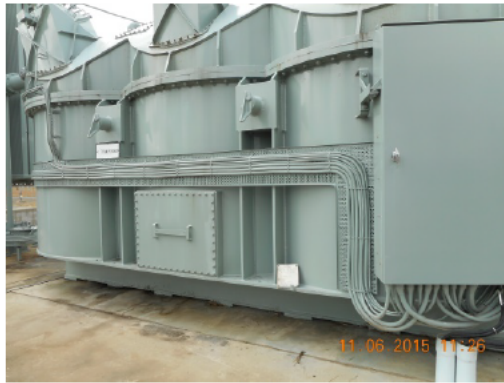
After 38 years, the cables are sure to have taken a set and any significant cable flexing (e.g. removal & reconnection) due to replacement of external ancillary items would likely create some insulation damage but if left physically alone, all of the multicore cables should not fail over the next several years (up to 10 years).

Figure 11: The UV stabilisers in the paint covering the external multicore cables will assist in preserving the outer PVC covering.

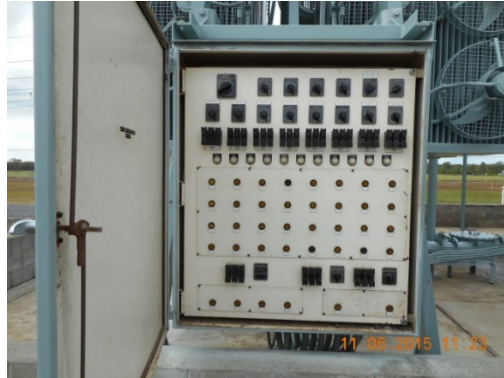
Figure 14: There were no issues noticed inside the Cooler Control Cubicle.

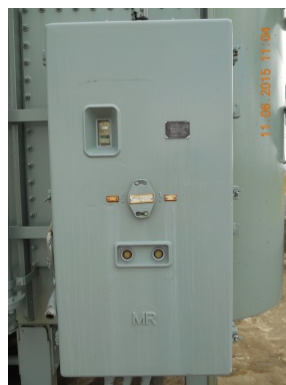
This transformer is fitted with a Reinhausen tap changer comprising three in tank columns, one for each phase, and has performed 95,213 operations, well within its expected life.

Figure 15: Reinhausen tap changer control cubicle for type 3 x M1 1200 150B 10193W.

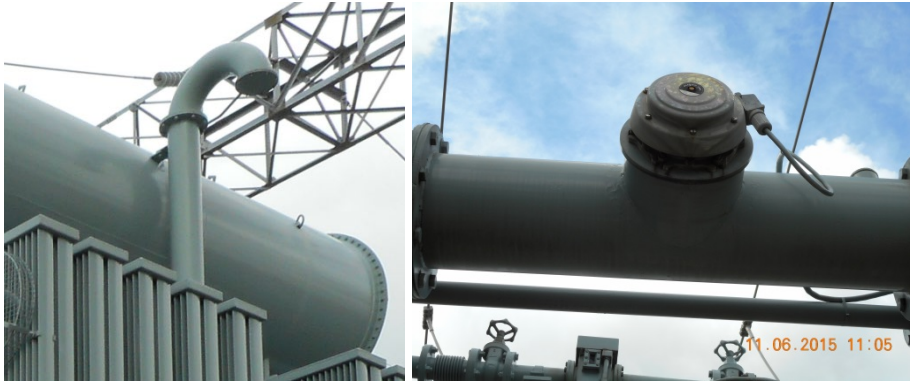
This transformer is fitted with an explosion vent (rupture diaphragm) on a high rise pipe as well as having a pressure relief device (PRD) installed on the HV side of the top main oil pipe which carries hot oil to the cooler bank for cooling. The effectiveness of both the PRD and the high rise explosion vent to rapidly reduce internal pressure adequately is considered to be poor due to the surge impedance of the pipework when confronted with a high frequency transient pressure wave. That is why for the last 30 to 35 years, the PRDs have been installed high up on the main tank side walls.

Figure 16: The explosion vent (rupture diaphragm) at the end of a high rise pipe as well as a PRD on the top main oil pipe between cooler bank and transformer main tank.

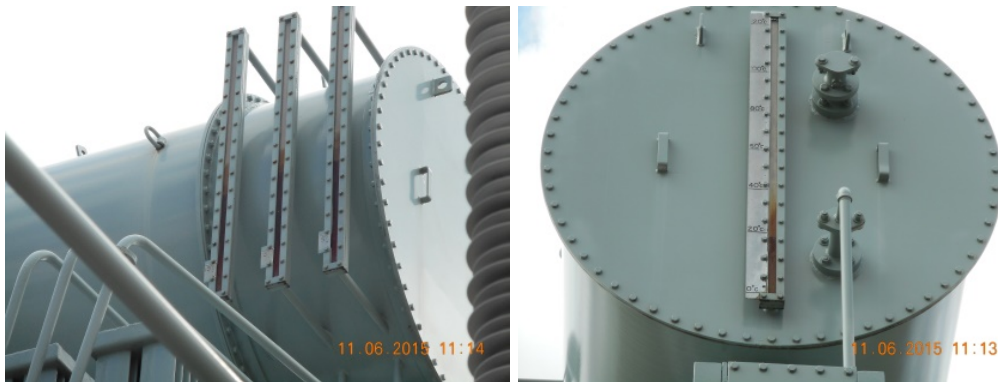
This transformer was manufactured with the main tank oil and tap changer oil sharing the same conservator but with three partial partitions separating four oil volumes, namely main tank oil and the oil for each phase of the OLTC. This still provided common air in the head space above the four separate oil surfaces for the exchange of dissolved gases and moisture between both oil volumes. The use of partial partitions was confirmed on site by observing only one desiccant breather shared by all conservators, as per the transformer general arrangement drawing. Hence the oil and insulation system inside the transformer, and especially in the main tank, had direct contact with the external air via the conservator dehumidifying desiccant breather.

Figure 17: (LHS) Three separate oil level gauges and oil delivery pipes for each OLTC phase. (RHS) One oil level gauge on the end for the main tank oil.

This conservator was originally designed and fitted with a Drycol refrigerant breather for drying the air when entering and while held within the conservator but was later replaced with a conventional desiccant breather. This is obvious from the plumbing shown on the end of the conservator and the English Electric transformer drawings.

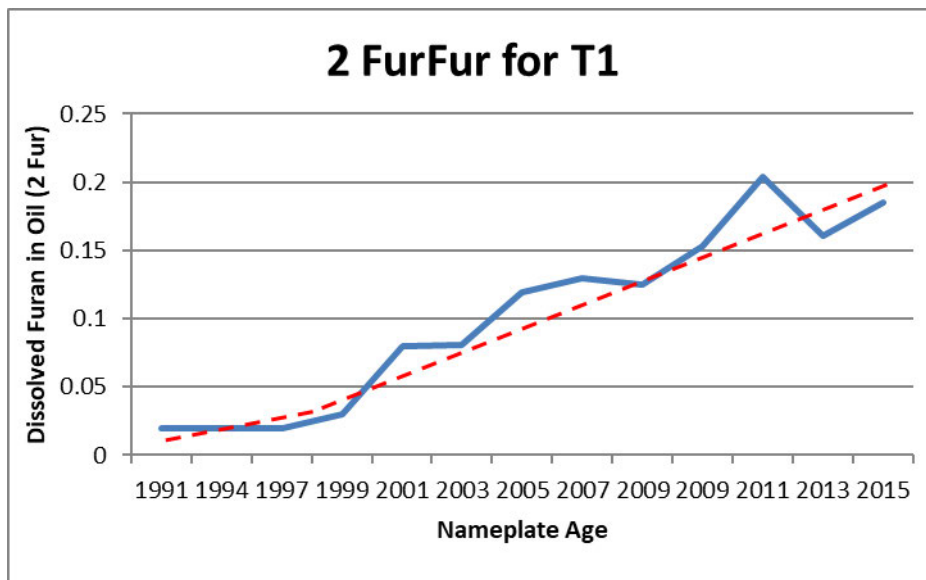
The measured dissolved furan levels in oil are shown in figure 18. There was a normal progressive increase as the transformer aged, however, there appears to have been some significant transformer loading variations over the past few years. The average trend in the bulk cellulose insulation aging (furan increase) is shown by the red dotted line in this figure.

Because there is normally a variation in insulation temperatures throughout the transformer windings when loaded, at times fairly significant, more localised higher winding insulation temperatures will generate higher than average amounts of furan which must also be considered in the calculation of cellulose insulation age.

Figure 18: The dissolved furan in oil (mg/kg) has been plotted against transformer nameplate age.

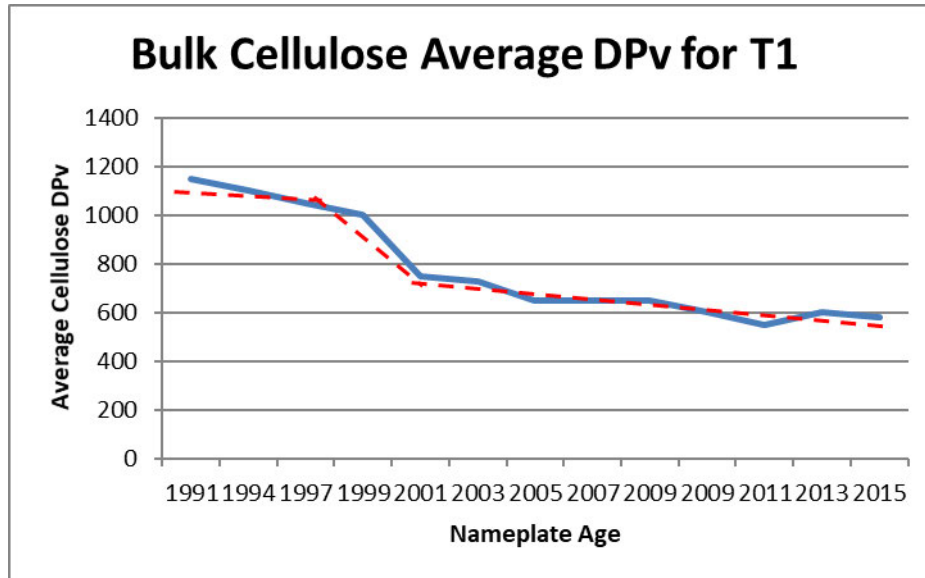
Figure 19: The bulk insulation average DP_v has been plotted against transformer age.

It is only natural that the cellulose insulation DP_v tracks roughly the inverse characteristic of the dissolved furan in oil level.

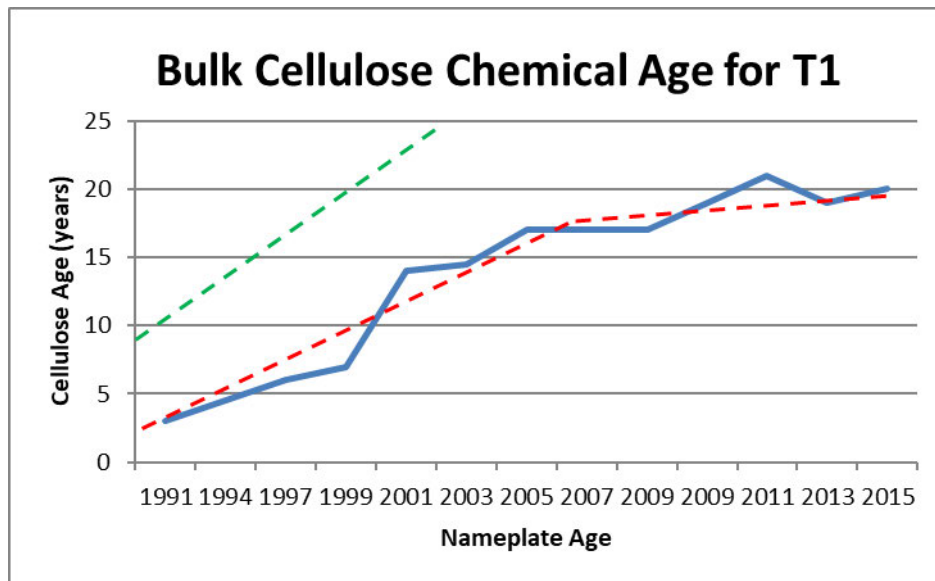
The average age of the bulk cellulose insulation system within the transformer is calculated to be approximately 19 years, with a localised winding hot spot insulation age of approximately 24 years. This is less than the 38 year nameplate age and tends to correlate with the low 35C to 40C winding hot spot maximum operating temperatures noted on site on the transformer temperature monitoring instrumentation.

Both the average and localised cellulose insulation in this transformer is still in reasonable condition and if this cellulose insulation aging rate persists, it could last at least a further 10 to 15 years.

Figure 21: The bulk (average) insulation chemical age has been plotted against transformer nameplate age. The green dotted line represents unity insulation aging rate.

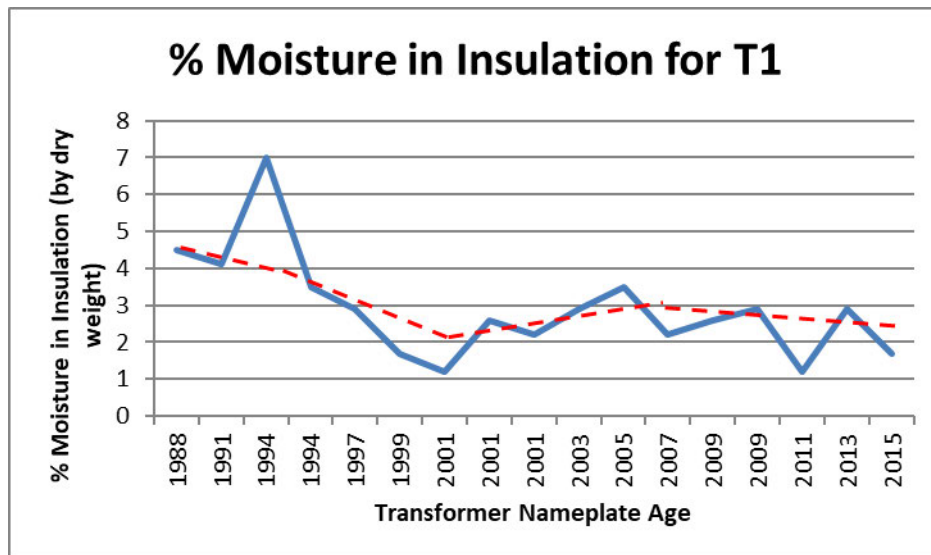
Because the oil samples taken from this transformer in 1981, 1983 and 1985 had no oil sample temperature information provided, the laboratory test data over this period was not usable for calculating the moisture in cellulose. Hence figure 22 shows a plot of the calculated percent by dry weight moisture in insulation over most of the transformer's life, starting from 1988. The red dotted line in figure 22 is an attempt to compensate for any erroneous data errors. The calculated average percent moisture in cellulose by dry weight at present is approximately 2.0%.

Figure 22: Calculated average of 2.0% moisture in insulation by dry weight.

There has been a significant reduction in moisture in cellulose insulation from the early years through to 2001 after which it slowly increased until 2007 after which it has slowly been reducing again. (refer to figure 22). This moisture migration in and out of the cellulose insulation in the winding clamping structure would have caused some accumulative relaxation in the winding axial clamping pressure and would make it less tolerant to through faults.

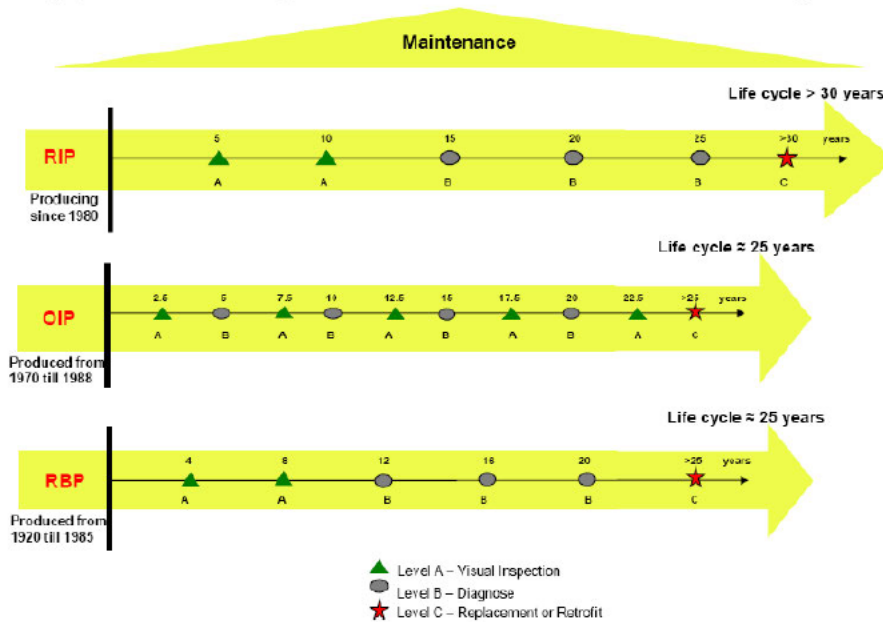
Figure 24: Bushing life expectancy provided by the bushing manufacturer.

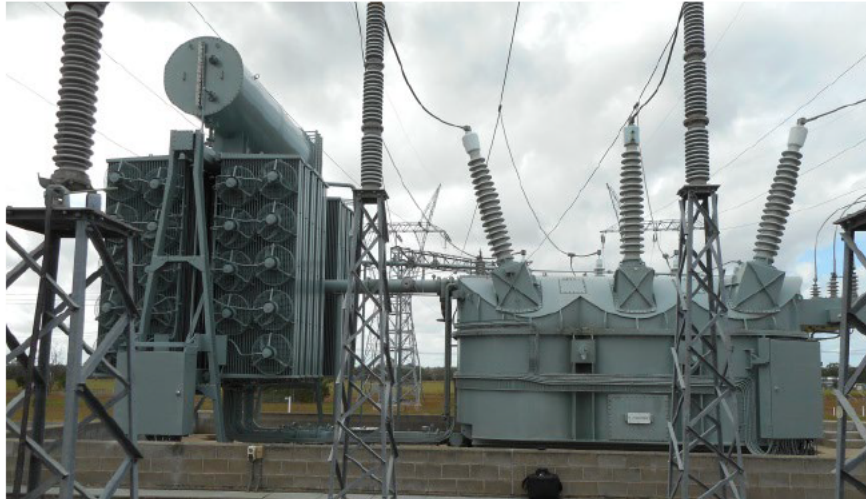
Figure 25: 200MVA 288/138/19.1kV transformer T2 at H010 Bouldercombe.

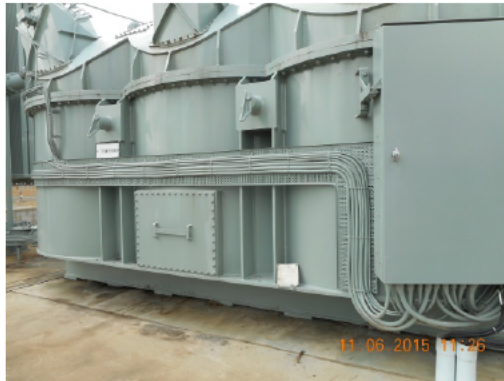
After 38 years, the cables are sure to have taken a set and any significant cable flexing (e.g. removal & reconnection) due to replacement of external ancillary items would likely create some insulation damage but if left physically alone, all of the multicore cables should not fail over the next five years.

Figure 37: The UV stabilisers in the paint covering the external multicore cables will assist in preserving the outer PVC covering.

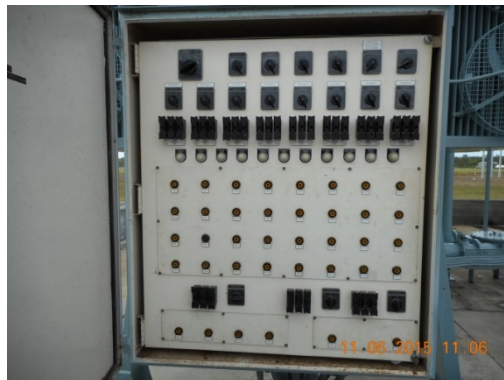
Figure 40: There were no issues noticed inside the Cooler Control Cubicle.

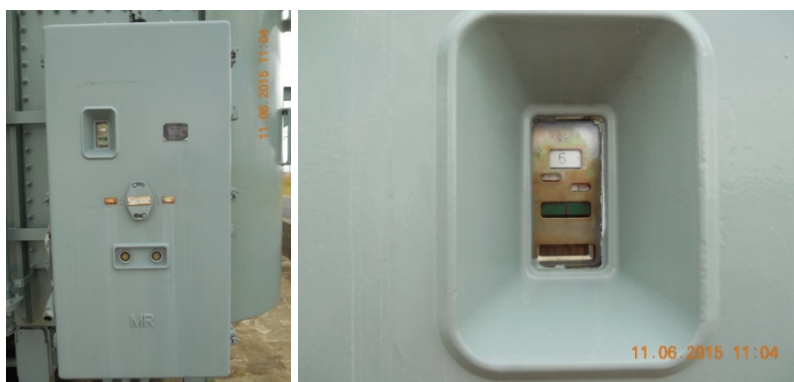
This transformer is fitted with a Reinhausen tap changer comprising three in tank columns, one for each phase, and has performed 95,282 operations, well within its expected life.

Figure 41: Reinhausen tap changer control cubicle for type 3 x M1 1200 150B 10193W.

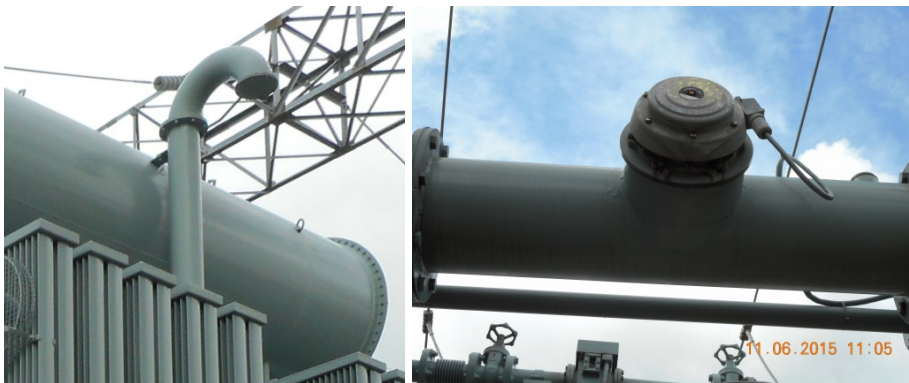
This transformer is fitted with an explosion vent (rupture diaphragm) on a high rise pipe as well as having a pressure relief device (PRD) installed on the HV side of the top main oil pipe which carries hot oil to the cooler bank for cooling. The effectiveness of both the PRD and the high rise explosion vent to rapidly reduce internal pressure adequately is considered to be poor due to the surge impedance of the pipework when confronted with a high frequency transient pressure wave. That is why for the last 30 to 35 years, the PRDs have been installed high up on the main tank side walls.

Figure 42: The explosion vent (rupture diaphragm) at the end of a high rise pipe as well as a PRD on the top main oil pipe between cooler bank and transformer main tank.

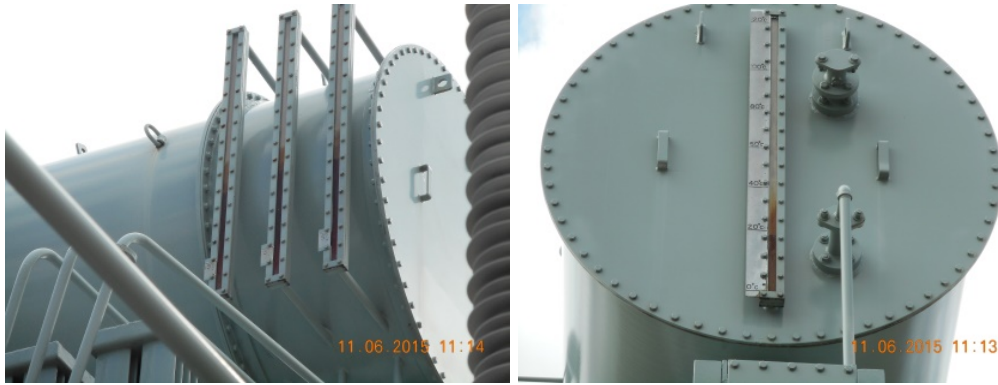
This transformer was manufactured with the main tank oil and tap changer oil sharing the same conservator but with three partial partitions separating four oil volumes, namely main tank oil and the oil for each phase of the OLTC. This still provided common air in the head space above the four separate oil surfaces for the exchange of dissolved gases and moisture between both oil volumes. The use of partial partitions was confirmed on site by observing only one desiccant breather shared by all conservators, as per the transformer general arrangement drawing. Hence the oil and insulation system inside the transformer, and especially in the main tank, had direct contact with the external air via the conservator dehumidifying desiccant breather.

Figure 43: (LHS) Three separate oil level gauges and oil delivery pipes for each OLTC phase. (RHS) One oil level gauge on the end for the main tank oil.

This conservator was originally designed and fitted with a Drycol refrigerant breather for drying the air when entering and while held within the conservator but was later replaced with a conventional desiccant breather. This is obvious from the plumbing shown on the end of the conservator and the English Electric transformer drawings.

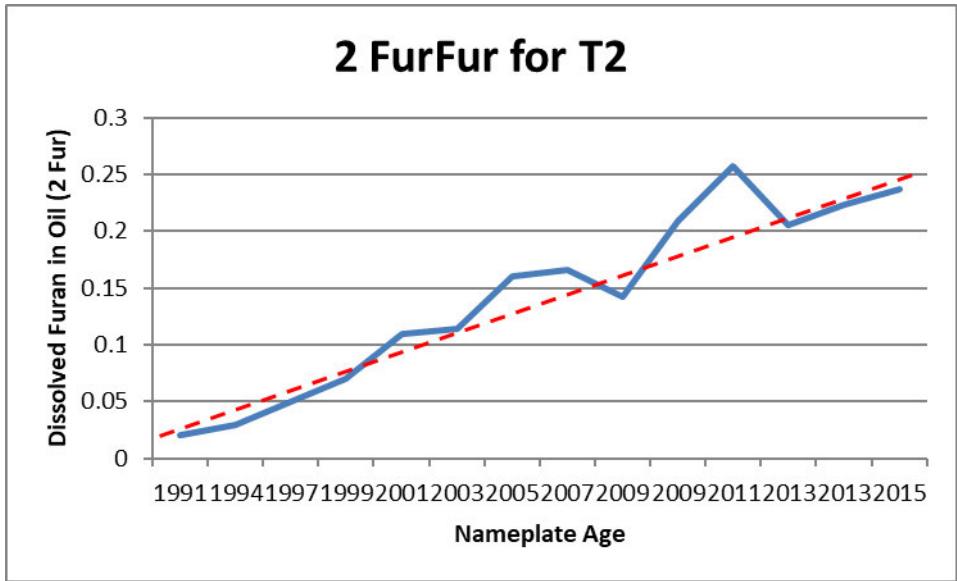
The measured dissolved furan levels in oil are shown in figure 45. There was a normal progressive increase as the transformer aged. The average trend in the bulk cellulose insulation aging (furan increase) is shown by the red dotted line in this figure.

Because there is normally a variation in insulation temperatures throughout the transformer windings when loaded, at times fairly significant, more localised higher winding insulation temperatures will generate higher than average amounts of furan which must also be considered in the calculation of cellulose insulation age.

Figure 44: The dissolved furan in oil (mg/kg) has been plotted against transformer nameplate age.

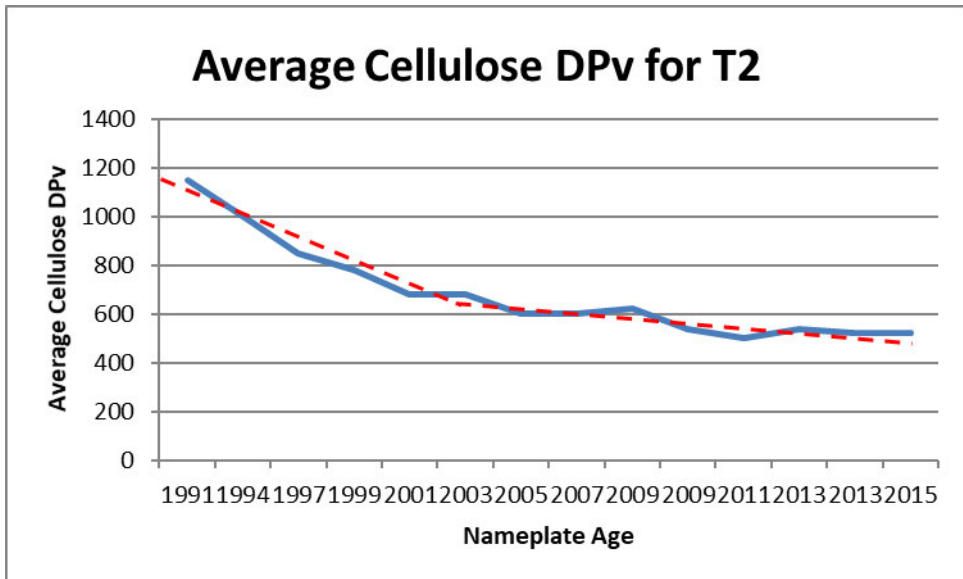
Figure 45: The bulk insulation average DP_v has been plotted against transformer age.

It is only natural that the cellulose insulation DP_v tracks roughly the inverse characteristic of the dissolved furan in oil level. Note the natural slowing down in loss of DP_v as the transformer ages, which simulates more of the characteristic shape observed in technical publications for DP_v.

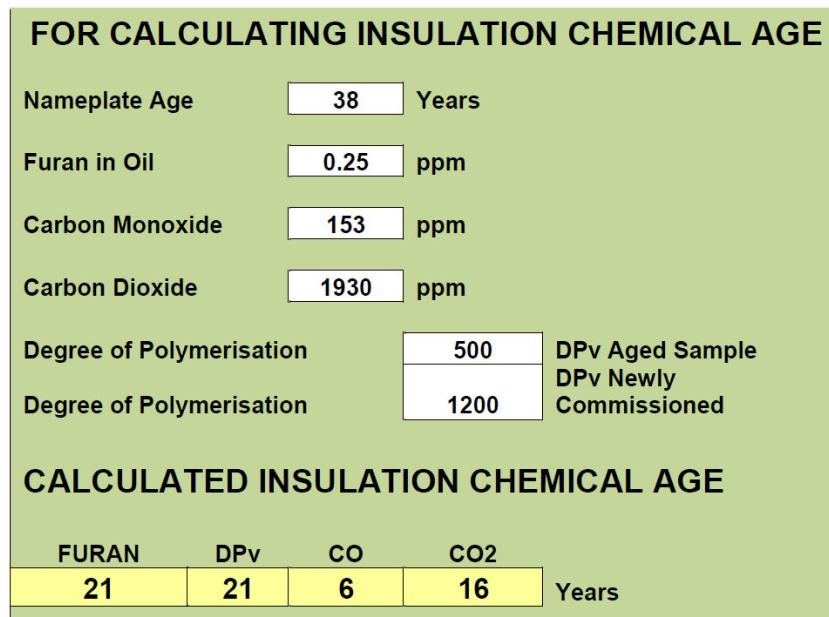
Figure 46: Calculation of the bulk (average) insulation age and comparison with the DP_v level of 500.

The average age of the bulk cellulose insulation system within the transformer is calculated to be approximately 21 years, with a localised winding hot spot insulation age of approximately 27 years. The calculated insulation age for T2 is slightly greater than the corresponding 19 years and 24 years calculated for T1 at H010 Bouldercombe but still far less than the 38 year nameplate age.

Both the average and localised cellulose insulation in this transformer is still in reasonable condition and if this cellulose insulation aging rate persists, it could last at least a further 10 years.

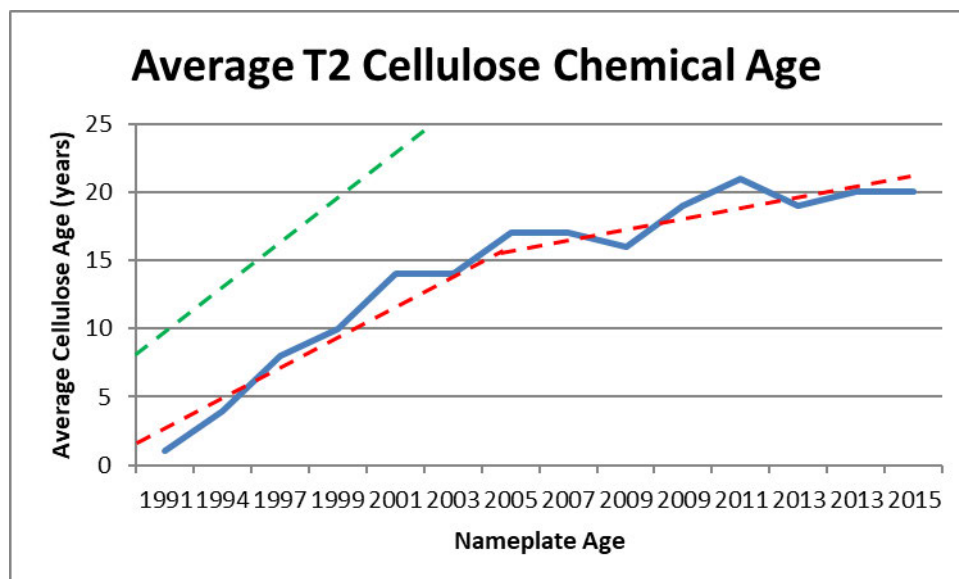
Figure 47: The bulk (average) insulation chemical age has been plotted against transformer nameplate age. The green dotted line represents unity insulation aging rate.

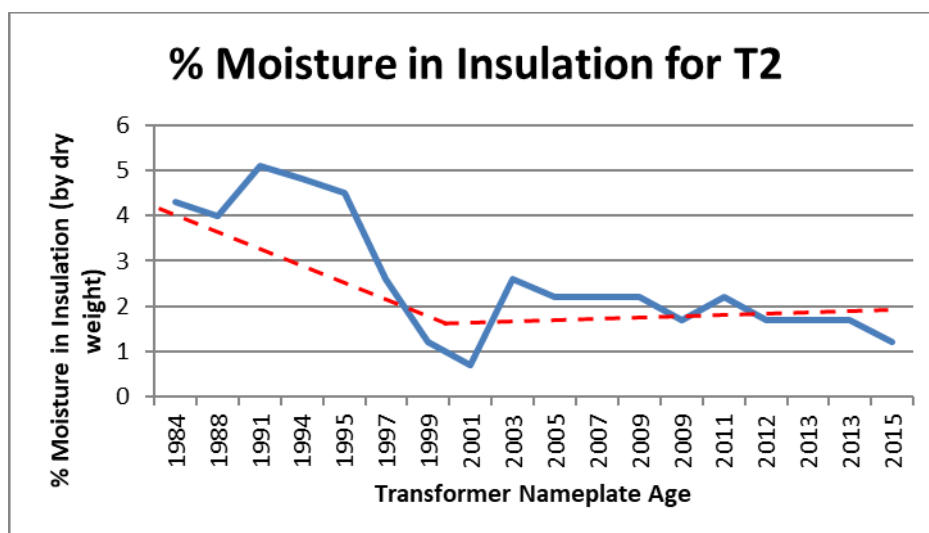
Figure 48: Calculated average of 2.0% moisture in insulation by dry weight.

When this transformer was designed and built, the insulation dryout methods were somewhat poor compared to the standards set by the vapour phase dryout systems used over the last 15 years or more and it was not uncommon to have relatively wet insulation

(by today's standards) from new. The measured moisture in insulation level appears to have been slowly reducing from 1984 and this may have been due to the efficiency of the conservator Drycol refrigerant drying system which continuously dried the air above the oil as well as the incoming air as transformer operating temperatures reduced. Maintenance records do not say but it is likely that the Drycol system on this transformer was removed around the same time as the removal of the Drycol system on T1, which was in 2004 after 27 years of operation.

The calculated moisture in insulation at present is still well below the 4% level beyond which can introduce risks of insulation failure under the right combination of specific operating / environmental conditions.

The only way of getting a more accurate measure of the % moisture in insulation is to install an on-line moisture and temperature probe in the main oil stream for a week and analyse the data collected under varying loads / temperatures.

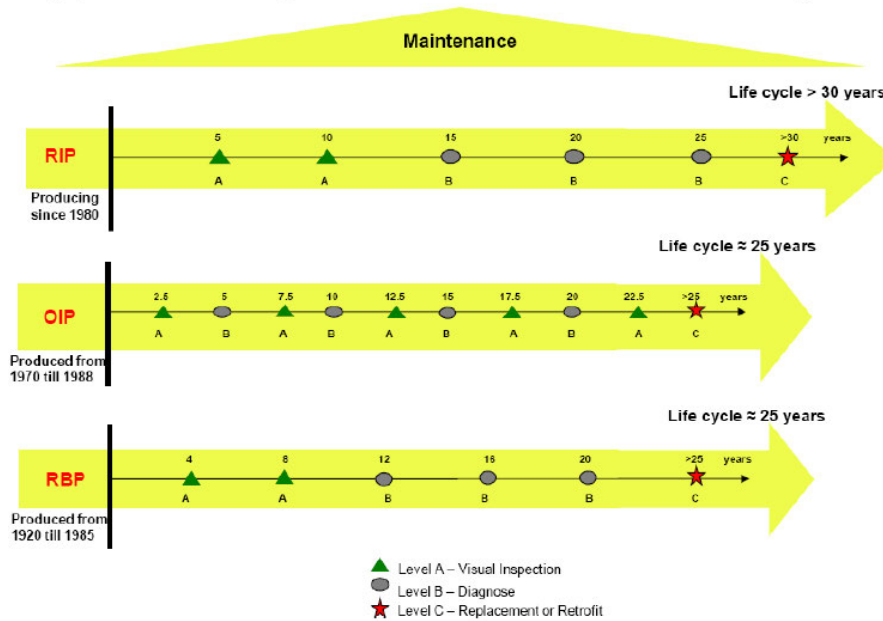
The HV and LV bushings installed on this transformer are an oil impregnated paper (OIP) design. Maintenance records from 2004 do not show the same issues with poor HV insulation dielectric loss and capacitance test data as compared to the same bushings on transformer T1. The recent tests showed very high reading of DLA measurement for B phase LV bushing and the oil samples taken also indicated progressed partial discharged in this bushing. Due to the concerns for safety of personnel in the event of bushing explosive failure, restricted access zone has been established around this transformer.

Figure 50: Bushing life expectancy provided by the bushing manufacturer.
