POWERLINK QUEENSLAND REVENUE PROPOSAL

CP.02415

Greenbank to Mudgeeraba 275kV Transmission Line Refit

**Transmission Line Condition Assessment – Report
BS1018/1019 – Greenbank to Mudgeeraba 275kV****Transmission Line Condition Assessment – Report****BS1018 and BS 1019****Greenbank to Mudgeeraba 275kV**

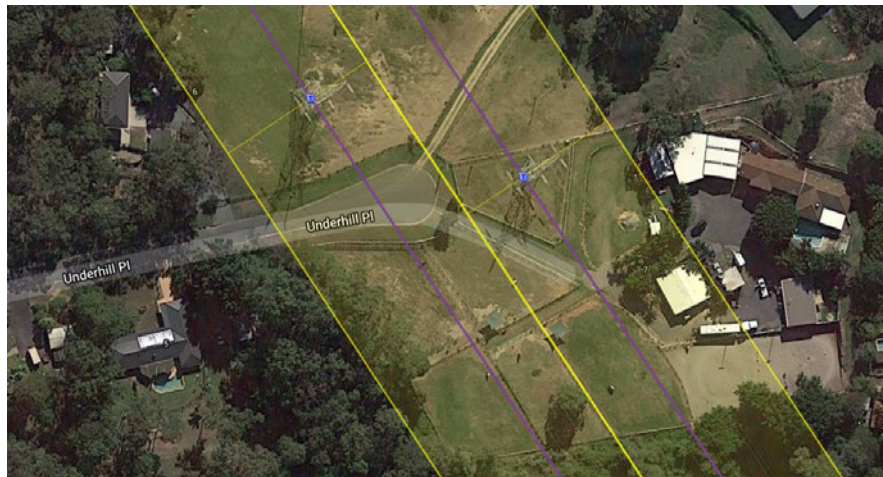
The transmission line is located in Southern Brisbane and extends to the southern end of the Gold Coast. The built sections cover the distance between Greenbank and Mudgeeraba substations. Parts of these transmission lines traverse residential areas and there are multiple road crossings, both major motorways and minor roads. There are also 2 rail crossings, one at the Northern end of the line and the other at the Southern end of the line. The lines run is close proximity to a large number of dwellings, with some unapproved construction and encroachment within the easement corridor.

Figure 10: Residences close to BS1018 and 1019

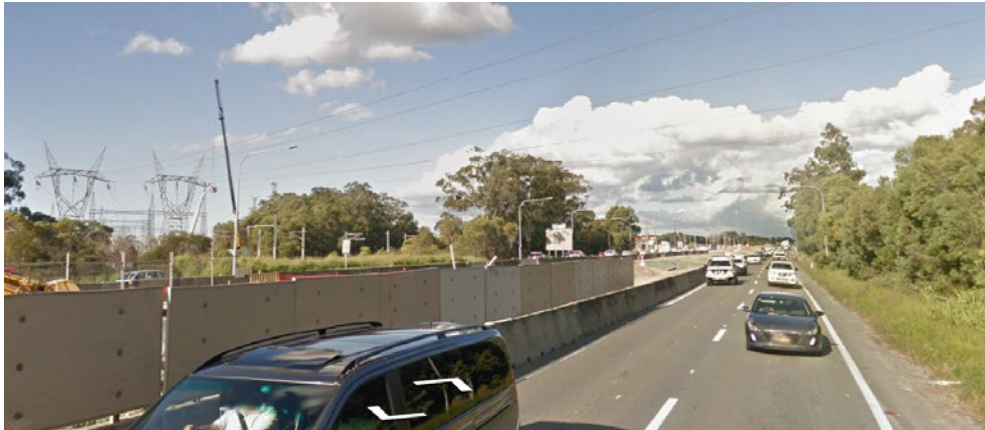
Figure 12: BS1018 and 1019 M1 Motorway crossing near Mudgeeraba Substation
