POWERLINK QUEENSLAND
REVENUE PROPOSAL

Tarong Transformers 2 and 3 Replacement

CP.02584 – Tarong Transformers 2 and 3 Replacement

H018 Tarong Transformer T1, T2, T3 & T4 Condition Assessment

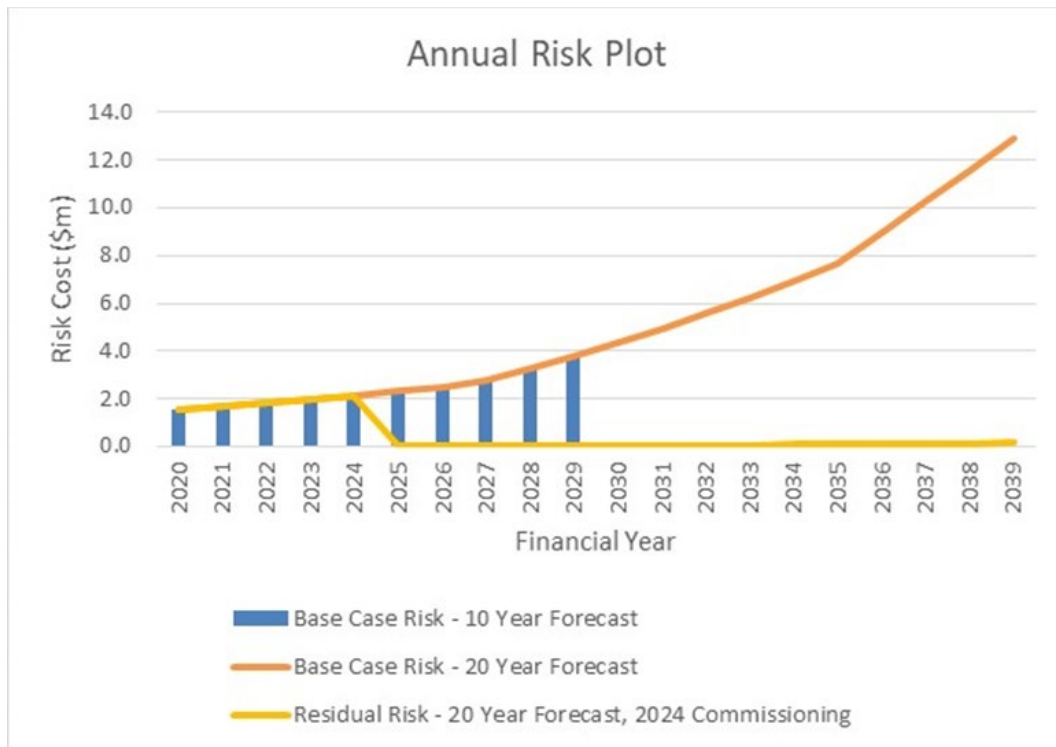
Figure 2-1 below shows the current recommended option reduces the forecast risk monetisation profile of Tarong substation T2 & T3 transformers by over \$2m per annum in 2025. The recommended option will extend the asset life by 40 years.

Where a 'Do Nothing' scenario is adopted, the forecast level of risk associated with the asset escalates from ~2m in 2020 to ~\$4m per annum in 2029 and continues to rise further. This is predominantly due to network risks (unserved energy) associated with potential concurrent outages of T2 and T3³.

Figure 2-1 Annual Risk Monetisation Profile (Nominal)

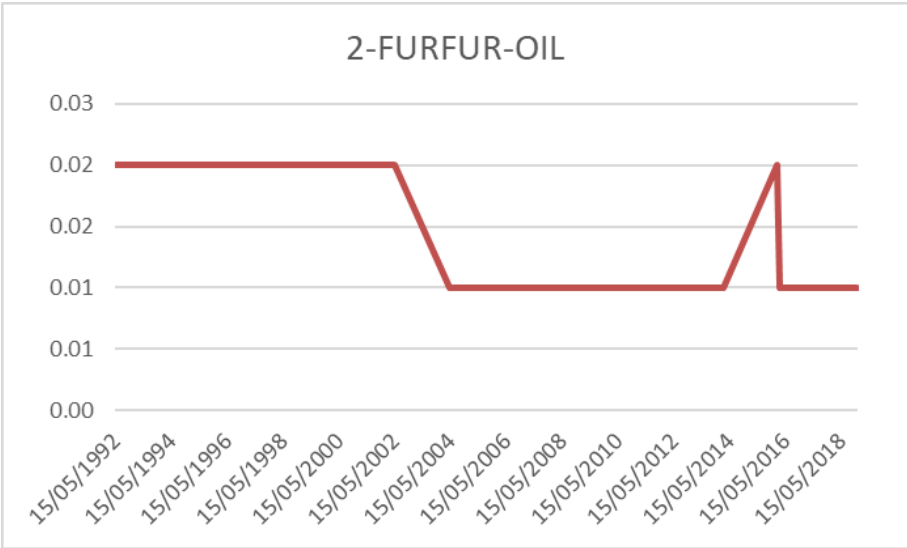
The dissolved furan levels in oil continue to be relatively stable and within acceptable limits (Figure 17).

Figure 17 – T1 2 Furfurals trend

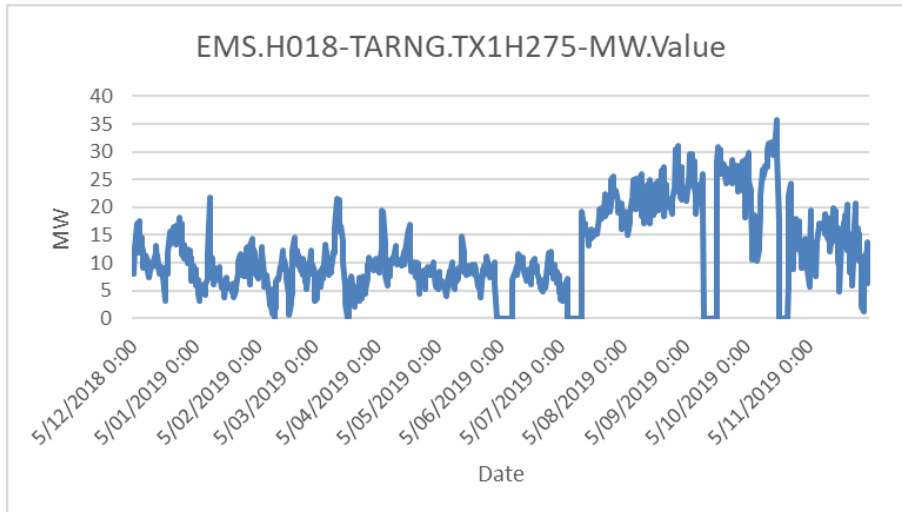
Figure 18 shows the transformer loading over the last 12 months and if this is representative of the loading over previous years, it could explain why the dissolved furan level in the oil is relatively low for a 34 years old free breathing transformer. The peak loading in MVA on the 275kV side of the transformer over the period 05/12/2018 to 05/12/2019 did not appear to exceed 40% of the nameplate ODAN rating. The average loading on the transformer for this period is 12MW.

Figure 18 -T1 transformer loading in MVA in period 5/12/2018 -5/12/2019 (the highest peak load is 36 MVA i.e 40% of ODAN nameplate rating)

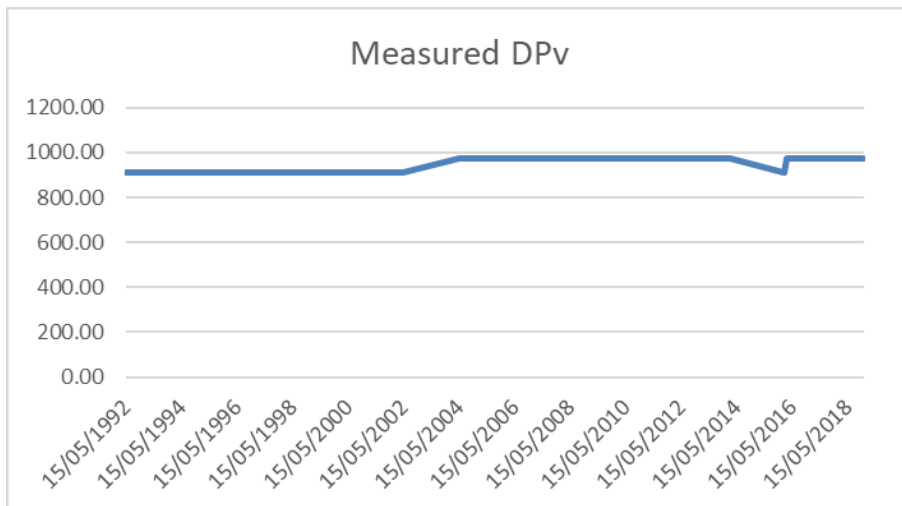
Figure 19 –T1 calculated DPv

The dissolved furan in oil test data can be used to calculate approximate and average bulk cellulose insulation DP_v and its estimated trend is shown in Figure 20. Assuming that the transformer operating conditions remain the same, the trend shows that the transformer has an estimated service life of more than 50 years (Refer Figure 20).

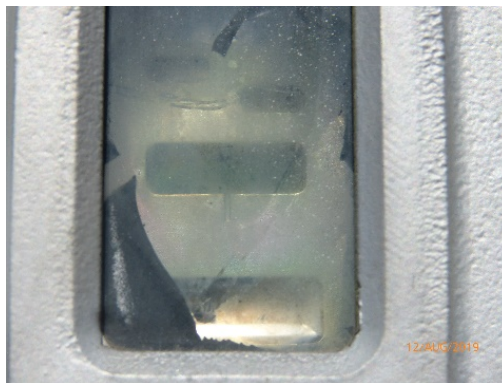
Figure 30- Tap changer sight glass

It was impossible to see anything through the front viewing window on the tap changer compartment, likely due to contamination build-up on the inside of the sight glass. The tap changer motor drive unit door has to be opened to take the number of operations reading. Maintenance records show that during the six yearly maintenance many parts of this unit were replaced and tap changer oil was also replaced. As of August 2019 the tap changer has done 124,777 operations and is in reasonable condition, apart from tap position indicator which is in a failed condition and has not been replaced – this is managed by utilising SCADA reading of the tap changer position.

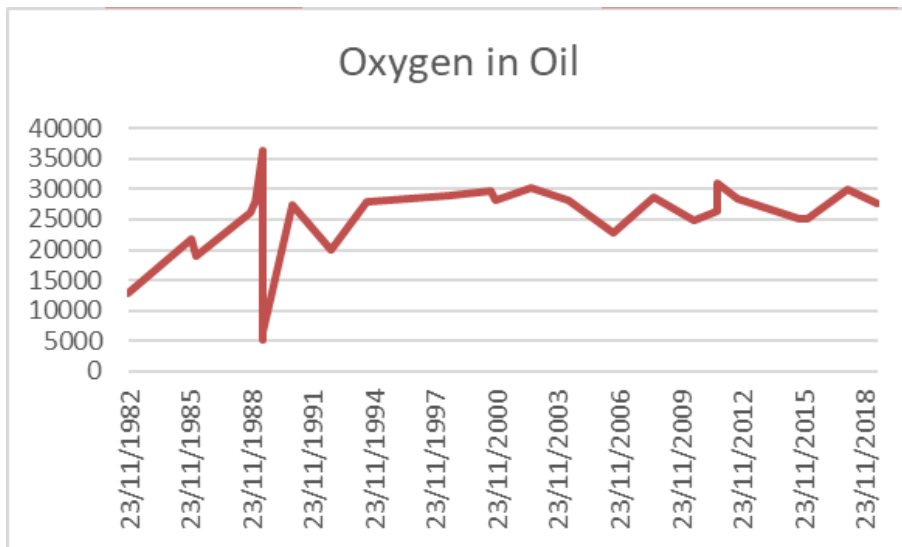
Figure 32 –Content of oxygen in oil

This GEC 90MVA 275/132kV transformer was manufactured prior to QEC introducing sealed internal HV insulation systems. The main tank conservator breathes to the atmosphere via a desiccant breather and this is obvious from the graph above showing oxygen content in oil in the main tank. The graph shown in Figure 32 indicates the oxygen level in the main tank in the service history. The level of oxygen in the oil is stable and at an acceptable level.

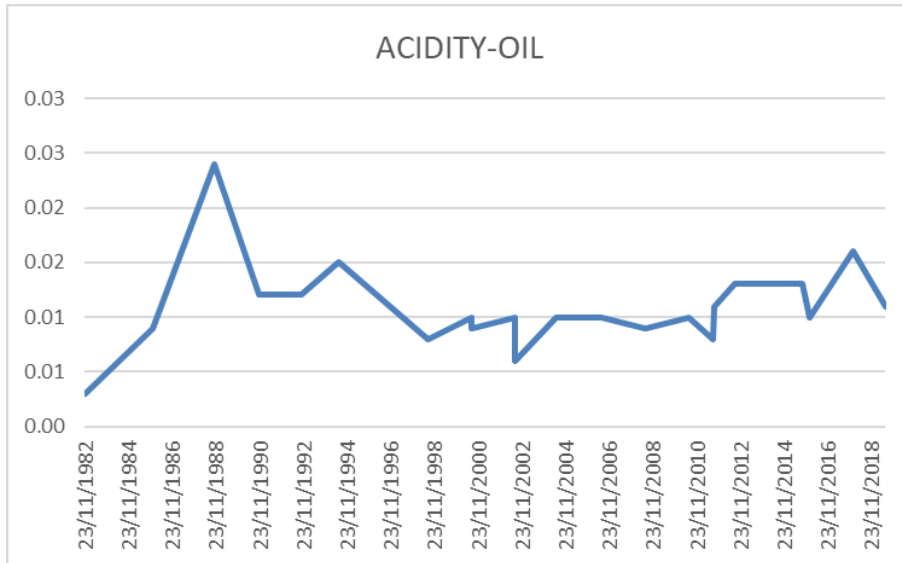
Figure 33 – Transformer T2 oil acidity

Figure 33 shows the level of acidity in the oil, which is at an acceptable level. The oil quality in this transformer has remained in reasonable condition over its life. The oil dielectric dissipation factor and dielectric strength are also within acceptable limits.

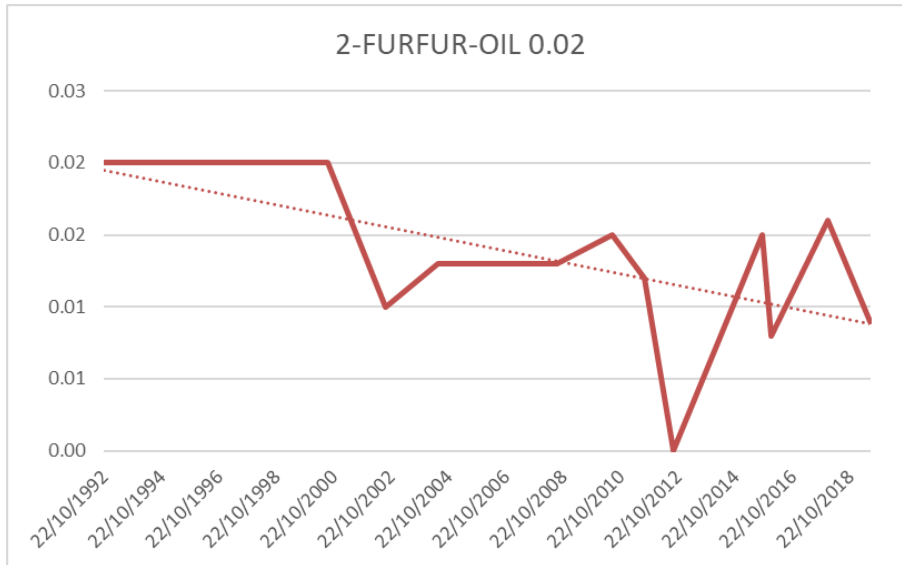
The dissolved furan levels in oil continued to be relatively stable and within acceptable limits (Figure 34).

Figure 34 – T1 2 Furfurals trend

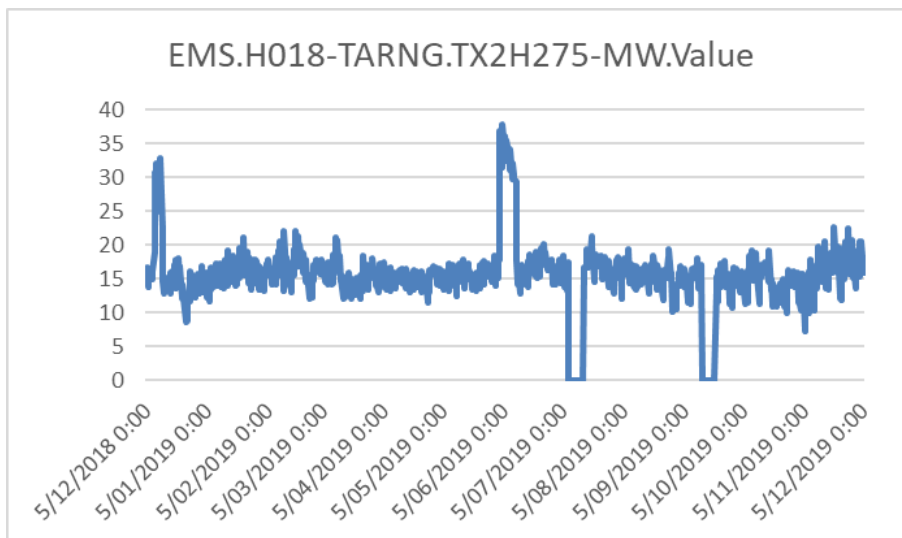
Figure 35 shows the transformer loading over the last 12 months and if this is representative of the loading over previous years, it could explain why the dissolved furan level in the oil is relatively low for a 34 years old free breathing transformer. The peak loading in MVA on the 275kV side of the transformer over period 05/12/2018 to 05/12/2019 did not appear to exceed 40% of the nameplate ODAN rating. The average loading on the transformer for this period is 16MW.

Figure 35 -T1 transformer loading in MVA in period 5/12/2018 -5/12/2019 (the highest peak load is 36 MVA i.e 40% of ODAN nameplate rating)

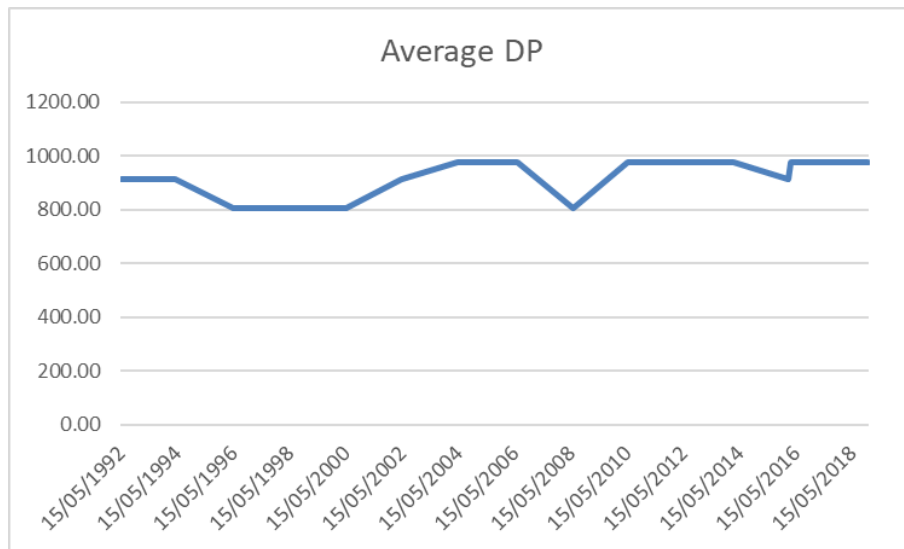
Figure 36 –T1 calculated DPv

The dissolved furan in oil test data can be used to calculate approximate and average bulk cellulose insulation DP_v and its estimated trend based on the Chendong method is shown in Figure 36. Assuming that transformer operating conditions remain the same, the trend shows that the transformer has an estimated service life of more than 50 years (Refer figure 37).

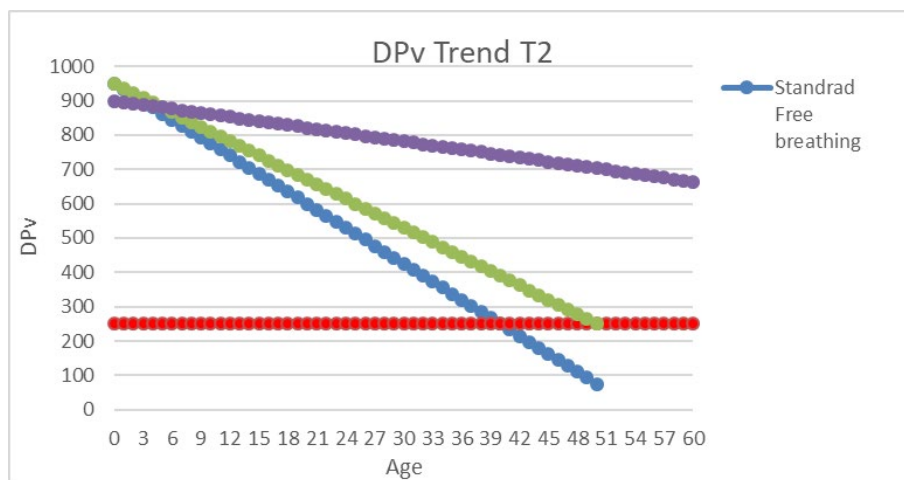
For a typical free breathing transformer the estimated service life is 40 years. The average loading of T1 transformer is only 16 MW which is 14% of its rated capacity, due to this lightly loaded operation, the expected service life of the substation power transformer is significantly greater than the design life.

Figure 37 –T1 DPv trend, typical DPv and EOL DPv

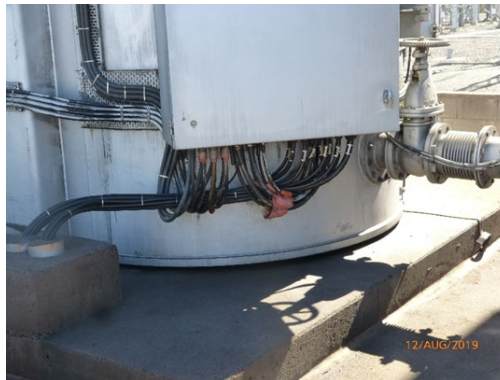
After 37 years of exposure to the elements, the external cables are set and any significant cable flexing (e.g. removal & reconnection) due to replacement of external ancillary items may create some insulation damage. If left physically alone, all of the multicore cables should not fail over the next 10 years.

Figure 44- Multi-core cables attach to the Main tank

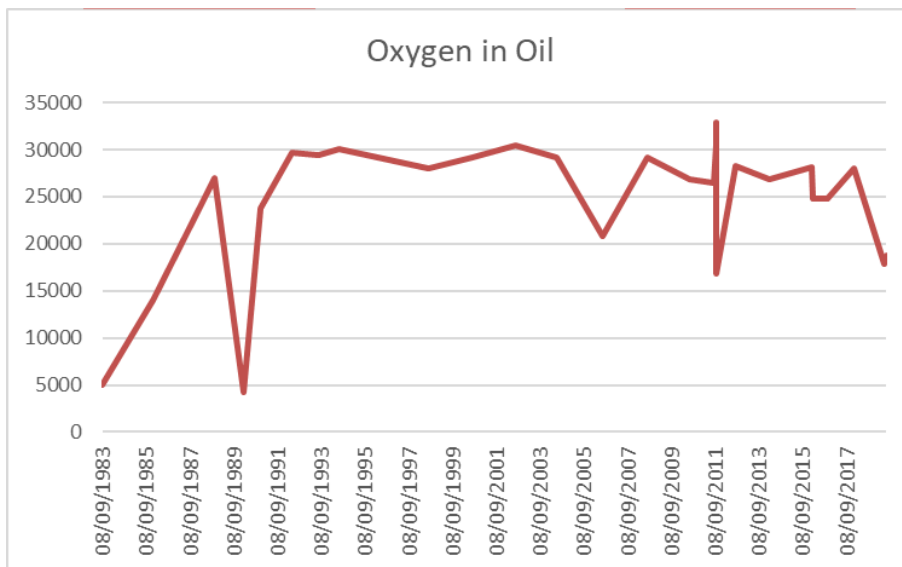
Figure 46 –Content of oxygen in oil

This GEC 90MVA 275/66kV transformer was manufactured prior to QEC introducing sealed internal HV insulation systems. The main tank conservator breathes to the atmosphere via a desiccant breather consisted of two paralleled units and this is obvious from the graph above showing oxygen content in oil in the main tank. The graph in Figure 46 shows the oxygen level in the main tank throughout its service history. The level of oxygen in the oil is stable and at an acceptable level.

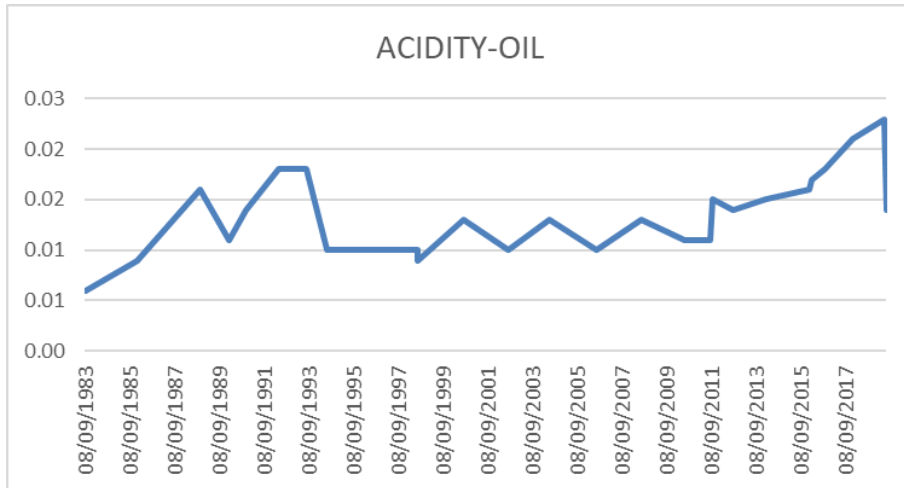
Figure 47– Transformer T3 oil acidity

Figure 47 shows the level of acidity in the oil, which is at an acceptable level. The oil quality in this transformer has remained in reasonable condition over its life. The oil dielectric dissipation factor and dielectric strength are also within acceptable limits.

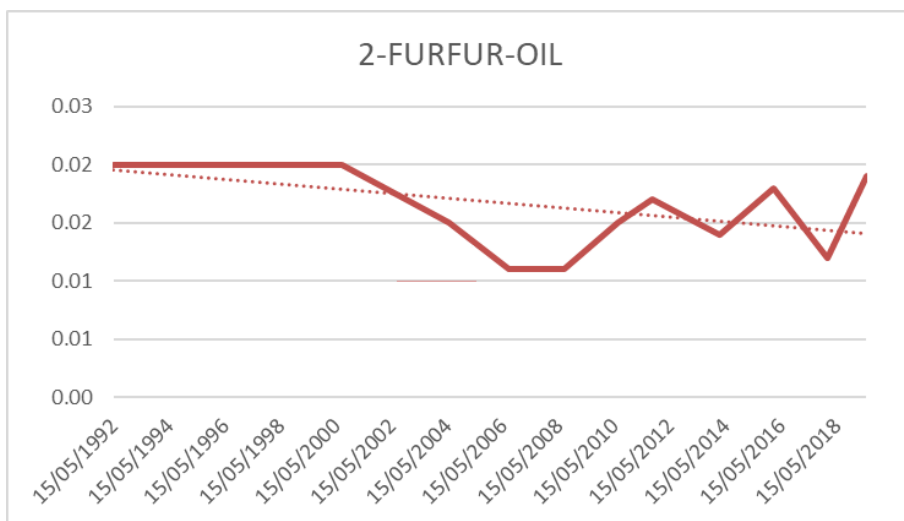
The dissolved furan levels in oil continue to be relatively stable and within acceptable limits (Figure 48).

Figure 48 – T3 2 Furfurals trend

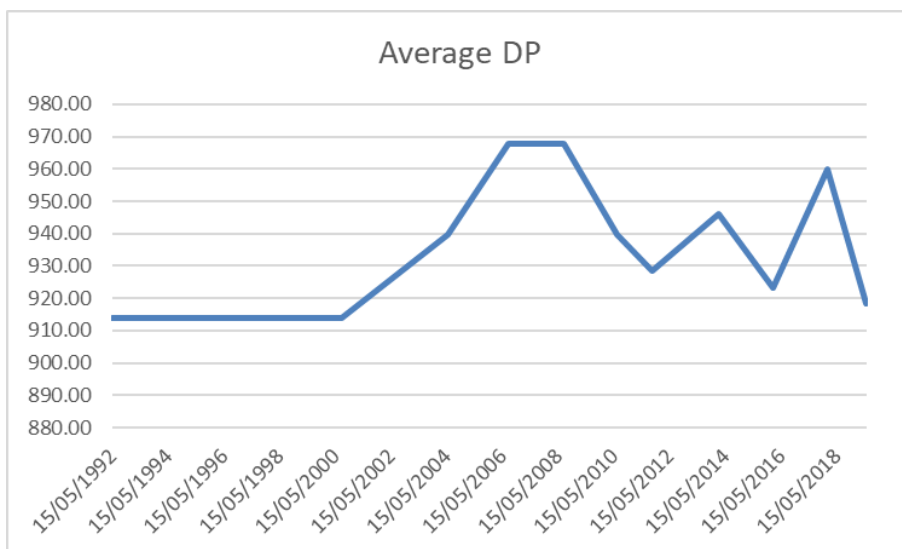
Figure 50 -T1 calculated DPv

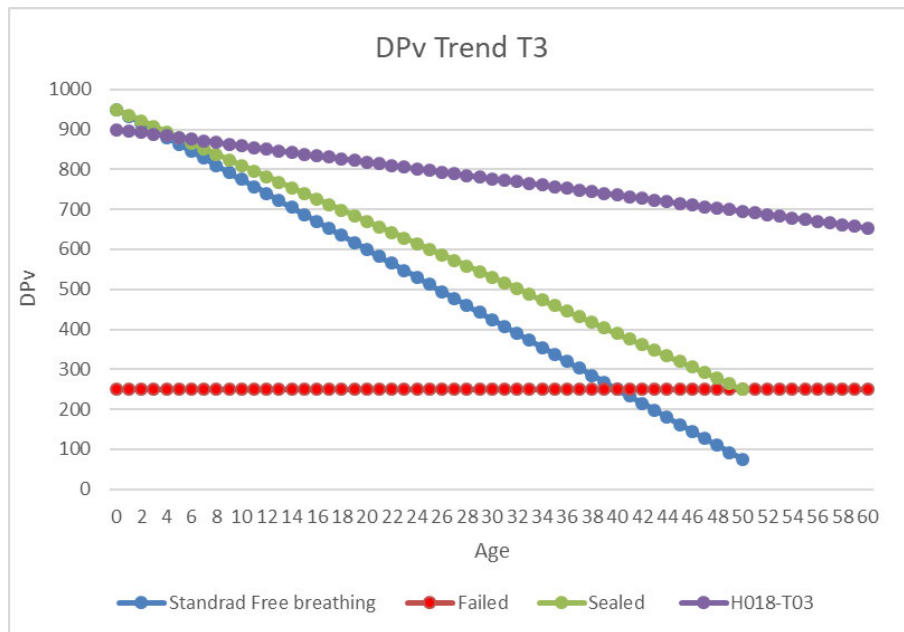
The dissolved furan in oil test data can be used to calculate approximate and average bulk cellulose insulation DP_v and its estimated trend using the Chendong method is shown in Figure 51. Assuming that the transformer operating conditions remain the same, the trend shows that the transformer paper has potentially an estimated service life of more than 50 years. For a typical free breathing transformer the total estimated service life is 40 years. The average loading of the T3 transformer is only 16 MW (14% of its rated capacity) being so light is the main reason for this large discrepancy.

Figure 51 – T1 DP_v trend, typical DP_v and EOL DP_v

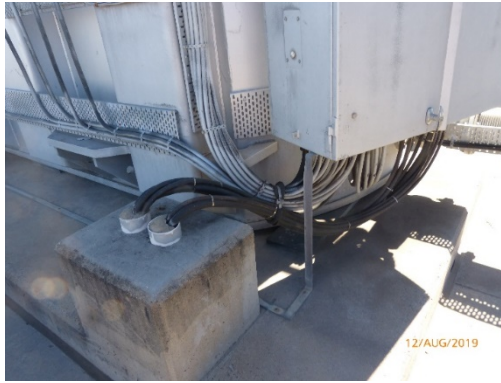
After 27 years of exposure to the elements, the external cables are set and any significant cable flexing (e.g. removal & reconnection) due to replacement of external ancillary items may create some insulation damage if left physically alone, all of the multicore cables should not fail over the next several years.

Figure 59- Multi-core cables attach to the Main tank

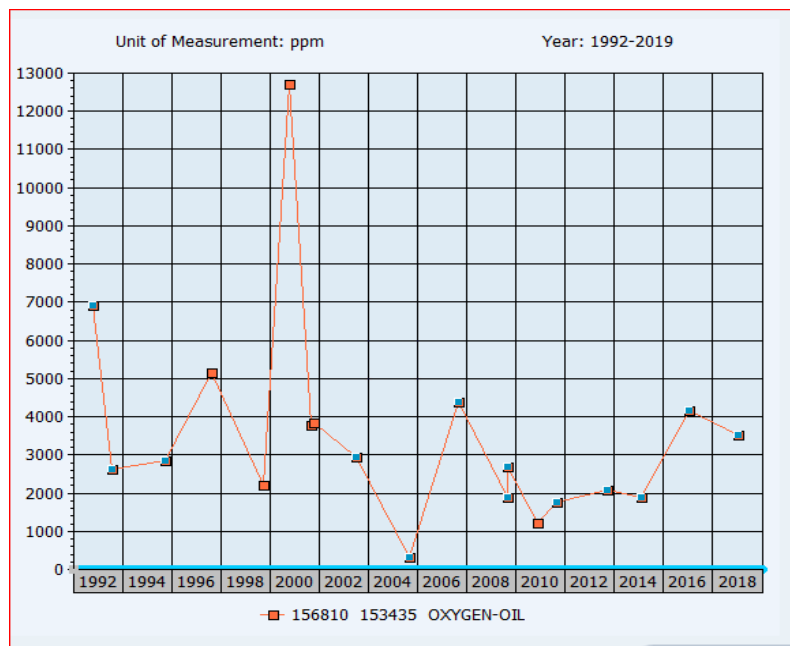
Figure 61 –Content of oxygen in oil

This GEC 90MVA 275/132kV transformer has a sealed internal HV insulation system. The graph shown on Figure 61 indicates the oxygen level in the main tank in the service history. The level of oxygen in the oil is relatively stable and at acceptable levels.

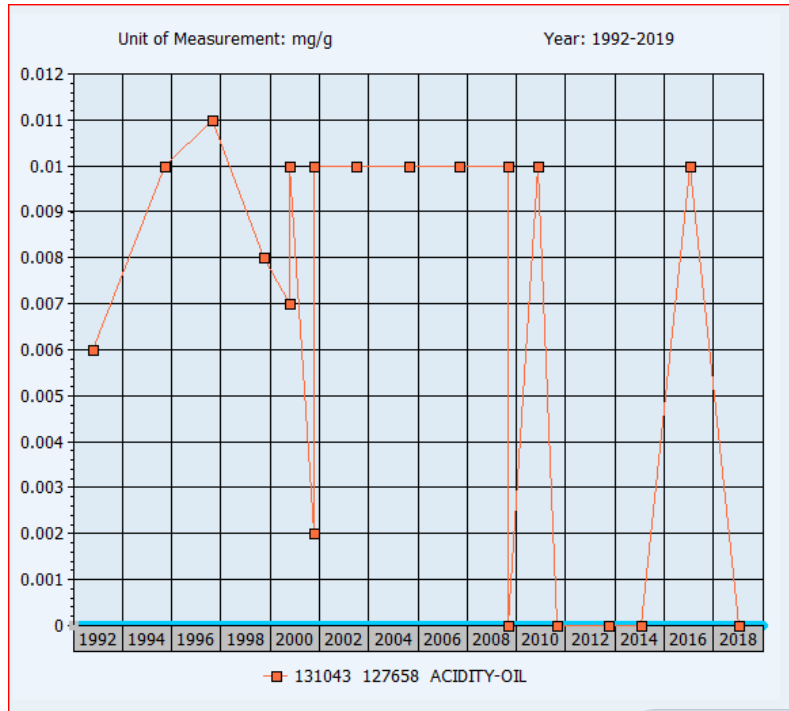
Figure 62 – Transformer T4 oil acidity

Figure 62 shows the level of acidity in the oil, which is low and at acceptable level. The oil quality in this transformer has remained in reasonable condition over its life, as expected for a transformer of this age. The oil dielectric dissipation factor and dielectric strength are also within acceptable limits.

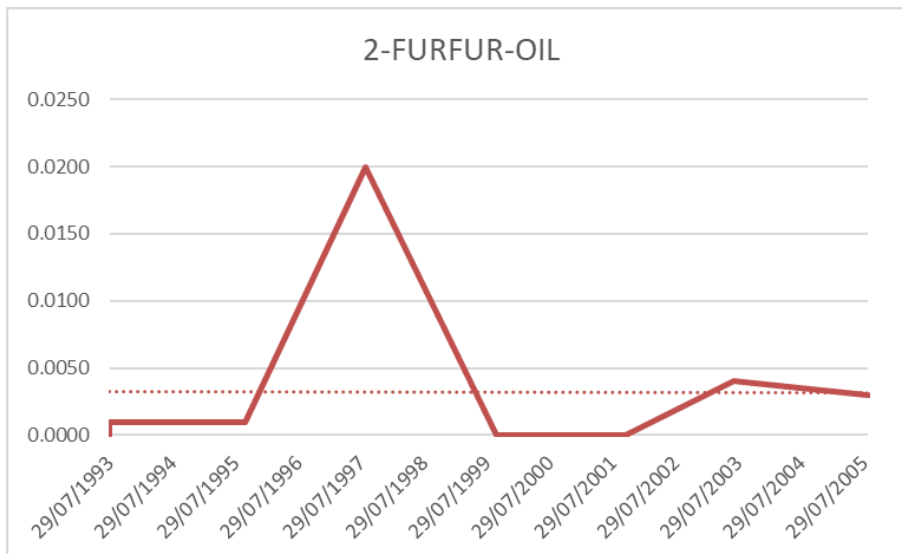
The dissolved furan levels in oil continued to be relatively stable (apart from an erroneous reading in 1997, repeated and confirmed to be 0.001) and within the acceptable limits (Figure 63).

Figure 63– T4 2 Furfurals trend

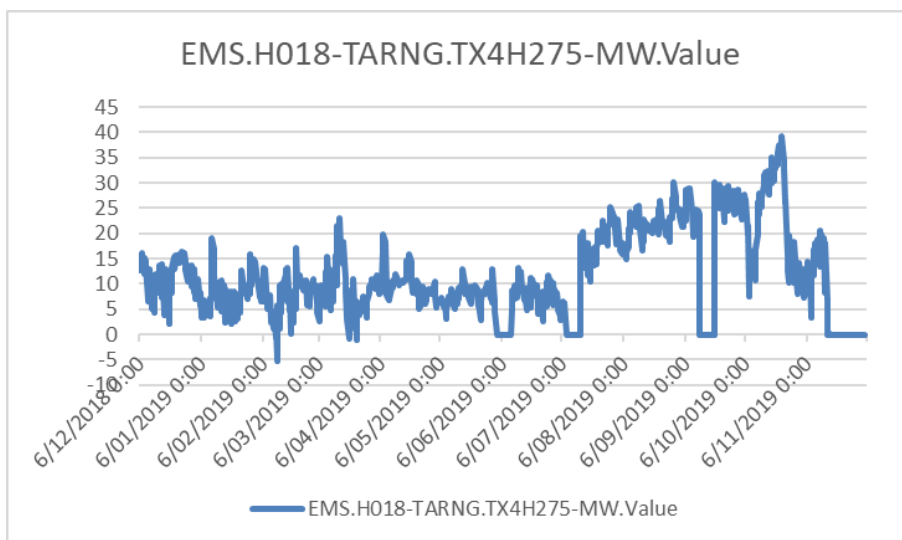
Figure 64 shows the transformer loading over the last 12 months and if this is representative of the loading over many previous years, it could explain why the dissolved furan level in the oil is relatively low for a 27 years old sealed transformer. The peak loading in MVA on the 275kV side of the transformer over period 05/12/2018 to 05/12/2019 did not appear to exceed 44% of the nameplate ODAN rating. The average loading on the transformer for this period is 12MW.

Figure 64 –T4 transformer loading in MVA in period 5/12/2018 -5/12/2019 (the highest peak load is 40 MVA i.e 44% of ODAN nameplate rating)

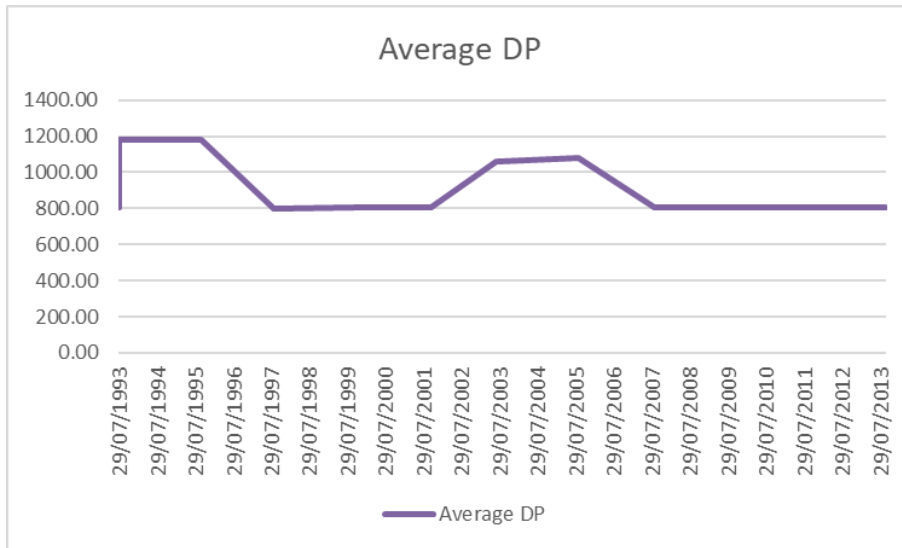
the cellulose insulation system has not shown any significant deterioration from new. The measured dissolved furan levels in oil are shown in Figure 65.

Figure 65–T4 calculated DPv

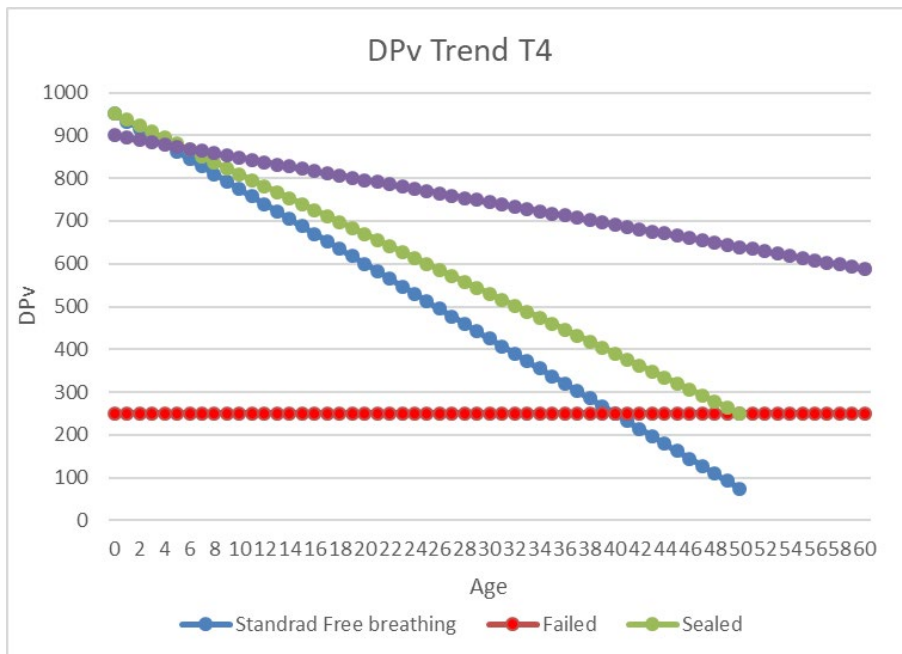
The dissolved furan in oil test data can be used to calculate approximate and average bulk cellulose insulation DP_v and its estimated trend is shown in Figure 60. Assuming that transformer operating conditions remain the same, the trend shows that the transformer has potentially an estimated service life of more than 50 years.

For a typical sealed transformer the estimated service life is 50 years. Considering the average loading of the T4 transformer being only 12 MW so far, the expected service life of this transformer is greater than the design life.

Figure 66 –T4 DPv trend, typical DPv and EOL DPv
