CP.02750

**Ross to Chalumbin 275kV Transmission
Line Refit**

**Transmission Line Condition Assessment – Report**
Built Section 1220 – Ross to Chalumbin 275kV**Transmission Line Condition Assessment Report****Built Section 1220**
Ross to Chalumbin 275kV

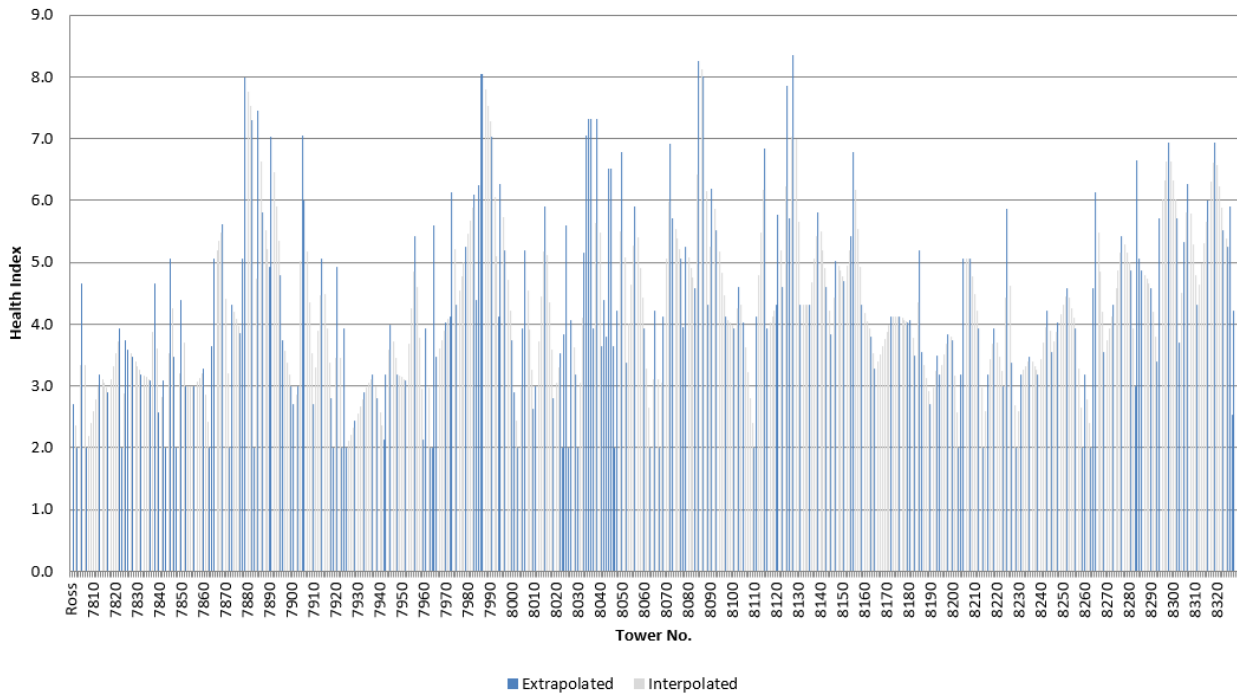
Health Indexes along BS1220 Ross to Chalumbin (Strs: 528 , kms: 244.1)

Below are the health indices of structures along the built section. While structures in average condition are not of concern, structures in the more elevated and exposed locations are currently at a health Index of greater than 7 (representing a complete loss of galvanising on some members and bolts).

The highest risk on the line is related to the vertically installed and axially loaded bolts in the attachment areas of some towers.

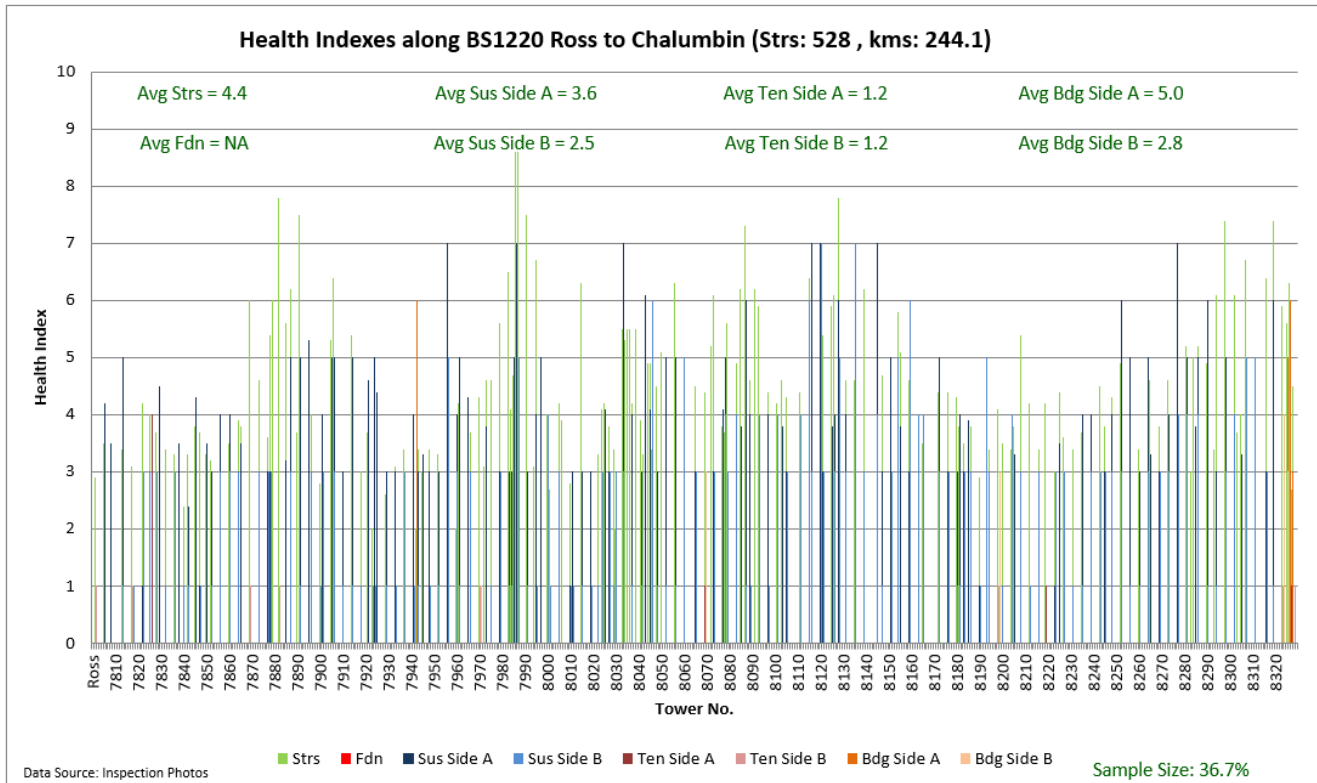
The condition data detailed in the below sections has been summarised in the following graph of available health indices for some major components.

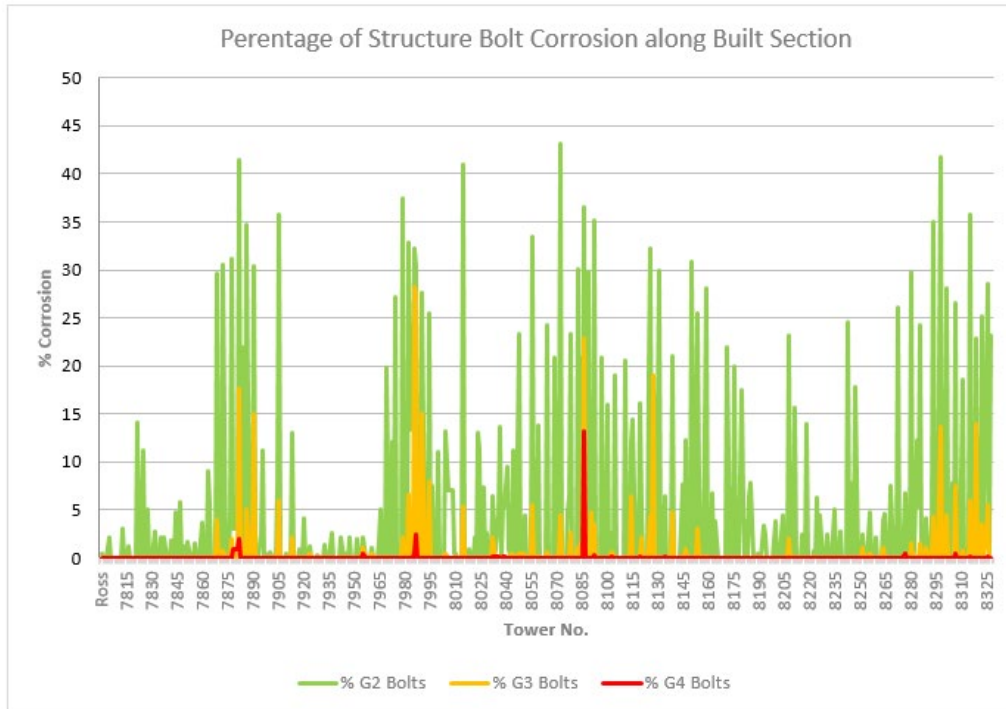
Below is the percentage corrosion of structures along the built section based on visual estimates on a sample of towers. The locations of structures with high nut, bot and member corrosion percentages along the line stands out clearly and correlates well with the SAP notifications graph (Appendix 7).

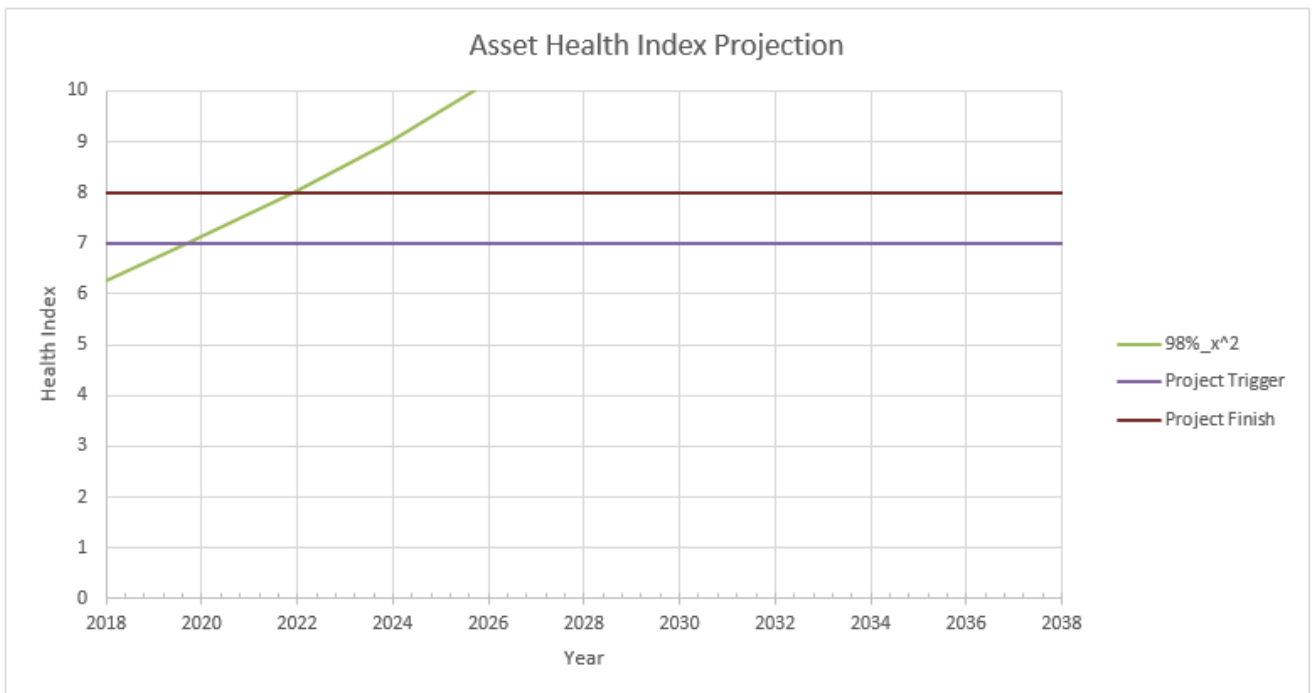
The percentages of corrosion are converted to a health index and based on statistical distribution of the results an Asset Health Index (AHI) is calculated. The following graph shows the AHI based on a threshold of 98% of towers which excludes the worst 2% of towers. The health index for the built section reflects the need to complete a project in the short term (2020-2022). However, since only a small percentage of bolts in a higher areas of towers is driving the need, a capital project could be deferred with increased maintenance or an operational refurbishment project.

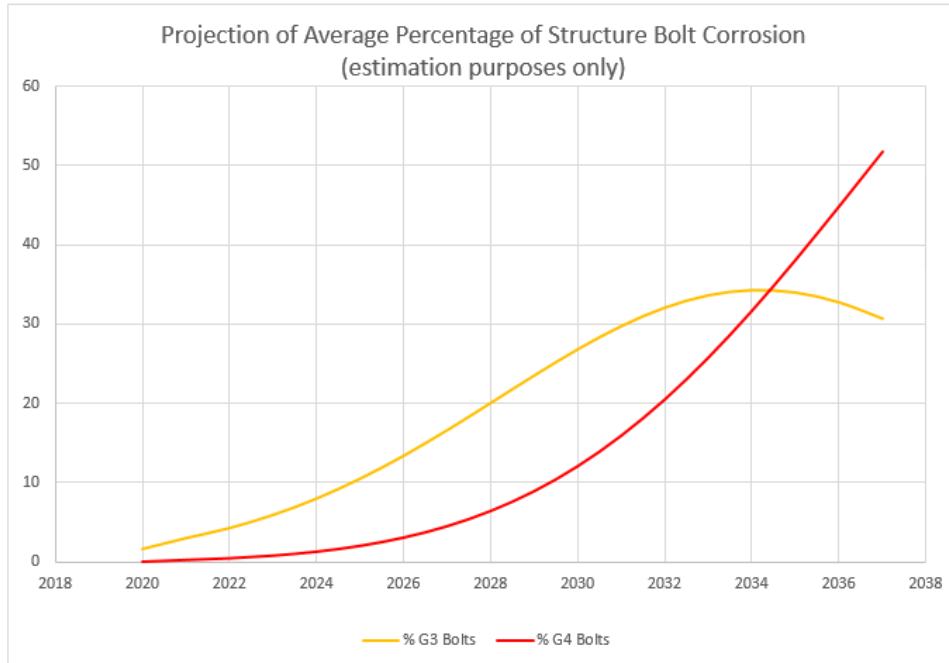
To aid with estimation, the average levels of corrosion calculated. Below is the projection of average level of corrosion on the entire built section based on the sample of data.

As shown in the below table, in 2024 it is estimated that on average across the built section 8% of bolts will have reached grade 3 if no maintenance is performed. This table can be used for high level estimating.

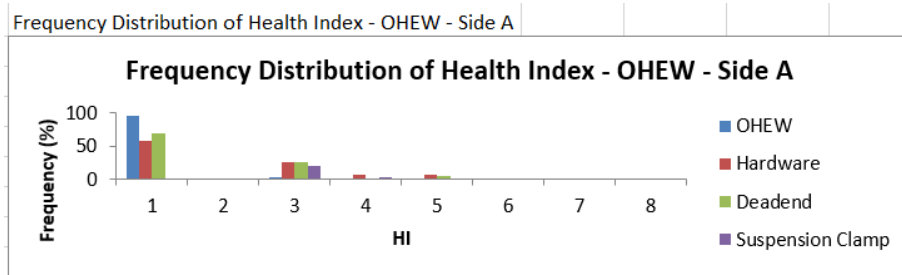
During 2015 and 2016 project OR.02017 replaced 181 spans of OHEW found to be in the worst condition (G3H and G4). An additional 21 spans of OHEW were replaced before the project under maintenance due to the damage, meaning that there are around 326 originally installed spans of the OHEW remaining on the line (around 62%).

Based on the latest visual inspection of the remaining original spans it is estimated that remaining service life of the OHEW system is 4 years.

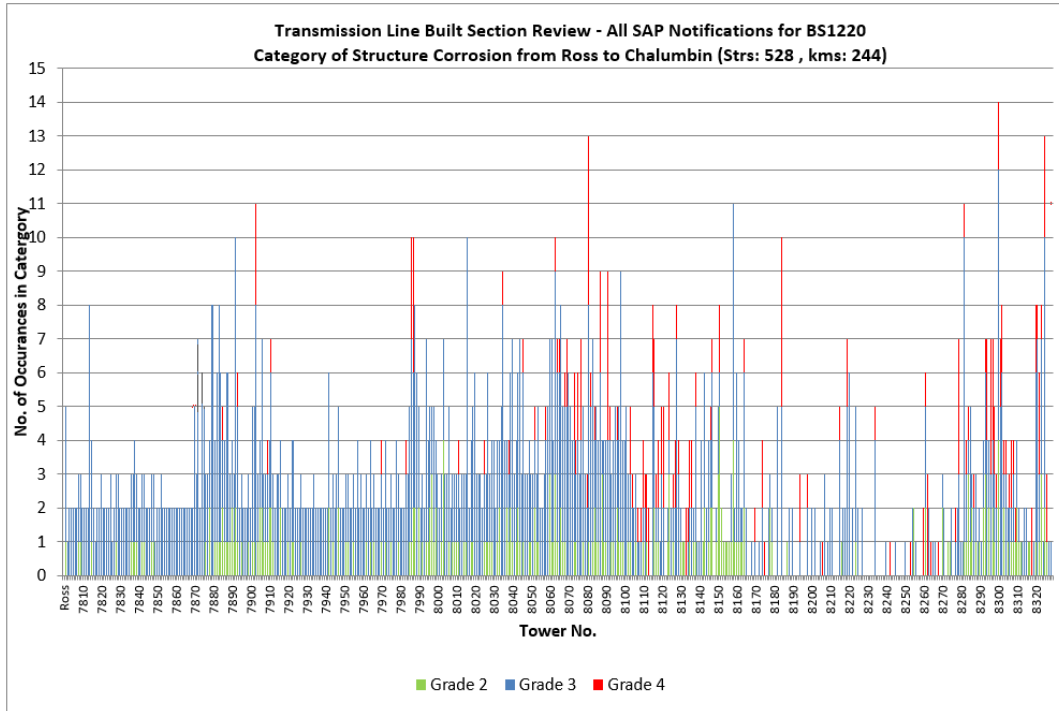
Figure 5: Graph of SAP all Notifications for Corrosion on Structures

Appendix 7 has two graphs of the number of notifications relating to corrosion. The notification graphs show correlation with the health indices and the percentages of corrosion.
