POWERLINK QUEENSLAND
REVENUE PROPOSAL

**Davies Creek to Bayview Heights 275kV
Transmission Line Refit**

CP.02754 – Davies Creek to Bayview Heights 275kV Transmission Line Refit

**Transmission Line Condition Assessment – Report
BS1235 and BS1664 – Chalumbin to Woree****Transmission Line Condition Assessment – Report****BS1235 and BS1664
Chalumbin to Woree**

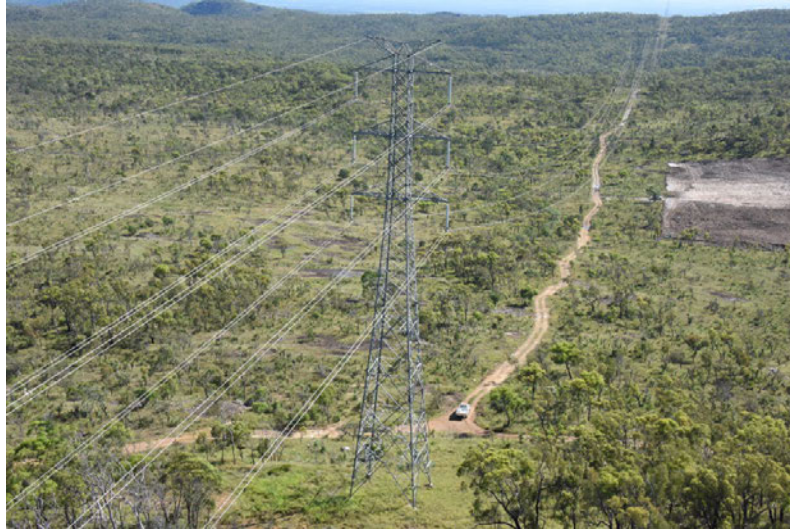
Figure 31: Typical easement outlook on South West section of BS1235 (2018)

On the South West section (BS1235) of the line, the predominant problems recorded in Notifications are related to the weed issues.

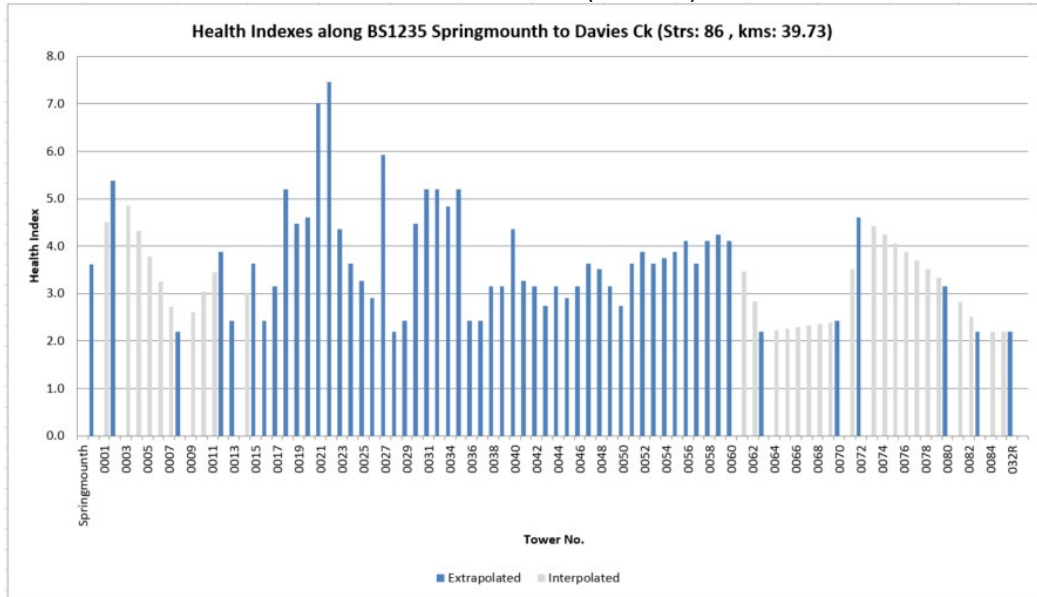
Figure 33: Graph of Health Indexes for Structures STR-0000 to STR-0084

Section 1 is the 40km long South - Western part of the line (STR-0000 to STR-0084) from Springmount area to Davies Creek National Park, and retains the original Built Section number, BS1235 This section has a small number of towers with notifications for G3 corrosion and G4 bolts observed in attachment areas, and an average structure health index (HI) of 4.2. This section will exceed HI7 in 2026 approximately, with an expected end of life (EoL) before 2030 (HI8).

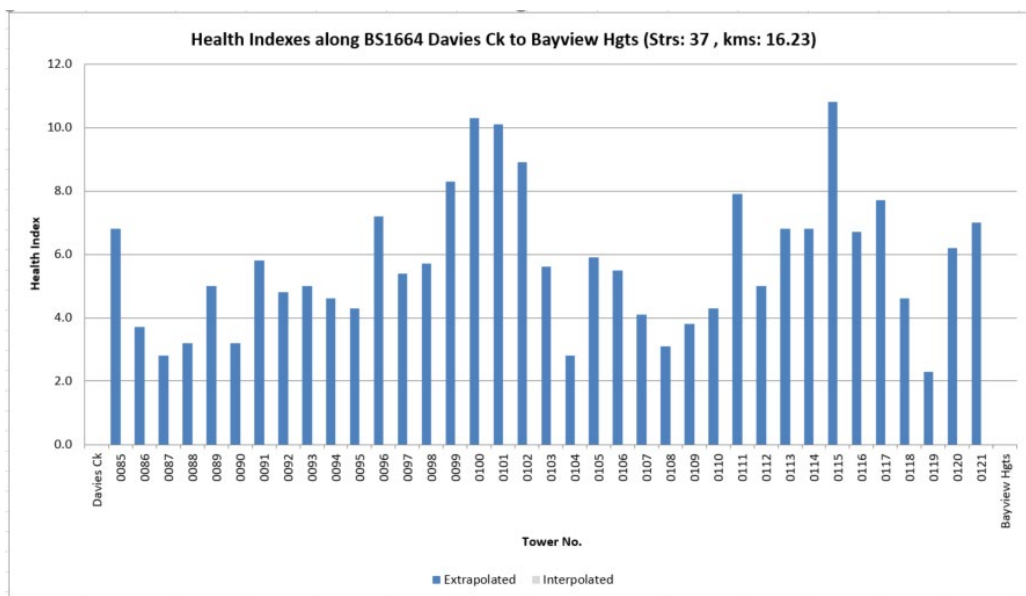
Figure 34: Graph of Health Indexes for Structures STR-0085 to STR-0121

Section 2 is a 16.2km part of the line, from STR 085 to the Bayview transition site (STR-0121), usually called the Wet Tropics section. This section has been re-numbered BS1664, and had an average structure HI of 8 at time of assessment (2020), with a significant proportion of the towers having outstanding G4 notifications. This section is already at its technical EoL and maintenance is currently being performed to maintain the asset in a serviceable condition.

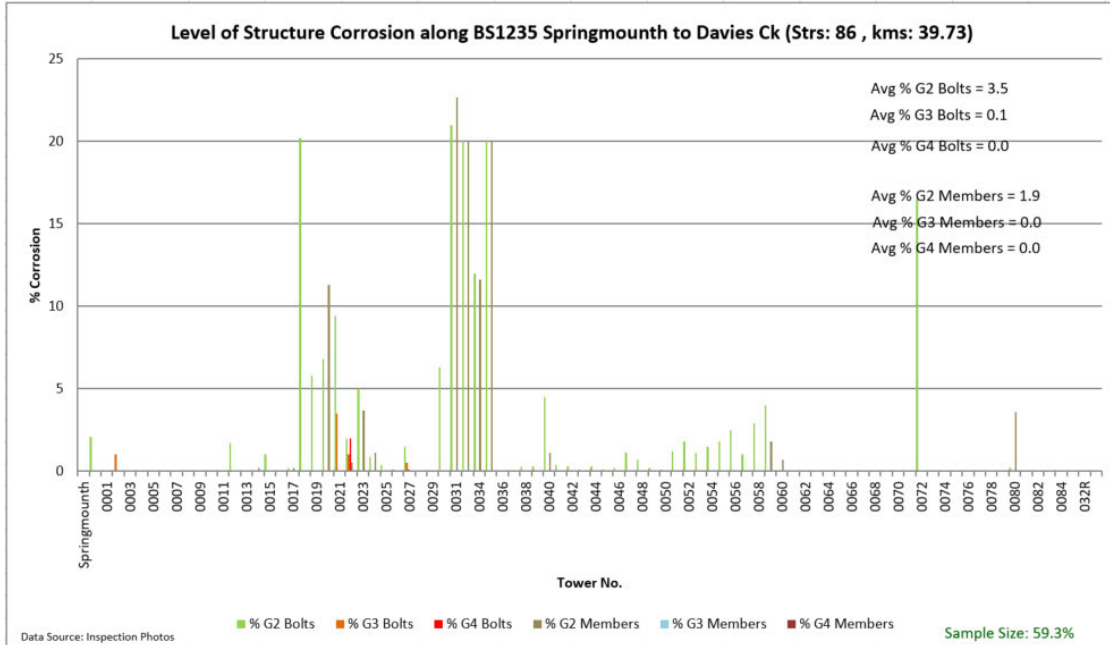
Figure 35: Percentage of Structure Corrosion STR-0000 to STR-0084

Figures 35 and 36 in Appendix 6.17 shows the contrasting levels of G2, G3 and G4 corrosion observed along the line from the sampled structures.
