POWERLINK QUEENSLAND REVENUE PROPOSAL

CP.02778

**Calliope River to Wurdong Tee 275kV
Transmission Line Rebuild**

Transmission Line Condition Assessment – Report
Built Sections 1122 – Calliope River to Gin Gin 275kV

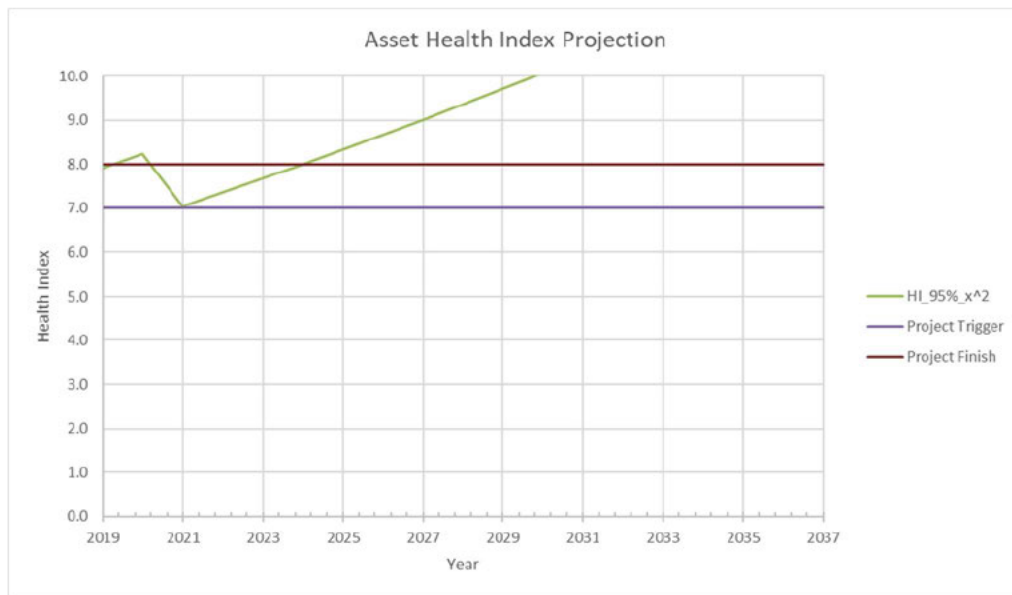
Based on a statistical distribution of the structure health index, an Asset Health Index (AHI) was calculated. The above mentioned OR project currently underway has been taken into consideration to show a reduction in health index following the completion of the projects in 2021. The following graph shows a projection of the AHI based on a threshold of 95% of towers which excludes the worst 5% of towers. Based on the data it is recommended that another project be completed before 2024, when the AHI reaches 8.

Based upon the data presented in this report and health indices for 33% of the structures, this line will require reinvestment within the next 1 to 4 years.

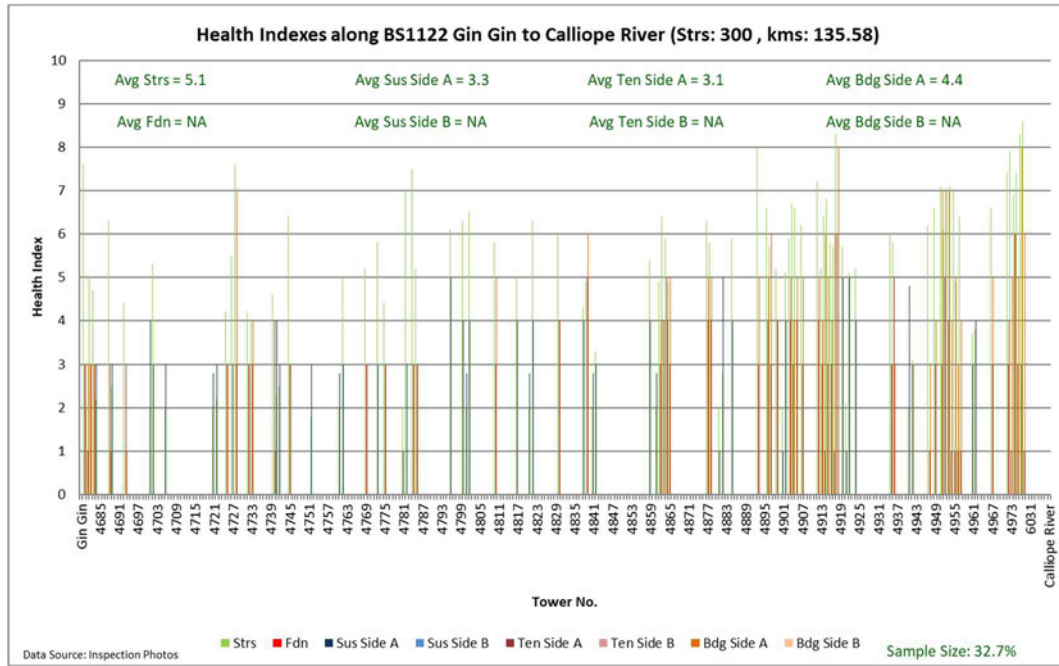
The condition data detailed in the below sections has been summarised in the following graph of available health indices for some major components.

Appendix 7 has two graphs of the number of notifications relating to corrosion. The notification graphs show reasonable correlation with the health indices and the percentages of corrosion which show the northern end as the most corroded section of line. The majority of the grade 4 corrosion relates to the bolts in the earthwire peak, conductor attachment plates, and superstructure which should be rectified during two OR projects currently underway.

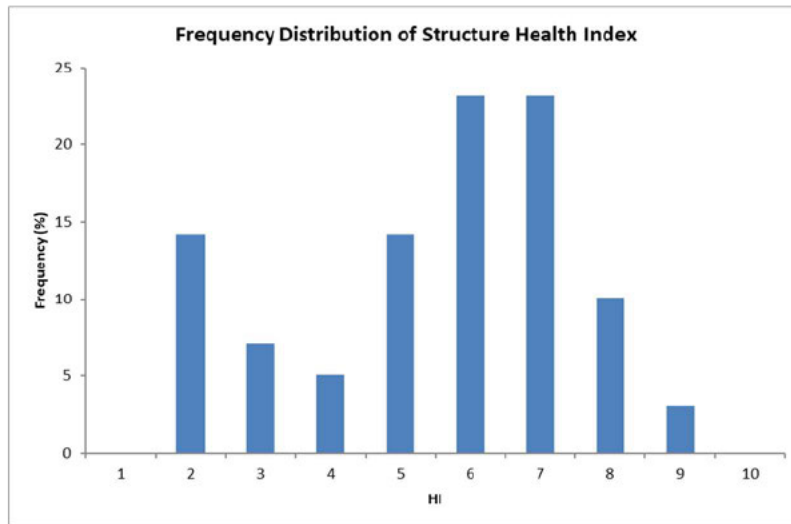
Below is the frequency distribution of structure health index based on the sample of data which can help to understand the spread of the data and determine if projects can have a staged delivery.

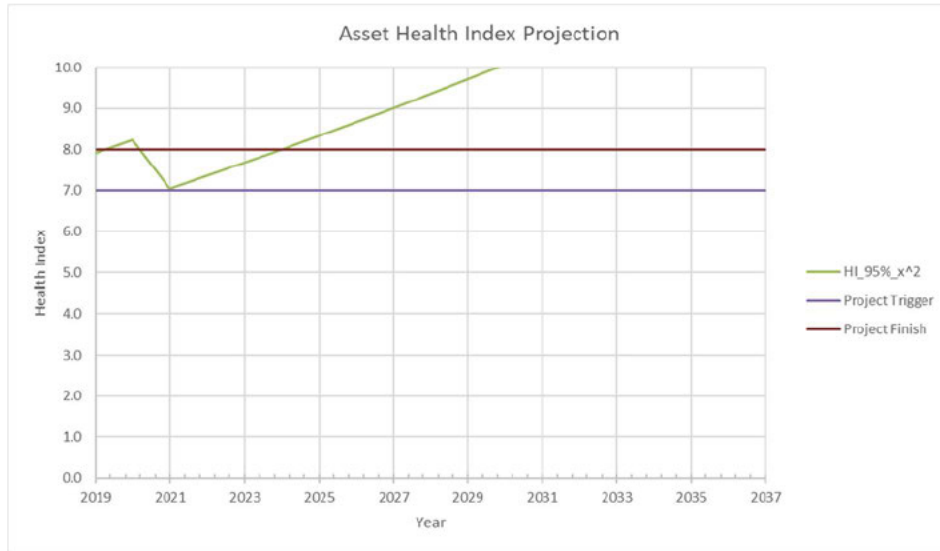
The percentages of corrosion are converted to a health index and based on statistical distribution of the results an Asset Health Index (AHI) was calculated. The following graph shows the AHI based on a threshold of 95% of towers which excludes the worst 5% of towers. There are a couple of refurbishment projects underway which are expected to remove approximately 1% of the worst bolts. The improved condition is estimated to reduce the health index by 1.5 in 2021. Based on the data it is suggested that another project be completed before 2024.

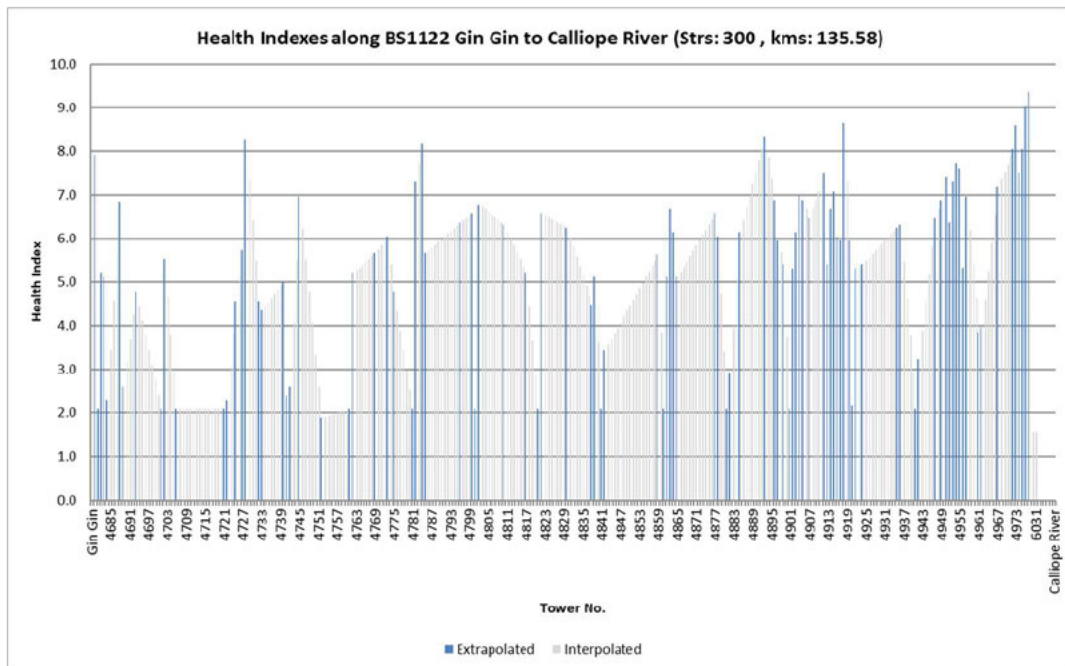
Below are the health indices of structures along the built section. These values are based on the calculated health index data for the sample of structures that were inspected. The calculated values have been extrapolated from the date they were recorded to the current year. The values for towers between known (calculated) points have been interpolated to determine a rough estimate of health index for those structures. The estimated values should not be used for calculating the asset health index.

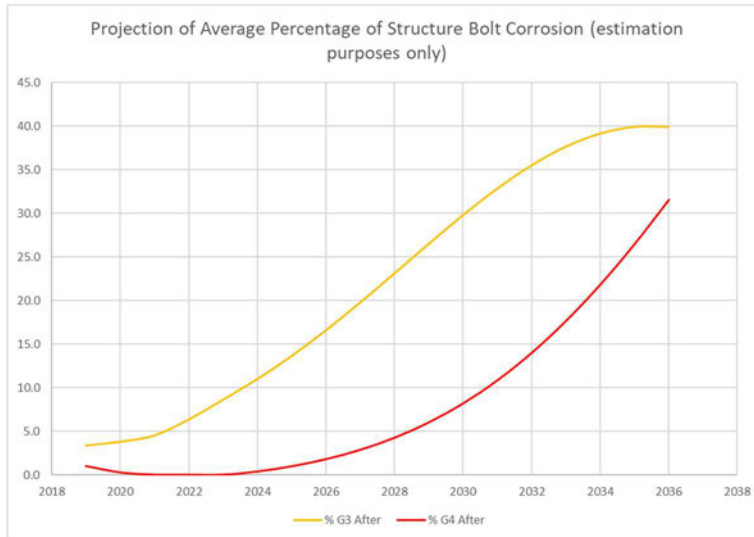
To aid with estimation, the average levels of corrosion are calculated. Below is the projection of the average level of corrosion on the entire built section based on the sample of data and an estimated service life of 52 years for bolts. The dip in the graph represents the bolts changed under the refurbishment projects.

The figures from the above graph are shown in the table below. In 2024 it is estimated that on average across the built section 11% of bolts will have reached a level of corrosion of grade 3 or higher if no additional maintenance is performed.

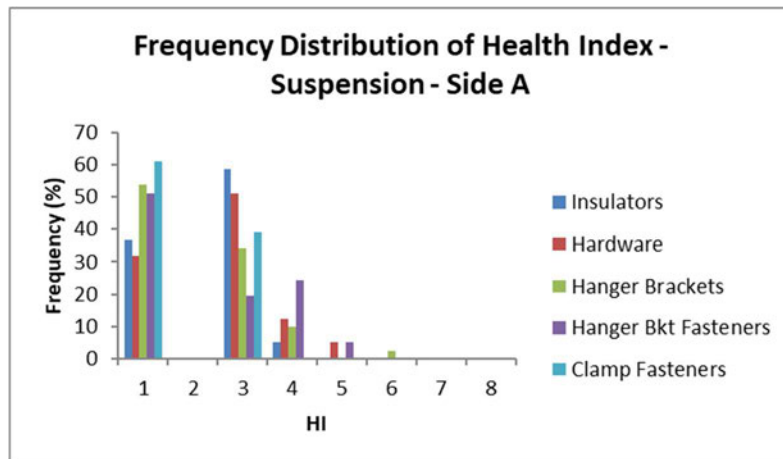
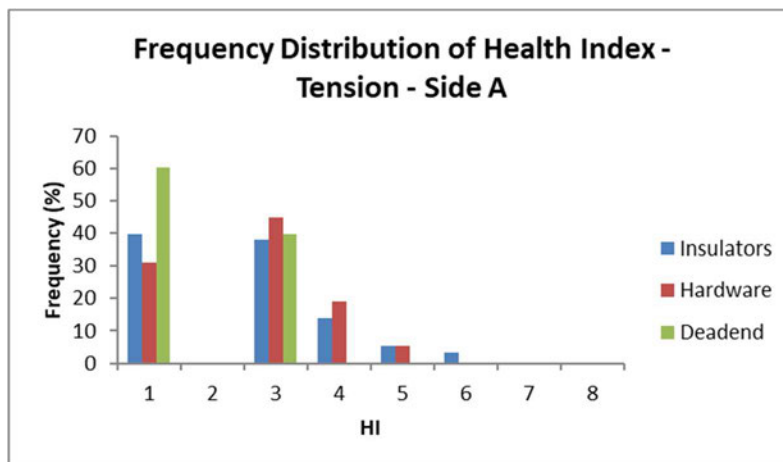
Insulator String Function	Comment	Estimated Remaining Service Life (years)
Suspension	Approximately 6% of suspension insulators were changed in 2000, 29% changed in 2003-2004, and the remaining 65% changed in 2009. All have the original hardware. The hardware needs to be replaced in the medium term.	3-8
Tension	The tension insulators are original from 1972 and 3% are showing signs of high grade 3 corrosion.	3-8
Bridging	The bridging insulators were replaced between 2000 and 2015. About 10% of bridging strings have hardware corrosion issues that need to be resolved in the short term. Approximately 3% of insulators are due for replacement in the medium term.	0-3

Below is the frequency distribution of suspension and tension insulator health index based on the sample of data.
