**Calvale Selective Primary Plant
Replacement**

CP.0XXXX – Calvale Selective Primary Plant Replacement

SITE CONDITION ASSESSMENT REPORT

H024 CALVALE

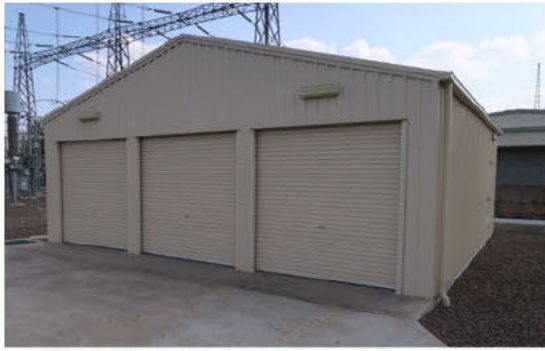
Figure 6: Storage Shed

A storage shed is located in vicinity of the control building. The shed exterior is in good condition and no issues were noted. See Figure 6.

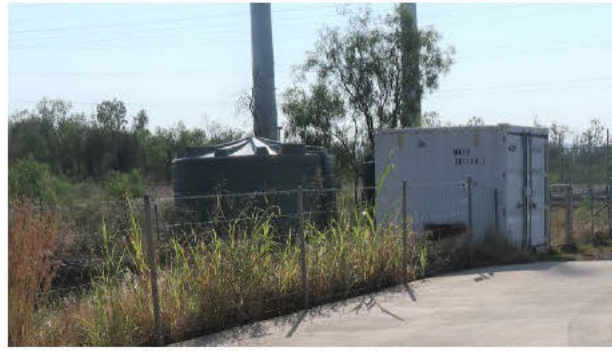
Figure 7: Water Tanks at wash-down station

There are no permanent water tanks within the yard. Two water tanks are positioned outside the yard at the wash-down station. The tanks are made from polyethylene and are in good condition. See Figure 7

Recommendation: Based on the condition it is recommended that this brick building is fit for purpose for another 40 years with regular maintenance.

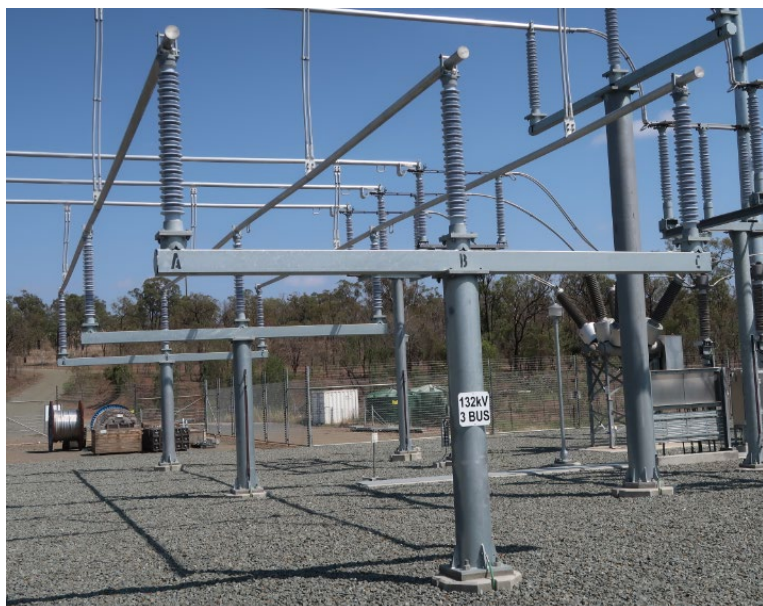
Figure 17: 132kV Bus Support Structure

The 132kV bus support structures were established in 2019 and are in as new condition. The structures support all three phases as shown in Figures 17 and 18.

Recommendation: The corroded bolts on all structures are recommended to be replaced immediately. Apart from this, based on the above observations, the primary equipment in these bays is in good condition and no replacements are required in the next 10-15 year outlook.

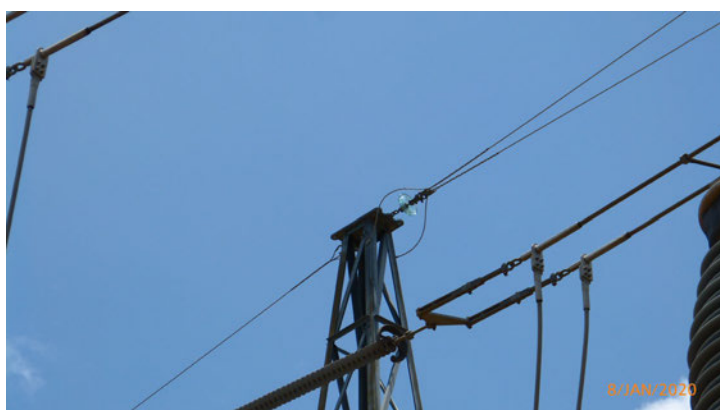
Figure 19: Earth wire

The overhead earth wire appears to be in good condition. The connections of the earth wire to their strain towers vary in configuration but these are also in good condition. Refer to Figure 16 and 17

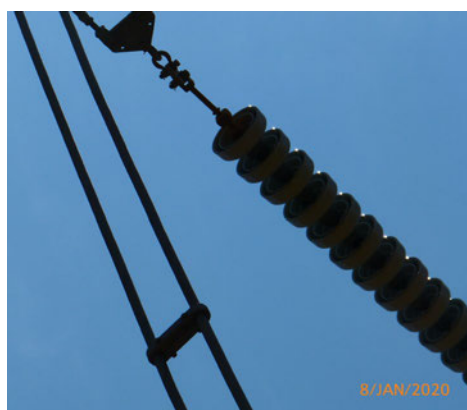
Figure 20: strung bus conductors

From ground level both 275kV & 132kV strung bus conductors and connectors over the bays appear to be in good condition.

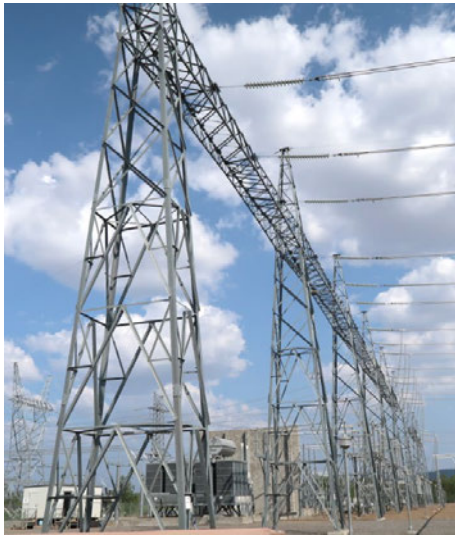
Figure 21: 275kV Strain Structure

The 275kV strain structures were established between 1984 and 2013. All 275 kV strain structures are the same lattice type as shown in Figures 18 to 19. No issues related to the structures were found.

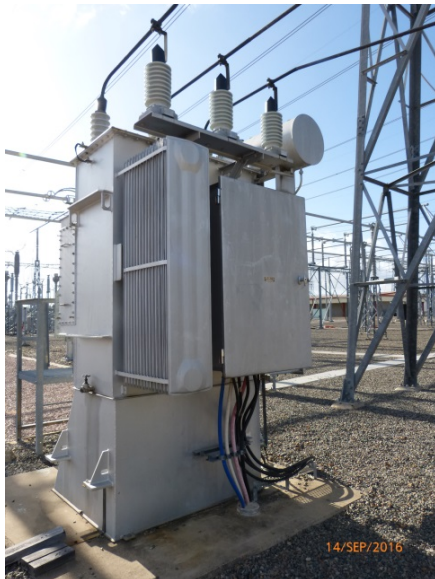
Figure 23: 3 Stn Transformer

These two station transformers are in good condition. However the 4 station transformer is 44 year old and is at the end of its technical service life where condition is expected to deteriorate rapidly.

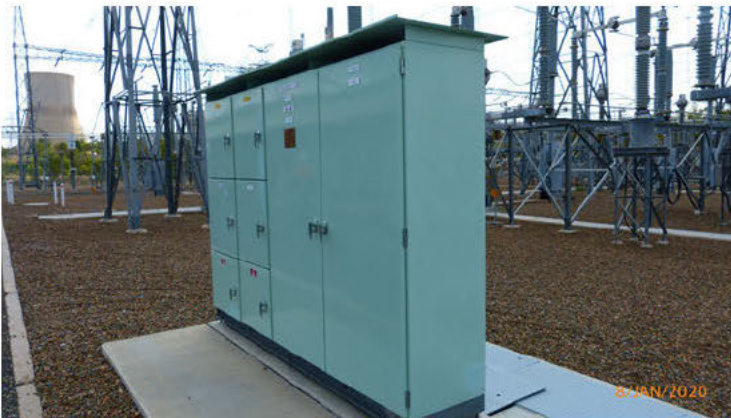
Figure 26: AC changeover board

The AC changeover board was installed under project CP.01151 and is in good condition.

Recommendation: Based on the above observations and records, there is no action required in the next 10 years outlook, apart from normal maintenance.

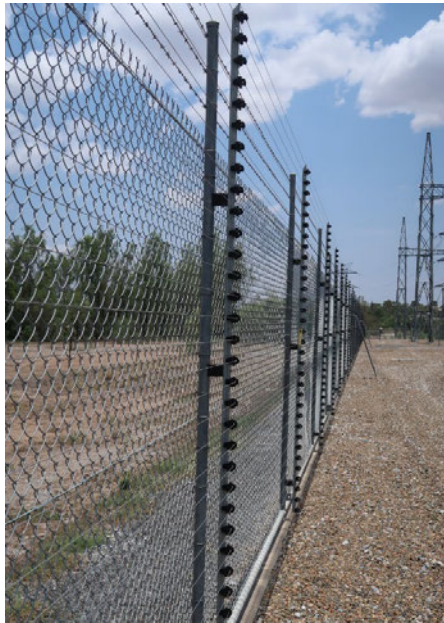
Figure 27: Security Fence

The substation security fence consists of a standard chain wire fence and an electrical fence mounted on the inside of the chain wire fence. The chain wire fence is approximately 3m tall, has a bottom rail and barbed wires at the top. At the base of the fence is a concrete strip in line with Powerlink's standard requirements. The fence is in good condition and its civil aspects should provide about 20 year life before significant repairs are required. A section of the fence is shown in Figure 27.

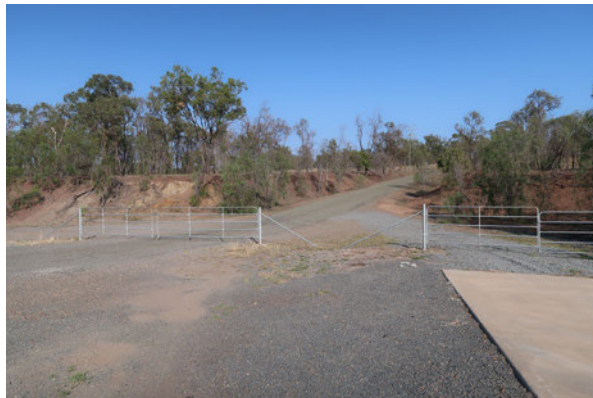
Figure 28: Substation access from Biloela Callide Rd

The Calvale Substation is accessed from Biloela Callide Rd, Biloela. This is a suburban road with good visibility of the entrance shown in Figure 28.

The access road through Powerlink's property between the road gate and the substation security gate is sealed and in good condition. The security gate and fence were not inspected due to the planned security fence upgrade project.

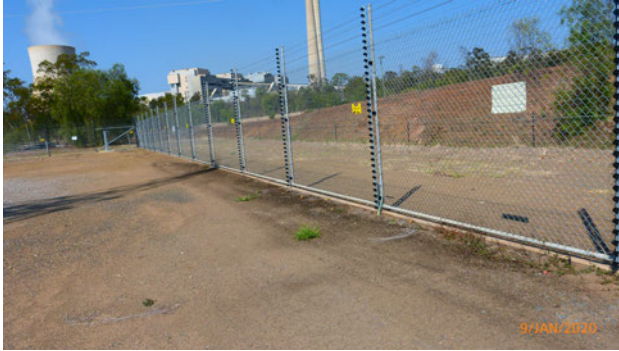
Figure 31: Gravel in the yard

A grid injection test was performed in August 2018 and the results were satisfactory. However the earth grid design report (objective ID A2984746) recommended that gravel surfacing be completed inside the north eastern fence and the south western gate and an asphalt strip placed outside these areas as a minimum and ideally gravel throughout and the asphalt around the entire yard. It appears that this recommendation was not done. The current gravel layer installed inside the substation appears to be for current plant maintenance strategies not for earthing.
