POWERLINK QUEENSLAND
REVENUE PROPOSAL

Project Pack – PUBLIC

Woree to Kamerunga 132kV Transmission
Line Rebuild

**Transmission Line Condition Assessment – Report**
BS1252 – Kamerunga to Woree**Transmission Line Condition Assessment – Report****BS1252****Kamerunga to Woree**

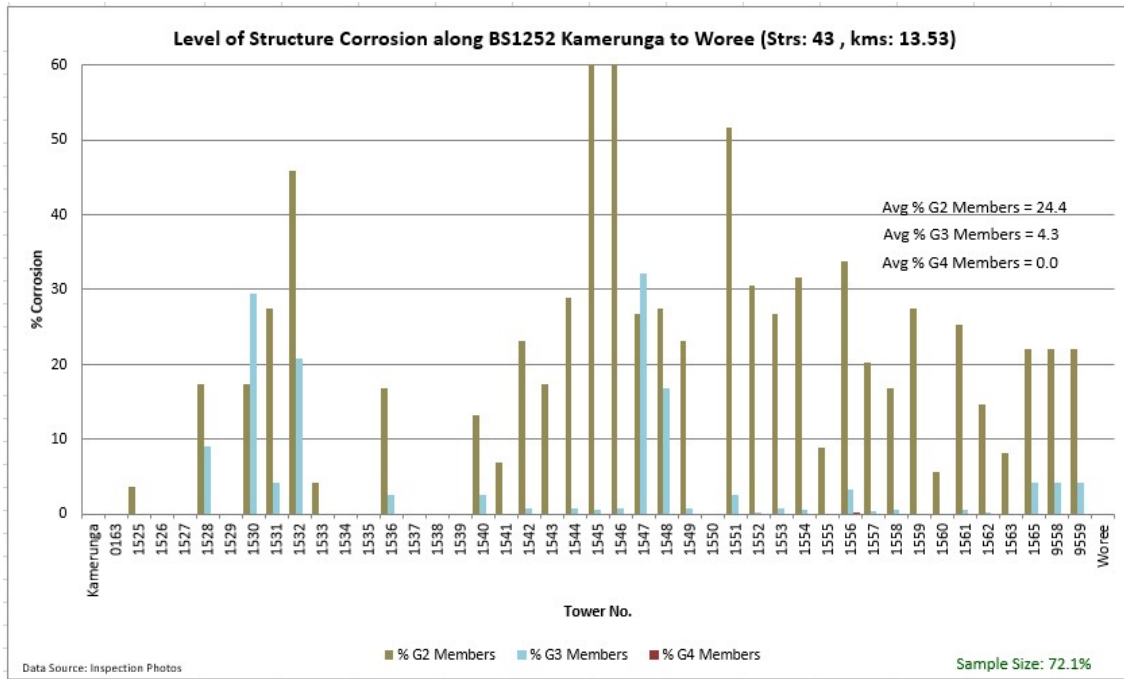
Figure 31: Structure Corrosion Levels (Members Only)

Figure 31 in Appendix shows the distribution of tower members with G2 and G3 corrosion observed on the assessed sample of structures.
