Asset Management Plan Poles

Part of the Energy Queensland Group

Executive Summary

This Asset Management Plan (AMP) focuses on the management of poles.

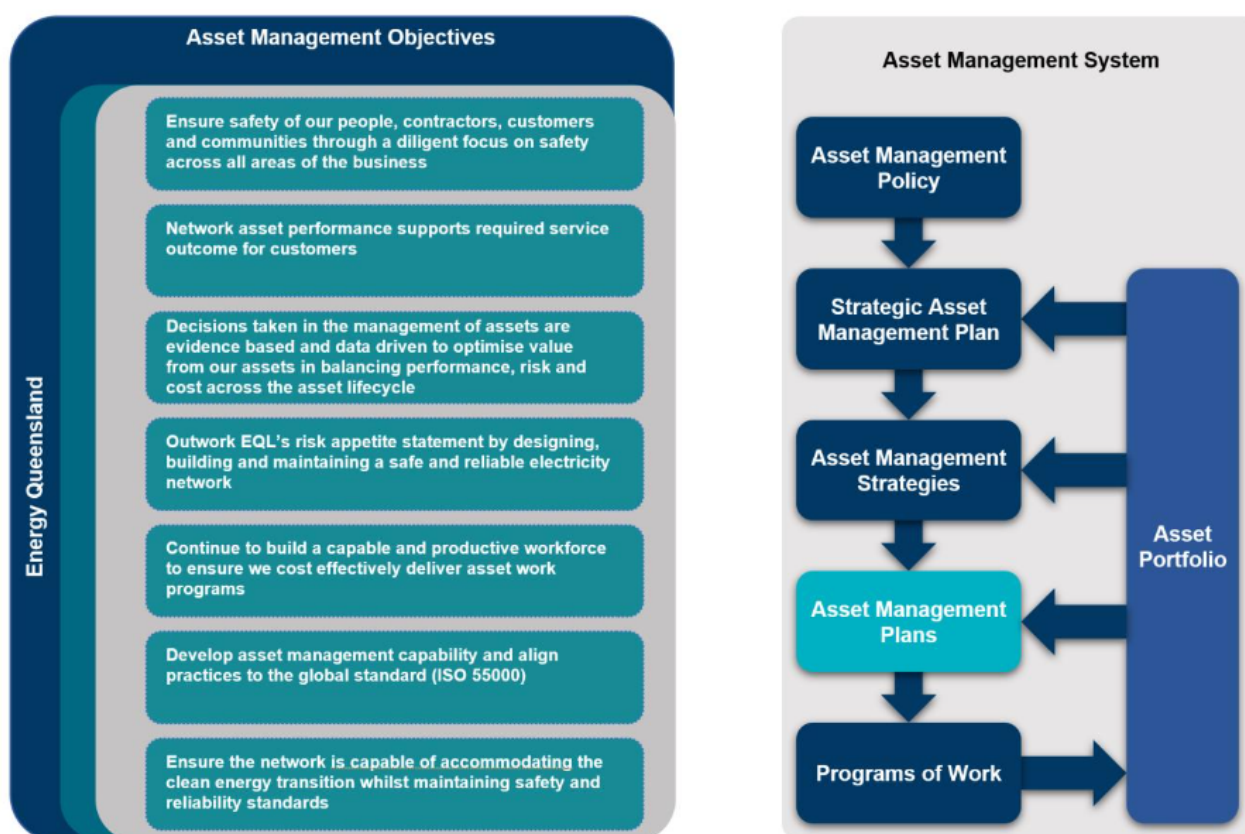
Figure 1 EQL Asset Management System

This Asset Management Plan forms part of EQL’s strategic asset management, and business objective documentation, as shown in Figure 1. It is part of a suite of Asset Management Plans, which collectively describe EQL’s approach to the lifecycle management of the various assets which make up the network used to deliver electricity to its customers. Appendix 1 contains references to other documents relevant to the management of the asset class covered in this plan.

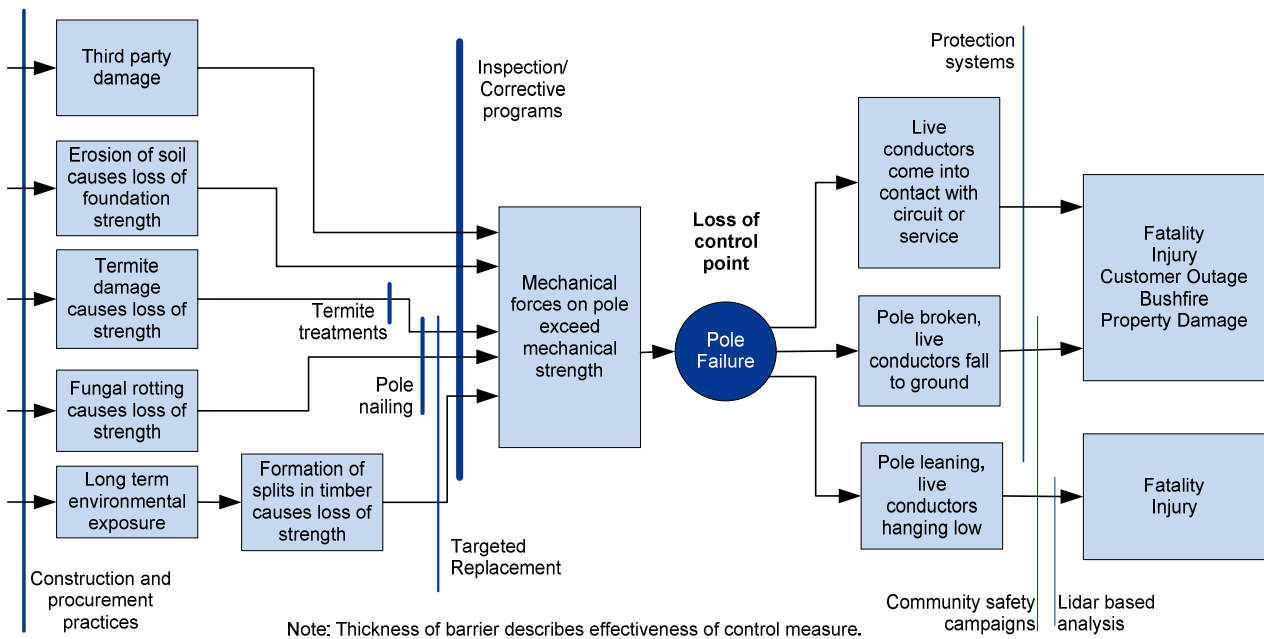
Figure 13 Threat-Barrier Diagram for Wood Poles

Figure 13, Figure 14, and Figure 15 provide threat-barrier diagrams for the different pole materials. Many threats are unable to be controlled (e.g. lightning), although EQL undertakes a number of actions to mitigate their safety components SFAIRP. Failure of a pole risks public and staff safety in several ways, most notably:
