Asset Management Plan Poles

Executive Summary

This Asset Management Plan (AMP) focuses on the management of poles.

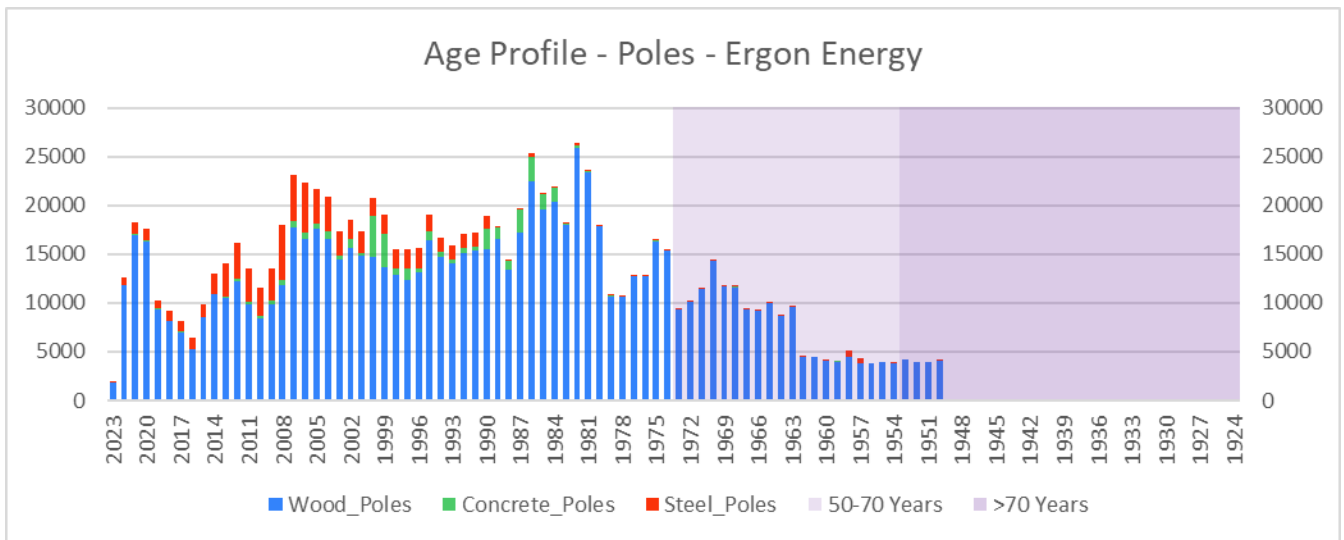
Figure 4 Pole Age Distribution – Ergon Energy

Figure 4 provides an age distribution of all poles in Ergon Energy region. Pole year of manufacture (YOM) is stamped on pole discs and recorded at site asset inspection which can lead to a delay in reportable pole age. Approximately 19% of the current Ergon Energy pole population is older than 50 years old, with another 5% of the population due to reach this age in the next 5 years.

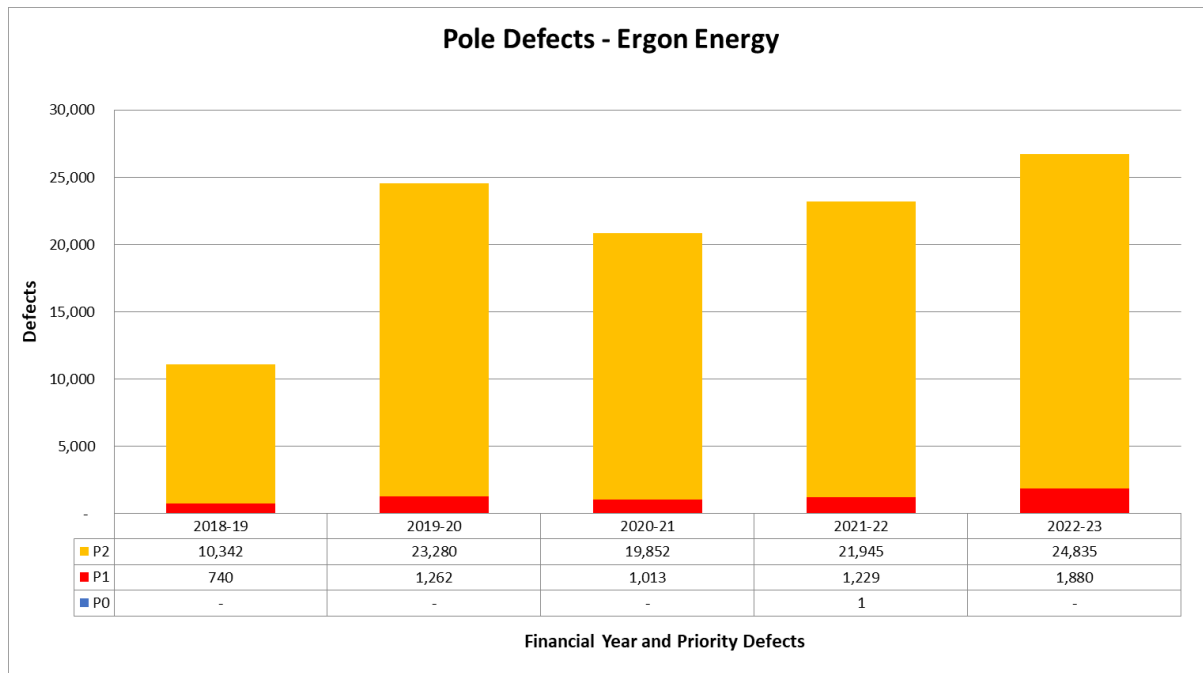
Figure 10 Pole Defect Totals – Ergon Energy

Figure 10 and Figure 11 demonstrates the number of defects identified on EQL poles. Identified defects are scheduled for repair according to a risk-based priority scheme. The P0, P1 and P2 defect categories relate to priority of repair from P0 requiring immediate rectification through to P2 where the normal planning processes are employed for rectification.
